The ICL Inquiry Report

Explosion at Grovepark Mills, Maryhill, Glasgow
11 May 2004

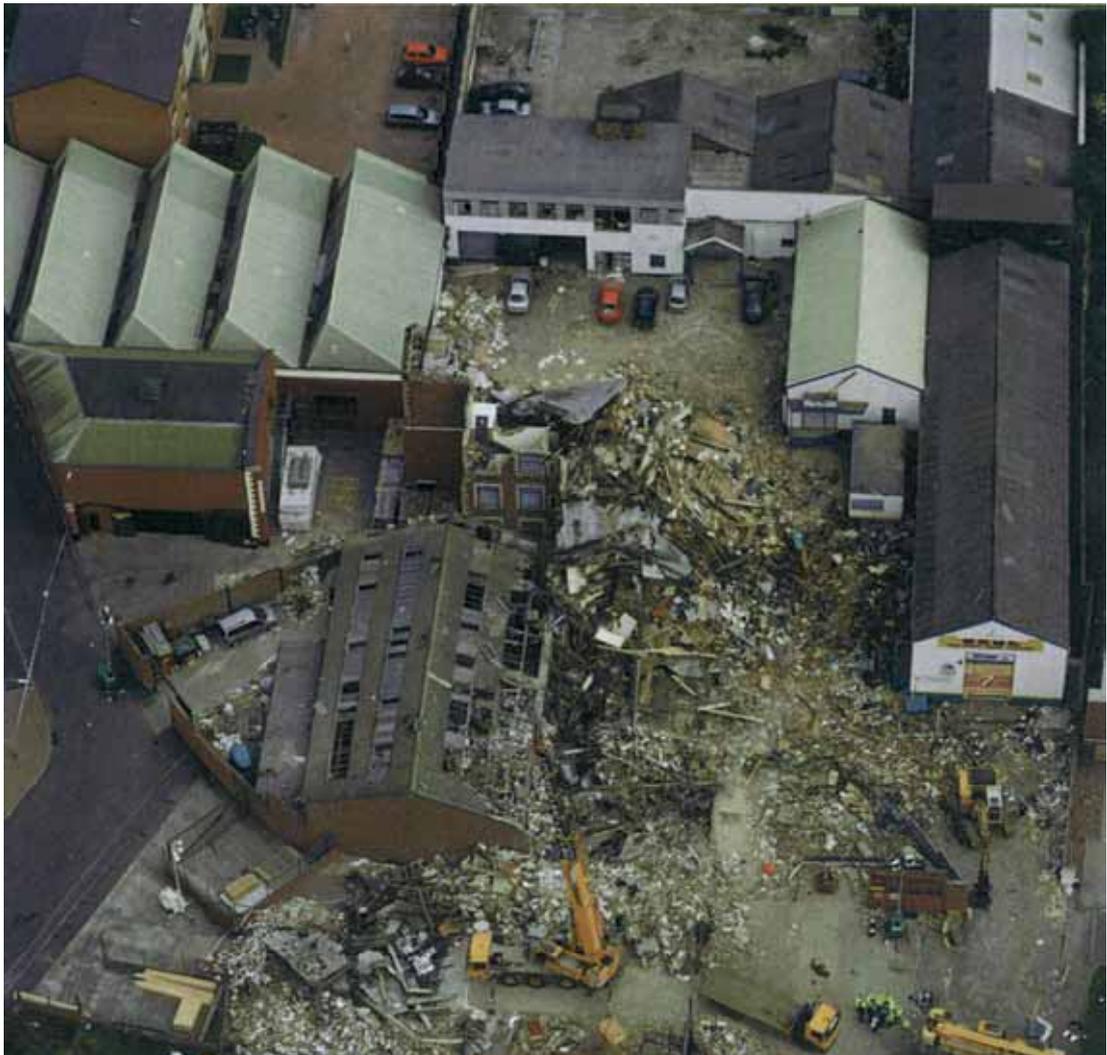
Figure 1 - Image copyright of HSE

On Tuesday 11 May 2004, at about noon, an explosion occurred at Grovepark Mills, Maryhill, Glasgow which caused the substantial collapse of the former Mill building. As a result, 9 people lost their lives and 45 people were seriously injured or exposed to the risk of death or injury.

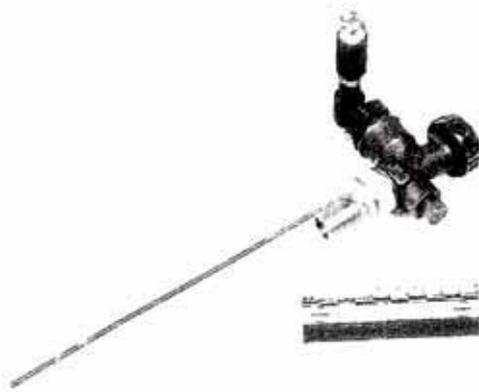
Figure 18 – The vapour take off valve fitted to the one-tonne propane storage tank

The one-tonne tank that had been fitted by Johnston Oils on 29 November 1998 was fitted with a vapour off-take valve (Fig. 18).

Although the valve appeared to have been originally fitted with an excess flow valve, which fitted into the base of the valve, the inner workings of the valve were absent when Dr Hawksworth inspected it. There was evidence that the working components of the valve had been in place at some time. This type of excess flow valve is intended to protect against a full pipe failure, or shear. It is not intended to offer any protection against a crack or a split in the pipe; nor to protect an underground pipe. The ICL installation was unusual in that there was no second stage regulator because of the high operating pressure of the oven.

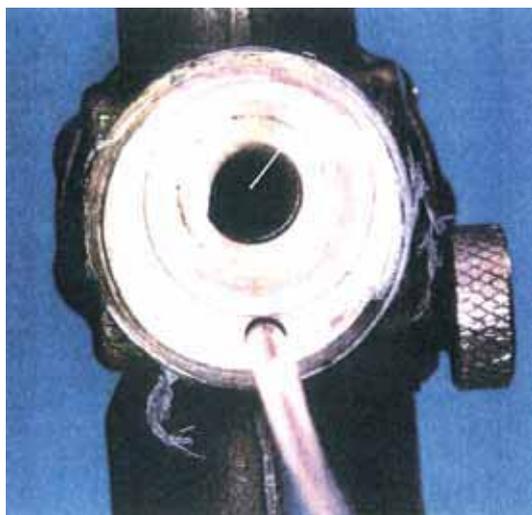
Figure 19 – The witness marks (arrow) left by the missing excess flow valve spring

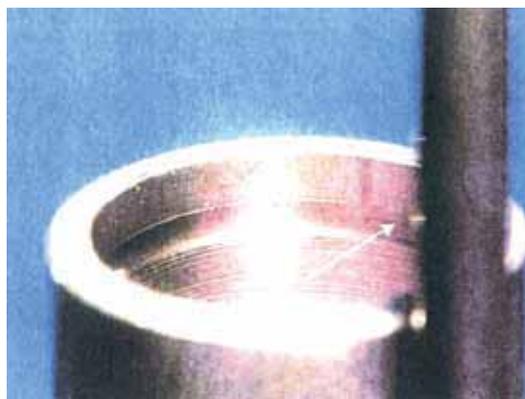
Figure 20 – The witness marks (arrow) in the circlip groove left by the missing excess flow valve circlip

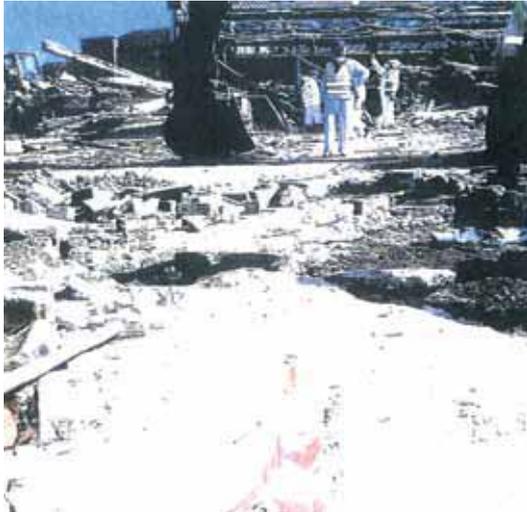
The underground pipe connecting the LPG storage tank to the LPG-fired oven was excavated. There was a right-angled bend in the pipe near to the wall of the building. Where it turned from the vertical to pass horizontally through the basement wall the pipe was significantly corroded. There was a crack in the underside of the right-angled bend which caused a considerable leak close to the entry point of the pipe into the basement. The crack extended to about 71% of its circumference.

Figure 23 – The position of the LPG pipe as it enters the ground from the one-tonne propane storage tank end.
