**INTERSERVE**

**Underground Caverns at Rhydymwyn, Mold**

**Report on Inspection, Remedial Works and Monitoring**

**21 March 2013**

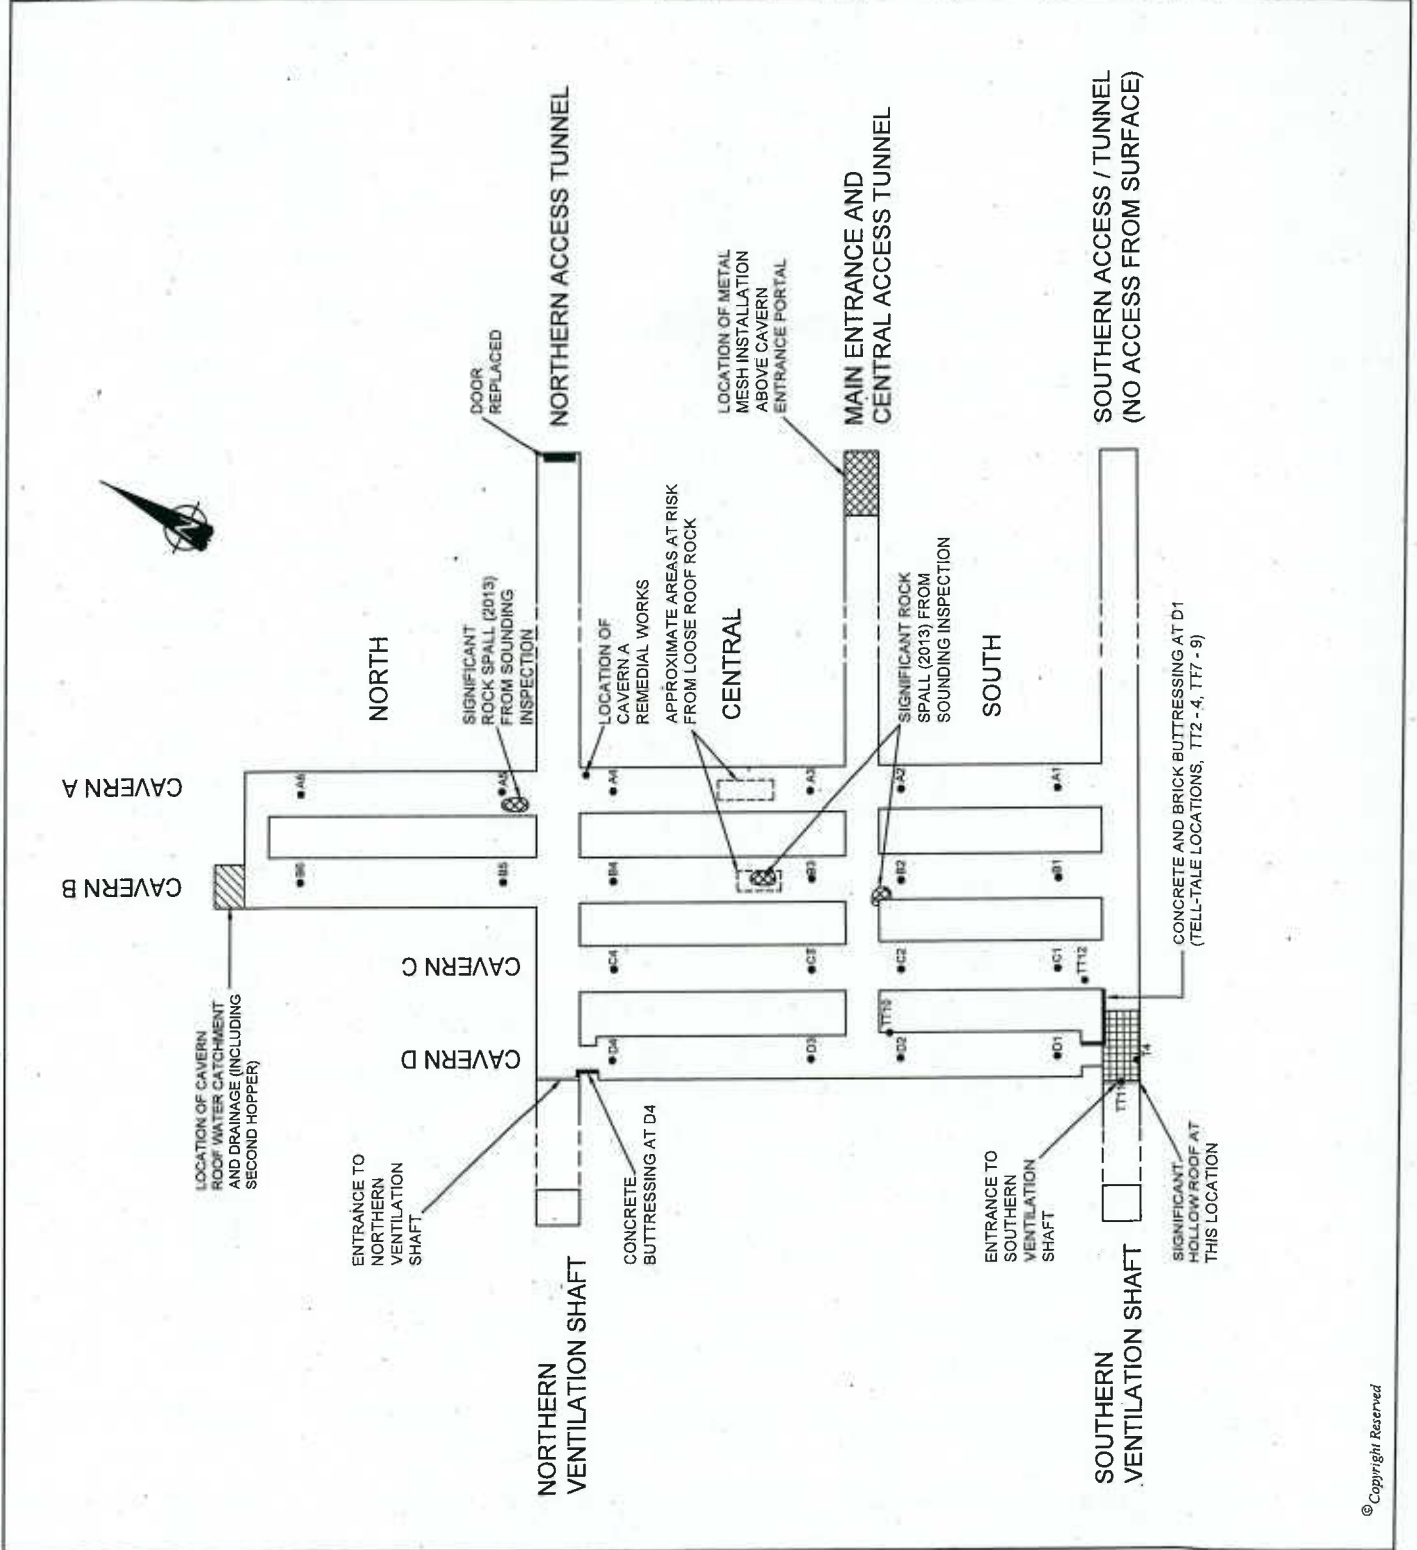
2.23 Directly within the cavern entrance portal previous inspections had determined that the concrete had deteriorated in part where the concrete roof is bisected by the former Cavern ventilation system, posing a risk to visitors to the Caverns. Remediation works were carried out to mitigate this hazard and are discussed later in this report. This area is indicated on Drawing No. NL00910/02.

- 2.26 Three specific areas where significant roof material was barred down occurred at the following approximate locations within the Caverns (indicated on Drawing No. NLO0910/02):

- convergence point A5;
  - the corner of the pillar immediately west of convergence point B2;
  - 15m north of convergence point B3.
- 2.27 The material was barred from the edge of roof slabs previously identified as being a hazard of falling due to sounding hollow previously. The material at each location comprised less than a volume of approximately 1.0m by 1.0m. There was also occasional “hollow” spots identified in Caverns C and A.

- 2.28 During the roof inspection of Cavern D outside the entrance to the tunnel leading to the southern ventilation shaft, the sounding inspection encountered significant “hollow” roof indicated on Drawing No. NLO0910/02. This area continues to pose a significant hazard and it may be necessary to cordon off the area to visitors or erect supports.

- 2.29 During the 2012 inspection, an approximate area of 12m x 4m, was identified to be “hollow”, located approximately 15m to the north of the main entrance tunnel adjacent to convergence point B3 shown on Drawing No. NLO0910/02. TL Excavations marked up the floor beneath this area to provide warning of loose rock above. A significant spall was identified associated with this area during the 2013 inspection and this particular area poses a safety risk.

- 3.3 A wire mesh has been installed above the cavern entrance portal to reduce the risk of future spalling impacting on visitors to the Caverns the location of which is shown on Drawing No. NL00910/02.
- 3.4 The wire mesh has been installed in such a way as to arch under the space where concrete would fall into, immediately above the floor of the main entrance. The wire mesh will now catch any spalling concrete and the risk of spalling concrete to visitors has now been mitigated.

- 3.11 The door accessing the northern tunnel was deemed to be in an unfit state and has now been replaced. The location of the replaced door is shown on Drawing No. NL00910/02.
