# Defence Infrastructure Organisation

## SAFETY ALERT

Subject: Windsock Inspections

Number: 10/13

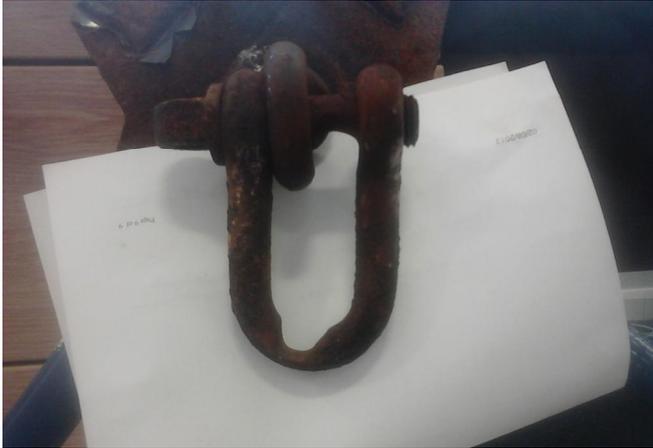
- a. A windsock frame was found to have suffered excessive mechanical wear over many years, with the shackle and fixing bolt on the point of failure, having lost upto 90% of their cross-section. The concern is that inspections had been undertaken within 26 months and certificates provided, but it was clear that the excessive wear and tear had probably been ongoing for over 10 years undetected.

15mm thick shackle is worn through at least 2/3rds of its diameter and  $\frac{3}{4}$  of its cross sectional area.

- a. The inspection of windsock frames and the supporting structure requires all elements to be thoroughly examined for signs of corrosion, damage or mechanical wear and to check for the correct operation of moving parts and mechanisms, including:

- (i) The windsock lowering mechanism and its hinge components, if it is a lowerable device.
  - (ii) Shackles, eye-bolts, swivels, fixing bolts, other connection points including welds and particularly any moving parts.

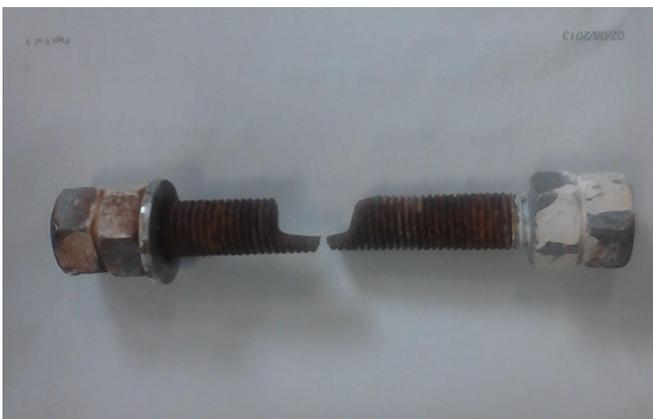
16mm diam. bolt is worn through 80% of its diameter and over 90% of its cross sectional area. This bolt fractured immediately on attempting to undo the nuts and disassemble the components.

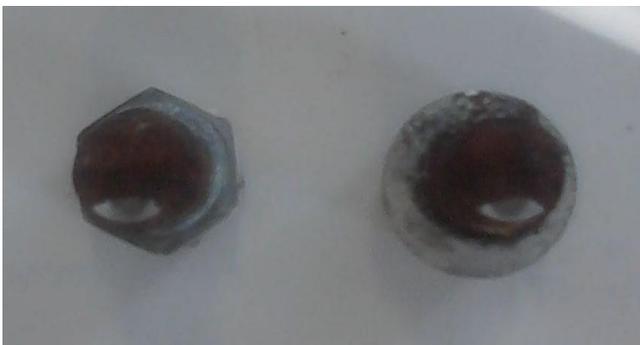
In lieu of a 16mm diam bolt with 201mm<sup>2</sup> cross-section area, only about 19mm<sup>2</sup> remained with a max thickness of 2-3mm.
