SECTION 1.4.3 – EJECTION SEAT FAILURE

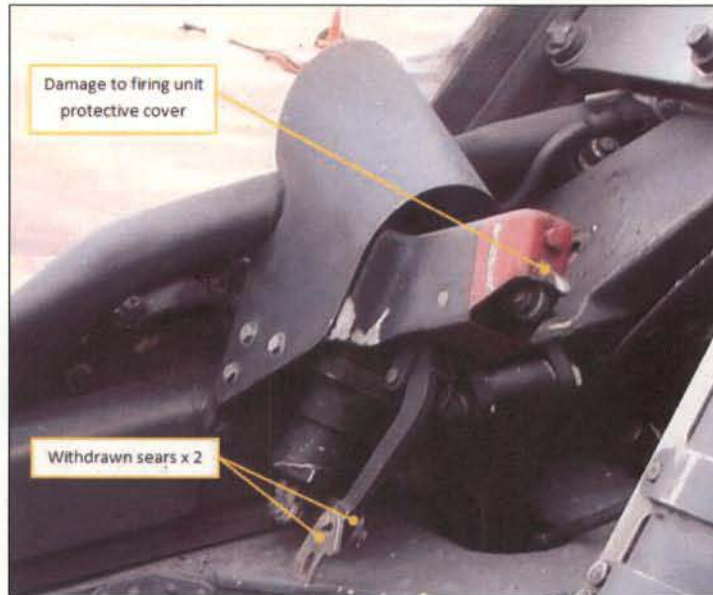
Figure 33 – XX177 Front Cockpit MDC firing unit and lever.

d. The front cockpit canopy MDC firing unit sears had withdrawn from the MDC firing units and the MDC had fired. Damage to the MDC firing unit lever protective cover indicated that the firing unit lever had operated by contact with the ejection seat striker (see Figure 33) as expected and this was **not a factor** in the accident.

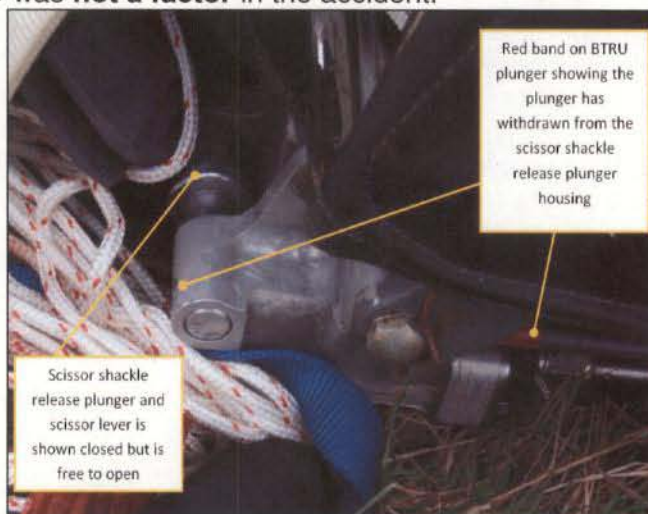
Figure 34 – XX177 BTRU Shackle Plunger.

h. The BTRU timer mechanism operated within expected limits and had released the scissor shackle release plunger (see Figure 34) and the scissor shackle jaws were found unlocked and free to open. The Panel concluded that the BTRU was **not a factor** in the accident.

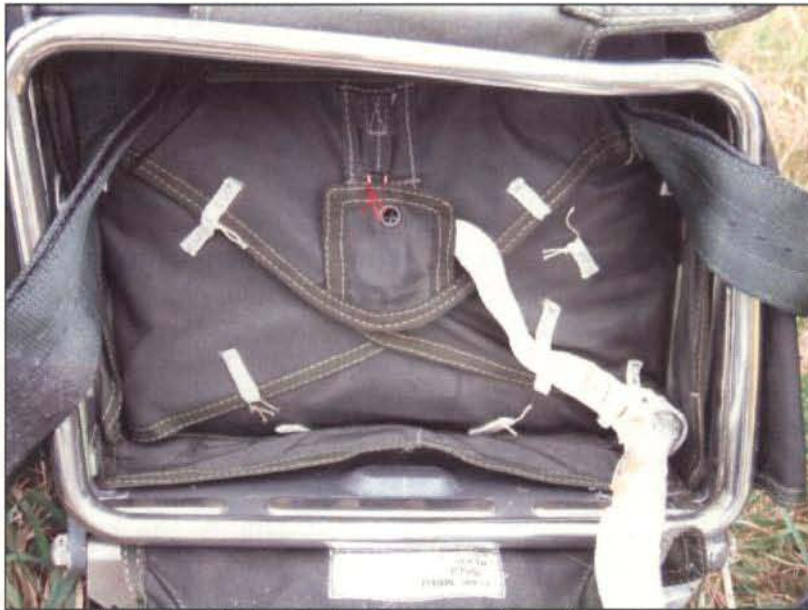
Figure 35 – XX177 Duplex Drogue and Parachute Container.

- i. The upper and lower harness locks were released and the strap lugs unrestrained consistent with normal operation of the BTRU and was **not a factor** in the accident.
- j. The sticker straps remained in place and intact and were **not a factor** in the accident.
- k. The parachute remained stowed in the parachute pack container and had not deployed; the parachute pack container was found distorted but intact (see Figure 35). The parachute retaining flaps were closed; one of the flap securing ties was intact and three flap ties had broken. Further examination of the parachute pack at RAFCAM determined that the parachute had been correctly packed. Functional testing demonstrated correct parachute pull-out sequence and operation; indicating that the parachute packing had not restricted the deployment of the main parachute and that it was **not a factor** in the accident.

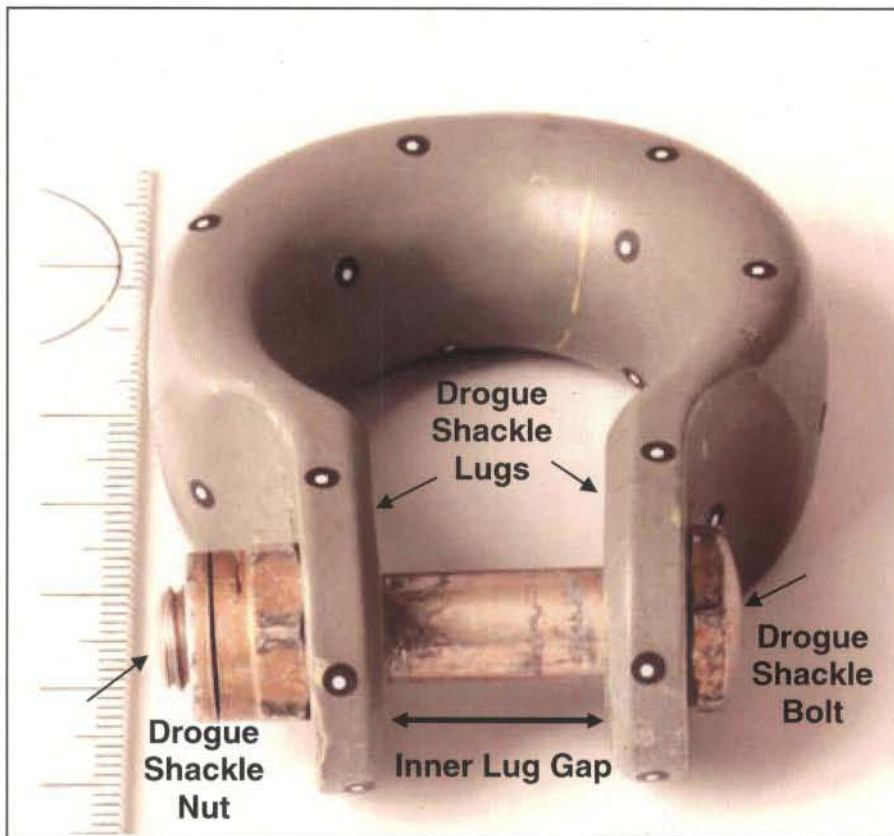
Figure 39 – XX177 Drogue Shackle.

- a. **Drogue Shackle Lug to Lug Gap.** The gap between the internal faces of the two lugs on the XX177 drogue shackle components was 0.098 inches too small (see Figure 39). When the nut was undone and the components separated, the lug to lug gap returned to within drawing specification; demonstrating that the compression out of tolerance was caused by fitment of the drogue shackle nut. It is most likely that the drogue shackle was manufactured within drawing specification. The effect of this compression is significant and is discussed below. The Panel concluded that drogue shackle manufacture was **not a factor**.

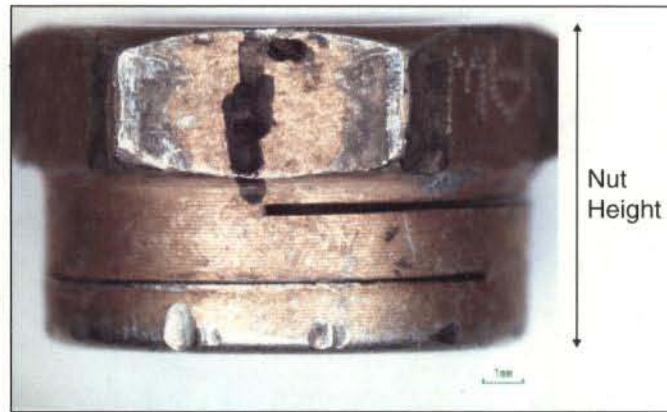
Figure 40 – XX177 Drogue shackle nut.

- b. **Drogue Shackle Nut.** The nut fitted to XX177 drogue shackle was 0.007 inches higher than the drawing specification (see Figure 40). By design, all locknuts plastically deform to create the required locking mechanism, increasing their height during fitment. Locknuts of the same specification as that fitted to XX177 were tested to ascertain the extent to which they deform. Following comparison, the Panel concluded that the drogue shackle nut fitted to XX177 was most likely manufactured within drawing specification and was **not a factor** in the accident.

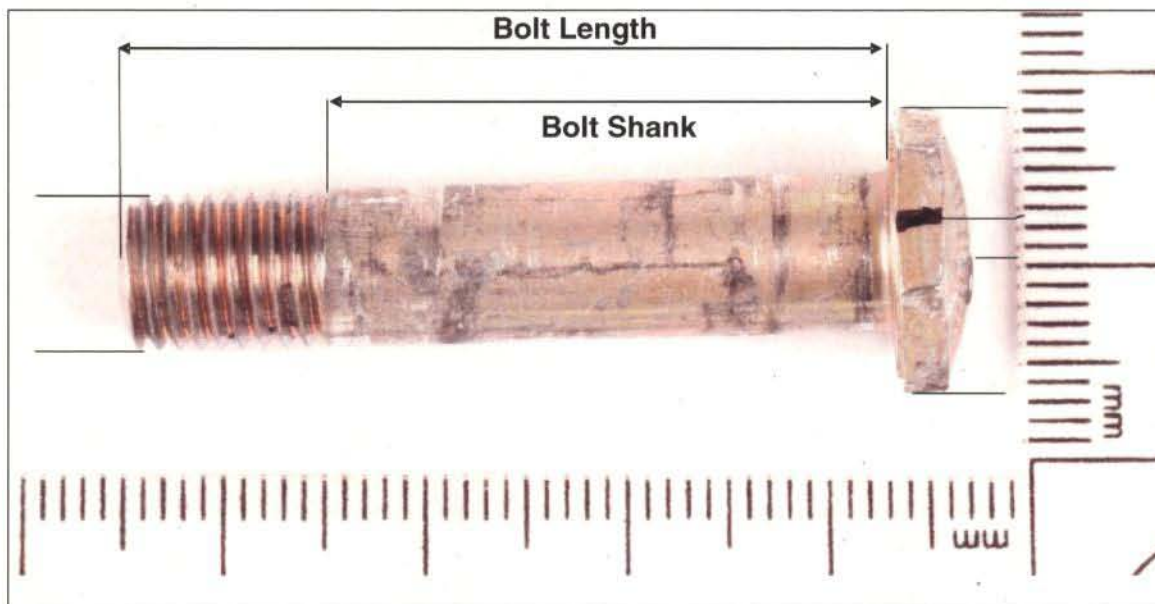
Figure 41 – XX177 Drogue shackle bolt.

c. **Drogue Shackle Bolt.** The dimensions of the XX177 bolt were within tolerance. Evidence existed of thread having been 'cut' during fitment of the drogue shackle nut. Testing revealed that other in-service bolts, including those that were un-used, although having the correct overall bolt length had a shank length marginally shorter than that required by design specification (See Figure 41). The Panel concluded that the specific finding of bolts with a short shank length was not a factor; however, that there were aircraft components in circulation that were outside of design specification might be indicative of a shortfall in quality control and was **an other factor**.

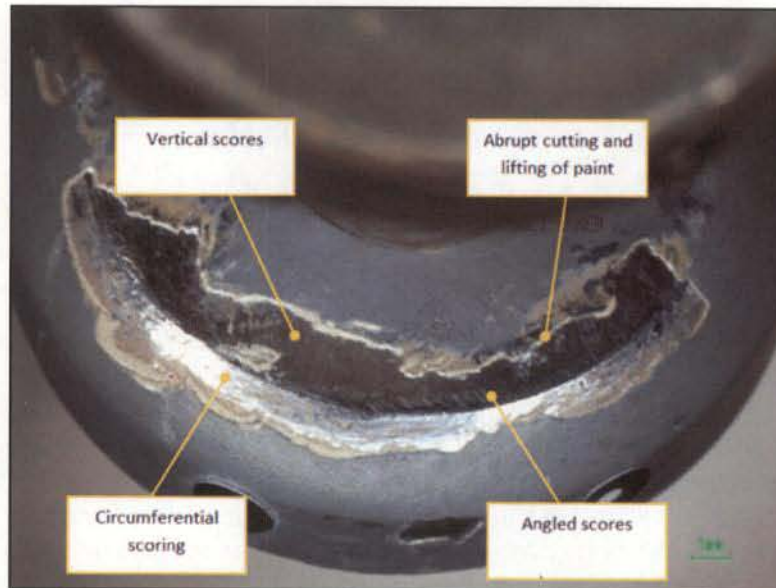
Figure 42 – XX177 Drogue Shackle Damage.

a. **Drogue Shackle.** A number of areas of damage were found adjacent to the shoulder (see Figure 42). Abrupt lifting of the paint, consistent with heavy localised loading, was identified along with angled, vertical and circumferential scoring. The drogue shackle lugs had been compressed by the drogue nut and bolt to such an extent that an interference fit of 0.009 inches existed between the drogue and scissor shackle (see Figure 43).

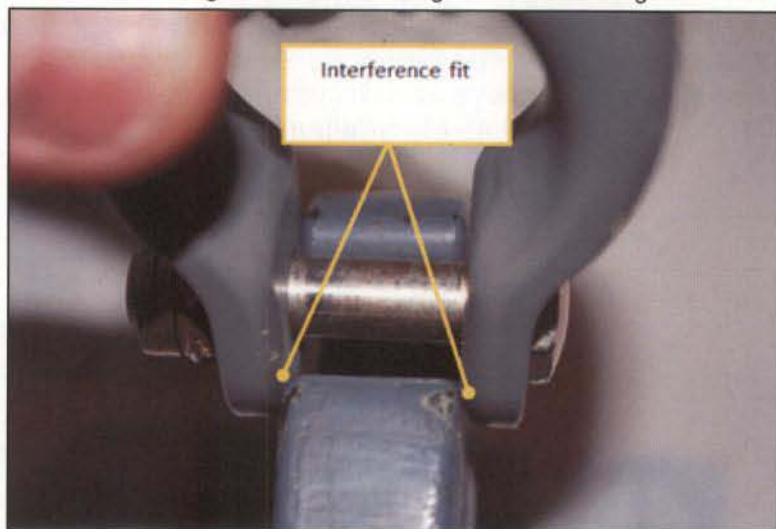
Figure 43–Drogue & Scissor Shackle Assembly (not XX177) showing interference fit.

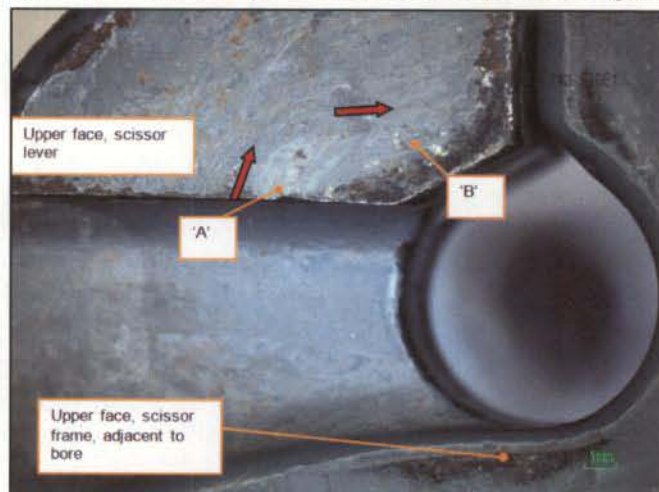
Figure 44 – XX177 Drogue Scissor Lever Damage.

b. **Scissor Assembly.** Visual examination of the scissor lever revealed scoring in an arc running from the bottom horizontal edge of the upper jaw face (see Figure 44) point A towards the vertical jaw edge (see Figure 44 point B).

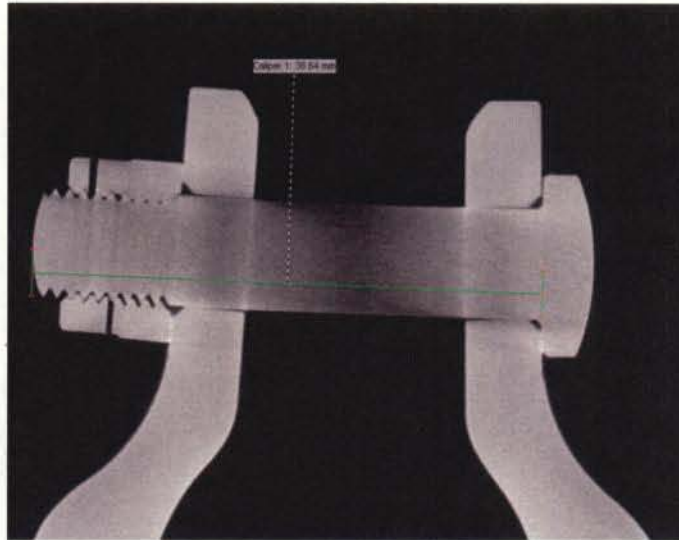
c. **Drogue Shackle Nut and Bolt.** The drogue shackle nut was tightened to 1.5 threads bolt protrusion above the nut (see Figure 45). There was no significant internal damage to the threads. However, evidence of swarf¹⁰ was found on removal of the nut, and the bolt had two separate score marks close to the unthreaded portion of the shank; the threads of the bolt exhibited adhesive wear in the region of contact with the nut threads. This suggested that the nut had bottomed out on the unthreaded shank of the bolt and cut new thread.

Figure 45 – XX177 Drogue Shackle Bolt showing bottoming out of the threads of the nut.

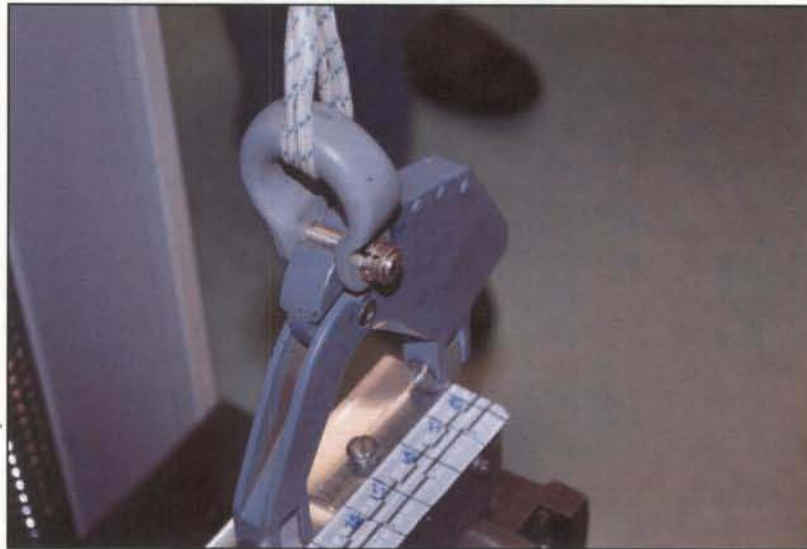
b. **Nut Fitted to 1.5 Threads (Representative Components).** Component parts taken from the stores system were measured for manufacturing tolerance. While many different combinations of components were used during testing, this particular test was carried out using the 'worst case' combination of components¹². This configuration resulted in drogue shackle lug compression which created a 0.023 inch interference fit with the scissor shackle. The drogue shackle failed to release from the scissor assembly despite the test rig applying a force of 756 N. Repeated testing found that as the bolt attempted to pass through the gap in the scissor lever, the drogue shackle lugs jammed on the scissor lever jaw (see Figure 47). Additionally, visual examination of the inner surfaces of the drogue shackle jaw concluded that the abrupt severance of paint, consistent with heavy localised loading, was similar to that found on XX177.

Figure 47- The drogue shackle jammed on the scissor shackle jaws.
