# Post Incident Annual Report 2010

# Foreword

We publish this report so that all those involved in reservoir safety learn from past incidents and by sharing experience we improve safety in the future. Please continue to help by reporting all incidents no matter how small or insignificant they may appear.

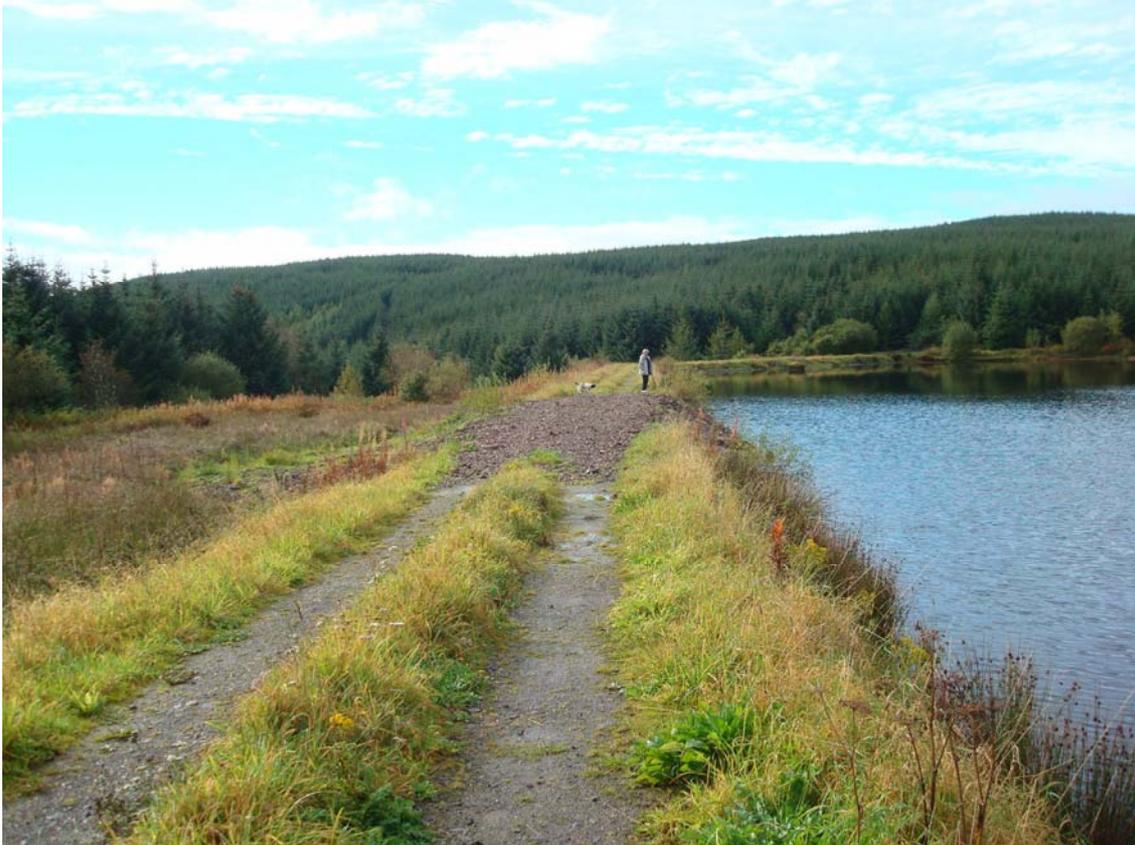
Leakage through the peat foundation of an embankment dam became obvious as snow melted. The scour valve was opened to lower the reservoir water level. A section of the dam had to be rebuilt.

The leakage is believed to have been due to unusually high reservoir water levels after the spillway culvert was blocked with logs about one month earlier. These logs were believed to have been deliberately placed in the culvert by vandals from a stockpile that had been placed near to the dam following forestry works. The reservoir is used for trout fishing.

Photo 1: Reservoir affected by Incident 345

There are several lessons that can be learnt from this incident. The design of the dam meant that it could not withstand the pressure from the raised water levels. The problems with the peat foundation of the dam were solved by rebuilding a section of the dam.

Storing the logs by the reservoir meant that it was easy for vandals to block the spillway. Owners should consider whether items kept close to dams can be misused and threaten reservoir safety.

Surveillance was carried out by the local fishing club, but there was no regular surveillance outside of the fishing season. If the vandalism had been noticed earlier, action could have been taken to reduce the level of water in the reservoir.

Responsibility for routine surveillance has now passed to the forestry company.

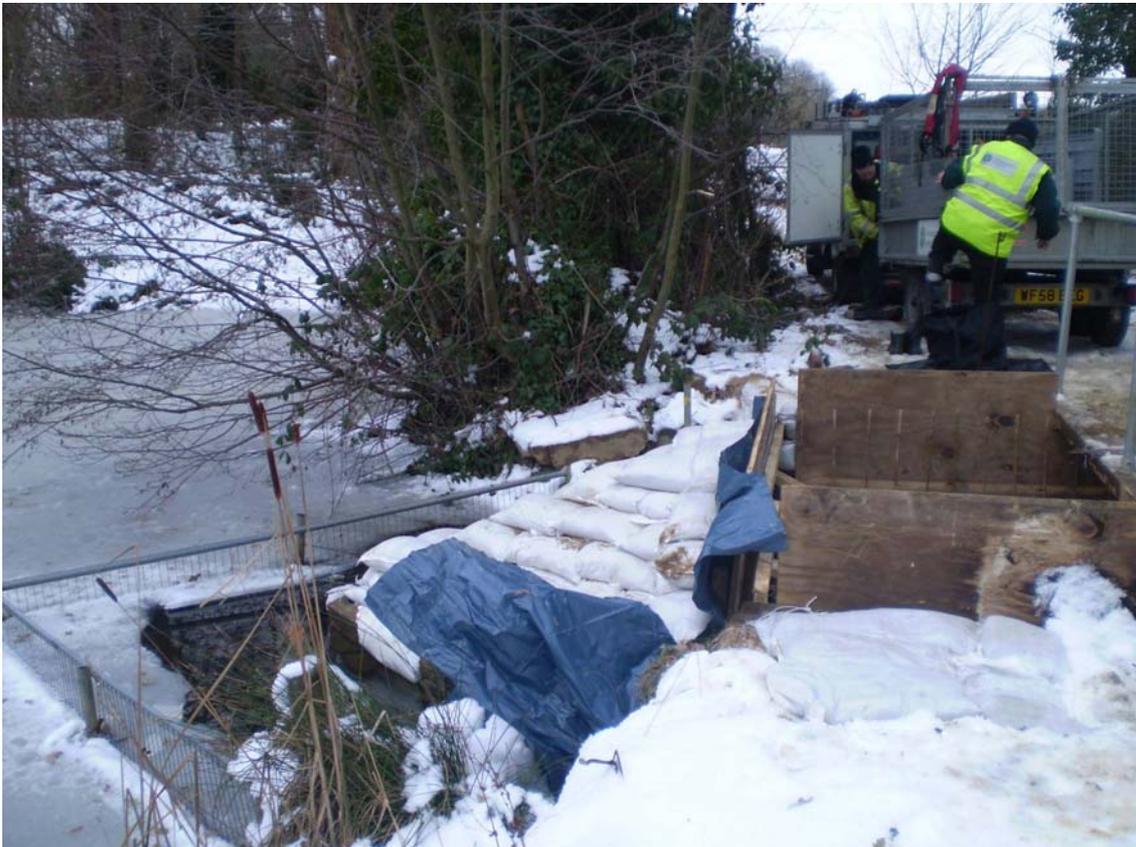
A new spillway had been designed for this earth embankment reservoir. The owner of the reservoir started construction without any professional supervision. Excavation for the spillway was carried out without any cofferdam and the notch for the new spillway was left unprotected with the sill close to the reservoir level.

The supervising engineer visited the site following heavy snowfall, when rain was forecast. There was no means of lowering the reservoir water level. Urgent works were arranged to protect the spillway excavation from flood erosion using sandbags.

Photo 2: Spillway works at reservoir affected by incident 348

This incident highlights the importance of effective surveillance and communication with undertakers, especially when safety works are being planned or under construction. Any construction works at a statutory reservoir that affects reservoir safety must be overseen by a qualified civil engineer in accordance with the Act.
