Review of Incidents at Hazardous Waste Management Facilities (Version 2.7 October 2013)

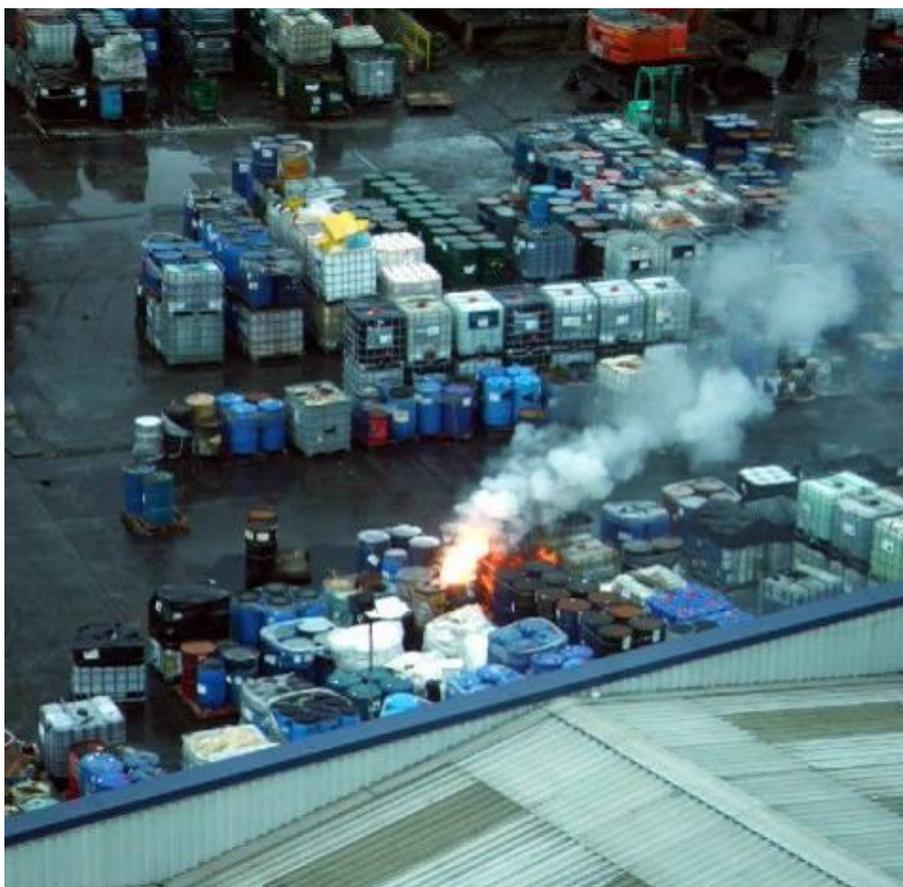
A fire was initiated after the lid on a 205 litre drum stored in the waste reception area was removed / loosened by an operative to enable the contents to be sampled and tested by the Site Chemist. It had previously been raining and it is believed that the waste in the drum had water reactive properties, giving rise to ignition, and a fire started.

Photo 1 – fire initiation (photo taken from adjacent office block)

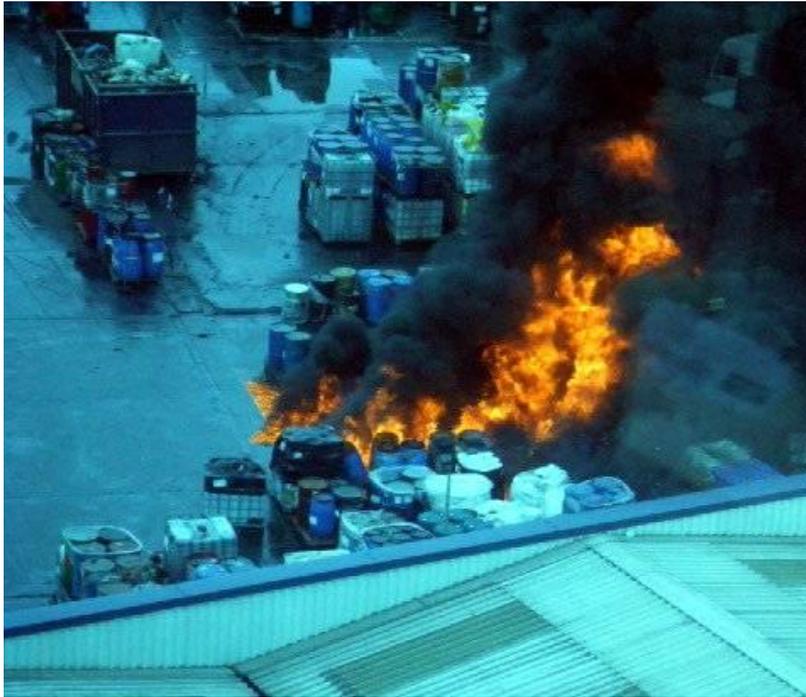
As containers in that area became hot, they pressurised and their lids were ejected from the site. Large volumes of dark smoke were emitted and the industrial estate units adjacent to the southern boundary were evacuated as a precaution. The police and fire service attended, as did a local environmental health officer.

Photo 2- fire escalation (note some reflection from the window)

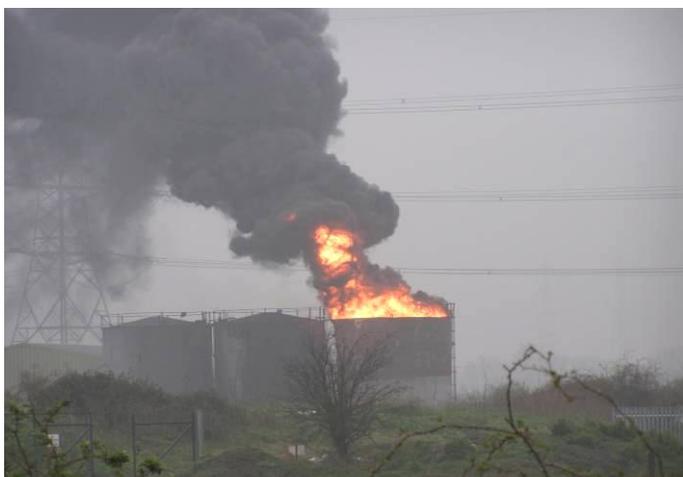
Figure 1 - Tank 4 on fire

During the morning of Monday 30th March an explosion caused one of the tanks on site (Tank 14) holding approximately 250,000 litres of oil to catch fire. The tank was located within a bund along with two further tanks. The bund walls were of breeze block construction with a concrete floor and had no drainage systems penetrating the wall or floor.

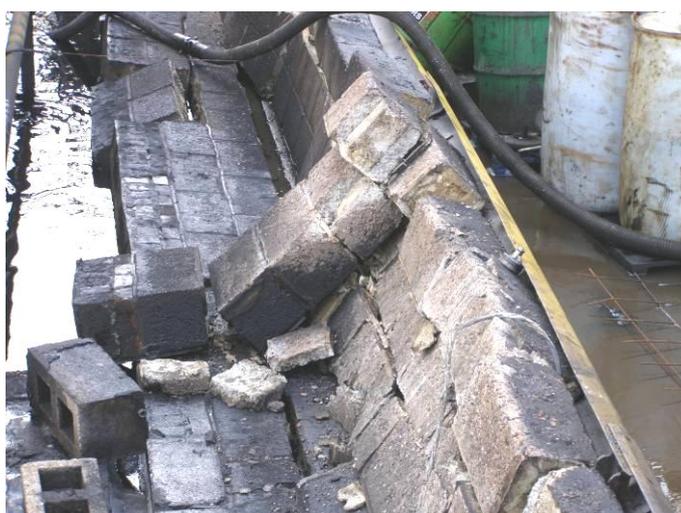
During the incident the bund became full with burning oil, firewater and foam, but shortly after the fire was extinguished (at 13:40) it collapsed outwards against an outer crash barrier.

Figure 2 - Collapsed bund wall

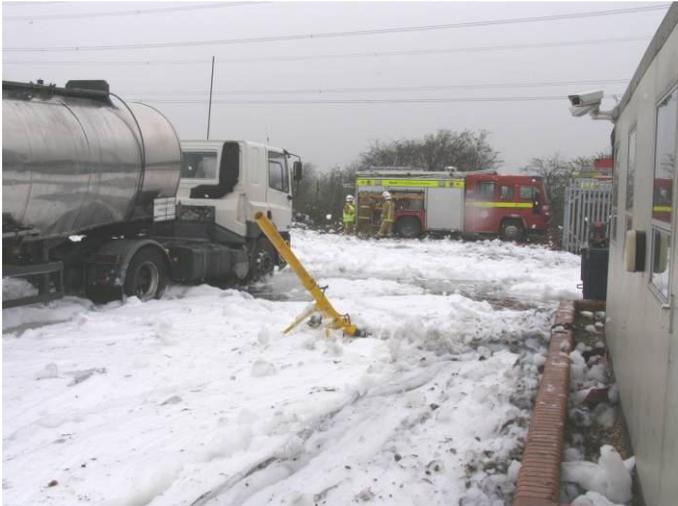
The oil, firewater and foam mixture that had been contained by the bund, spilt out but was largely contained within the boundary of the site by tertiary containment systems (for example kerbing). This prevented a more serious environmental incident from occurring. A small volume of contaminated water did escape from the site.

Figure 3 - Contaminated water held on site

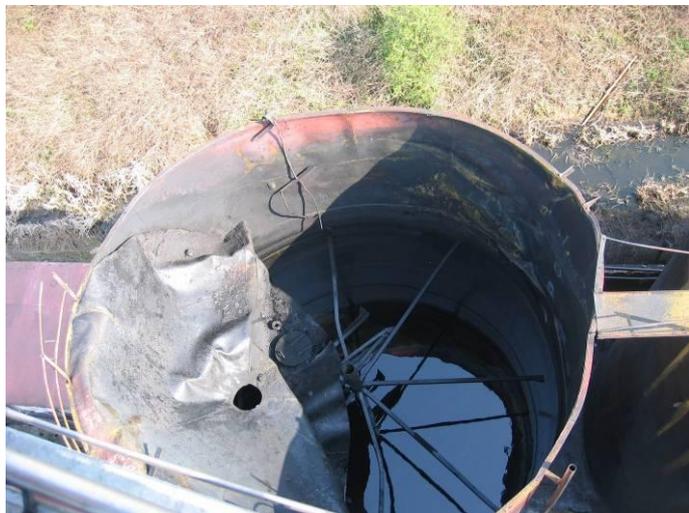
When the incident happened, one contractor was on top of tank 14 installing a walkway, welding parts of the walkway into place using a welding torch. The contents of the tank ignited and blew off the tank's roof. The welder was rescued from the top of the burning tank by a colleague using a mobile elevated platform. The contractors vacated the area as the fire service arrived and fought the fire.

Following the investigation, the HSE inspector concluded that the incident occurred because the site operator had "lost control of what it's contractor was doing".

Figure 4 - Tank 4 after explosion

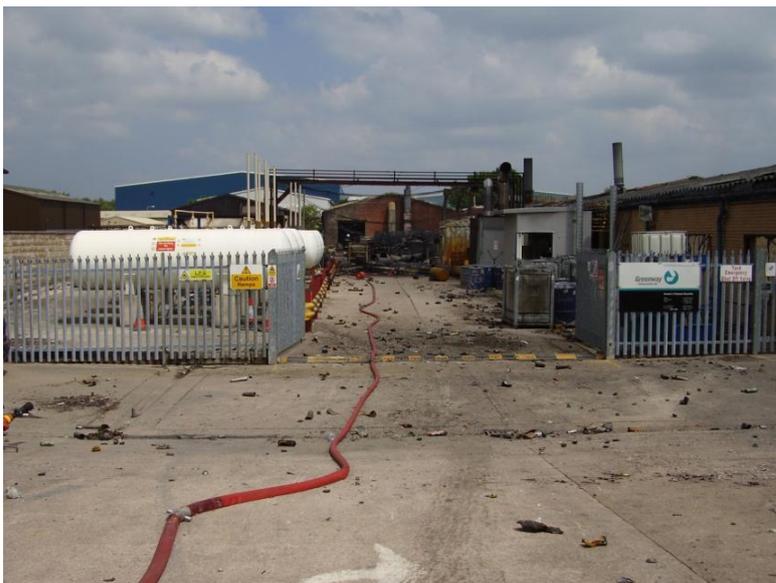
An explosion inside a bespoke aerosol canister shredder operated by Greenway Environmental Ltd caused a fire which spread to the production and storage areas of Aztec Chemicals Ltd (part of the same holding company) destroying the entire site, damaging neighbouring property and causing major disruption in Crewe as surrounding roads were closed all day.

Figure 1 - Damage and aerosol debris on roof of nearby building

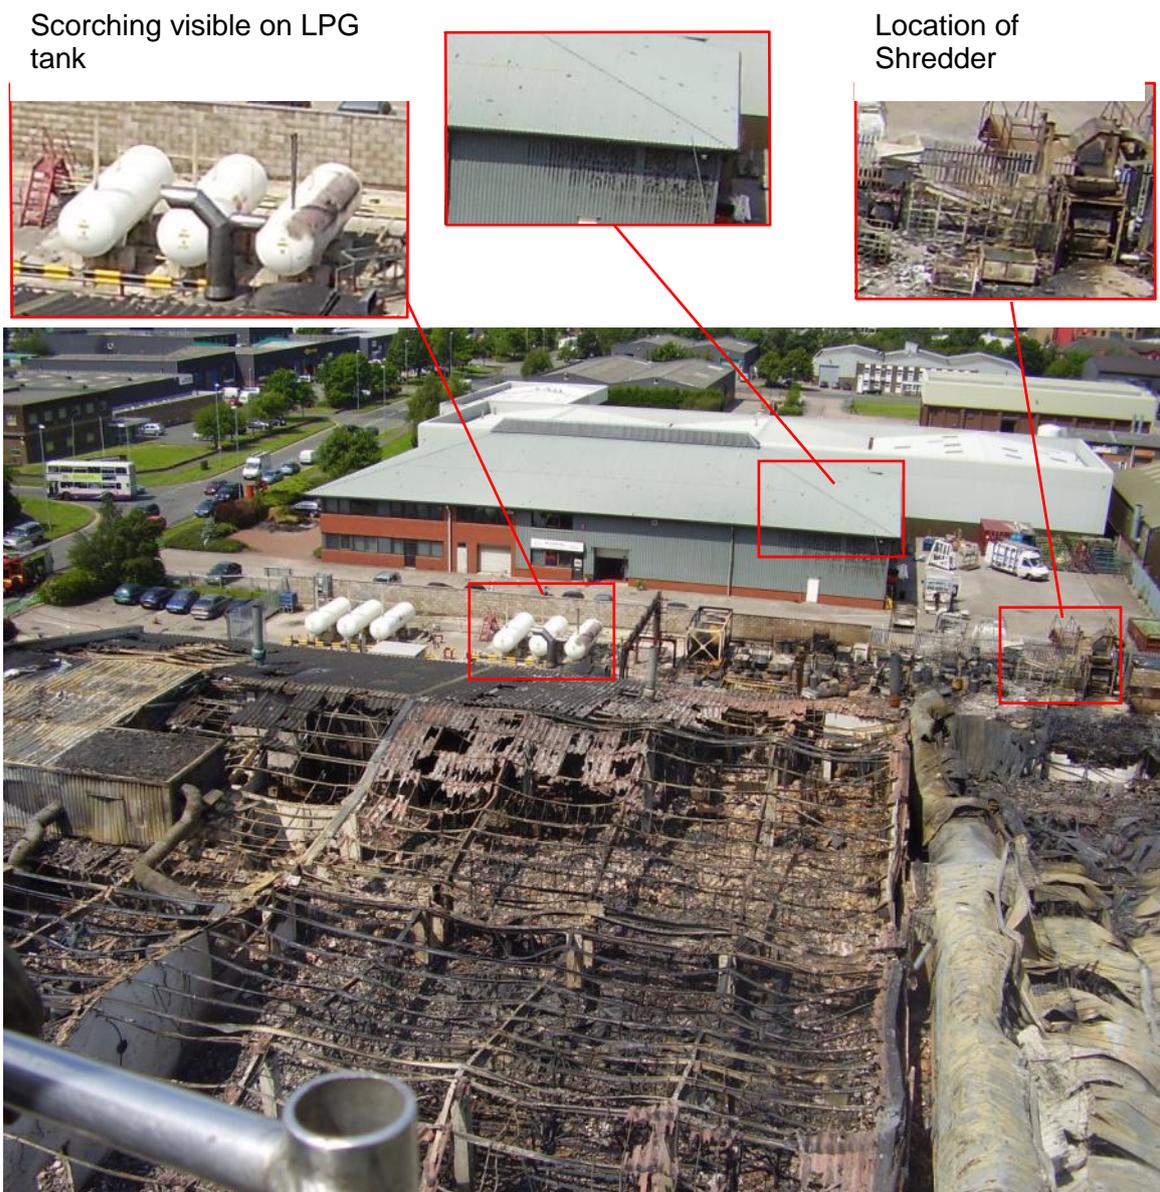
Figure 2: An aerial view of the site after the incident

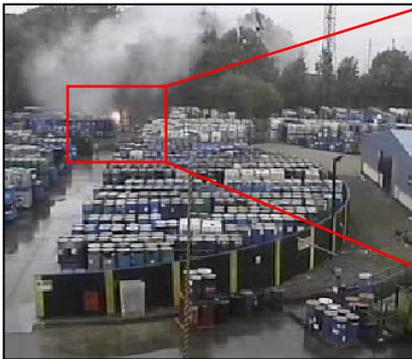
The fire started just after 6am on Sunday 2nd July in an open storage area (storage Area B) which was used to store drums and intermediate bulk containers (IBCs) of flammable and non-flammable waste chemicals with a flash point above 21°C. It had been raining overnight (there had been 31mm of rainfall over the weekend up to the initiation of the fire) and, whilst it cannot be confirmed, it is believed that the fire may have started when a pallet of lithium batteries reacted with water and spontaneously ignited and then spread to other flammable waste materials that were stored adjacent to the batteries (see Figure 1 and Figure 2).

Figure 1 – Approximately 5 minutes after fire initiation

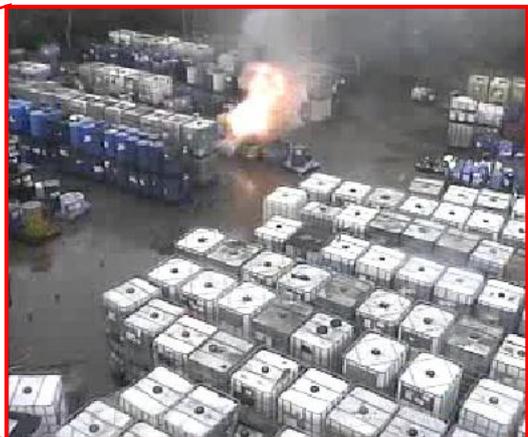
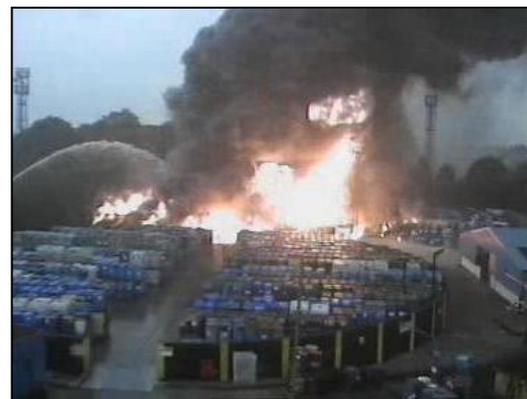
Figure 2 – Approximately 60 minutes after fire initiation

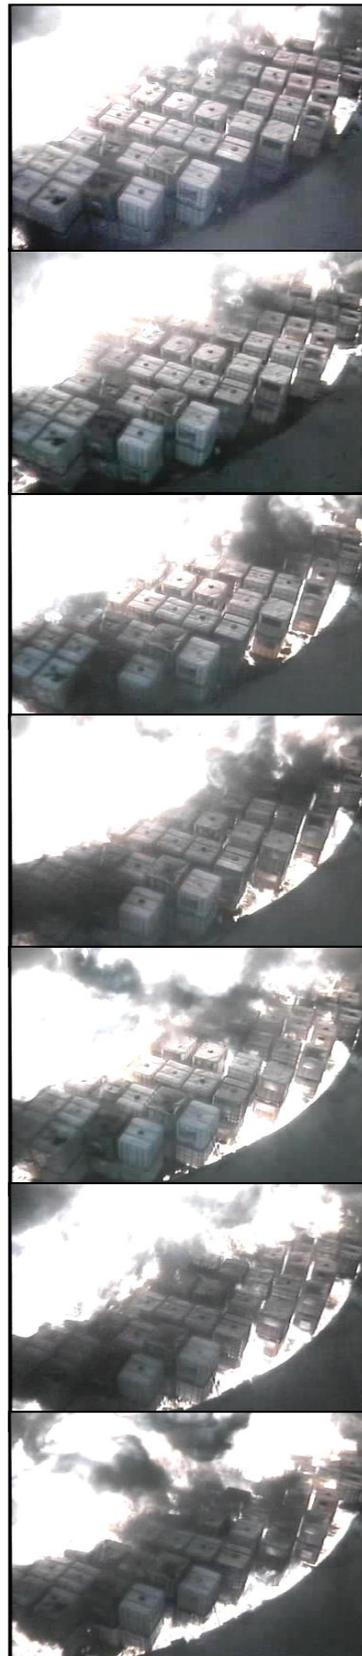
Figure 3 – 60 seconds of CCTV footage approximately 25 minutes after fire initiation

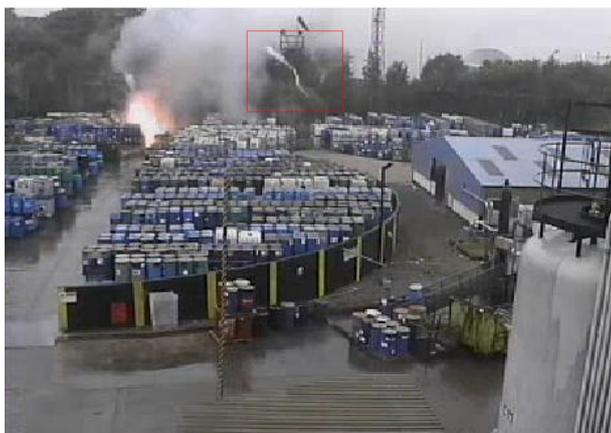
Figure 4 –Smoke trail from missiling waste

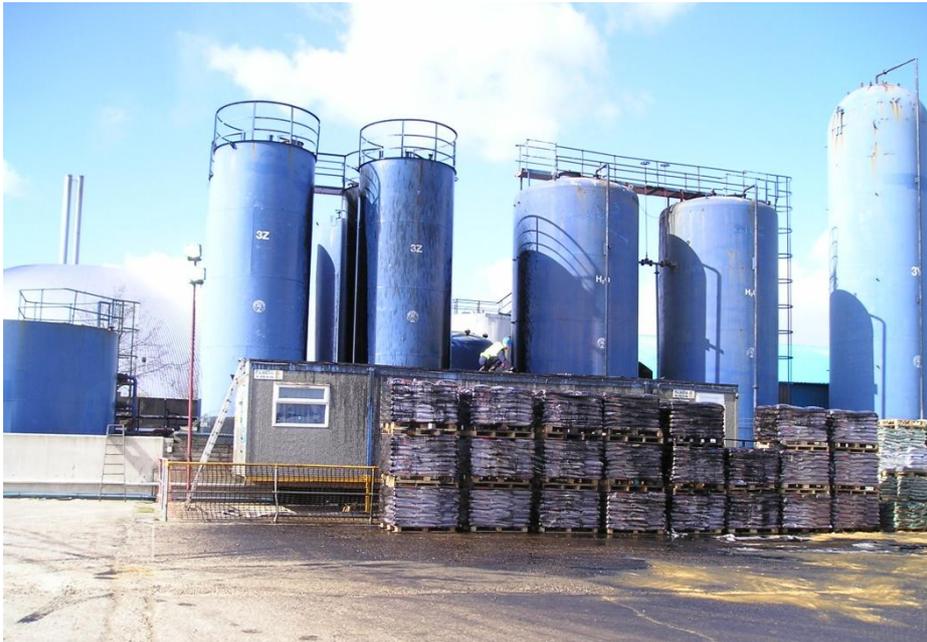
into a tank, the tank overflowed from the manlid on top of the tank and due to the strong winds on the day, the waste oil was picked up and blown across the site boundary and on to neighbouring property. As soon as this was reported, the discharge was stopped.

Figure 1 - Bulk oils storage tanks and oil spillage

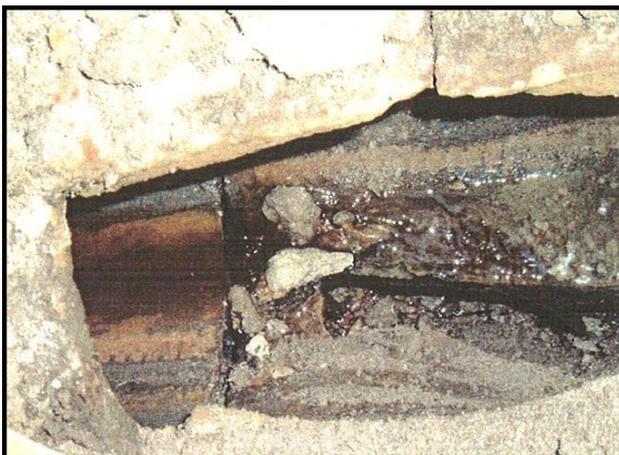
The discharge of effluent from a hazardous waste treatment process and the failure to check the integrity of a private sewer system were identified as the causes of groundwater pollution by substances including dichloromethane (DCM), acetone and tributyl tin (TBT).

Figure 1 – Broken drain

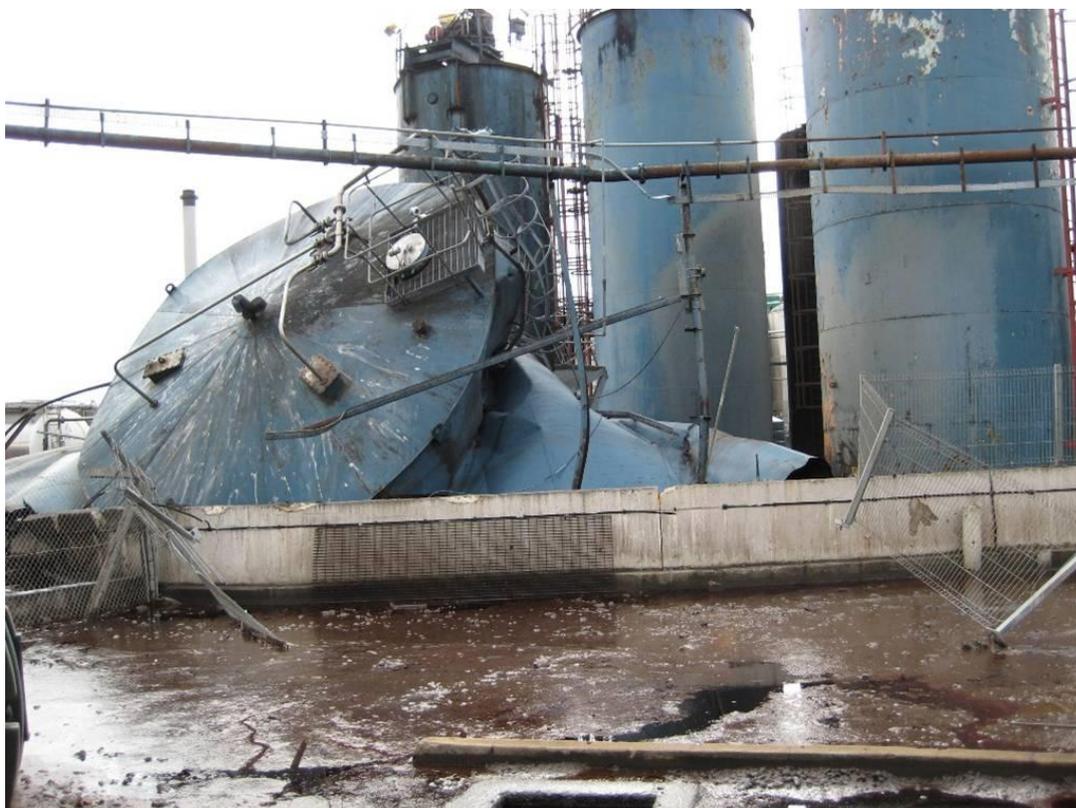
At around 2.10 am a steel storage tank at the site collapsed, breaching a concrete bund and spilling 340 tonnes of mixed waste onto the site. The mixture contained approximately 91% water, 2% solids and 7% mixed solvents, predominantly toluene. The collapse damaged a valve on a neighbouring tank, causing the release of another 90 tonnes of contaminated water. Some of the material released escaped from the site's tertiary containment, reaching a neighbouring industrial site, but was later pumped back. No significant environmental damage was caused.

Figure 1 - Collapsed tank and spillage.

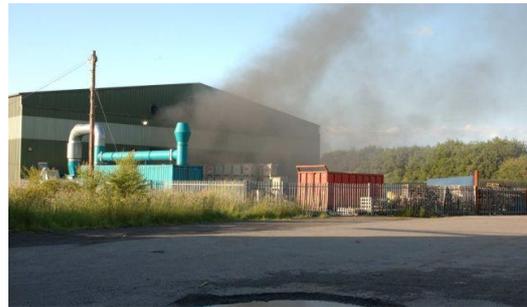
Figure 1 – incident 2, smoke exiting building

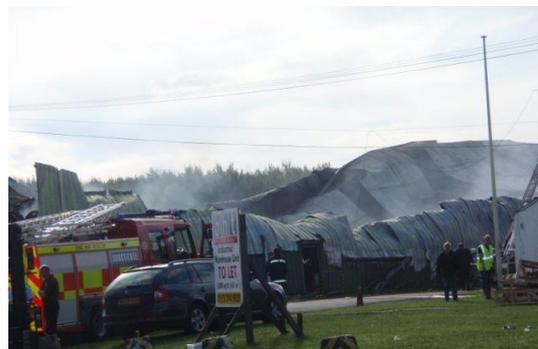
Figure 2 – Incident 3 collapsed transfer building

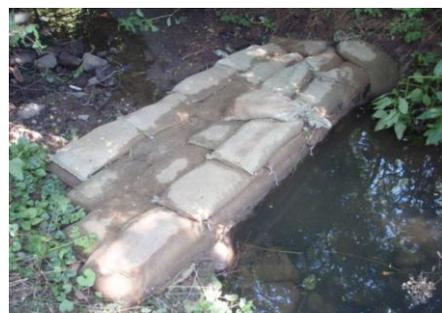
Figure 3 – Fleet Beck dammed using sandbags and booms.

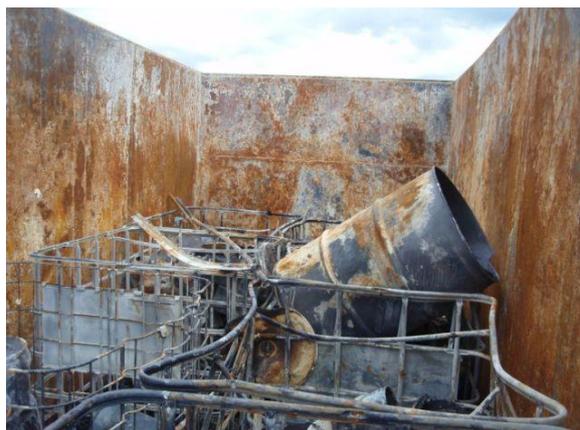
cardboard discs impregnated with oil. It is thought that the filters in the skip spontaneously combusted. While it was not proven that this was the cause of the fire, it had been a very warm weekend and the skip had been loaded and left undisturbed in the building for at least 48 hours before the fire was reported.

Figure 4 – incident 2, remains of skip fire.

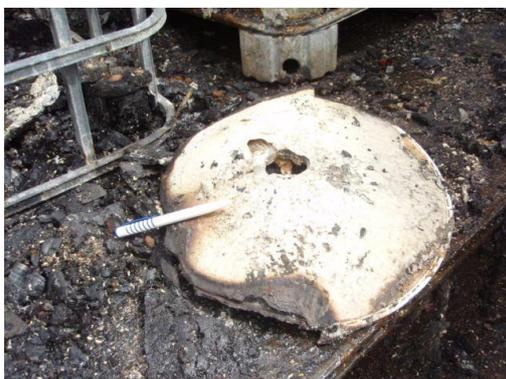
Figure 5 – remains of cardboard filter

Unsaturated oils such as vegetable or fish oil can spontaneously ignite at quite low temperatures. When exposed to air they undergo oxidation which generates heat. As bulk liquids the rate of oxidation is low enough to ensure the heat is dissipated. However where oils have been absorbed onto a porous matrix such a cloth (or in this case the cardboard filter), the rate of oxidation increases markedly due to the increased surface area and can lead to auto-ignition temperatures being achieved. Enclosed conditions, as long as there is enough oxygen present, can exacerbate this by slowing

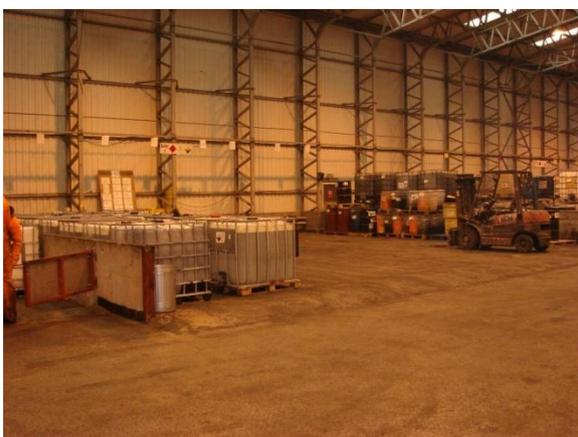
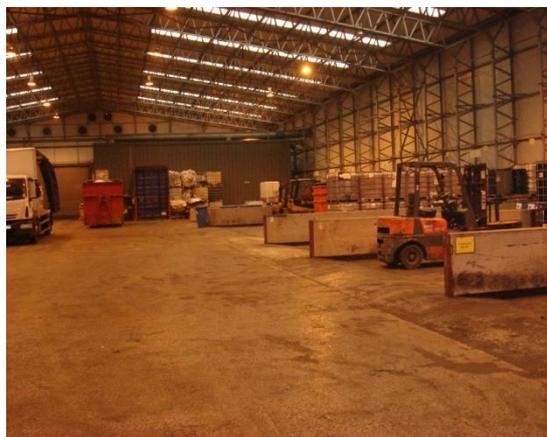
Figures 6 & 7 - interior of transfer building

As a result of the fire, the operator made improvements to the fire alarm system including off-site telemetry and improvements to smoke detectors. BCB clarified storage and packaging requirements with waste producers, and transfer notes were improved. Better information was made available to the fire service regarding what waste was stored and where.

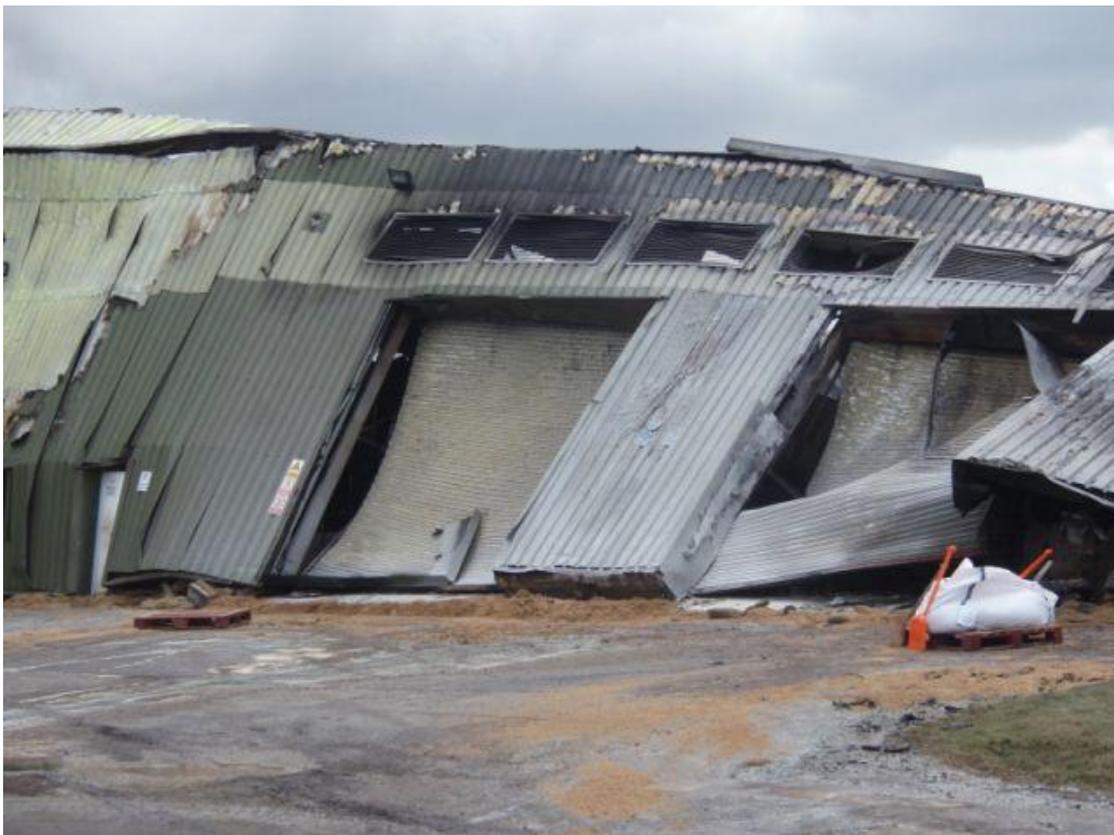
Figure 3 – collapsed building and emergency sand bagging along bottom of the door.

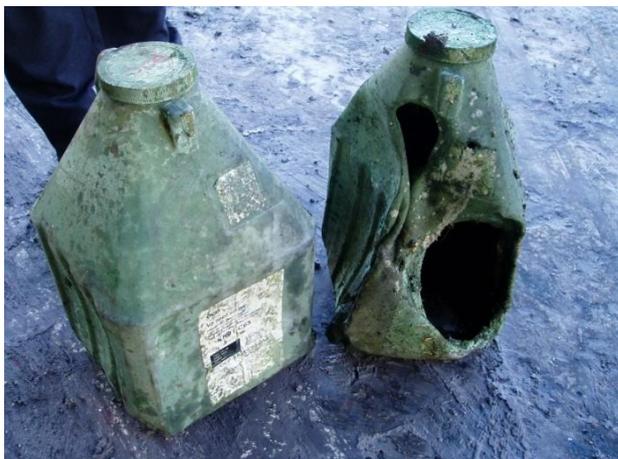
Empty toner powder containers were identified in the debris ejected from the hopper, together with a spattering of green powder around the shredder. The green powder was found to contain chromium III oxide.

The cause of the incident is believed to have been a dust explosion within the shredder as toner powder was suspended in air to form an explosive mixture and ignited, probably by sparking from metal on metal contact as wastes were shredded.
