learning from experience

Post-incident reporting for UK dams
2008 Annual Report

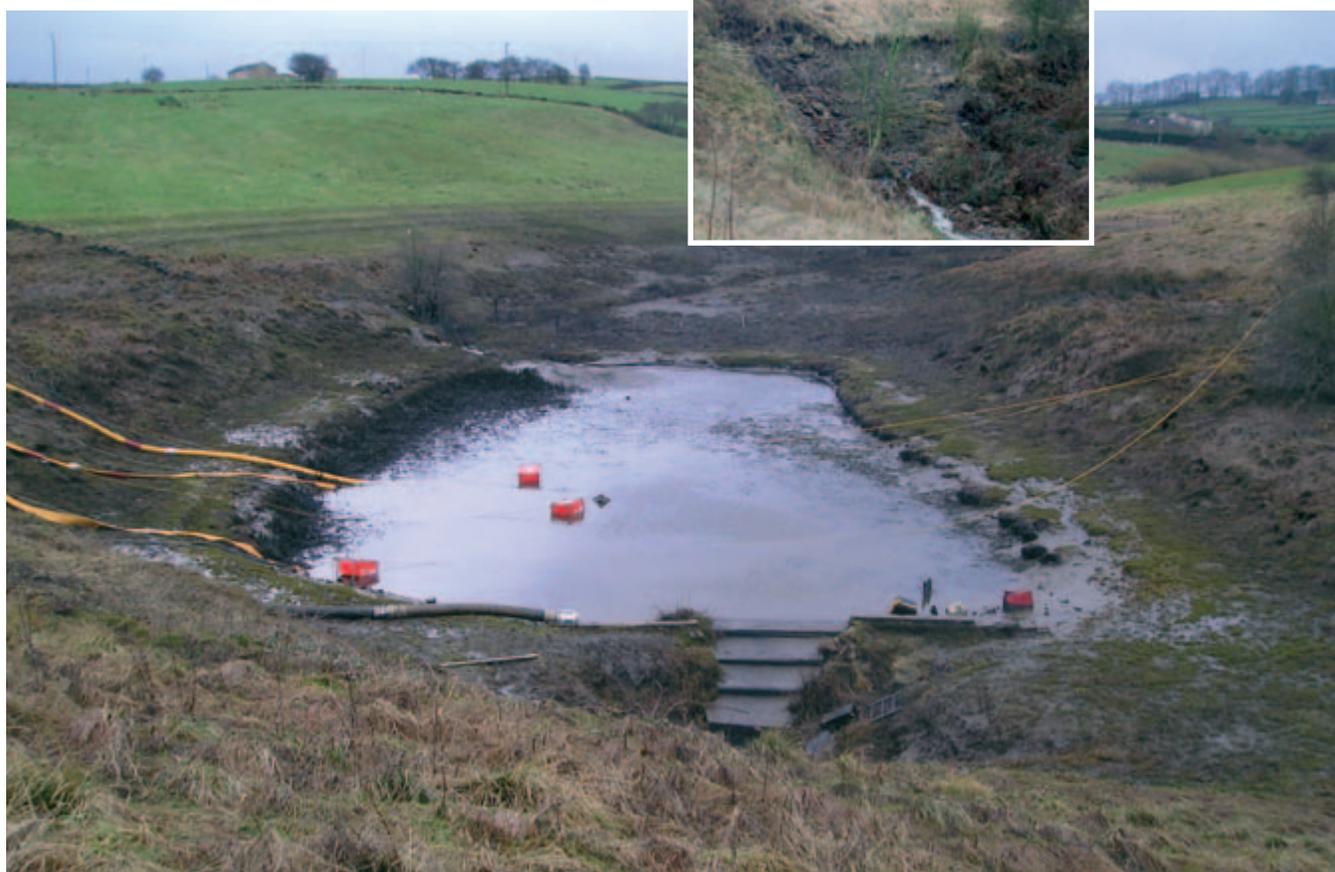
During heavy rain, the valley upstream of a road embankment filled with water. The culvert through the embankment had become blocked with debris as there was no screen to stop it. The embankment overtopped which led to part of the downstream face failing. This then blocked the culvert. There was significant risk of further slips which could have caused the complete failure of the embankment.

The culvert was blocked due to the lack of an effective debris screen. This shows the need for regular inspection and maintenance to ensure that blockages do not happen. This incident also highlights a problem with culverted road embankments which pose a risk to life but do not fall under the Reservoirs Act 1975.

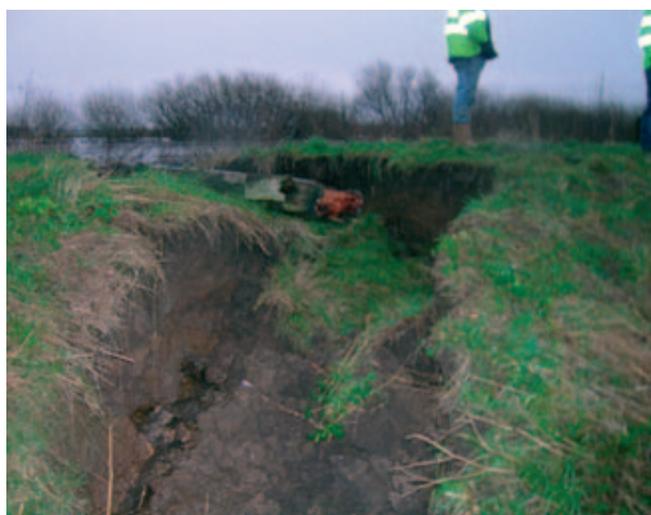
Incident 329

Dam type	Earthfill embankment
Reservoir legal status	Large raised reservoir, impounding
Dam height (m)	9
Incident type	Embankment stability, downstream slip
Incident severity	3

A historical rotational slip in the downstream face was noted and the reservoir level was held down by 600mm. High rainfall and valve operating problems caused the water level to rise and the slip reactivated. The slip threatened to block the spillway channel. The reservoir water level was lowered using the scour valve.

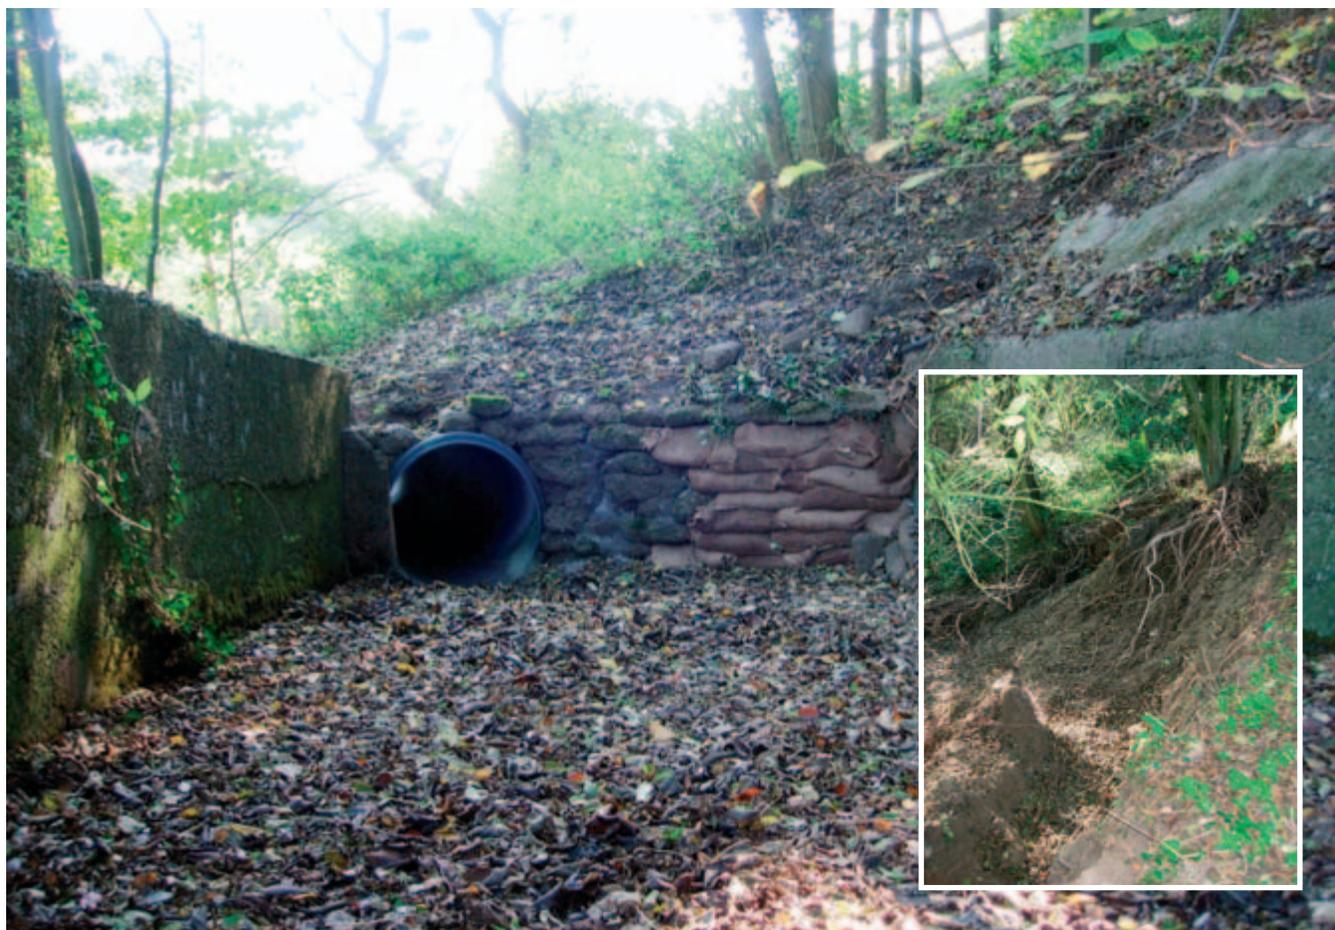
Incident 335

Dam type	Earthfill embankment
Reservoir legal status	Small raised reservoir
Dam height (m)	9
Incident type	Inflow flood, Embankment overtopped
Incident severity	2

This non-statutory reservoir had been leased to a local fishing club. As it was not subject to the terms of the Reservoirs Act 1975 there was no supervision by a panel engineer. During a heavy rainstorm the dam was overtopped. This caused serious erosion of the downstream face of the dam. A number of local residents were evacuated from their homes and roads were closed.

The situation was made worse by screens being placed across the overflow to retain fish and the outlet pipework not being maintained. The screens were removed from the overflow and the embankment dam was demolished.

This incident shows how important regular supervision and maintenance is. It also highlights the value of emergency planning procedures.

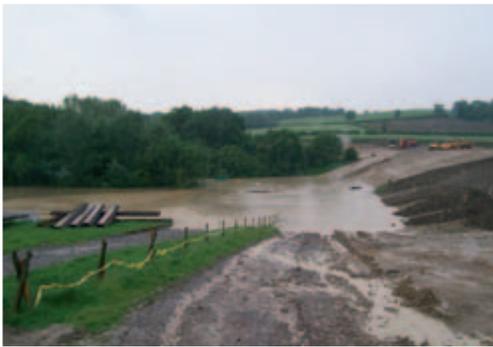
Impoundment event 29th May 08

Bruton flood storage reservoir is located on the River Brue about 2km upstream of Bruton, a town with a long history of flooding. The earthfill dam was built in the early 1980s to reduce the risks of flooding. The reservoir was designed to be kept empty under normal conditions, but during flooding the reservoir gradually impounds water and has an open spillway to allow the discharge of larger floods. Following inspections under the Reservoirs Act 1975 and various studies, the undertaker implemented a £2.6million programme of remedial and improvement works in 2008, designed by Black & Veatch to improve the functioning of the reservoir.

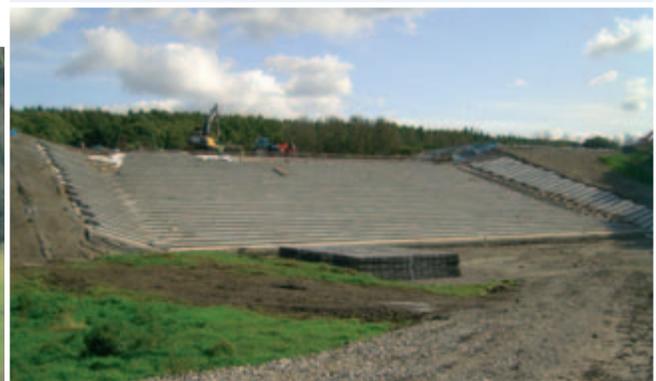
Above: Spillway

- The peak velocity of up to 11m/s on the spillway chute was much greater than the normally recognised limit of 8m/s recommended for the cellular concrete blockwork that formed the original surface protection.
- The trash screen at the upstream end of the culvert did not meet current standards regarding screen area or safe access.
- The storage capacity fell well short of that required to meet the original design standard, based on current hydrological appraisal methods.

- upgrading the surface protection on the spillway using stepped blocks;
- building a new, larger screen structure at the upstream end of the culvert;
- raising the spillway crest by about 2m, with corresponding raising of the rest of the embankment crest.
