learning from experience

Post-incident reporting for UK dams
2007 Annual Report

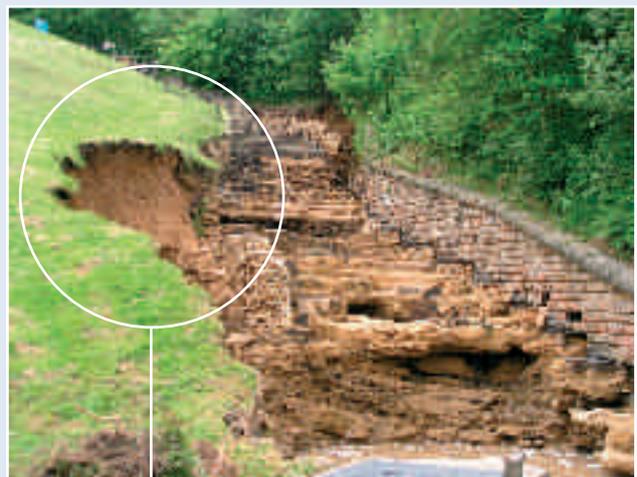
It is not clear what caused the structural damage to the spillway channel as the walls and channel bed were of good quality masonry with tight joints backed by concrete. Damage may have been caused by out-of-channel flow or by loss of masonry.

Severe erosion damage to masonry channel and adjacent earth embankment

It is important to consider the risk of flows exceeding the capacity of spillway channels and, where appropriate, to consider erosion protection works. There are similarities with incident 307 (Ulley) and it would seem appropriate to carry out research into the performance of masonry spillway channels.

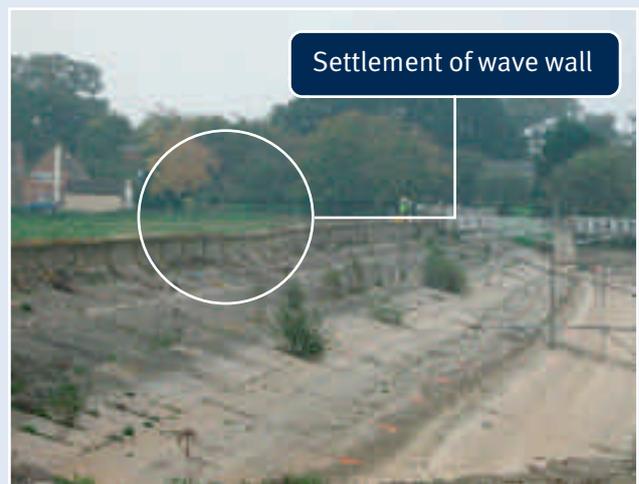
Settlement monitoring of the dam crest highlighted that movement had accelerated at three points. A deep seated slip in the upstream shoulder is thought to have been caused by operational drawdown of the reservoir in the summer and high pore water pressure within the upstream shoulder of the embankment.

This incident shows the value of settlement monitoring. It also highlighted that drawdown facilities need to be sufficient to reduce the water level in a reservoir even at times of high inflow.

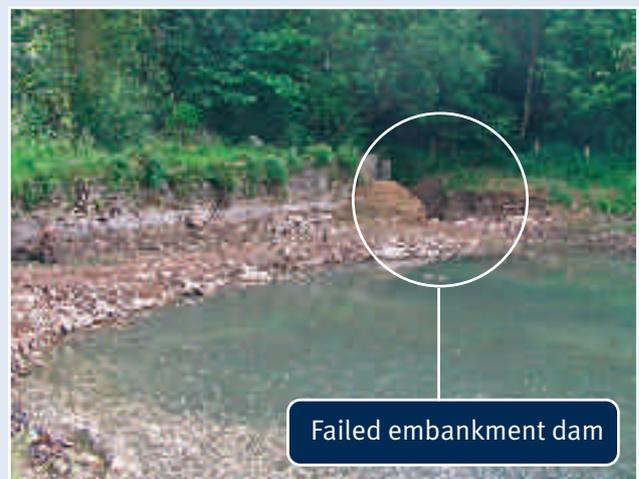
This dam failed due to flood inflow. The dam was overtopped causing erosion of the downstream shoulder and eventual breaching of the dam. The embankment was inadequately designed, as it was constructed of an uncontrolled mixed fill material, which contributed to the failure. The spillway provision was also inadequate.

Embankments and spillways need to be designed and built to appropriate standards.

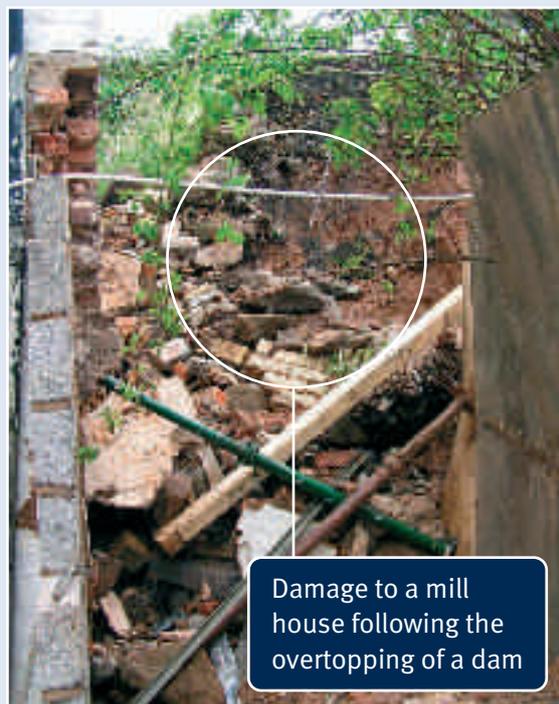
The new owner of this reservoir was unaware of the inadequate spillway capacity and bottom outlet (drawdown) capacity. The dam was overtopped in a flood event, causing damage to the downstream shoulder and the mill house.

The incident shows the need for owners of non-statutory reservoirs to be aware of reservoir safety guidance.

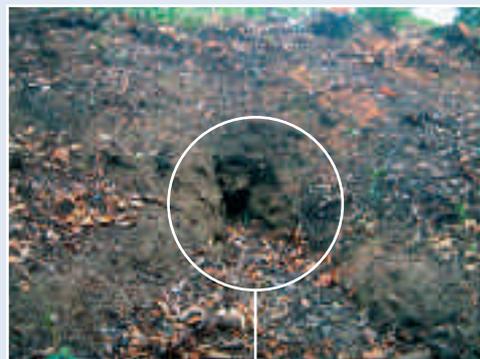
An erosion hole was found at the toe of the dam after vegetation was cleared. During a wet spell a panel engineer visited the dam and found that the hole had become bigger, was still visibly growing and was passing a clear flow of about 0.5l/s. As wet weather was forecast for the next few days, a precautionary drawdown of the reservoir was recommended by fully opening the bottom outlet until flow in the hole ceased. However, the bottom outlet was not fully opened due to concerns over pollution.

Erosion hole at toe of dam

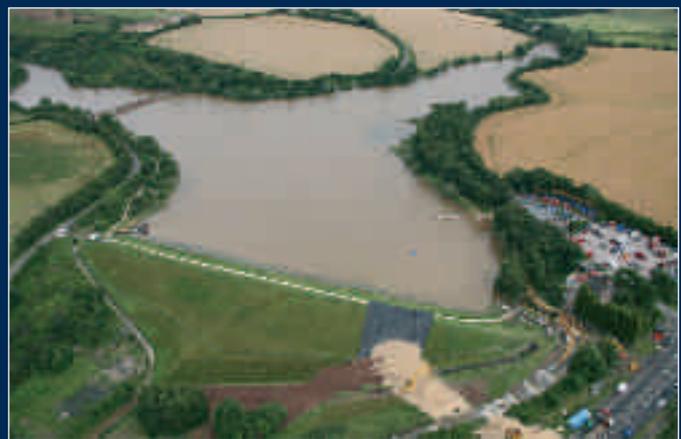
Aerial view of Ulley during incident

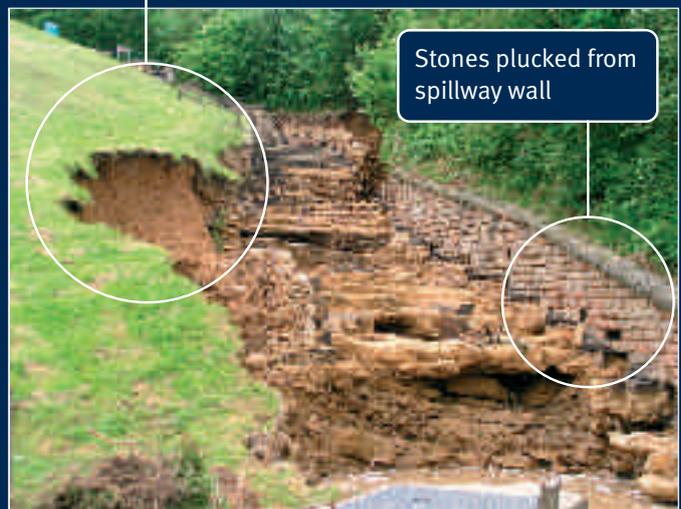
Stones plucked from spillway wall

- consider any possible ways ashlar block spillway chutes could fail when they visit the reservoir;
- advise undertakers about maintenance such as removing vegetation and re-pointing blocks;
- make sure that where blocks deteriorate or are removed they are replaced quickly.

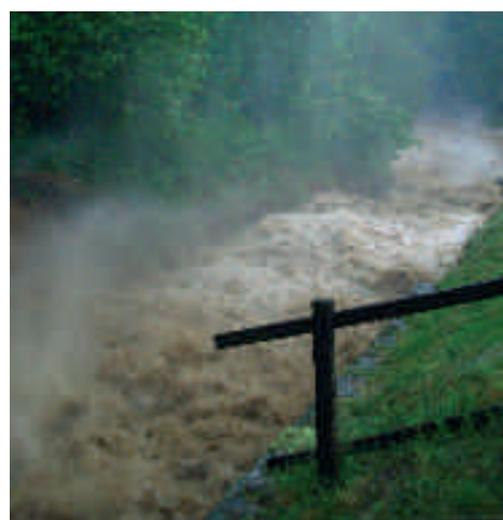
If the capacity of the masonry channel is exceeded, flood water can overtop the wall and flow into and erode the fill behind the wall. This can cause the wall and/or the base slab to fail.

High velocity flows exceeding channel capacity

The capacity of the channel needs to be checked to make sure that there is no out-of-channel flow or that it only happens where works have been put in place to protect the dam or adjacent fill. The conditions when the maximum flow rate occurs need to be checked to make sure that the velocities and pressure fluctuations within the channel do not pluck out the stone blockwork.
