THE WRECK OF  
THE SS  
RICHARD MONTGOMERY

A SUMMARY REPORT

The **COASTGUARD** Agency

July 1996

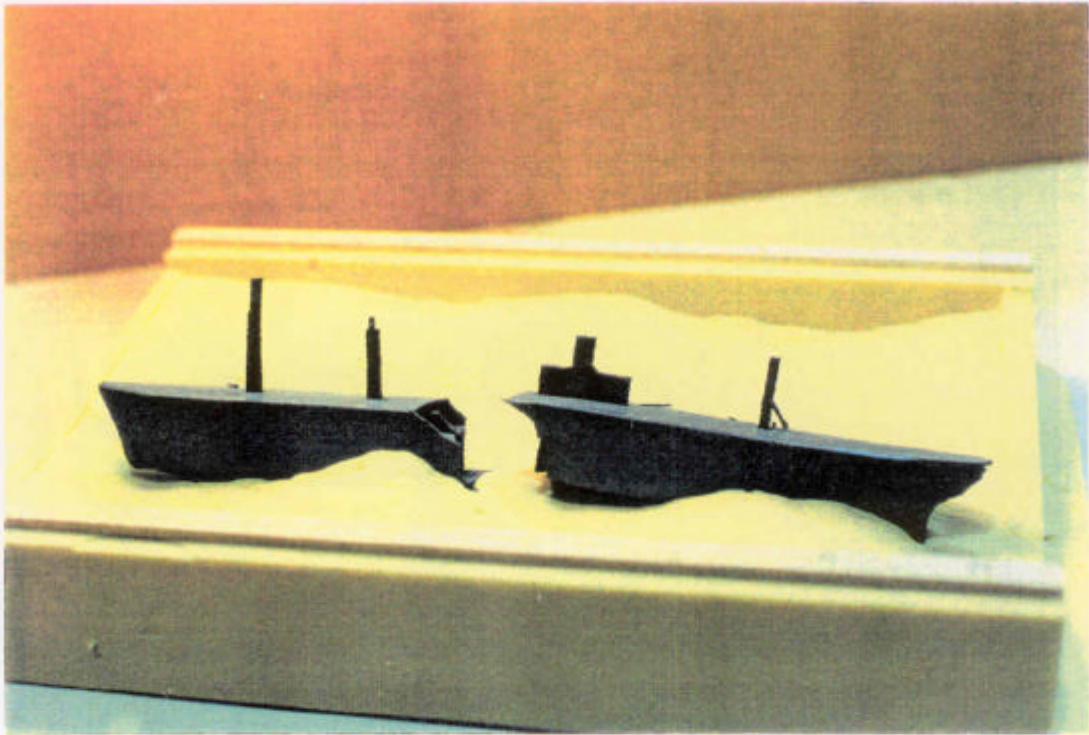
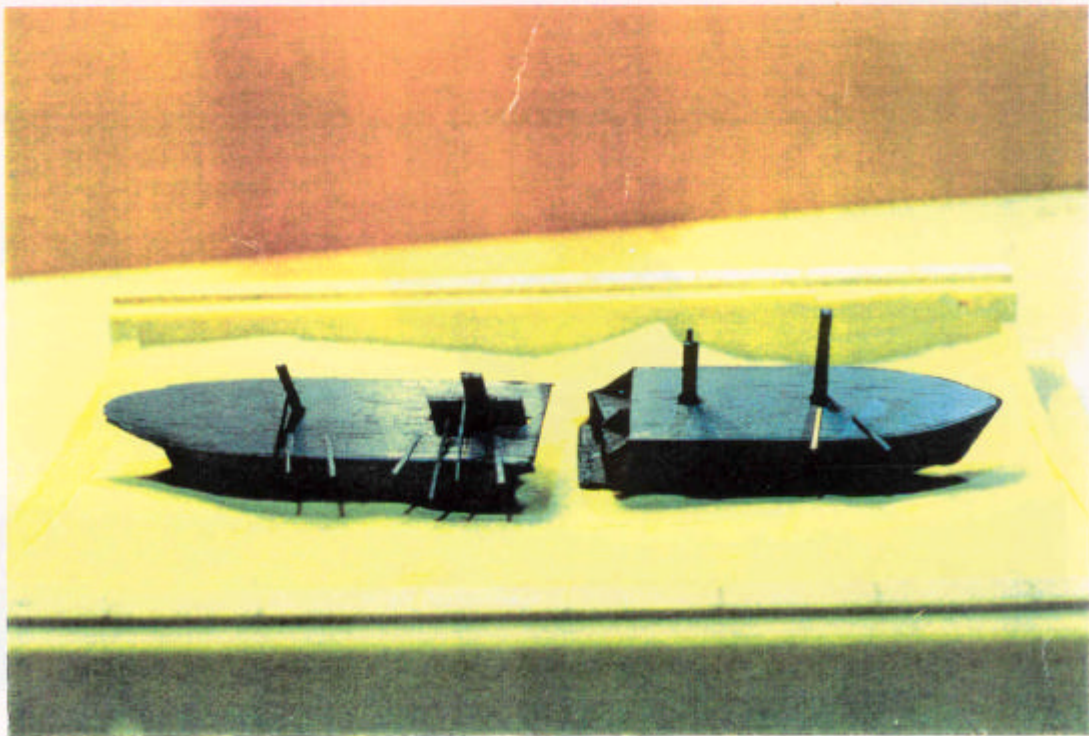
Figure 1 - The 3D Model

22. The plots produced can only give a two dimensional representation of the site of the wreck. To aid the perception of the wreck a three dimensional model of the wreck and the surrounding terrain was made. Sonar Research & Development Ltd. constructed the model of the wreck and the model of the seabed terrain was produced in conjunction with Hull University. The model is shown in figures 1 & 2.
