SS Richard Montgomery 2008 Survey Report

1. Executive Summary

1.1 In October 2008, the Maritime and Coastguard Agency commissioned a repeat high-definition multibeam sonar survey of the wreck of the SS Richard Montgomery and the prohibited area around it. The aim was to gather information about the current state of the wreck for comparison with previous surveys. Particular attention was to be paid to the masts and to areas where previous surveys have identified signs of deterioration.

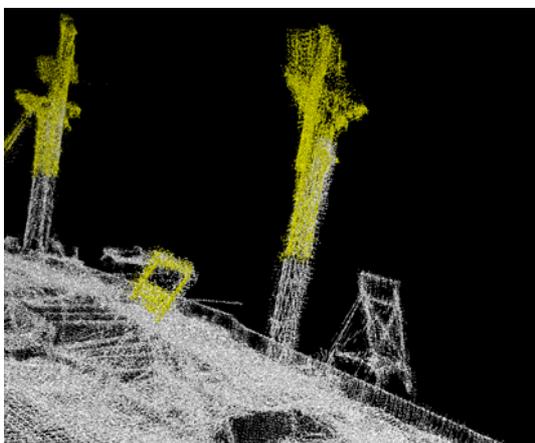
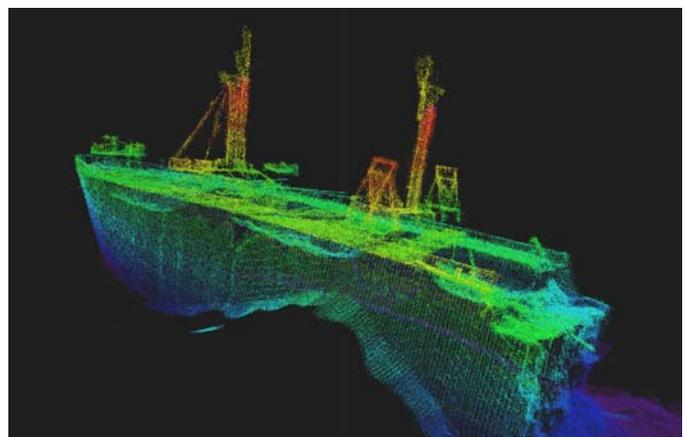
Figures 2 & 3 Multibeam & laser data for masts on bow section

7.2 Two different datasets were collected for each of the masts. This consisted of multibeam sonar data gathered whilst using the sonarhead in a tilted position and, secondly, laser scanning data. Figures 2 and 3 above show the laser and multibeam data knitted together in order to provide measurable details of the wreck in its entirety, both above and below water. Although previous multibeam surveys have provided a very high standard of physical data and visualisation, the masts have been outside of the range of these surveys. The laser scanning and multibeam data acquired during the 2008 survey is the first time that the masts have been surveyed and visualised in this way.

7.3 Both the multibeam and laser data showed that, although both the masts and the hull itself list to starboard, and despite the fact that the masts bear the additional stresses of exposure to wind and wave action, all three masts appear to remain perpendicular to the mast housing and deck as far as it is possible to measure.

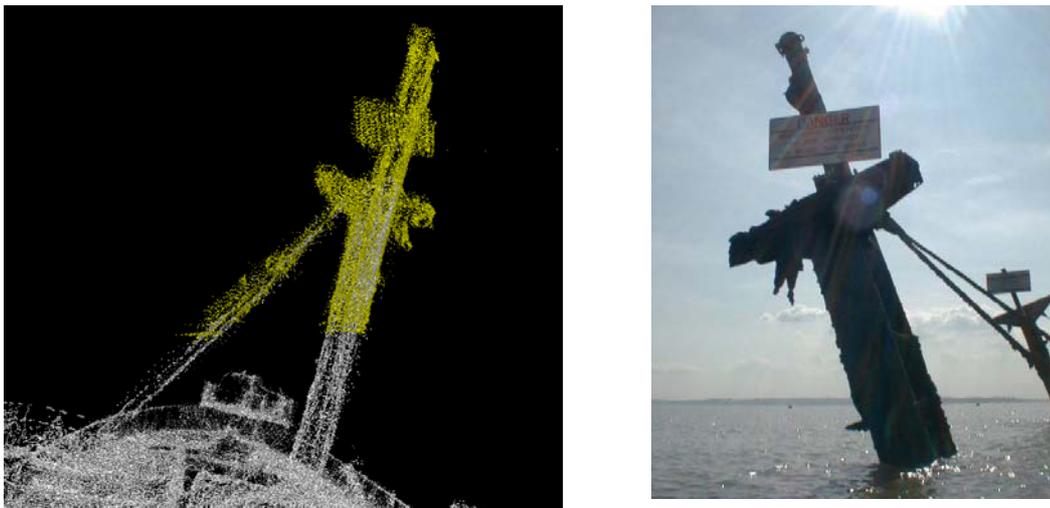
Figure 4 & 5 Foremast multibeam & laser data 2008 and photographic record 2005

7.4 All three masts appear to be in generally good condition given their age and their environment. However, heavy marine growth may be obscuring areas of corrosion. As previous multibeam surveys have not provided details on the masts, there is no comparable dataset with which accurate and reliable comparisons can be made. It is possible to assess the data gathered in 2008 along side the various photographic records of the masts above water and a comparison of the 2008 data with photographic records of the masts above water in 2005 appears to suggest that no major deterioration has occurred in that time (see figures 4 & 5 below).

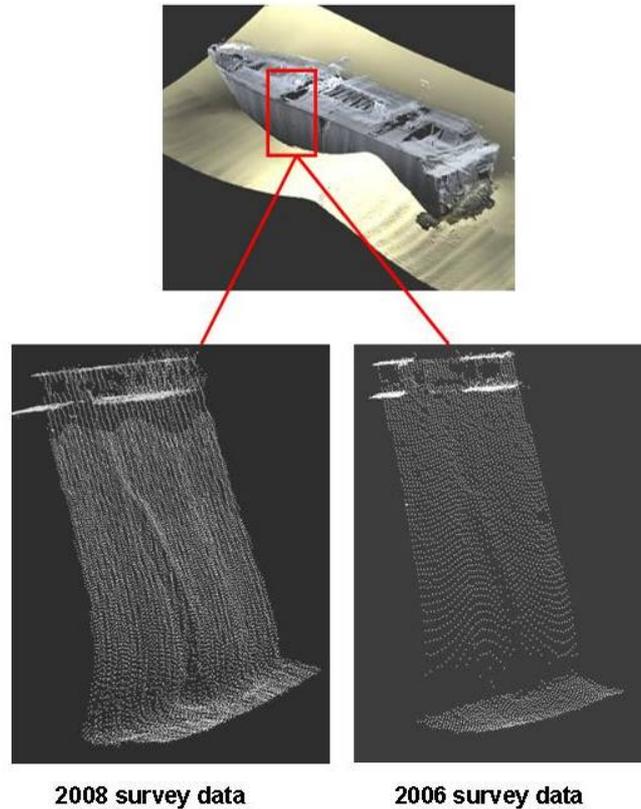
8.2 Evidence for an increased level of hogging in the bow section includes a further collapse of the port side deck plating by Hatch 2 (from 0.35m in 2006 to 0.5m in 2008) and what appears to be a more pronounced bulging of the hull plating on the port side by Hold 2 (see fig.6 below).

8.3 This bulging in the area of Hold 2 has been identified in previous surveys and is probably the result of the weight of the cargo in an area where the structure is likely to be weakened due to the split in the hull plating. This distortion was apparent in 2005 and had not measurably changed in 2006. However, the survey report for 2006 did suggest that the effects of the weight of the cargo in this area of the hull were likely to become more pronounced as the steel corrodes. As can be seen in the images below (fig. 6), a visual inspection of the 2008 data shows that this bulging does appear to have become slightly more pronounced since 2006, although it has not been possible to provide a specific measurement of it.

Figure 6 More pronounced buckling of hull plating in 2008 data

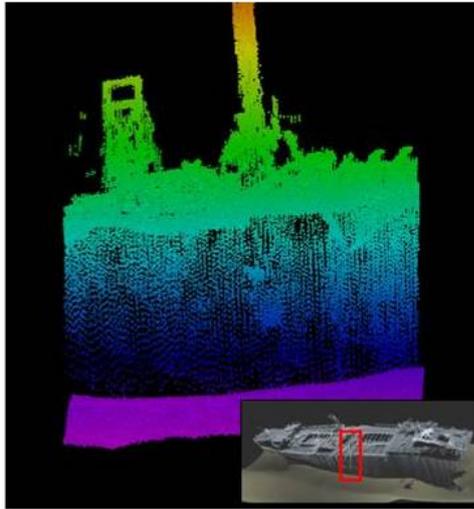
Figure 7 Aft Starboard section by mizzen mast, no cracks visible

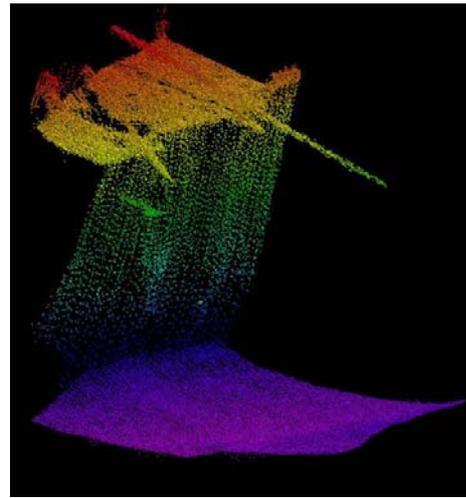
Figure 8 View down side of hull showing overhanging debris & no visible cracks

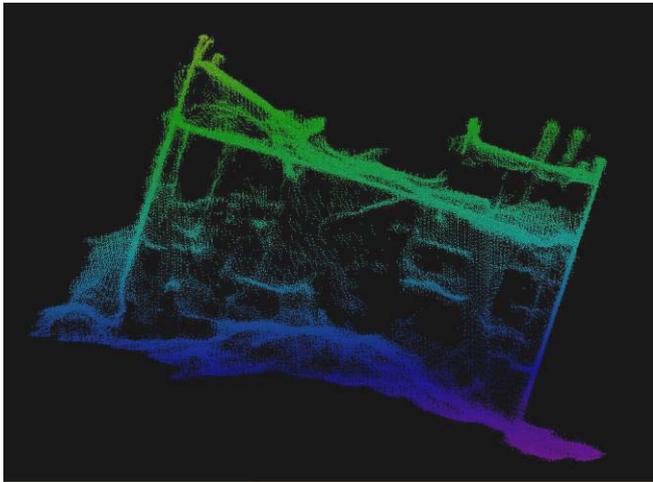
10.4 The debris field between the two sections of the wreck was also surveyed. A comparison between the multibeam surveys undertaken in 2002, 2005, 2006 and 2008 indicates that no changes have taken place in the size and shape of this debris and there is no evidence of any cargo material having spilt from apertures in the bulkhead or elsewhere on the wreck.

Figure 9 View of bulkhead & debris mound 2008

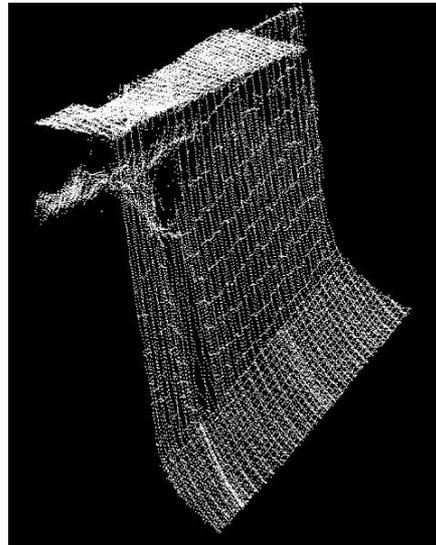
Figure 10 View along port side of Bow section showing material inside hull

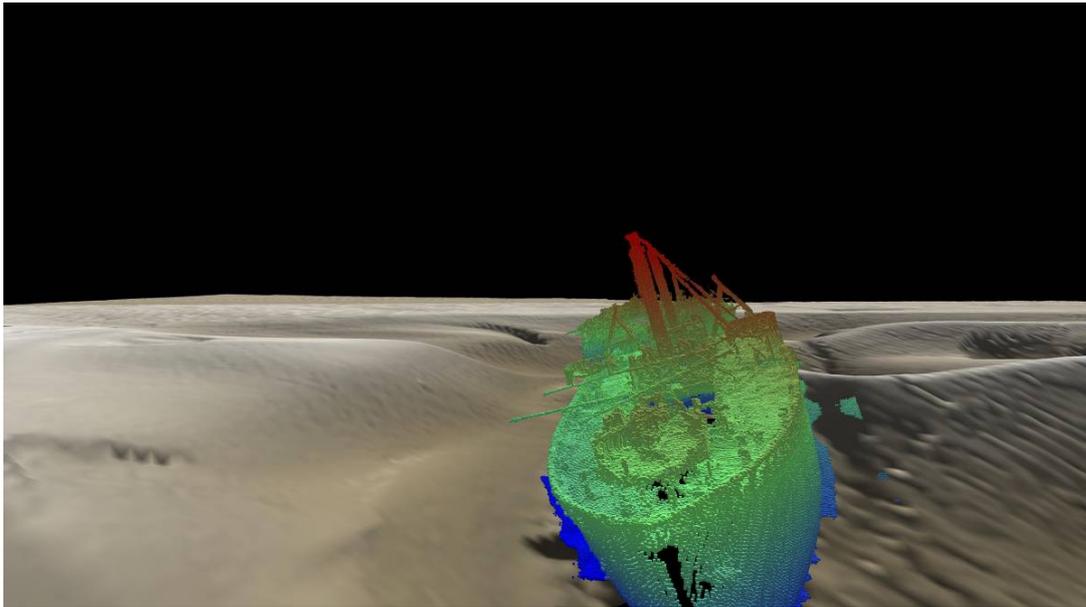
Figure 11 The wreck and surrounding seabed (2008)

11.1 Sonar surveys of the wreck of the SS Richard Montgomery also include a full seabed survey within the prohibited area. This seabed survey aims to locate and identify scattered debris and to provide details on the movement of sediment around the wreck site. The 2008 survey shows that both the bow and stern sections of the wreck are still fully supported by the seabed and that further sediment has gathered around the bow since 2006. The measured depth around the forefoot in 2006 was approximately 20m, and this depth was measured at approximately 18m in 2008.

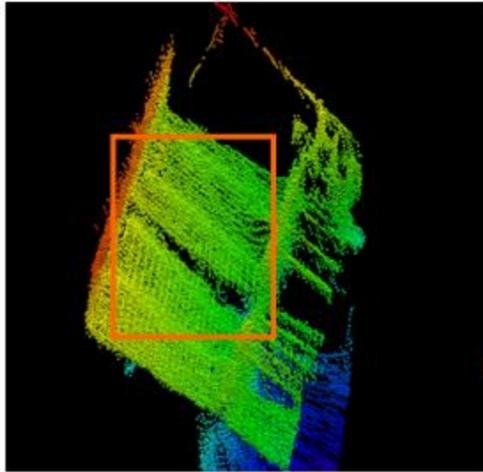
9.3 The main aperture and crack on the port side at Hold 2 has not increased in size since 2006, however, the partially collapsed deck plating at this part of the wreck appears to have dropped a further 15cm since 2006. Smaller holes in the tween deck level on the starboard side of Hold 2 may have increased slightly in size since 2006, but by such small amounts that accurate measurement is difficult. On the stern section of the wreck, a split in the deck plating on the starboard side now appears as a hole next to fallen debris (probably a cargo handling boom) which has sagged approximately 0.3m.

Deck plating collapse increased from 0.35m in 2006 to 0.5m in 2008

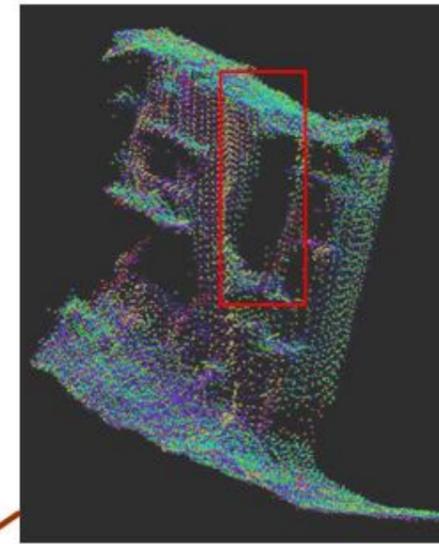
9.4 The 2008 survey noted that, whilst the bulkhead at the aft of the bow section is still largely intact, the visible level of corrosion has increased since 2006. On the starboard side of the bulkhead, an aperture noted in the 2006 survey appears to have increased in size by c.200cm. This is the largest area of change noted in the 2008 survey.

Hole in bulkhead at aft end of the bow section, stbd side, has increased in size by c.200cm since 2006

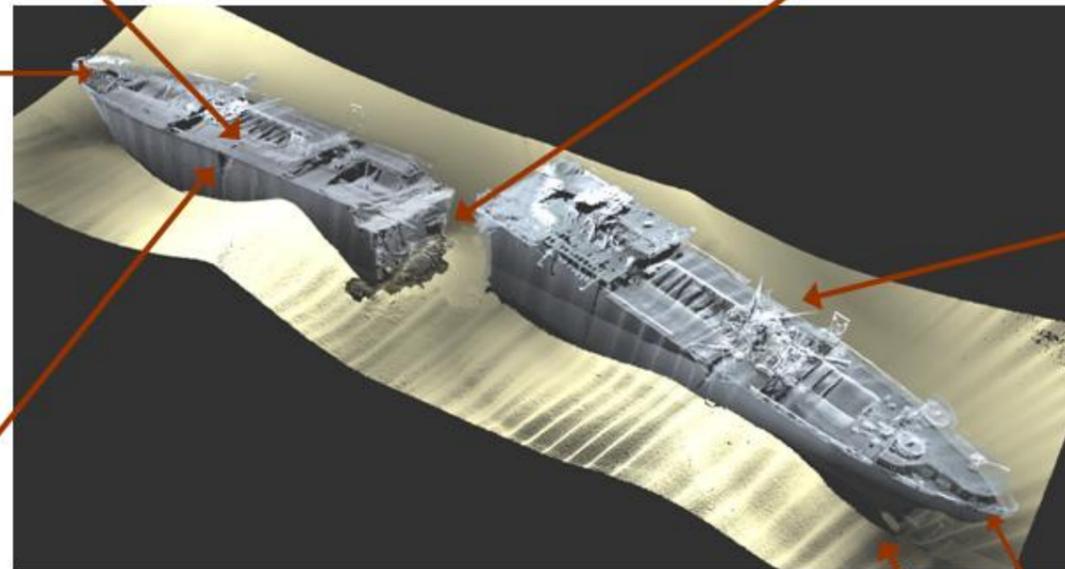
Bow and stern sections both fully supported by seabed sediment.

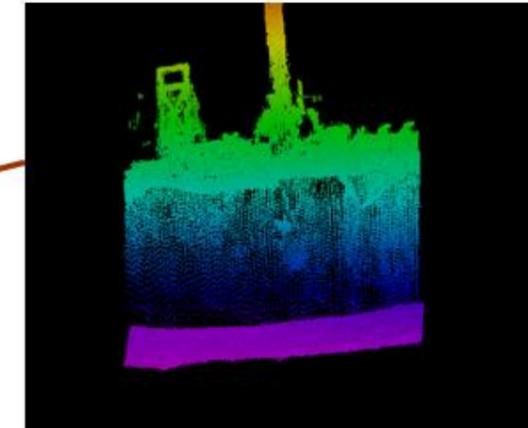
Cracks in hull identified in previous surveys, but new data gathered in 2008 shows no evidence of cracks.

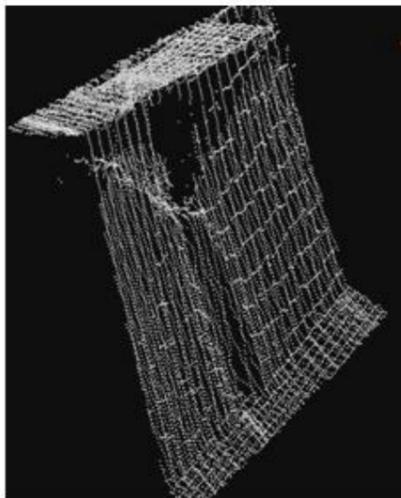
The hole & crack on the port side at hold 2 has not increased since 2006 survey
