SAFETY ALERT

Defective B&S OQFRN Range of High Voltage Fuses

Number: SA 05/10

Date of issue: 05 Oct 10

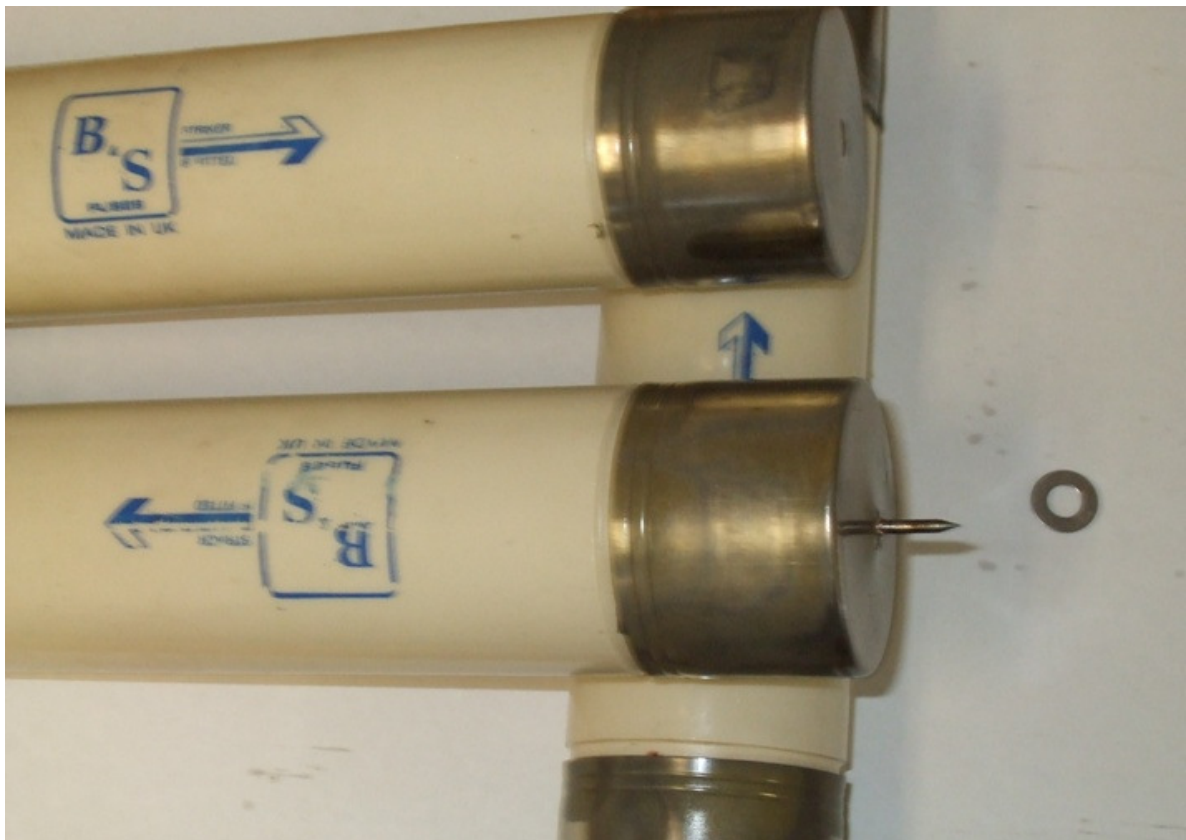
Product	High Voltage B&S Fuse Links – OQFRN range
Manufacturer/Supplier	B&S (now Cooper Bussmann (UK) Ltd)
Problem	Striker pin ejected, but at opposite end to indication on fuse body (see photograph below), so did not trip the Reyrolle ROKS switch that the fuse was fitted to.
Scope	This type of fuse is usually installed in oil-filled Ring Main Units (RMU). Manufacturers of such RMU include Reyrolle, Lucy, Long Crawford, Yorkshire Switchgear and South Wales Switchgear.
Risk	Switch will not trip on downstream faults thus relying on the upstream protection to operate with consequential wider supply disruption
Action	<p>During annual maintenance of the RMU check the fuses to ensure they are correctly installed with the striker pin pointing in the correct direction.</p> <p>This should be carried out by visually checking that the arrow on the label points to the end cap with the counter-bore (approx 12 mm in diameter). On the more modern fuses the counter-bore may be a protrusion on the end cap rather than forming a depression.</p>

- a. Dangerous Incident Notice (DIN) 2010/0057/00 notified the following incident:
- b. HV fuse (type OQFRN) operated. Striker pin ejected, but at opposite end to indication on fuse body, so did not trip the switch (Reyrolle ROKS).

Photograph showing striker pin ejection in opposite direction to that indicated on fuse body.

- a. This Safety Alert has been raised in response to DIN 2010/0057/00.
- b. Addressees of this Safety Alert are to bring its contents to the attention of their Authorising Engineers (Electrical), or equivalent, who are required to take appropriate action.
- c. Although the B&S OQFRN fuses are no longer manufactured they will still be widely in use.
- d. Where incorrectly marked B&S OQFRN fuses are found, the manufacturer will provide free replacement fuses (fully interchangeable Cooper Bussmann OEFMA range). The manufacturer can be contacted as follows:
