ACCIDENT TO GAZELLES XX 415 AND XV 859 OF 705 SQUADRON ON 13 JUNE 1977

AIU/R4/77

ACCIDENT TO GAZELLES HT2 SERIAL NOS XX 415 AND XW 859 OF 705 SQUADRON
ON 13 JUNE 1977

TECHNICAL INVESTIGATION INTO ACCIDENT TO GAZELLE HT2 SERIAL NOS XX 415
AND XN 859 OF 705 SQUADRON ON 13 JUNE 1977 BY LT [REDACTED] AND
AA1 [REDACTED]

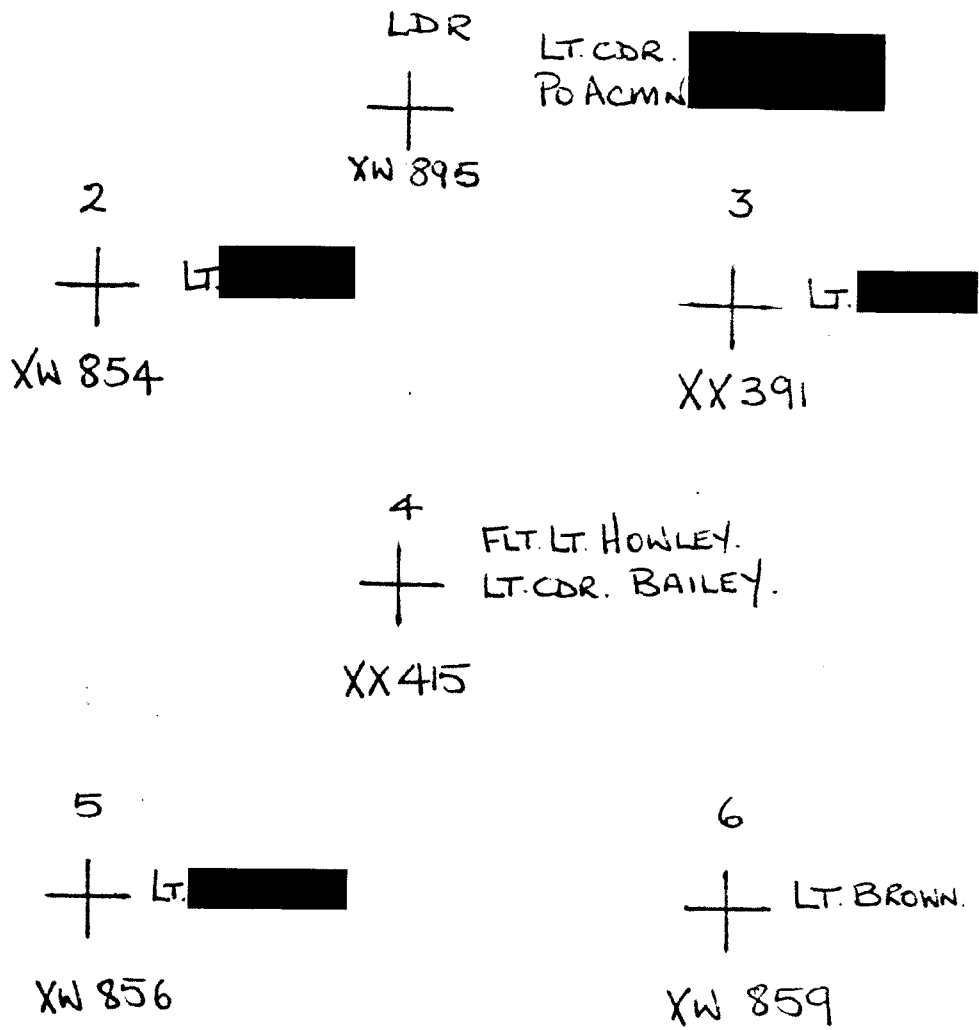
FIG. 1

DISPOSITION OF AIRCRAFT

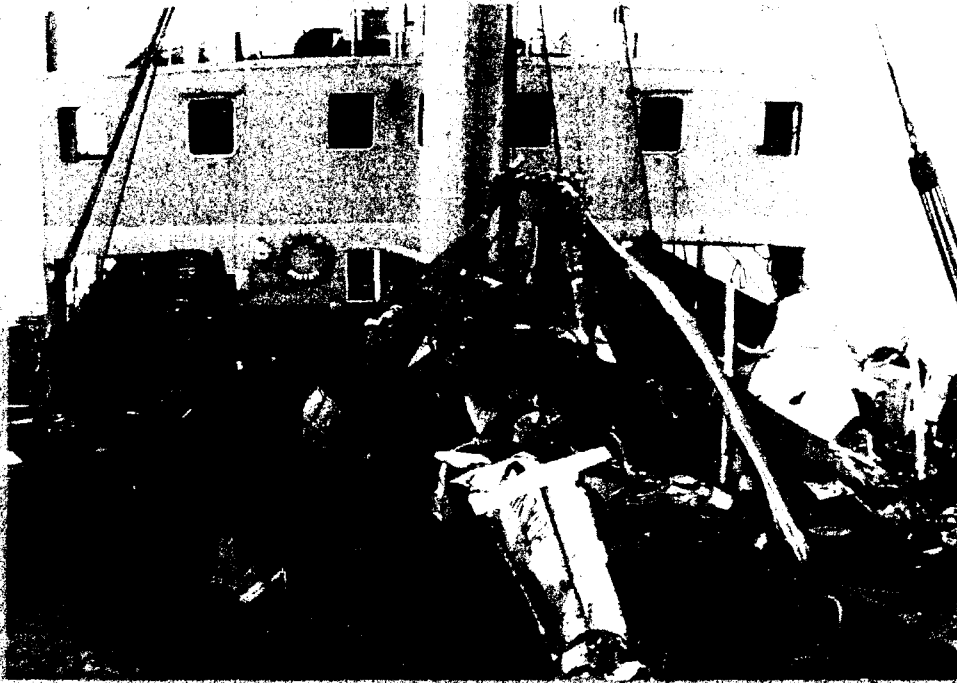
PHOTO 1 Condition of aircraft on salvage

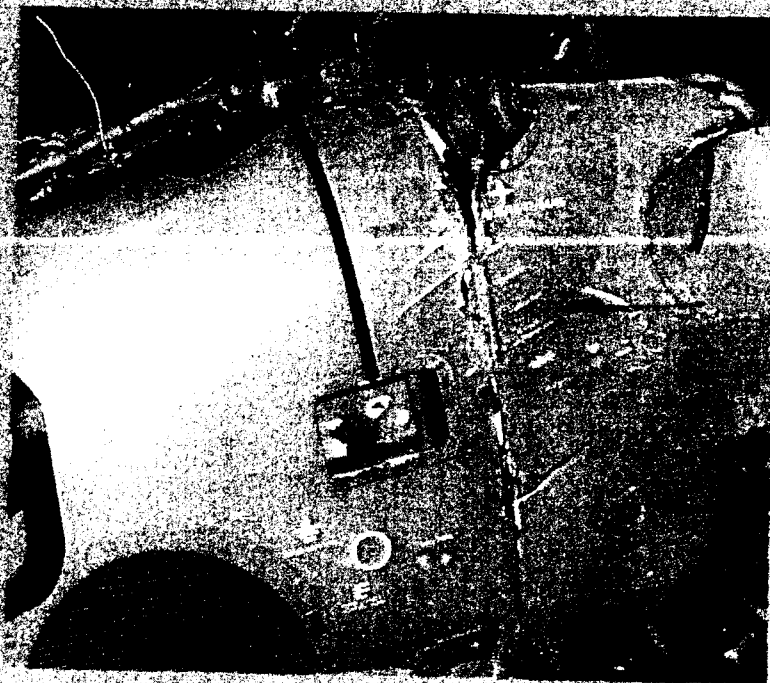
c. Central Structure This was intact although the transmission support panel had detached from the forward bulkhead and had been deformed rearwards, the bulkhead had been pushed into the fuel tank area. The front gearbox mountings had been torn out of the transmission decking, the remains of the gearbox rear supports were still attached, having failed in tension approximately midway between the gearbox and transmission decking. The right hand centre section skin panel had detached, exposing the interior of the fuel tank, the panel being recovered separately. The panel had a series of parallel strike marks which corresponded with marks on the rear section right hand side, this indicating the marks had been made before detachment of the panel. The marks were consistent with light contact by a sharp metal object. There were eleven marks at an angle inclined upwards towards the main rotor disc (PHOTO 4).

a. XX 415 (No 4) There was evidence of light blade tip contact, probably by the 'nib' on the extreme end of a blade tip, on the right hand centre section. It was considered that the most likely sequence of blade strikes was upwards and into the main rotor disc. Two main rotor blades had suffered damage to their undersides. All three coning stops had failed, showing that at some time during the accident, or the descent to the water that followed it, the rotor disc had 'cone up'. The evidence of heavy contact between the base of the fin of XX 859 and the rear section of XX 415 would seem to explain the evidence of most witnesses that the tail had failed in flight. It is considered that, following the severe damage to the main rotor blades, an excess in torque at the tail rotor would exist for a short period of time, this would normally have the effect of yawing the aircraft nose left. However, in the case of an already weakened rear section it is considered probable that the structure would fail to the right instead.

PHOTO 4 Rotor blade strikes

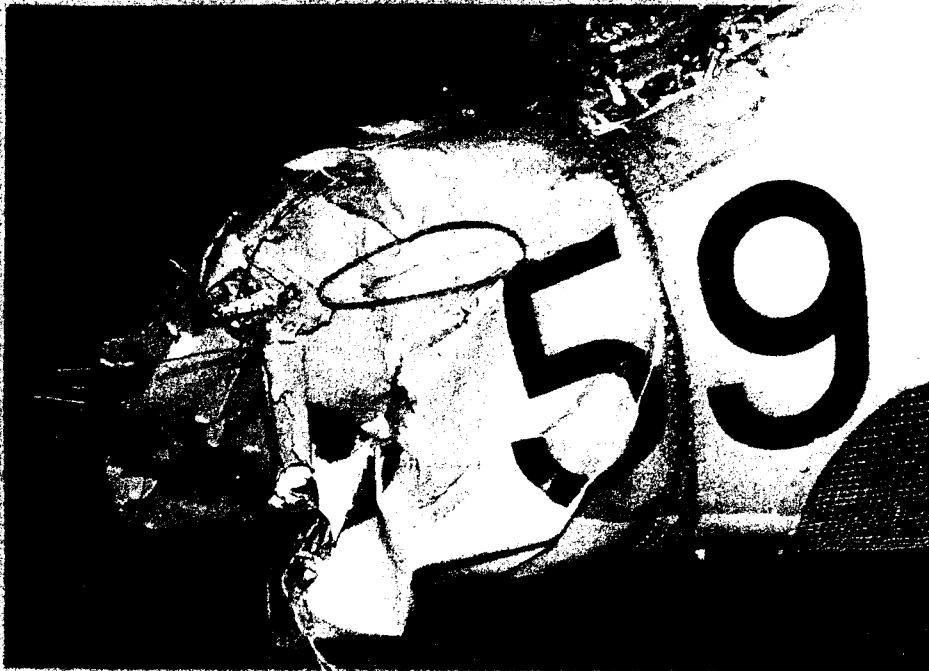
PHOTO 5 Black marks in damaged area of rear fuselage
EX 415 (No. 4)
