MARINE ACCIDENT
INVESTIGATION BRANCH

SAFETY DIGEST

**Lessons from Marine
Accident Reports
3/2004**

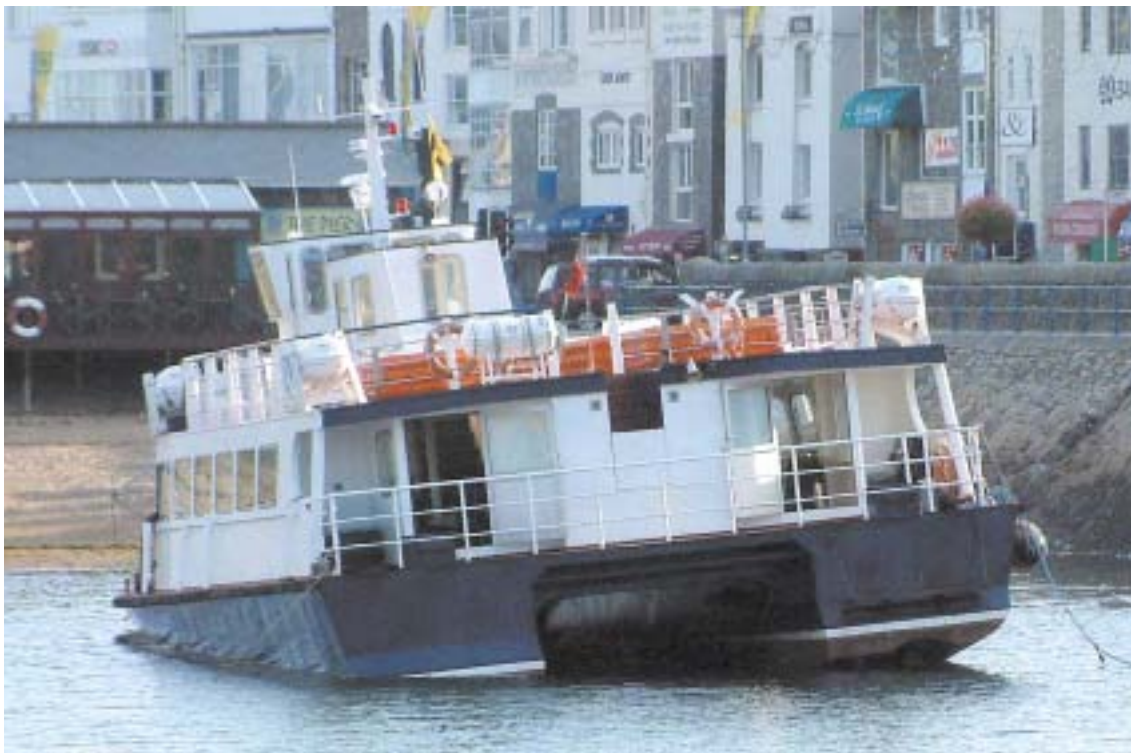
Vessel afloat in harbour on the day after the accident

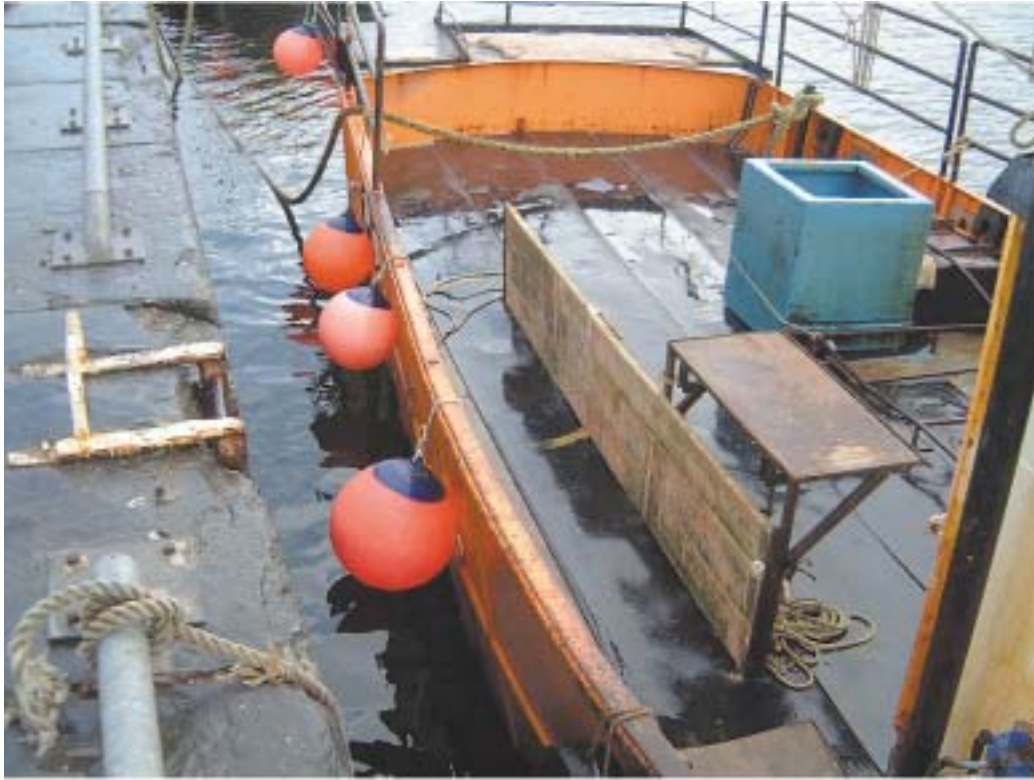
Working deck area showing pound board arrangement

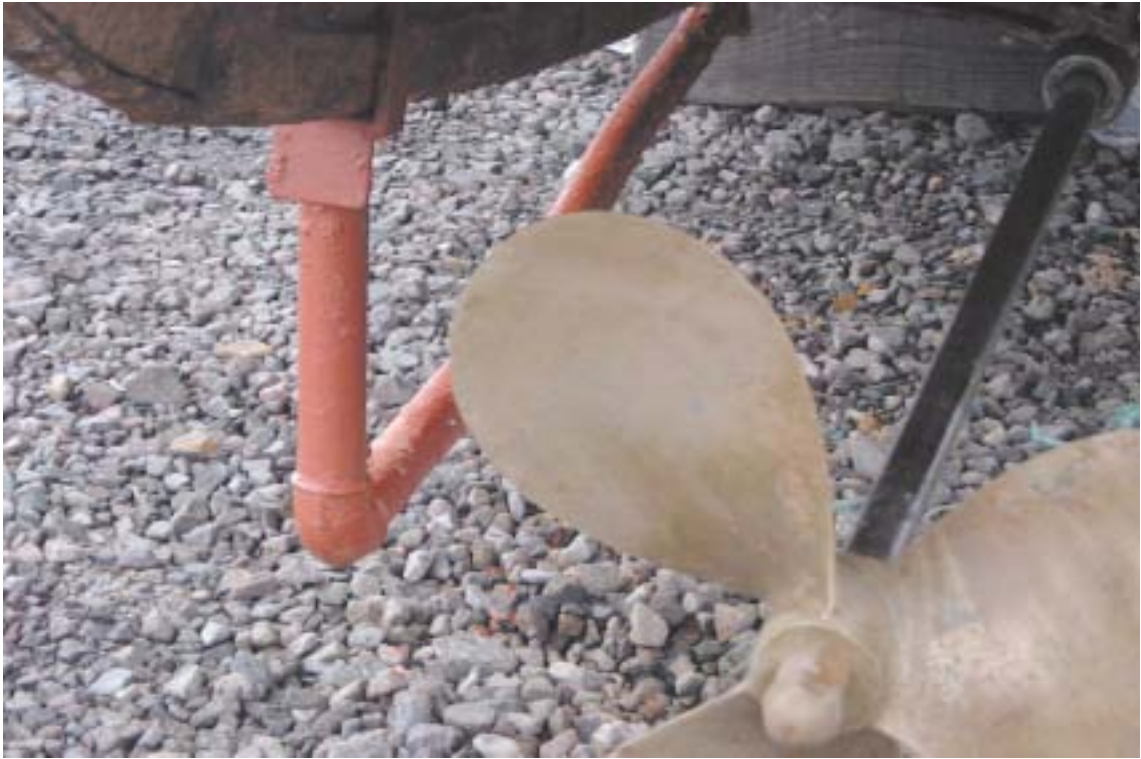
The local lifeboat arrived on the scene approximately 20 minutes later, and a portable salvage pump was put on board the fishing vessel. She was then towed back to port where she was lifted out of the water, and where a detailed inspection revealed that the propeller and the propeller inspection box had both been damaged. In addition, the splines on the propeller shaft, connecting it to the gearbox, had sheared.

View of propeller
