MARINE ACCIDENT
INVESTIGATION BRANCH

SAFETY DIGEST

**Lessons from Marine
Accident Reports
1/2004**

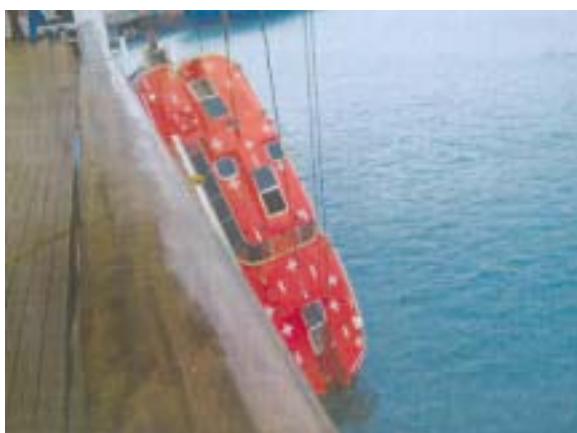
The unusual direction of load on the aft suspension hook damaged the boat's stern, but there were no injuries.

A later examination showed that the remote release wire of the winch had not been set up correctly, and had prevented its brake from being fully applied. Reports from the crew also indicated that there had been earlier incidents where lifeboat winch brakes had not been applied properly because of problems with remote release wires.

The boat continued to slowly lower, until the tricing/bowsing gear at the forward end pulled free. Further lowering then caused the boat's bows to continue until they reached the water, with the boat hanging by the stern (see figure).

1. It would have been sensible for the senior officer to ask what the ratings were doing to the lifeboat before he diverted them to another task. He would then have been aware that there was a problem with this lifeboat.
2. The vessel's safety management system failed to take account of earlier reports of similar winch brake release wire problems to identify a safety-related issue that required attention.
3. Care and attention needs to be taken to ensure that remote operating wires for winch brakes are properly adjusted.

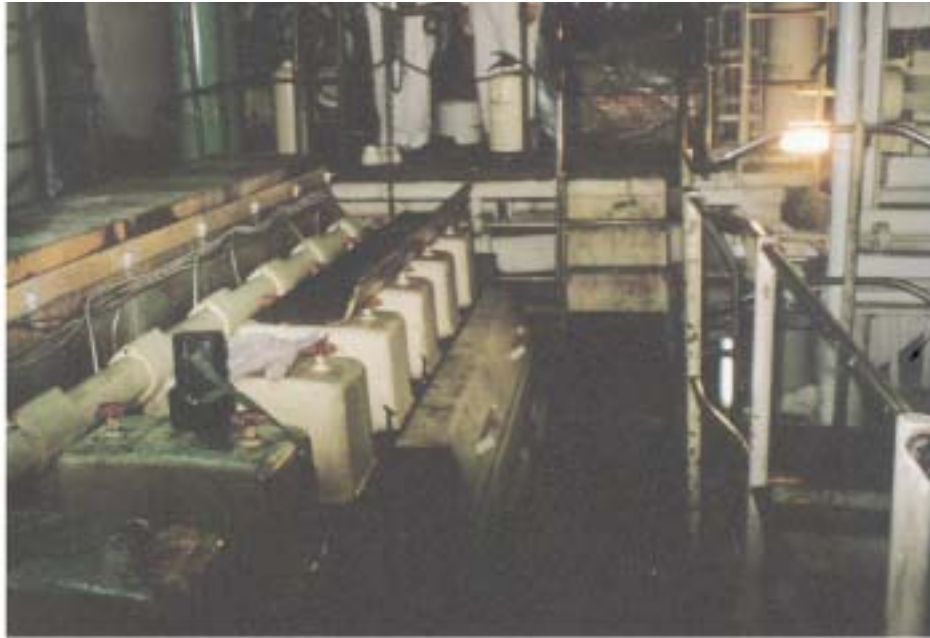
Stairs to lower level

Generator top

When he investigated, the engineer found fire around the top of a diesel generator. He rang the engineers' fire alarm and attempted to tackle the fire using several portable extinguishers.

Later examination of the generator found that a low pressure fuel line had failed because it was not properly secured. This had allowed heated

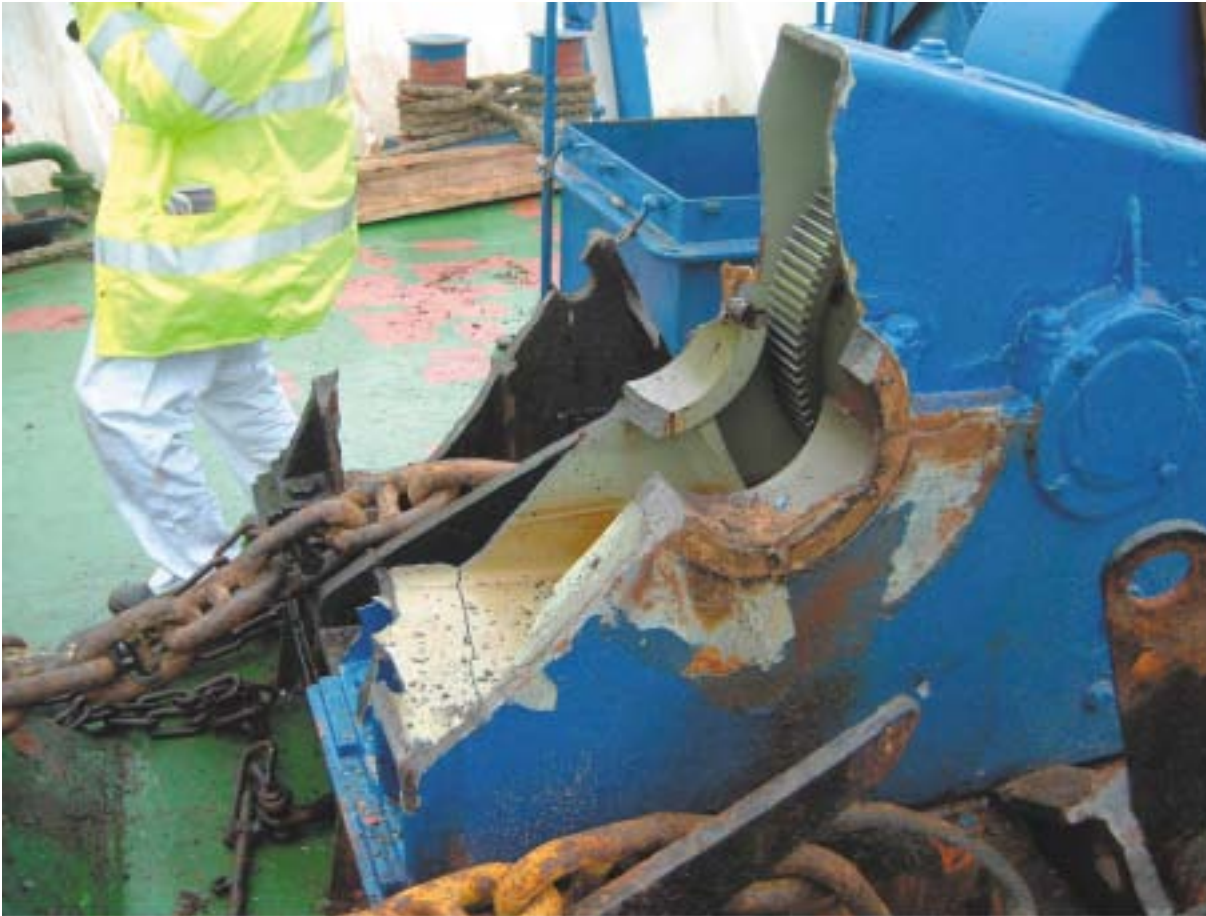
Windlass after catastrophic failure

its bollards until it was secured by its eye. The port anchor was then let go using a similar amount of cable as before, but when applying the brake, the windlass catastrophically failed (see figure), and its shaft containing the winch drums and associated fittings was wrenched from the deck and pulled forward over the hawse pipes.

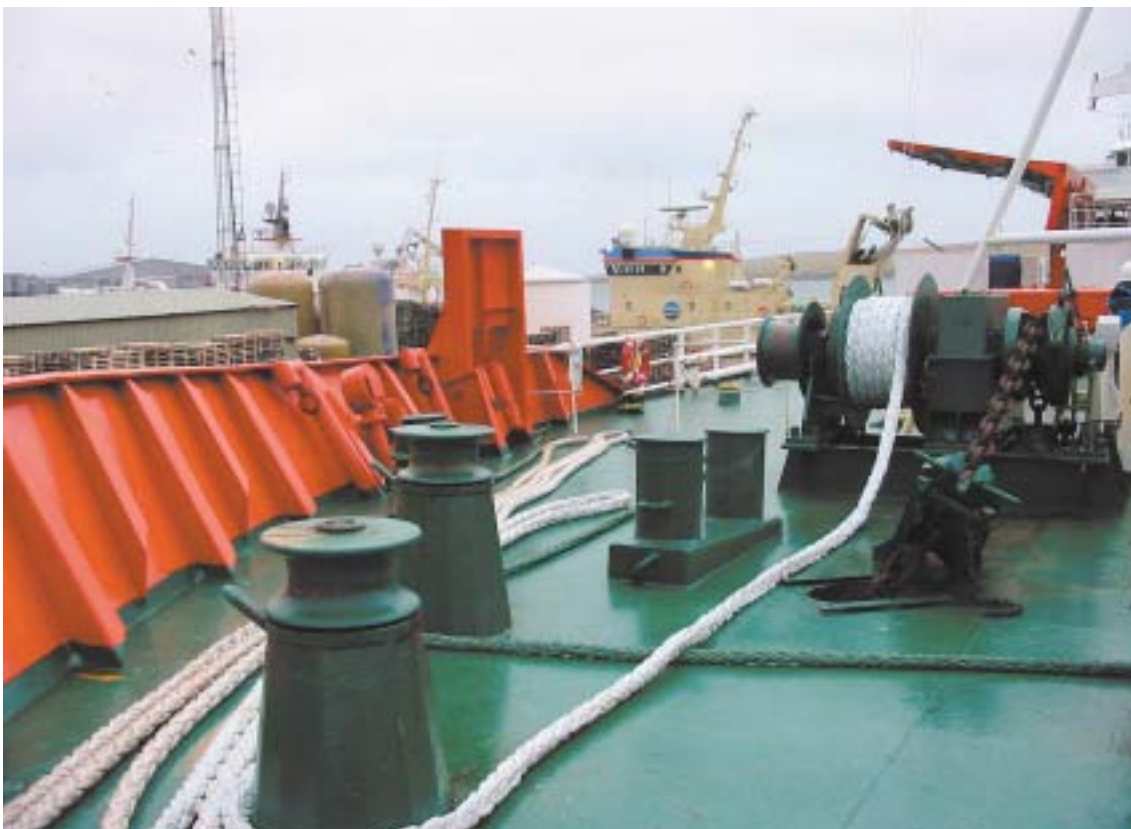
Polypropylene rope flaked out for use as a spring

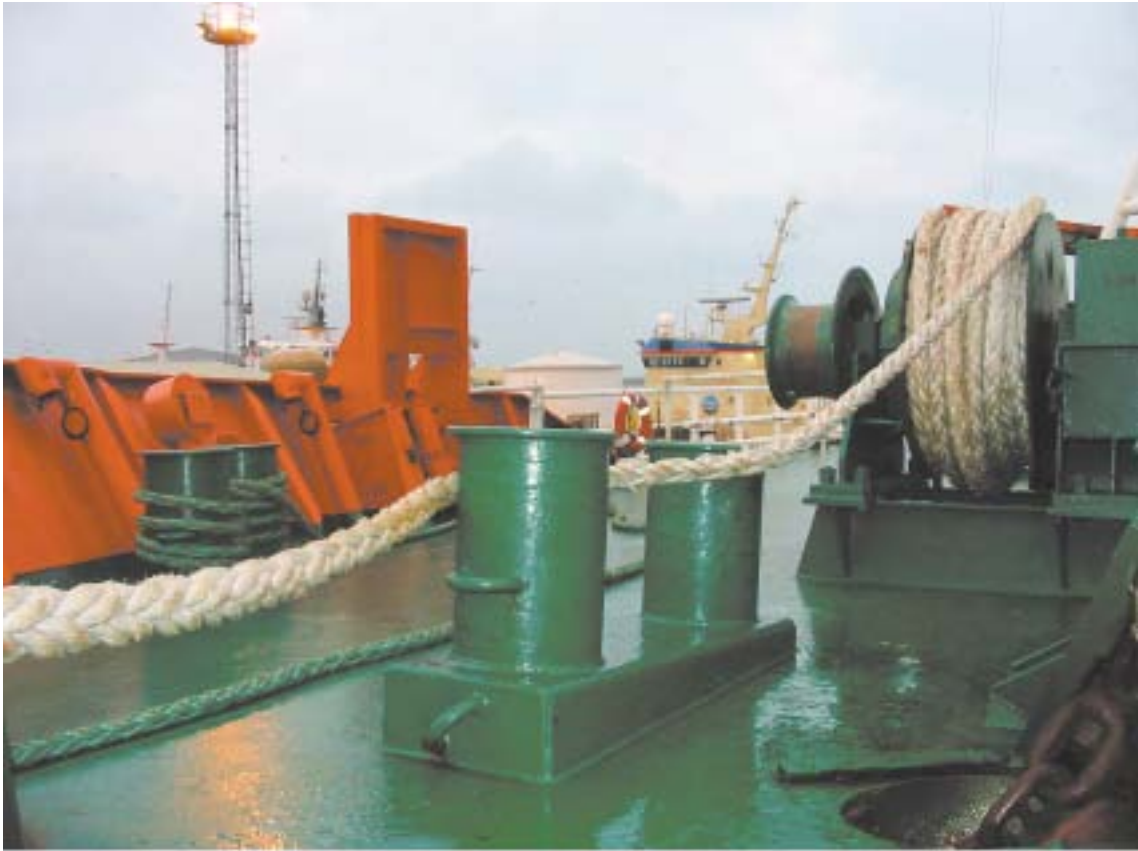
During this manoeuvre, the pilot advised the master that tugs would be secured forward and aft using ship's lines. The master immediately passed this information to the mooring teams, and the forward spring was quickly re-configured so that it could be used by the tug. From its drum, it was led between the bitts on the starboard side (Figure 2).

Rope led between the bitts on the starboard side

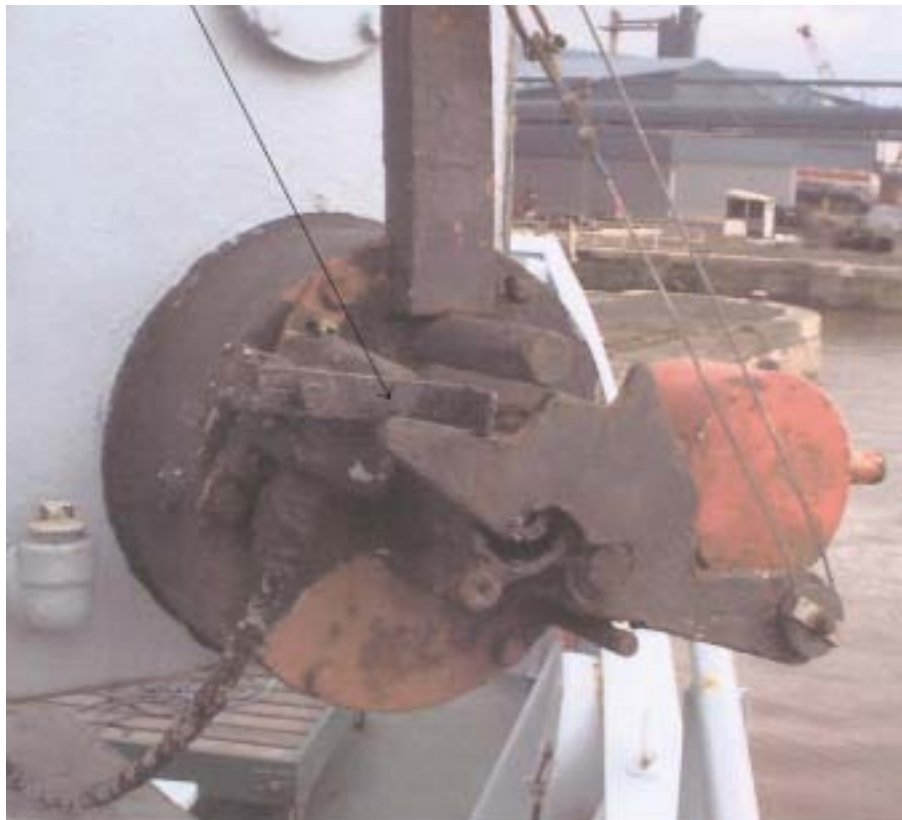
Interlock switch lever

Correct position of interlock switch lever

As an interim measure, a substantial external stop was welded to the winch's body to prevent unwanted movement of the switch lever.

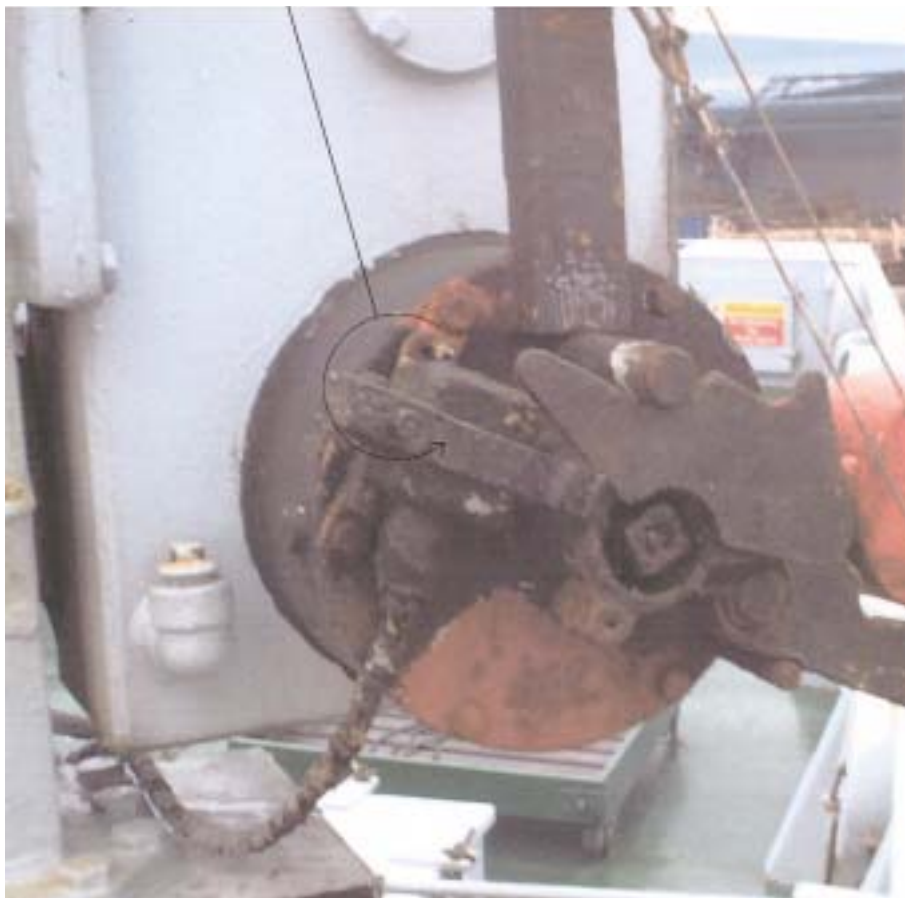
330° rotation of interlock switch lever

Incorrect position of interlock switch lever

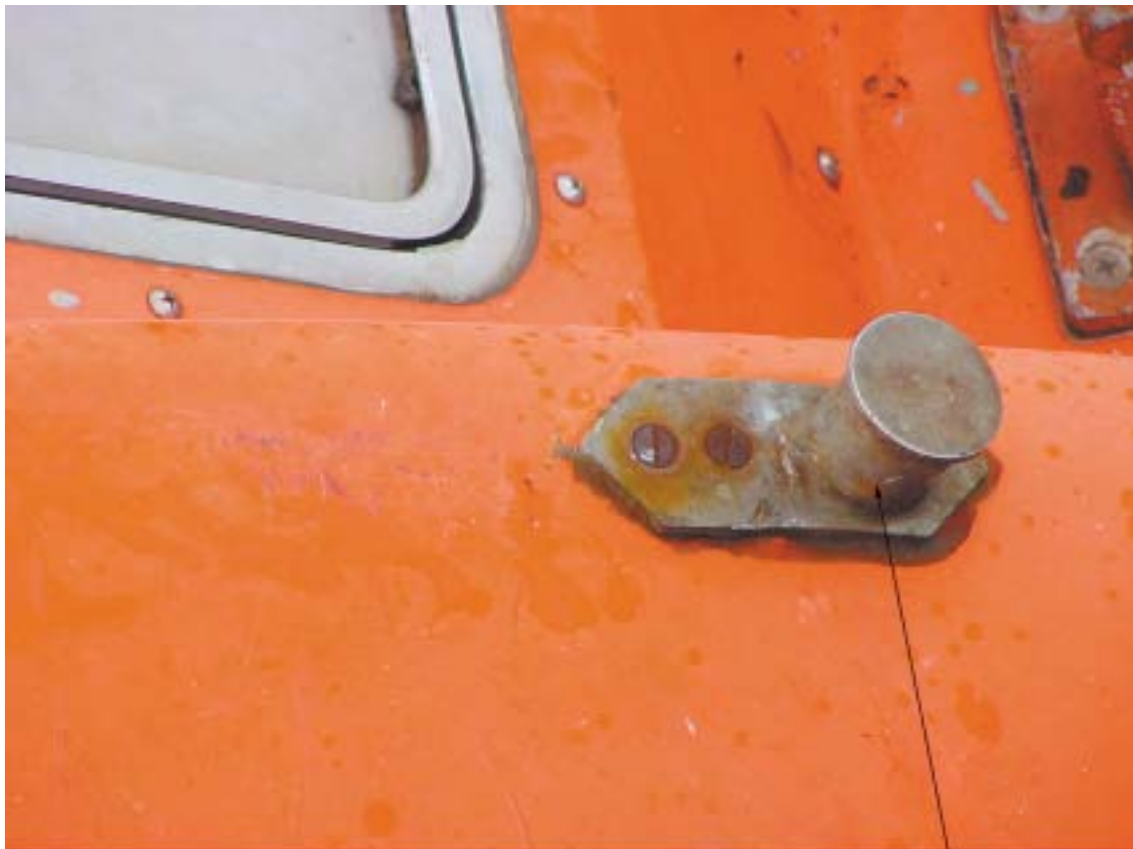
An investigation concluded that the ring on the released end of the forward gripe, instead of safely sliding over the lifeboat's canopy during lowering, had fouled on the gripe bobbin attached to the lifeboat (see figure).

Gripe bobbin

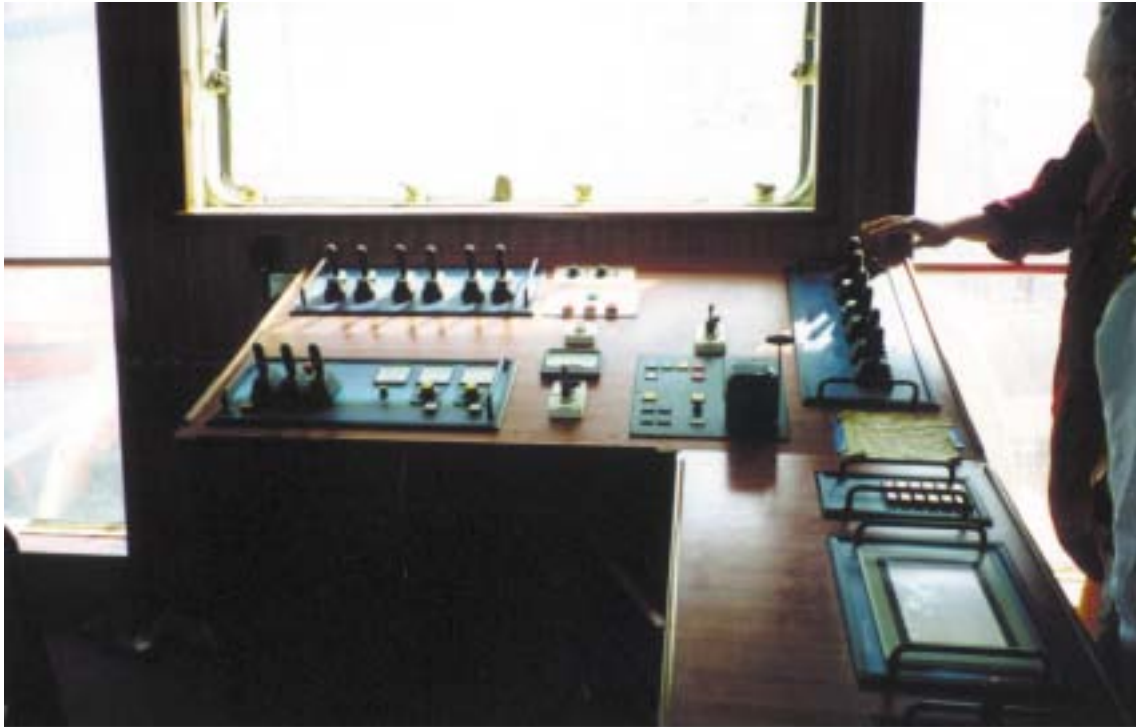
Winch control panel

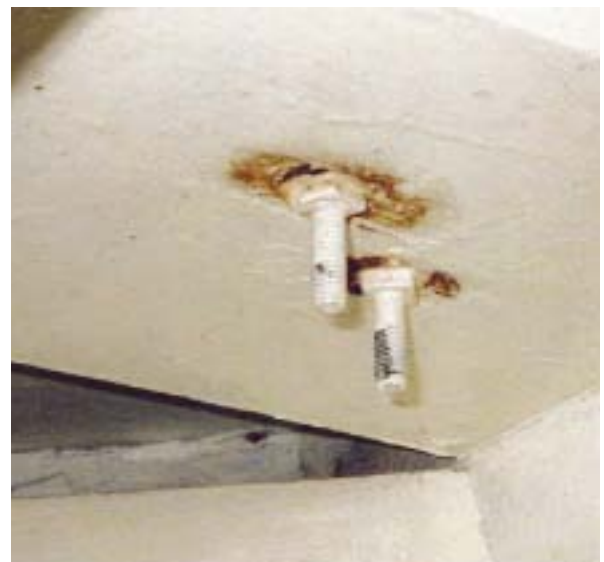
The boat owner had no set maintenance programme for his boats, and did not look at fittings on a regular basis. The last time the bolts had been inspected and replaced was 8 years before the accident.

View from under sheared bolts before removal

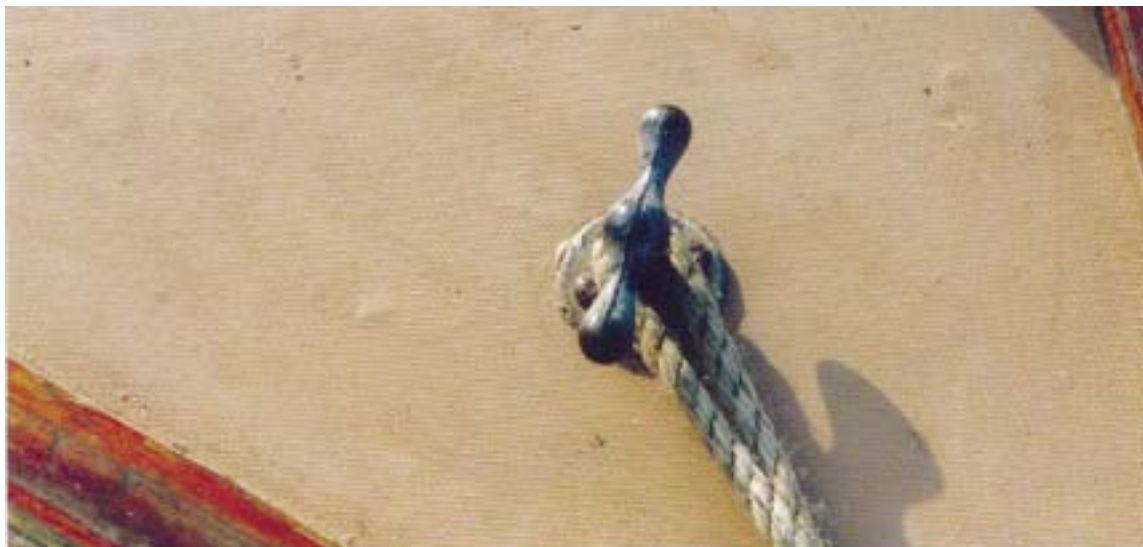
Above view of adjacent cleat (incident cleat would have looked exactly like this)
