MAIB
MARINE ACCIDENT INVESTIGATION BRANCH

SAFETY DIGEST

Lessons from Marine Accident Reports

No 2/2003

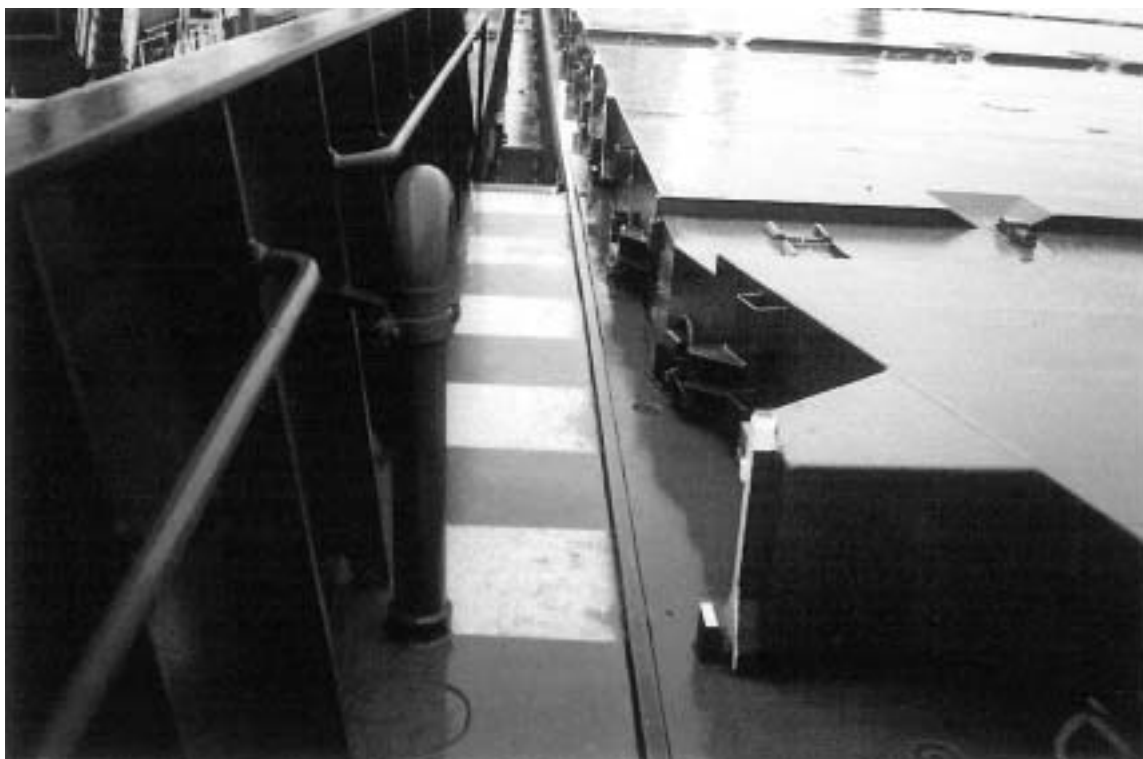
The chief officer had been standing in a position where there was a narrow gap between the gantry rails and the ship's side. The space was further restricted by a hand rail and an air pipe and, when the gantry crane was forward, by the access ladder to the crane (see **photographs**). In fact, in one position, the crane's access ladder came to within 6cm of the air pipe.

View showing gap between gantry crane ladder and vent pipe

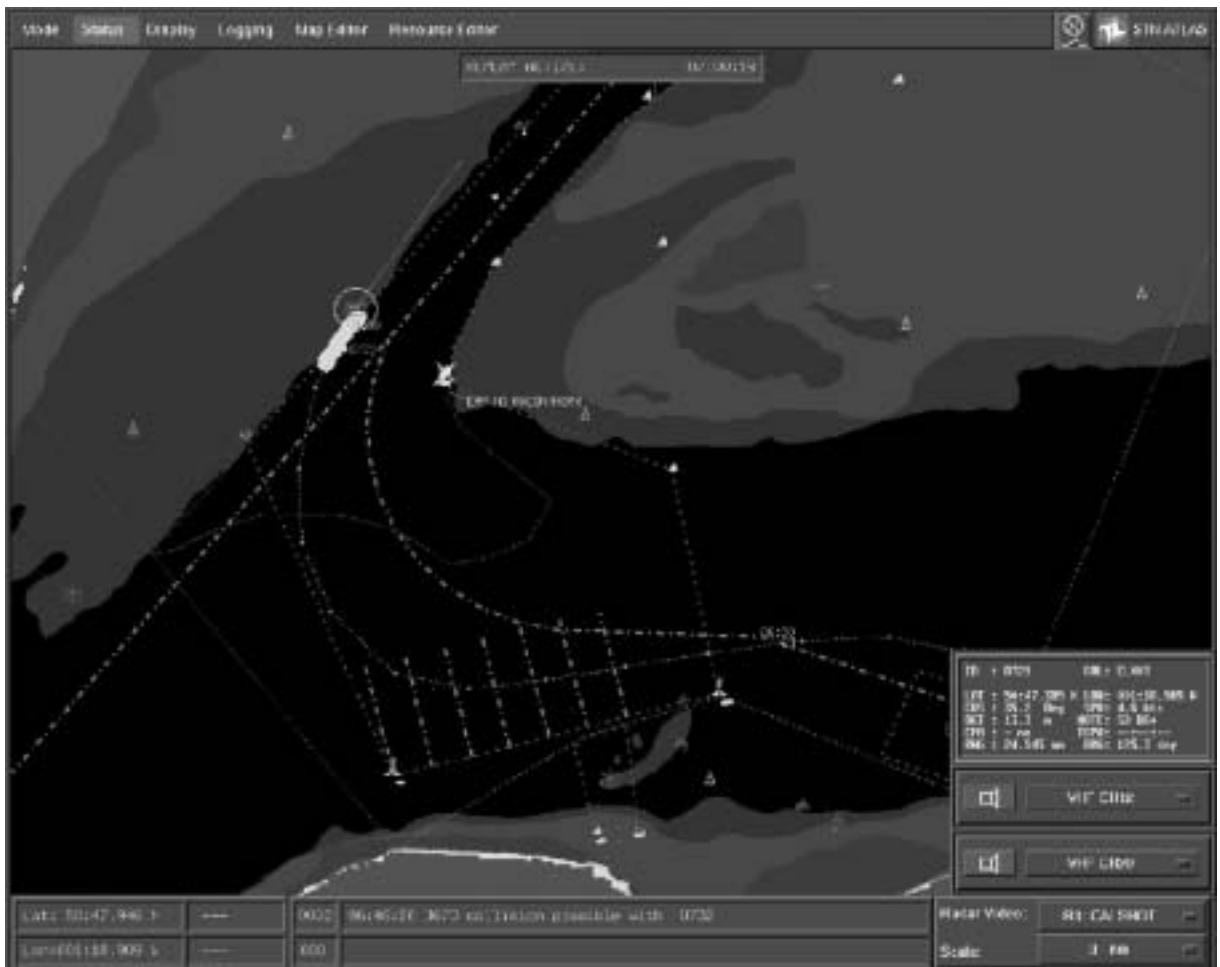
When the west Bramble and north-east Gurnard buoys appeared, the pilot realised the ship was outside the intended track for the turn. Despite further helm and engine orders, she grounded at about 0700.

Container ship grounding on edge of navigable channel
