Marine Accident Investigation Branch (MAIB) - Safety Digest 02/1999

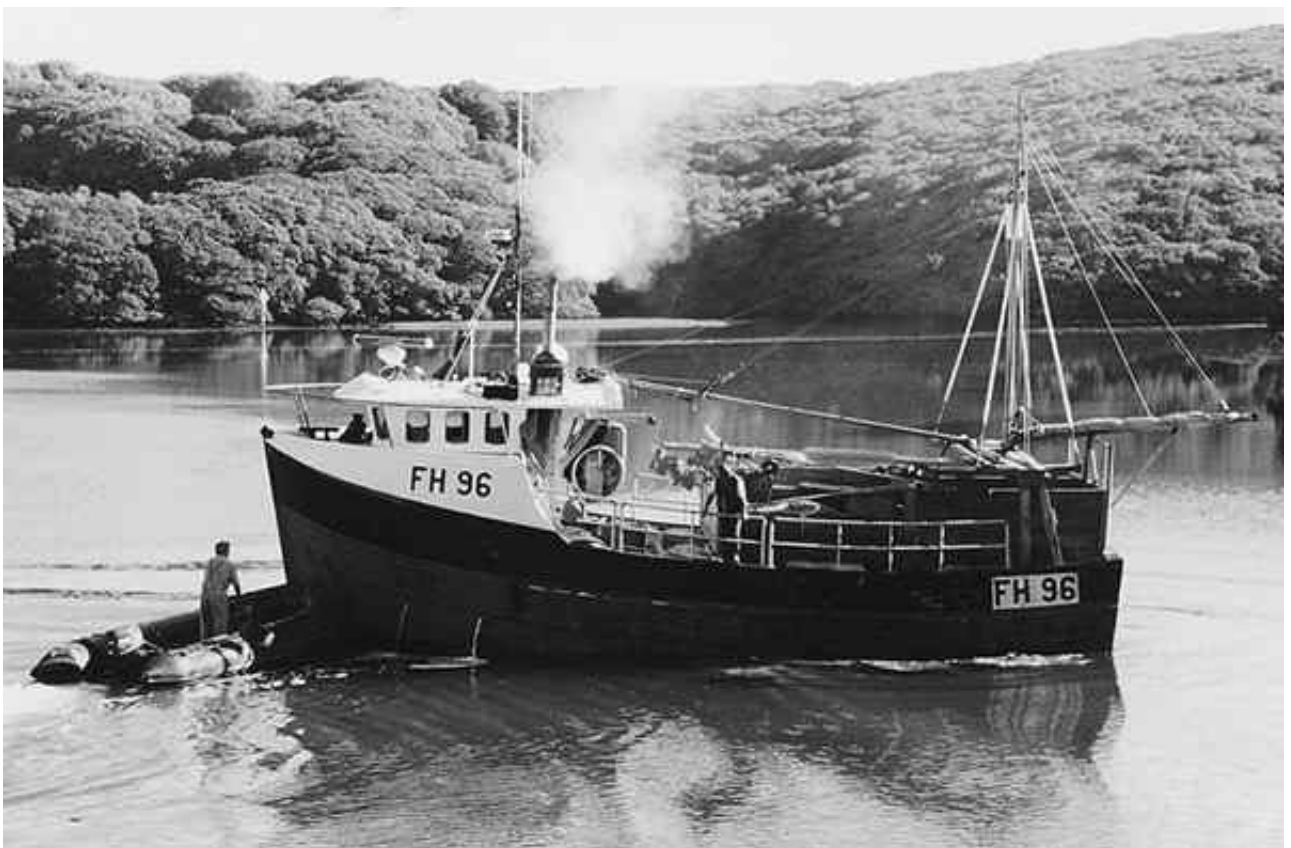
Heart of Oak of Helford

While making way in the heavy swell the vessel started to roll heavily and the partially full net bin slid from where it was stowed, starboard of amidships, to where the deckhand was working. He raised himself up to try and fend it off but was caught by the bin and lost his balance. He fell overboard.

The skipper brought the vessel around in an emergency turn to get as close as possible to the man overboard. When the vessel reached him, a lifebuoy with a line attached was thrown towards him while the remaining two crew members shouted at him to grab hold of it. He did not respond. The operation was repeated three times without success then the victim fell face downwards in the water and appeared unconscious. Shortly after he disappeared beneath the sea surface his body was not recovered.

Since this unfortunate accident, the owners of the vessel have fitted aluminium rails round the working deck and the crew now wear single chamber self-inflating lifejackets at all times when working on deck.
