# Marine Accident Investigation Branch (MAIB) - Safety Digest 01/1997

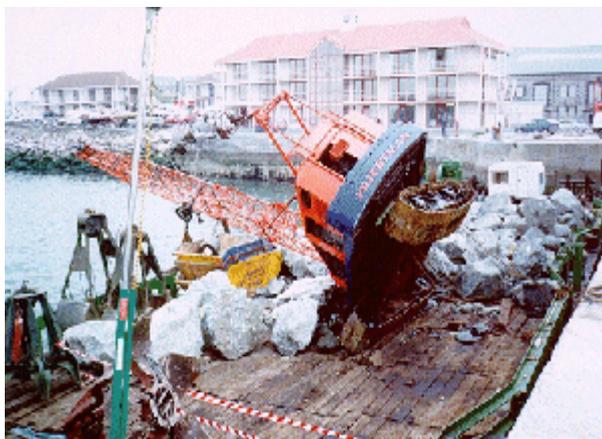
At about this time, the crane driver selected a piece of limestone rock, estimated to weigh between 3.5 and 4.0 tonne. As the rock was lifted and came free, it swung away from the jib, effectively increasing the lift radius and overloading the crane. To counter the overloading and overturning moment, the crane driver started to luff-up or raise the jib. At that moment, the barge moved under the influence of the sea swell rapidly adding to the overturning moment. With the situation becoming critical, the driver tried to drop the rock back on to the deck. Unfortunately the foot brake jammed, preventing him from releasing the load. He considered releasing the brakes by hand but realised that the sudden uncontrolled release would cause the counter weight to pull the jib and grapple rapidly back, leading to possible damage to the driver's cab itself. With the crane now unbalanced and on the verge of toppling, the driver jumped out of the cab. In doing so he broke his left arm. The crane toppled over and ended up with the jib resting over the side, slightly crushing the hand rail.

1. Although the crane was chained down during the transit voyage, it was not chained down whilst working. It was considered that to secure the crane whilst working would not only prevent the operator sensing any degree of unbalance but also restrict his ability to manoeuvre the crane. Auto-indication of overloading is mandatory but rectification lies in the hands of the crane driver.
2. The use of a crawler crane for the cargo operation was brought about by the lack of an alternative loading arrangement during the initial stages of the contract. The incident itself was brought about by a combination of the failure of the crane braking system and the rolling effect of the sea swell.

1. The Merchant Shipping (Hatches and Lifting Plant) Regulations 1988, SI No 1639, require that the employer (and Master, although in this case the barge did not have one) shall ensure that no lifting plant is used unless it has been thoroughly examined by a competent person within the preceding 12 month period. In this case, the employer - the crane driver - was provided with a certificate stating that the crane had been thoroughly inspected in June, some two months earlier.
2. The cause of the brake failure was not immediately apparent but as the mobile crawler crane had been sold with a current examination certificate, the Health and Safety Executive (HSE) were to pursue the matter under their Regulations.
