Marine Accident Investigation Branch (MAIB) - Safety Digest 02/1997

Part 1 - Merchant Vessels

1. Passenger ship suffers damage in hurricane

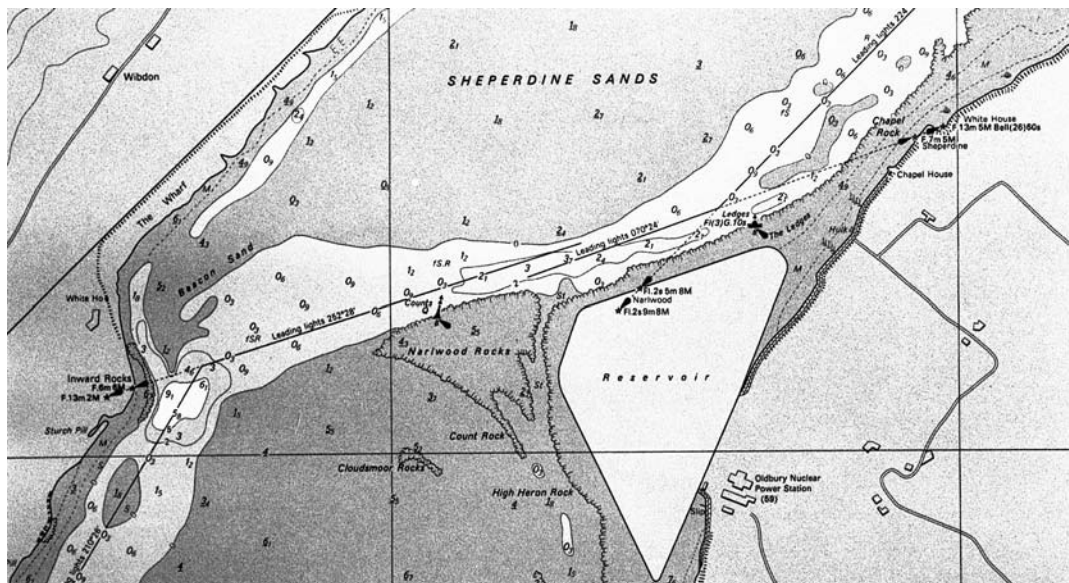
Reproduced from Admiralty Chart 1166 by permission of the Controller of HMSO and the Hydrographical Office.

A UK registered sail training vessel was outbound in the River Severn on passage from Sharpness to Barry at the time of the incident. She was carrying twelve crew and twenty trainees. The weather was favourable with good visibility and the tide was ebbing. A pilot was on board and the vessel was making a speed of about 7 knots under power (the sails had not been set).

At 1200 the Master handed over the watch to the Sailing Master and went below for his lunch. The Sailing Master was standing next to the pilot in the cockpit where he could monitor the compass heading and the pilot's orders to the helmsman. The pilot was conning by ordering specific courses to steer.
