CONTENTS

AAIB Field Investigation reports

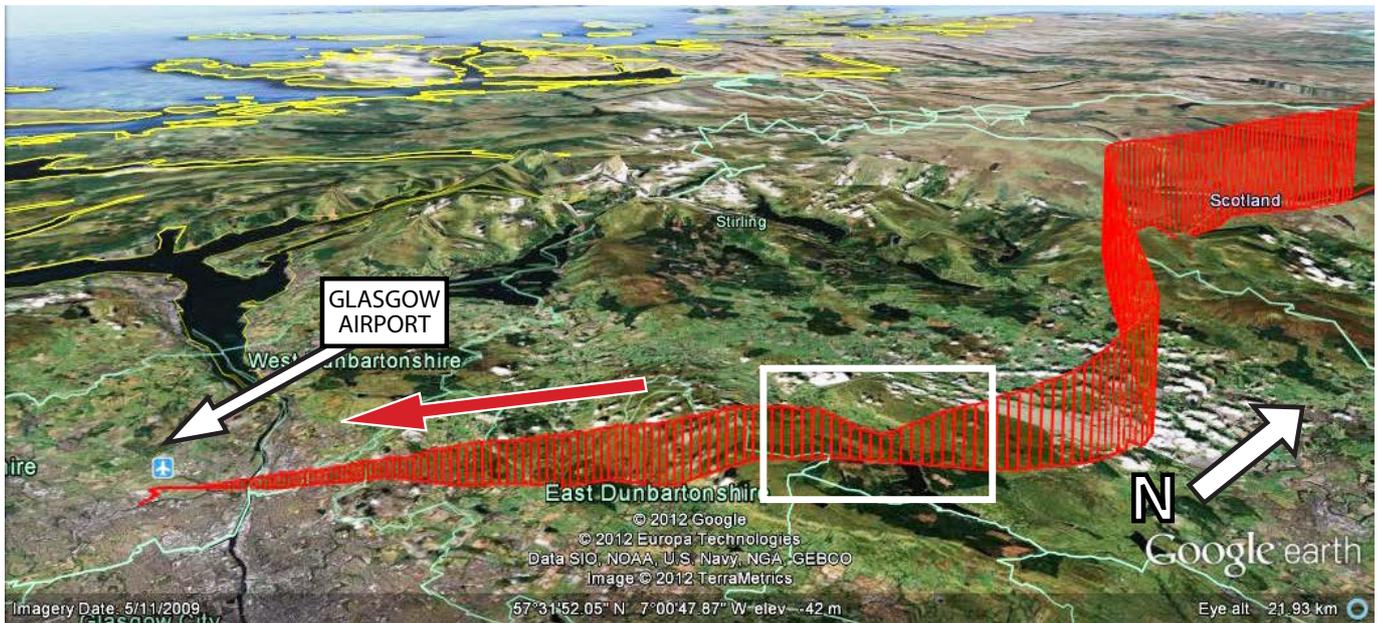
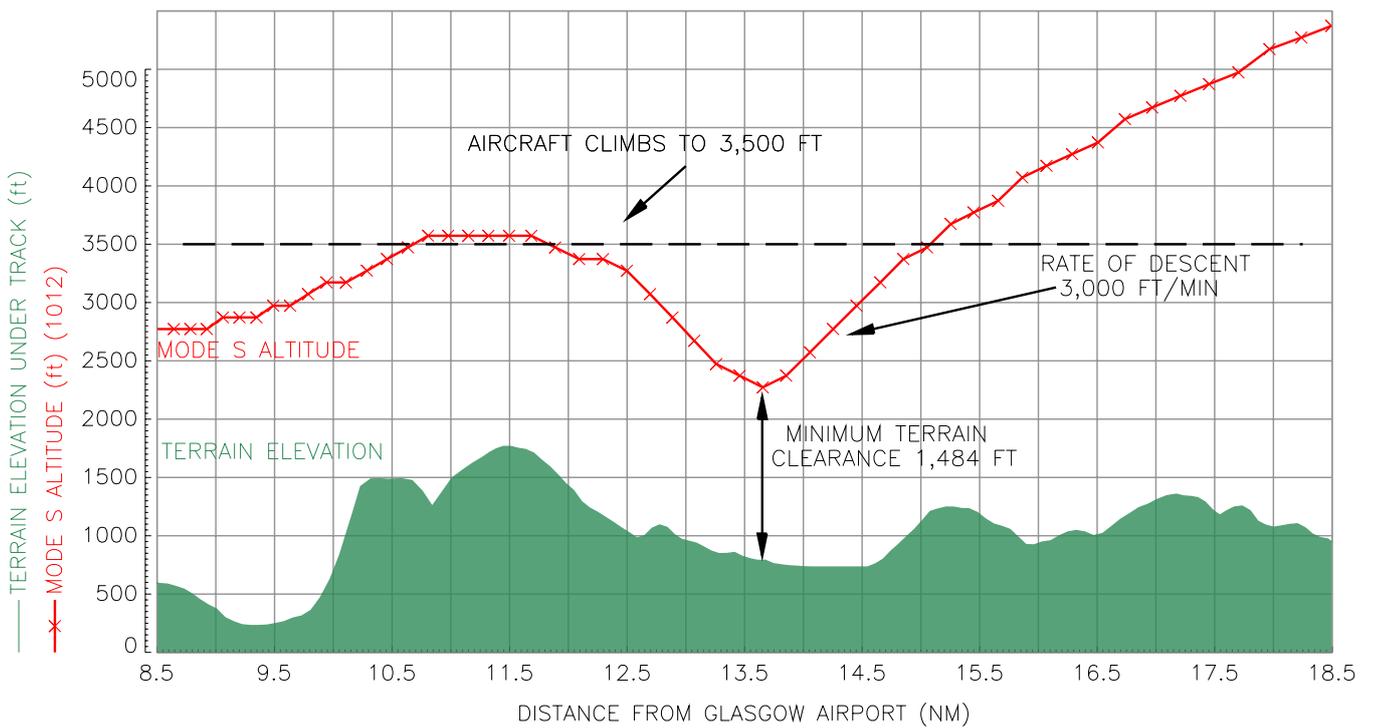
Figure 1
G-SYGA radar track and terrain under track

The aircraft's position was recorded by the Glasgow radar head which also recorded the aircraft's Mode S altitude to within ± 50 ft. This altitude was corrected to the Glasgow QNH of 1012 hPa. The recorded track shows the approach to Glasgow Airport which crossed over the high ground to the north-east of the airport (see Figure 1).

As the aircraft descended through 3,500 ft, the rate of descent increased to approximately 3,000 ft per minute which was maintained for around 16 seconds. The aircraft descended to 2,273 ft before climbing back to 3,500 ft over 40 seconds and then continuing its approach to Glasgow Airport. The minimum terrain clearance during this manoeuvre was 1,484 ft.

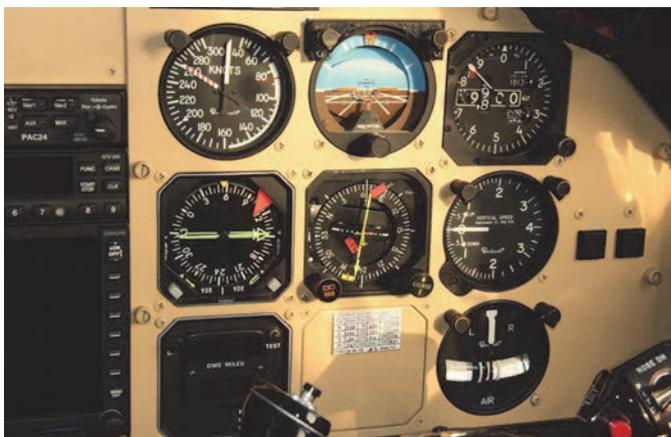
Figure 3

G-SYGA - Right primary flight instrument display

The co-pilot was unfamiliar with the instrument presentation on this aircraft which may have diminished the effectiveness of his instrument scan and increased his workload. Actions associated with the inadvertent autopilot disengagement distracted both pilots from the primary flight instruments and caused a breakdown in situational awareness, such that the aircraft descended below its cleared altitude unnoticed by the crew.

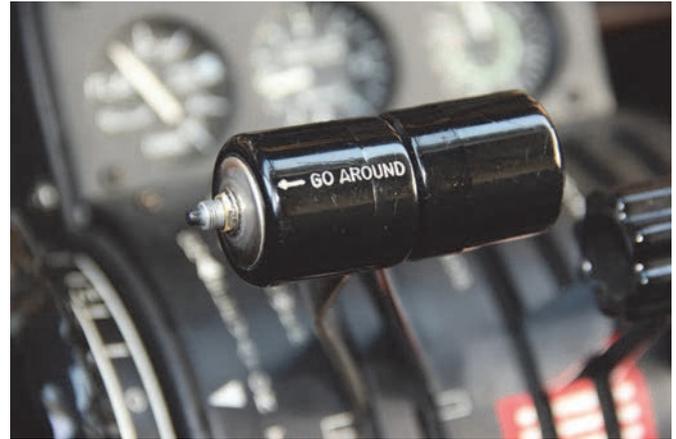
Figure 5

The WARN HORN SILENCE button is located on the lower main instrument panel just in front of the commander's left knee. The GO-AROUND button is located in a position similar to that of Pro Line 21-equipped aircraft but the button protrudes from the power lever knob rather than being recessed in it.

G-SYGA – Power levers.

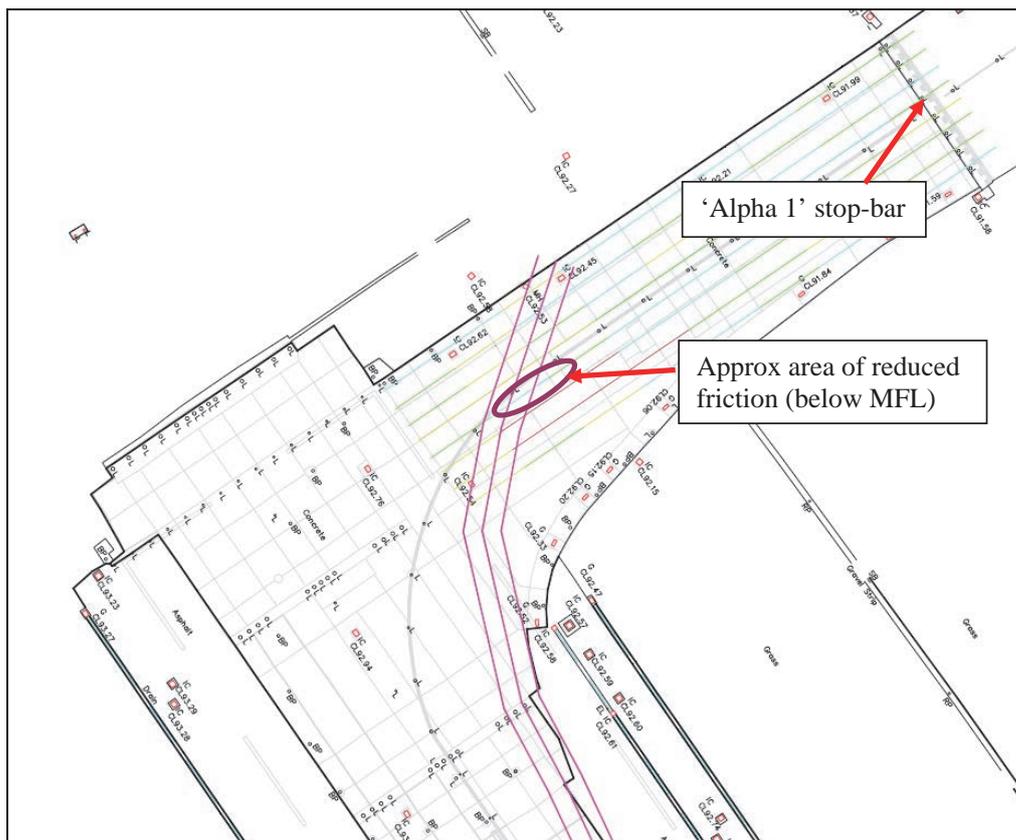
Figure 2

An examination by the engineering organisation that usually conducted turn-round checks for the operator revealed cuts in the tyre tread which probably occurred when travelling over the grass. The nosewheels and tyres were replaced.

area of the surface was found to be under the MFL value on Alpha One. However, the average value for the surveyed area was in excess of 0.70.

Northern end of Runway 33 showing approximate track of LY-SKA's wheels and area of friction below MFL

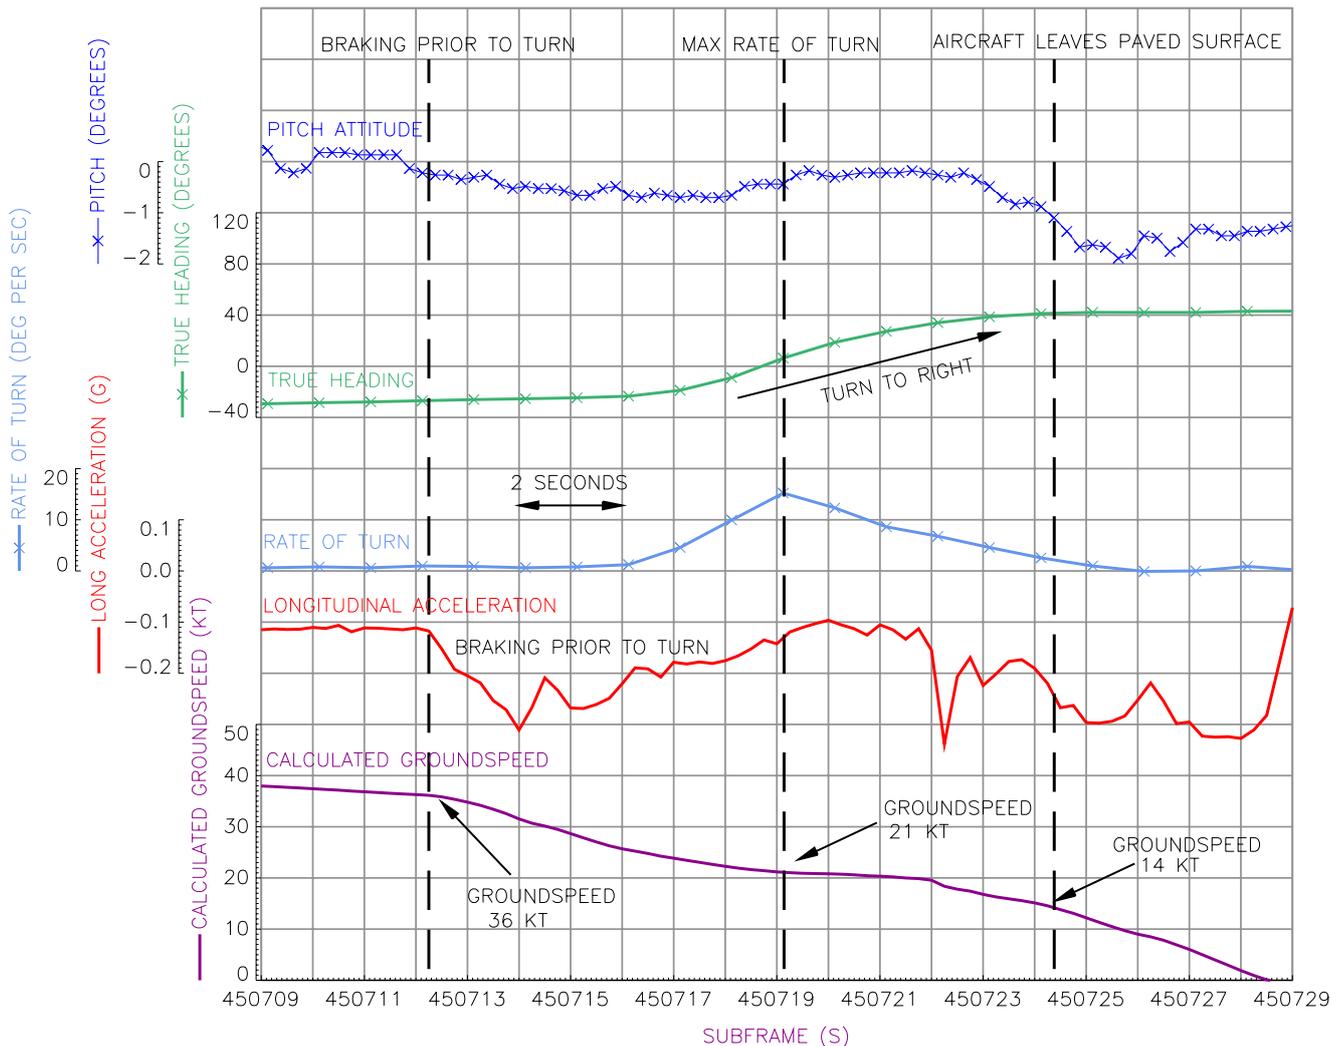
Taxiway Alpha. Figure 3 shows that at a calculated groundspeed of 36 kt, further deceleration, from pedal braking, was applied just prior to the turn. When the rate of turn was at a maximum, the calculated aircraft groundspeed was 21 ± 3 kt which reduced to 14 ± 3 kt as the nosewheel left the taxiway onto the grass.

LY-SKA FDR parameters

The aircraft departed the paved surface of the taxiway because it turned to vacate the runway at a speed inappropriate for the conditions.

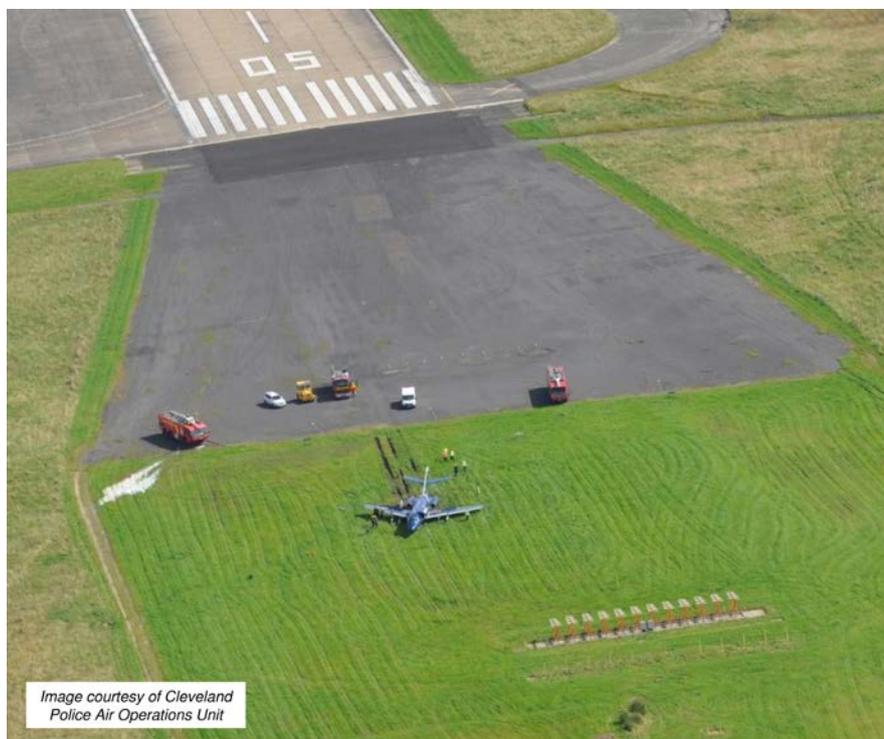
Figure 1
Incident site

The aircraft came to rest within the RESA, on a soft grass surface 54 m beyond the end of the Runway 23 strip (Figure 1). The aircraft's tyre marks were discernible on the concrete-surfaced section of the runway and on the stopway and strip, both of which had an asphalt surface covered by scattered loose gravel. Inspection of these tyre marks showed no evidence of mainwheel skidding or locking.

landing gear. A small quantity of fuel leaked from the right wing fuel tank vent, due to the resting attitude of the aircraft. Mud and stones were ingested into both engines. The right inboard brake unit had seized and was removed to allow the aircraft to be recovered.

The remains of a single carrion crow, weighing approximately 1 lb, were recovered from the runway at a point approximately 1,400 m (4,600 ft) from the start of the aircraft's takeoff roll. The crow was largely intact and showed no evidence of having been ingested by either of the aircraft's engines. No witness mark from a bird impact was visible on the aircraft, although it may have struck the landing gear with any impact marks having been subsequently obscured by mud.

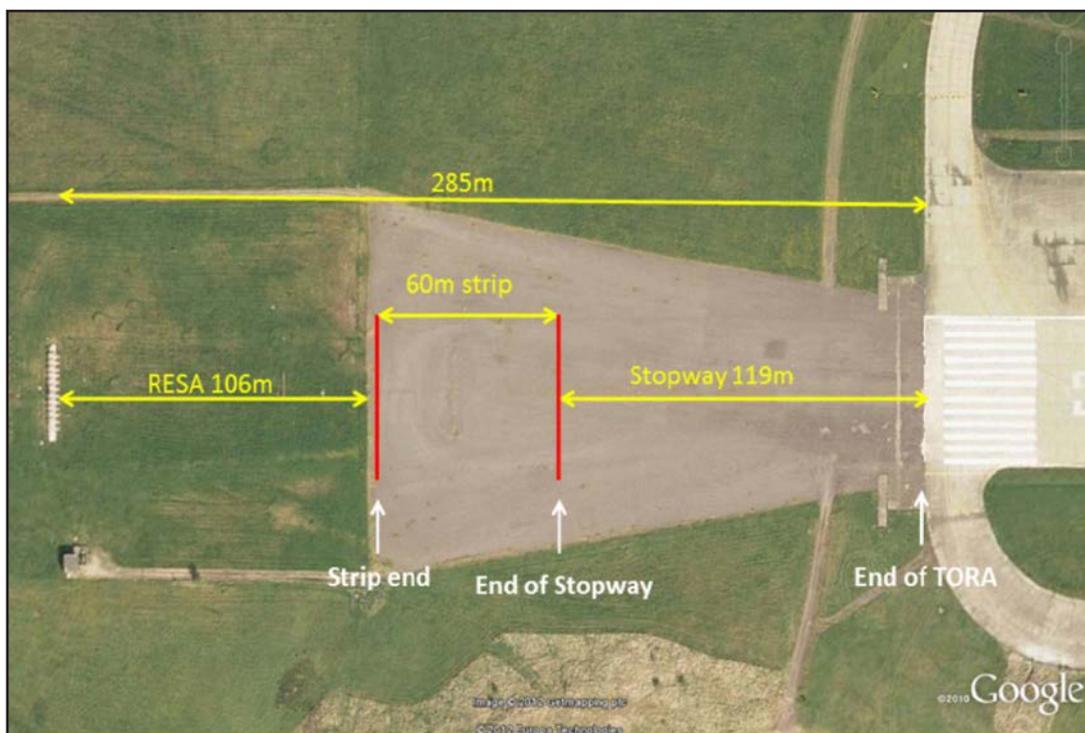
Figure 2

The end of Runway 23 at Durham Tees Valley Airport

The recorded data indicates significantly less retardation, about -0.22 g, whilst the aircraft was on the stopway and runway strip. This is approximately half that of when the aircraft was on runway and is considered to have been as a consequence of the reduced friction afforded by the change in surface material or contamination by loose debris.

Had the friction levels been the same as that of the runway, it is estimated that the aircraft would have entered the grass area at 6 KIAS rather than the 50 KIAS recorded. The current inability to measure the friction levels accurately of such areas is of concern as it may result in friction levels below those required in CAP 683. The airport has advised that it is reviewing this issue. However, as it is evident from the incident data that the stopway friction is significantly below that of the runway the following recommendation is made:

Safety Recommendation 2013-004

It is recommended that Durham Tees Valley Airport takes action to ensure that, in accordance with the requirements of *CAP 683 – The Assessment of Runway Surface Friction Characteristics*, the surface of the Runway 23 stopway has friction characteristics not substantially less than those of the associated runway.

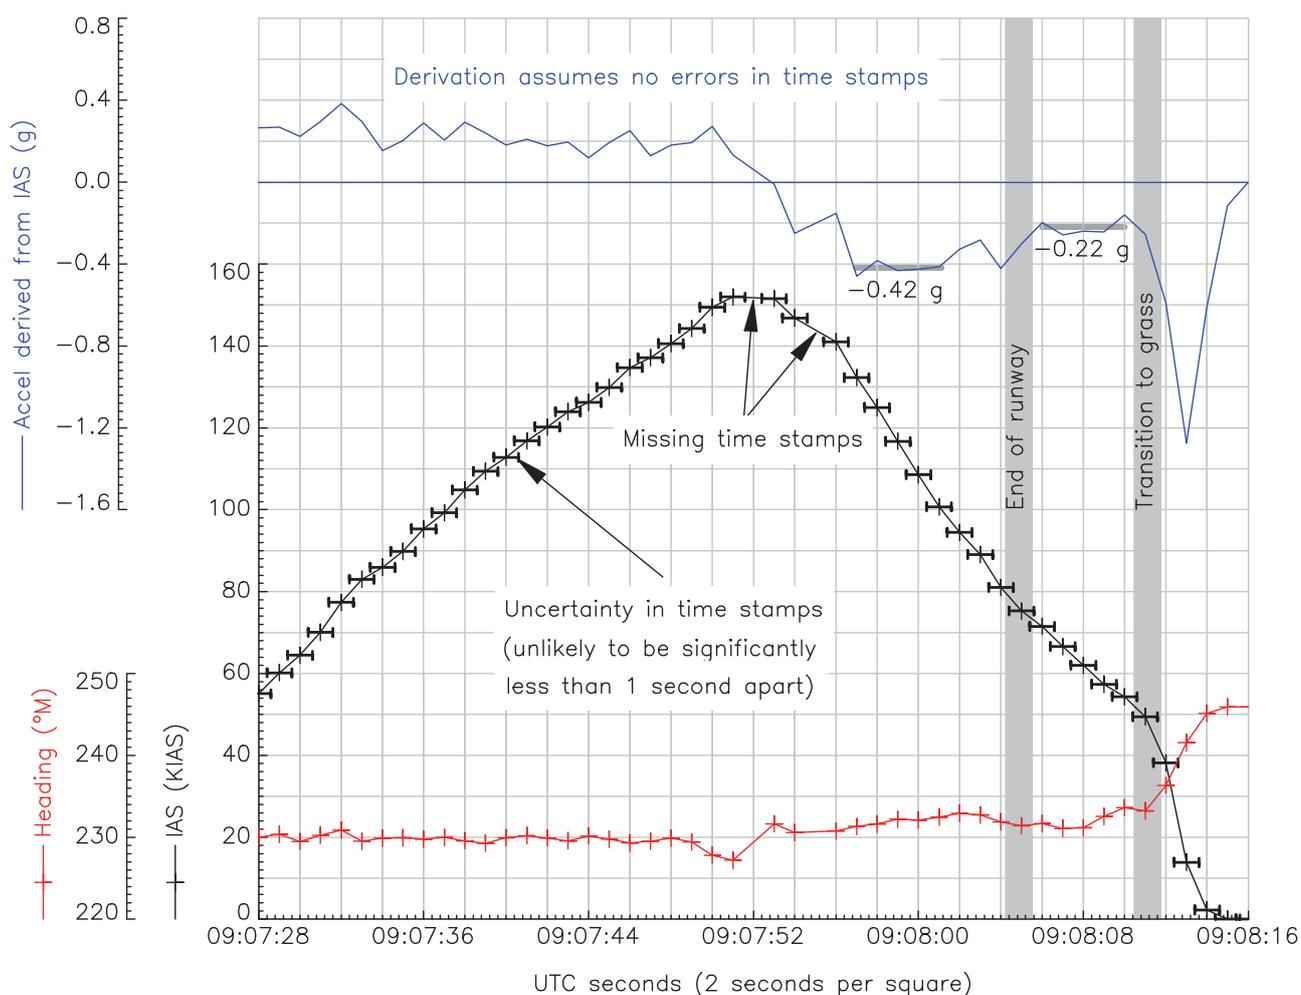
Figure 4
Pertinent recorded data and calculated acceleration

During the RTO, at the time of peak speed and another point shortly after this, two time-stamps and their associated parameters were not recorded. With a missing time-stamp, samples that are stamped as 2 seconds apart could theoretically be between 0.8 and 3.2 seconds apart.

From 140 KIAS to 100 KIAS, assuming accurate time-stamps, the average deceleration was -0.42 g. The aircraft left the end of the runway at approximately 75 KIAS. Once on the stopway and then the runway strip, deceleration reduced significantly and the aircraft continued until it ran onto the grass. The aircraft departed the stopway with a speed of approximately 60 KIAS and entered the grass with a speed of approximately 50 KIAS. The data indicates the grassed area provided significant retardation, bringing the aircraft to a stop.

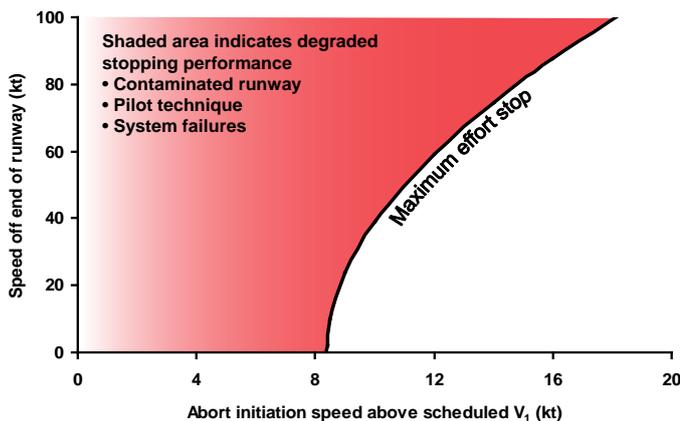
Figure 6

Effect of initiating RTO above V_1

The manufacturer's performance figures indicate that with fully operational systems, applying the correct actions in the appropriate transition times yields a peak speed of less than 2 KIAS above the V_1 speed. In the absence of any known system failures and assuming the correct crew actions and timing, the performance modelling indicates that the decision to reject the takeoff was made at a speed such that the equivalent V_1 was 150.2 KIAS.
