SPECIAL BULLETINS / INTERIM REPORTS

AAIB FIELD INVESTIGATIONS

Aircraft Type and Registration:	Airbus A319-131, G-EUOE
No & Type of Engines:	2 x IAE V2522-A5 turbofan engines
Year of Manufacture:	2001 (Serial No 1574)
Date & Time (UTC):	24 May 2013 at 0716 hrs
Location:	London Heathrow Airport
Type of Flight:	Commercial Air Transport (Passenger)
Persons on Board:	Crew - 5 Passengers - 75
Injuries:	Crew - None Passengers - None
Nature of Damage:	Fire damage to the right engine; mechanical damage to: fuel and hydraulic pipes, slats, flaps, horizontal stabiliser, landing gear and fuselage skin
Commander's Licence:	Airline Transport Pilot's Licence
Commander's Age:	50 years
Commander's Flying Experience	14,337 hours (of which 8,036 were on type)
Information Source:	AAIB Field Investigation

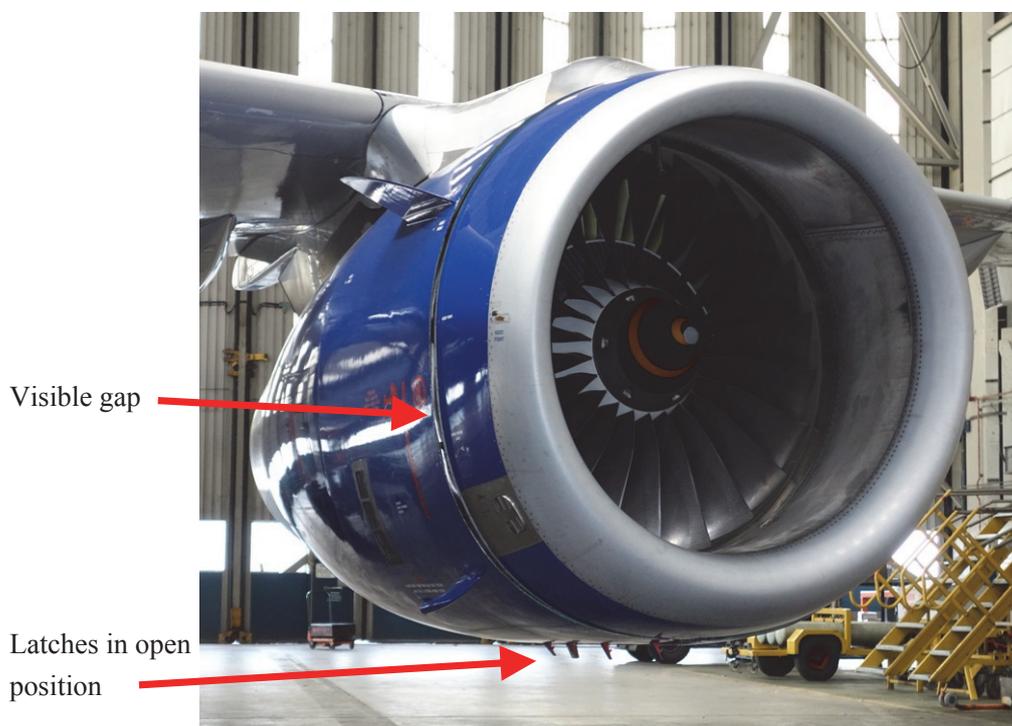
Figure 1

cowl doors from closing fully under gravity. In this condition the fan cowl doors stand slightly proud of the nacelle (Figure 1), to provide a visual cue that the doors are not latched.

Following the event photographs of the aircraft, taken prior to pushback, were provided to the AAIB. These photographs show the fan cowl doors unlatched on both engines.

Generic photograph showing fan cowl doors in the unlatched condition

Following previous events of fan cowl door separation on A320-family aircraft, Airbus recommended that operators strictly adhere to Aircraft Maintenance Manual (AMM) task 71-13-00 for proper latching and closing of fan cowl doors after each maintenance action requiring cowl opening.

It is recommended that Airbus formally notifies operators of A320-family aircraft of the fan cowl door loss event on A319 G-EUOE on 24 May 2013, and reiterates the importance of verifying that the fan cowl doors are latched prior to flight by visually checking the position of the latches.

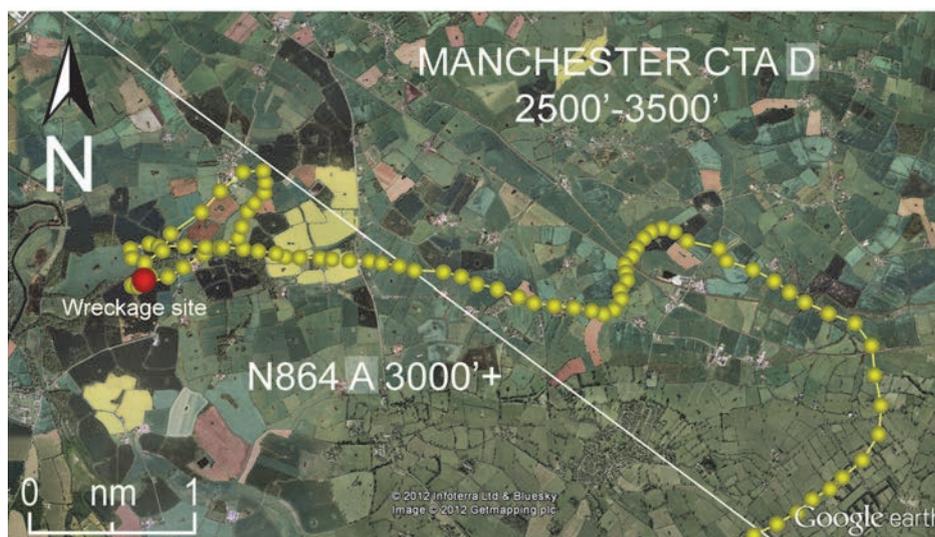
Figure 1

Clee Hill's radar track for the last eleven minutes of the flight is presented at Figure 1; the time between consecutive points (radar returns) is eight seconds. Figure 2 plots the variation in calculated groundspeed (both point-to-point and five-point average) and the

Clee Hill radar track for the last eleven minutes of the flight

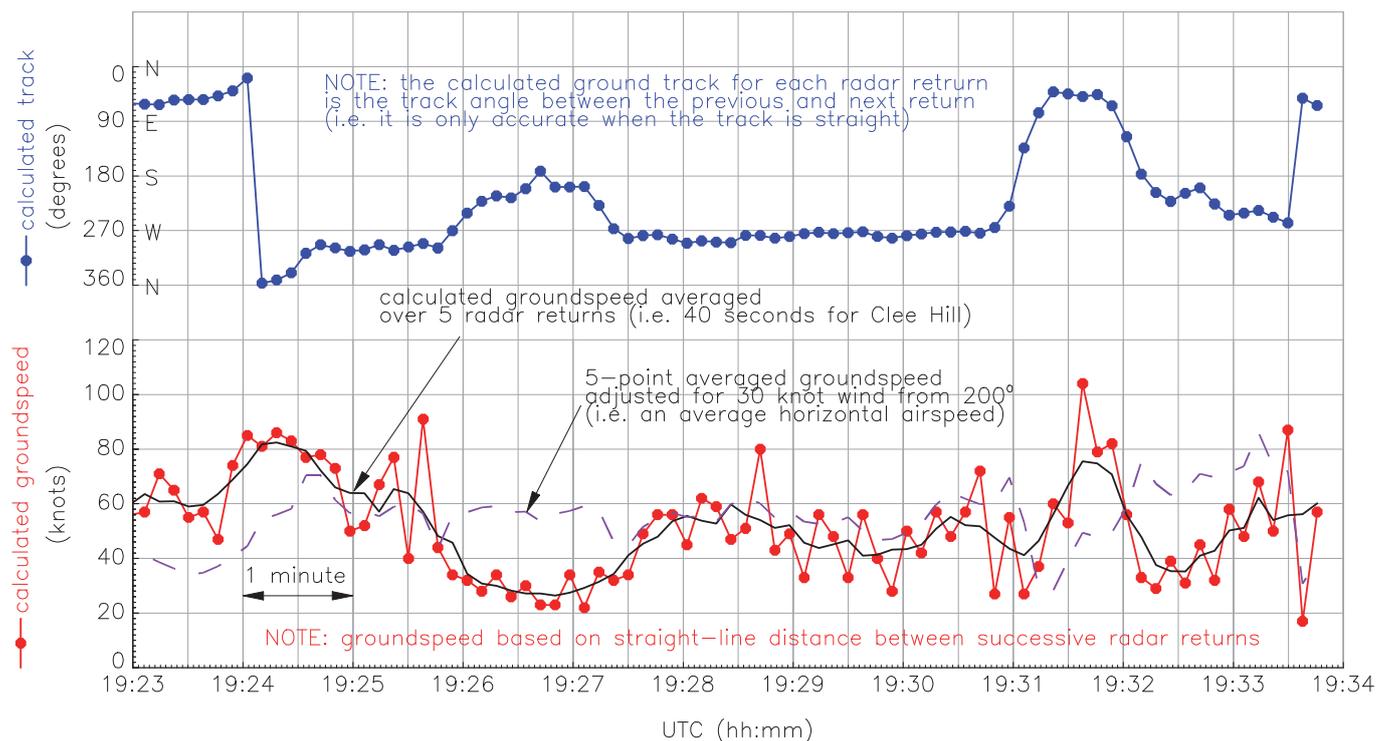
Figure 2

Variation in groundspeed and track for the last eleven minutes of the flight (Clee Hill radar)

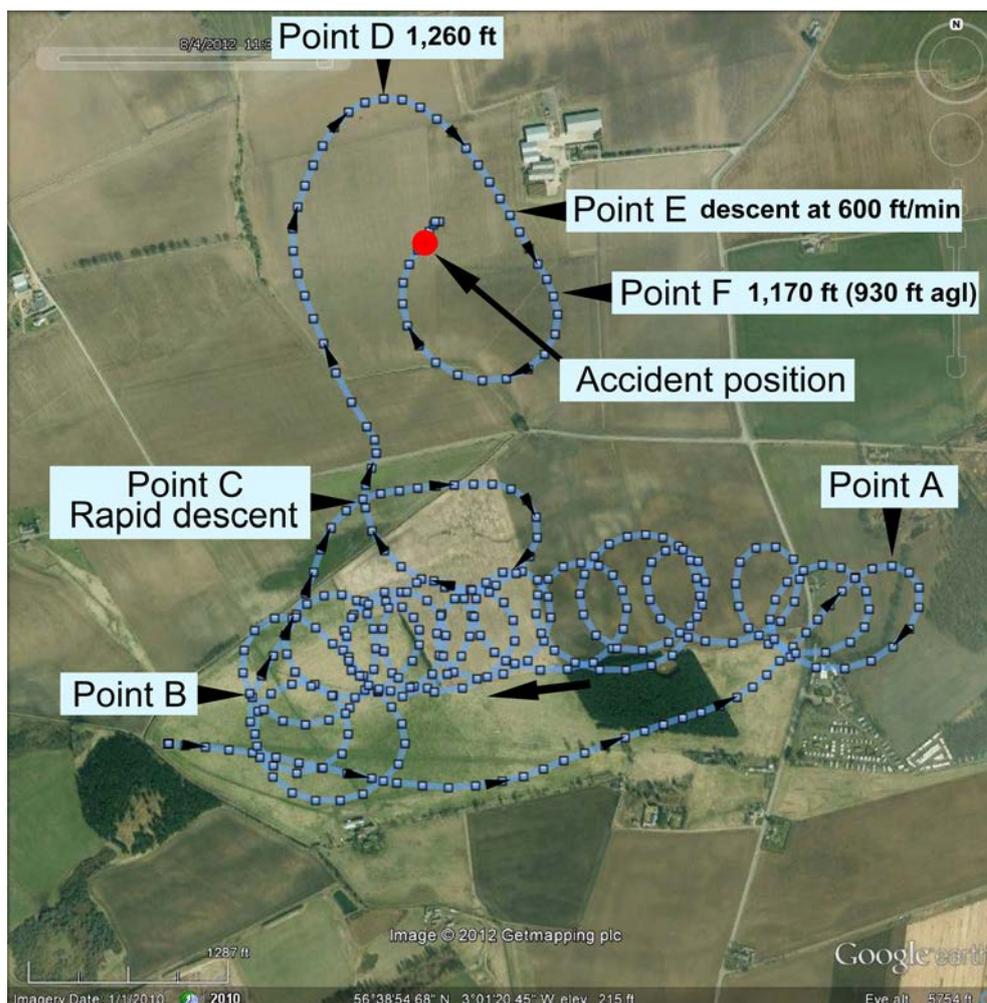
Figure 1

G-DDFN – Flight recorder GPS track

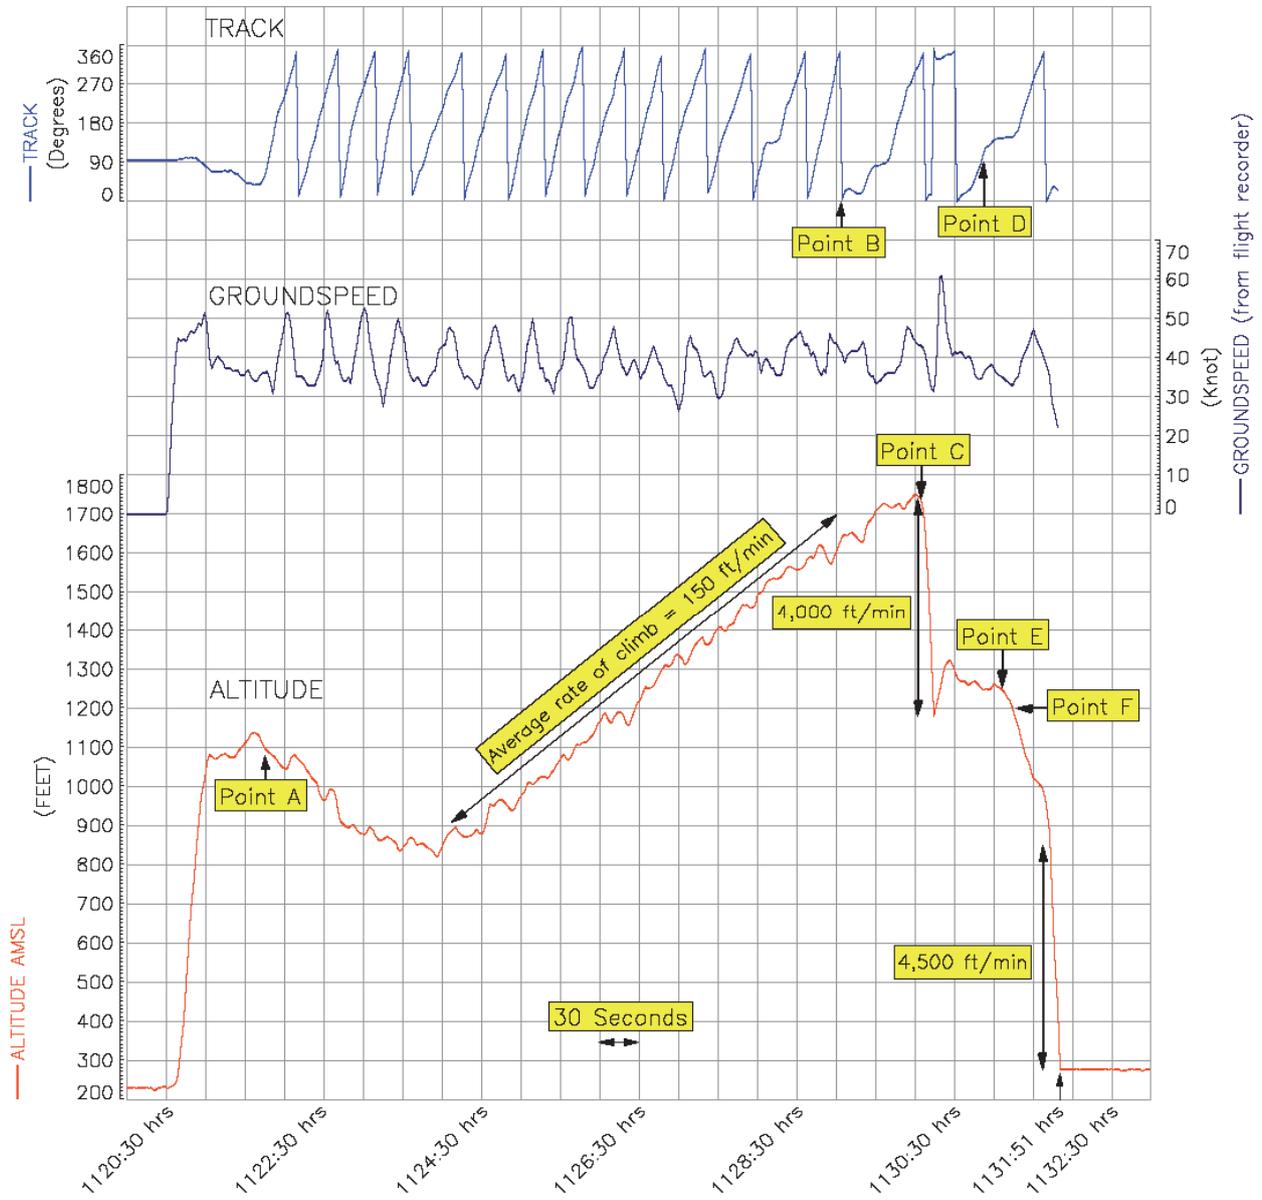
Figure 2
 G-DDFN –Altitude, track and groundspeed
 (Takeoff to ground impact)

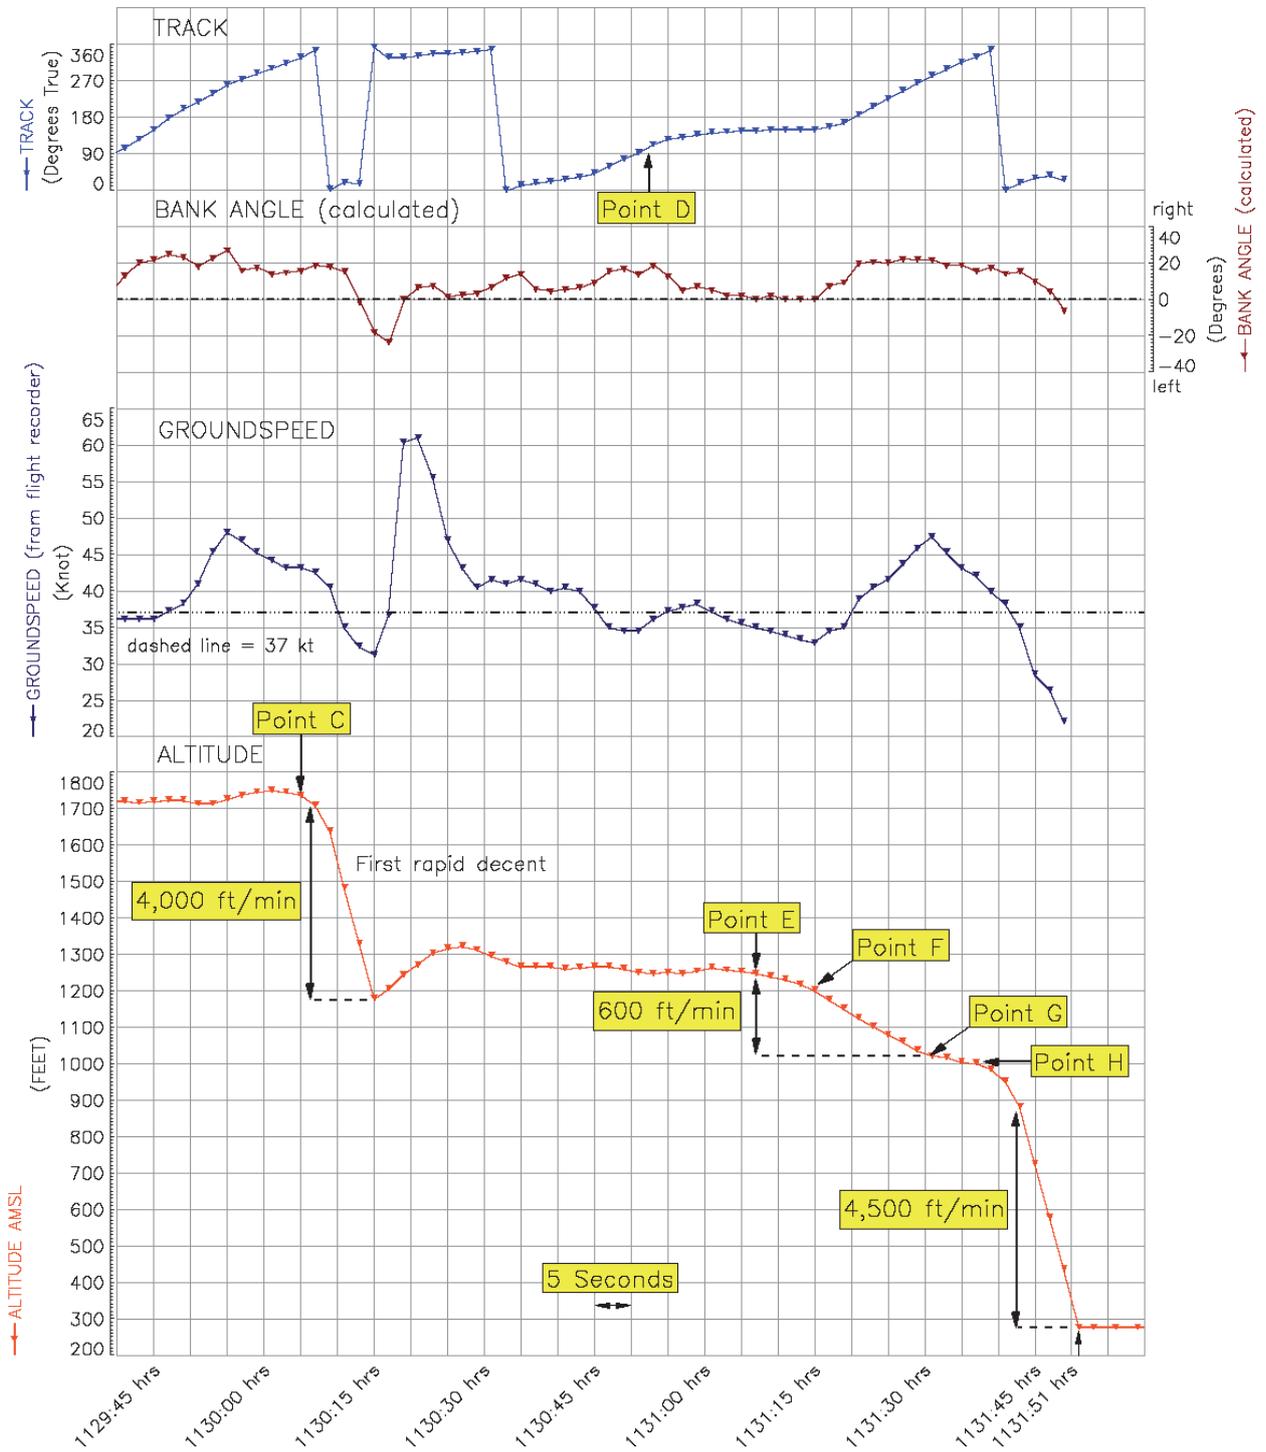
Figure 3

G-DDFN – altitude with track,
groundspeed and bank angle (calculated)
(Final minutes of flight)

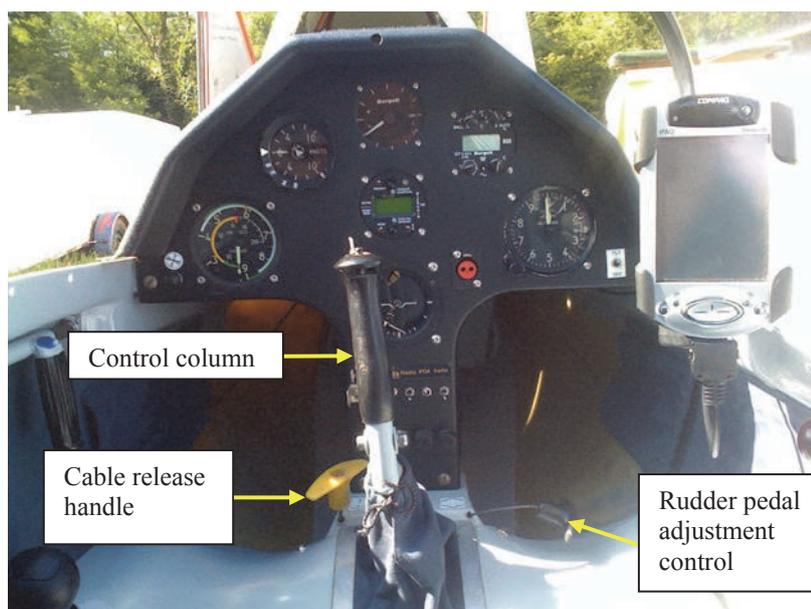
Figure 1

Photograph of the cockpit in G-EENN taken several years prior to the accident

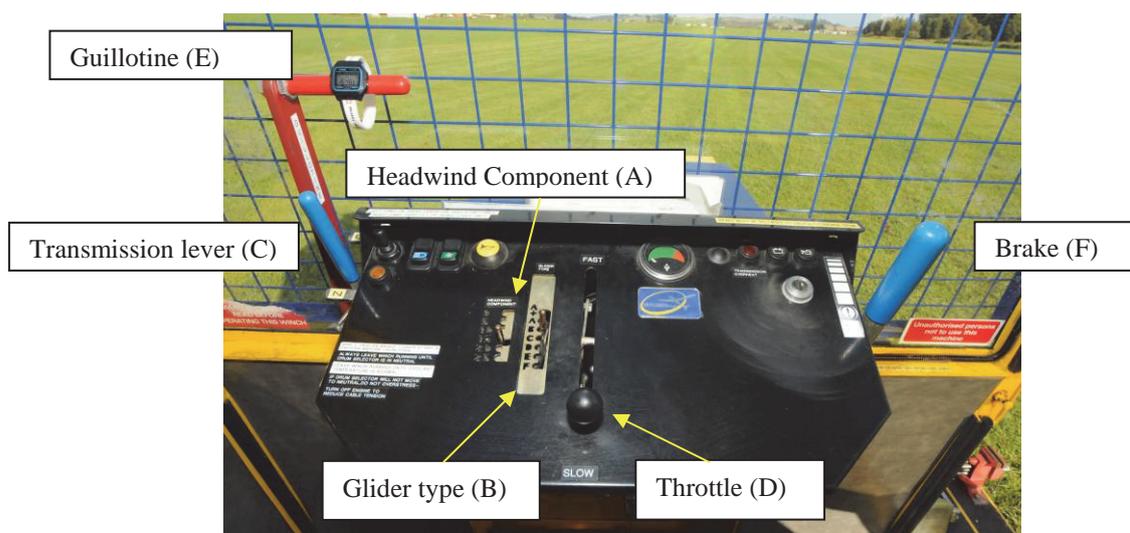
Figure 2

Following the accident, the preset for the headwind component was found to be set at 15 kt and the 'glider type' was set at 'B'. The weak link fitted to the launch

Winch controls

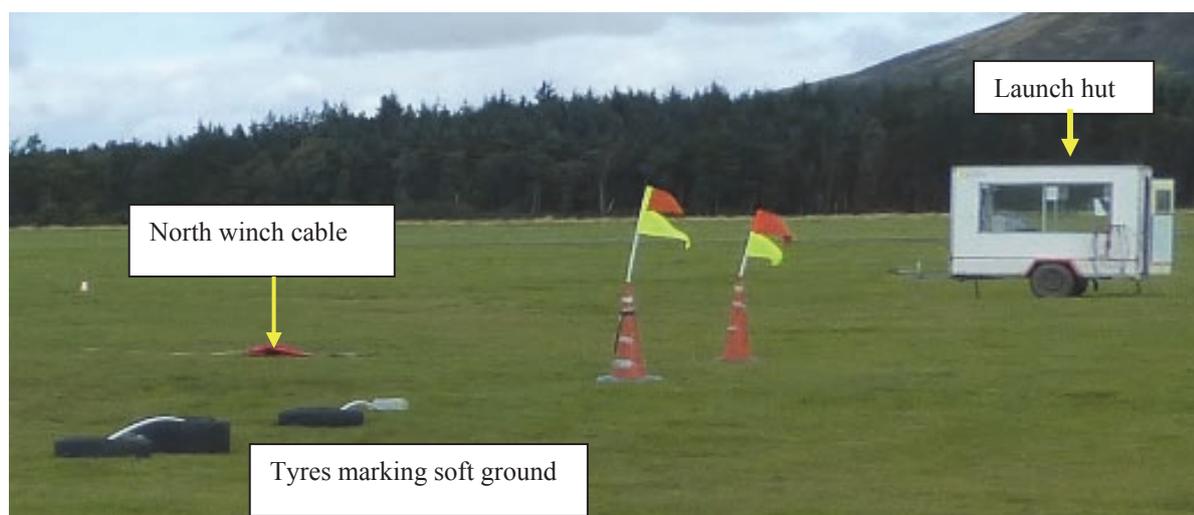
Figure 3

The winch cables were pulled to a position marked by two cones and flags with sufficient space for a glider to be launched from either side of the cones. An area of soft ground adjacent to the cones was marked by two tyres. G-EENN was launched from the southern position using the 'south' cable and from the ground marks it was established that at the start of the launch it was approximately 60 m from the launch hut. After the accident the 'north' cable, which was still in the position where both cables had been delivered, was found to be approximately 30 m north of the position from where G-EENN was launched (Figure 3).

Launch area at time of the accident, looking north-west

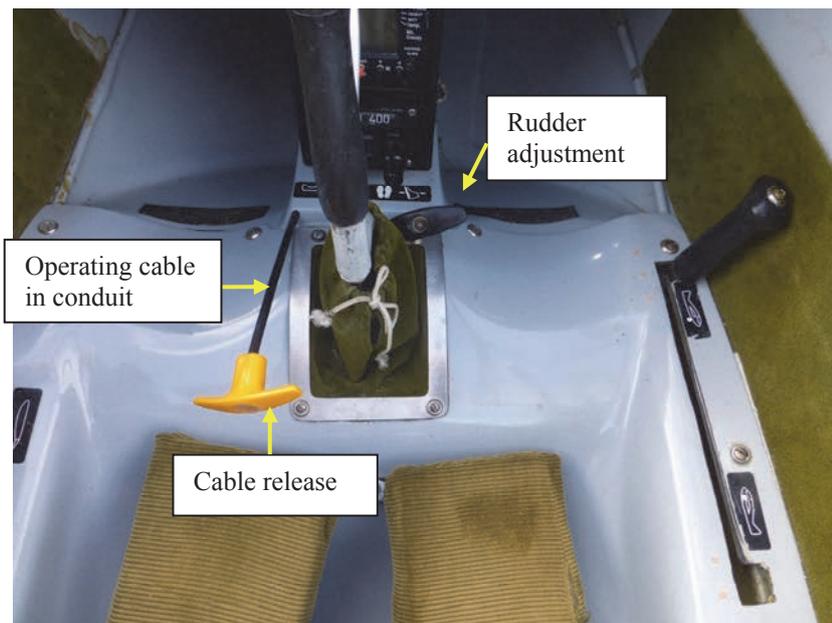
Figure 5

Cockpit layout in glider used in test

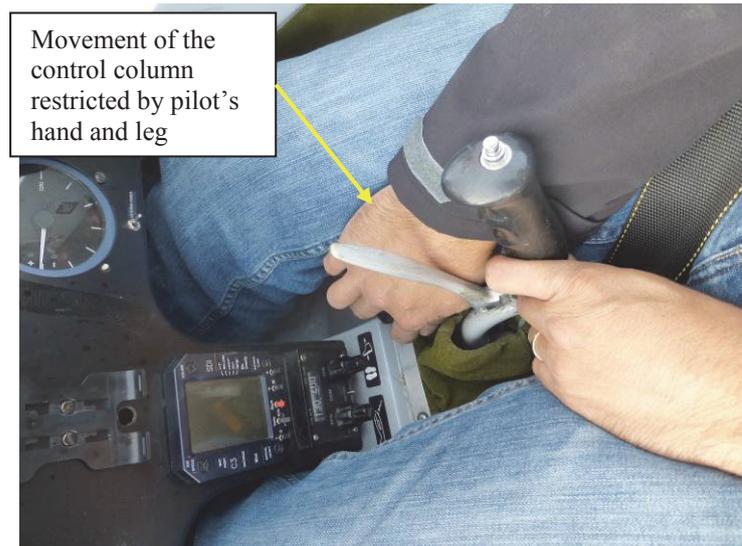
Figure 6

that the control column could move corresponded to the aileron surfaces moving approximately 55% of their full range. When the test was repeated using the winch cable release handle equipped with the longer operating cable contained in the black conduit, the control column and ailerons could be moved through their full range of travel.

Movement of the control column restricted by pilot's hand and leg

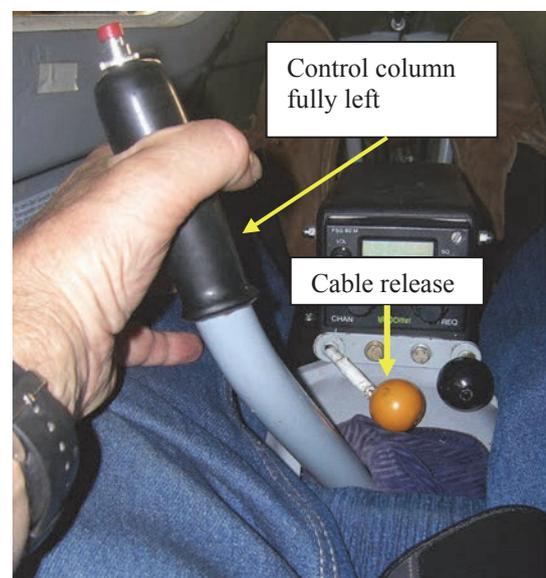
Figure 7 shows the location of the cable release on a Schleicher ASW 19 glider, which has a similar arrangement to the ASW 20L. The photograph was taken with the control column in the full left position.

Control column fully left

Cable release

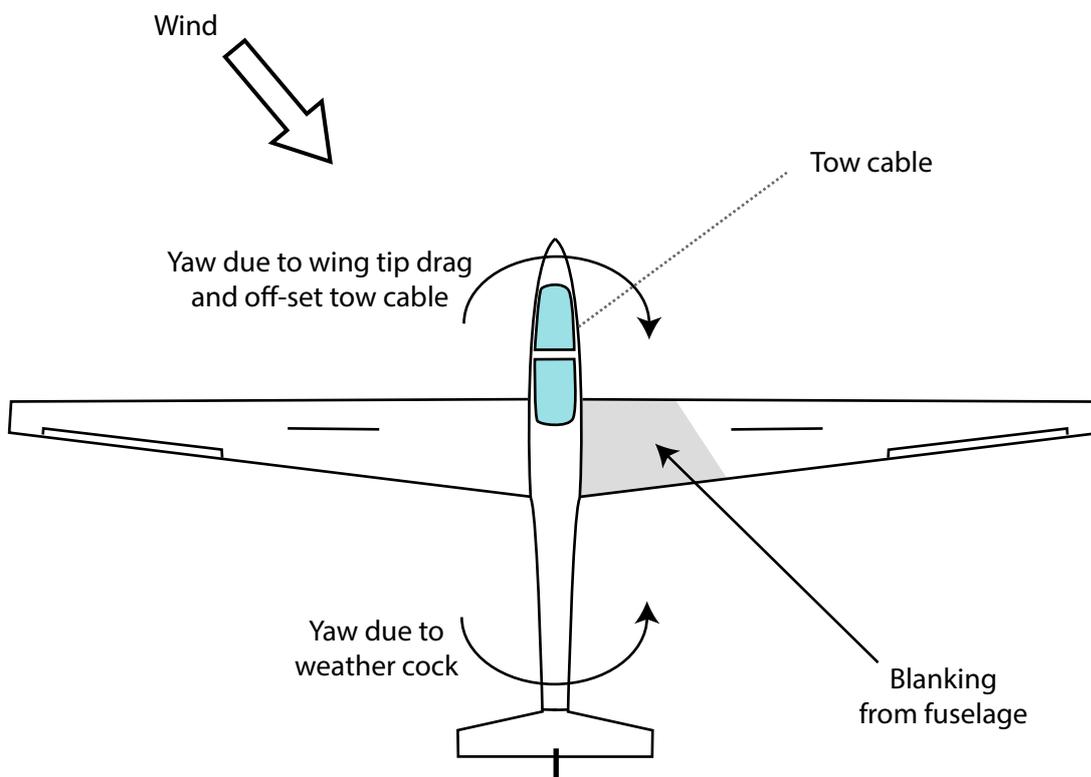
Figure 9

Example of winch launch dynamics

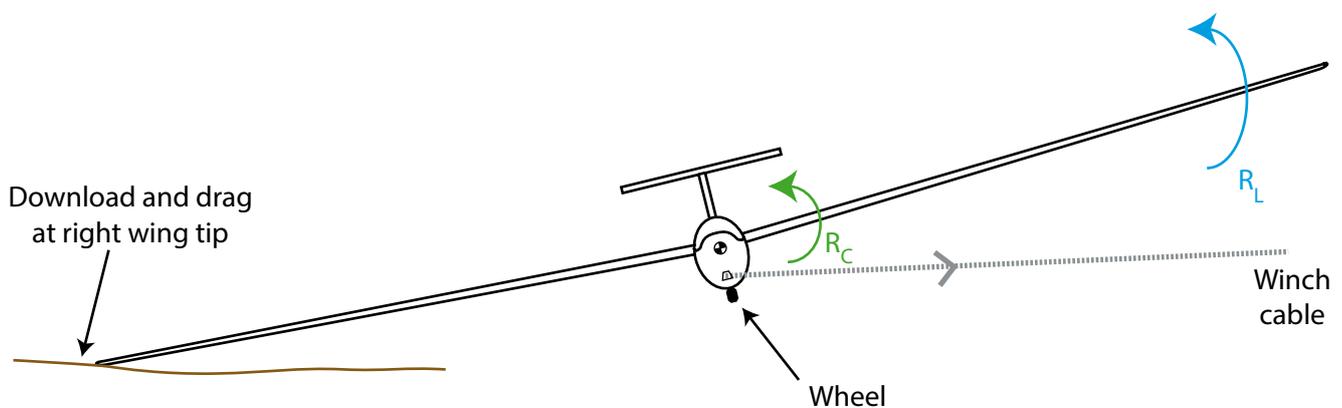
Figure 10

With a modern winch the weight will come off the main wheel approximately three to four seconds after the start of the launch sequence. With the main wheel off the ground, and the winch cable offset from the glider's heading, the force from the winch cable will introduce a rolling moment (R_c) about the glider's C of G (Figure 10).

Rolling moment due to offset winch cable

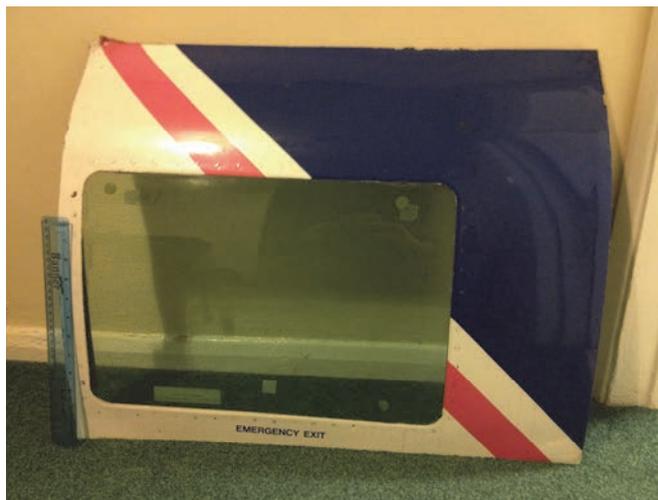
Figure 1

Examination of the door confirmed that there was no evidence of adverse wear to the door attachment flange or to the two securing lugs. An inspection of the aircraft, carried out by the operator, confirmed that the door release handle had not been operated and was secure in its receptacle. The 'tell-tale' wire attached between the door release arm and the fuselage was found intact and the shear pins retaining the door locking pins were in place.

G-NOSE right emergency exit door
