## CONTENTS

### SPECIAL BULLETINS / INTERIM REPORTS

S4/2013 Britten-Norman BN2A-26 Islander	VP-MON	07-Oct-12	3
---	--------	-----------	---

**(ALL TIMES IN THIS BULLETIN ARE UTC)**

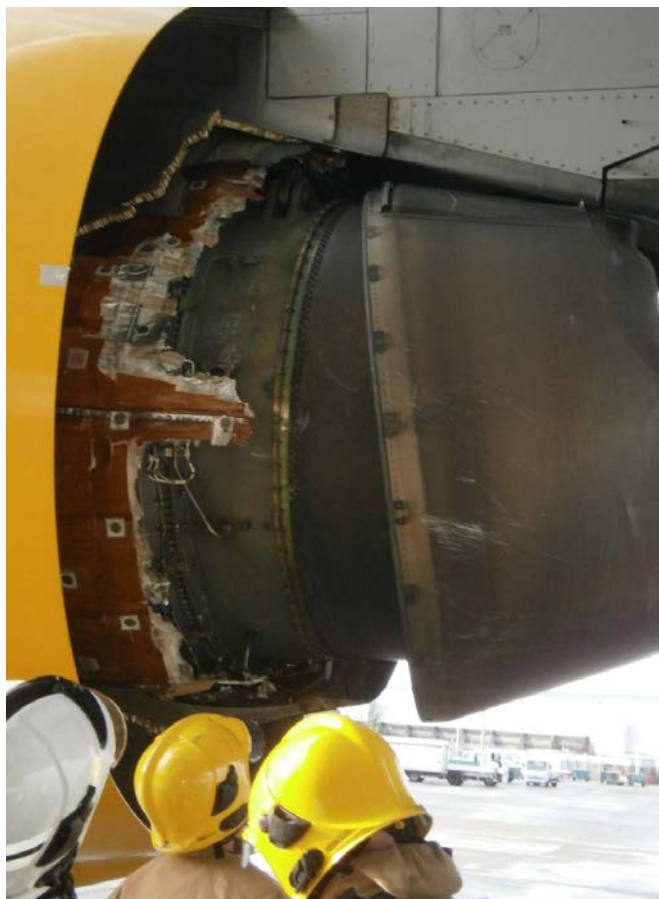
**Figure 1**

Following an uneventful overweight landing, inspection showed that a large amount of the right engine inboard thrust reverser inner wall structure was missing and the engine nozzle was damaged. This was the fifteenth similar occurrence known to the manufacturer and a number of inspections and modifications were already in place to try to mitigate inner wall damage and

Upon examination, it was found that the right engine inboard thrust reverser half was missing a large amount of material from its inner wall and consequently, the exhaust nozzle had been damaged and was loosely attached (Figure 1). A considerable amount of the missing composite structure was recovered later that day from a property in Broxbourne, Hertfordshire. All parts, including the damaged reverser half, were despatched to the aircraft manufacturer for further examination.

Right engine thrust reverser showing material missing from inner wall and dislodged exhaust nozzle

potential parts liberation. The aircraft manufacturer has advised that replacement of the thrust reverser inner wall will be required, and may be mandated, for all affected aircraft.

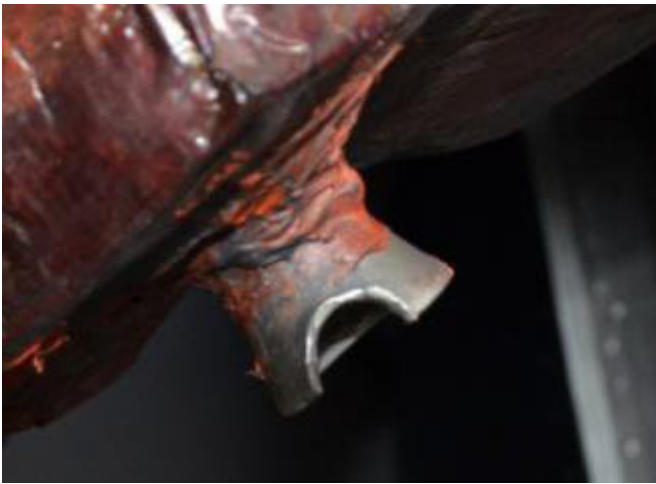
**Figure 2**

four compression rods which carry the hoop stresses in the inner wall was not correctly engaging the receptor cups when the thrust reverser was closed (Figure 2). Because of this, the end of the compression rod had damaged the insulation blanket in that area, although no evidence of associated heat distress was found, as well as wear to the hanger brackets (Figure 3). The manufacturer reports that the cause for the misalignment and subsequent incorrect engagement has not been determined, but that investigation continues.

Receptor cup showing witness mark where compression rod has not engaged (Boeing picture)

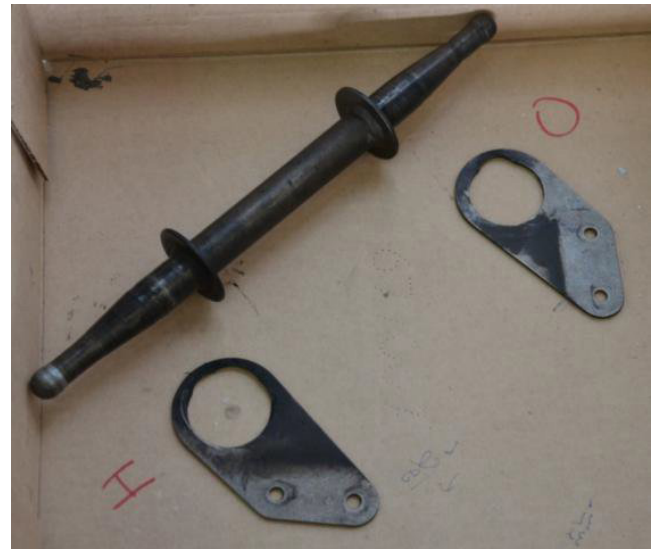
**Figure 3**

No.1 compression rod and worn hanger plates (Boeing picture)

Whilst an additional inspection has been required to inspect for evidence of disconnection or wear in the compression rods, the manufacturer has devised a programme of thrust reverser inner wall replacement for reversers, because existing non-destructive test techniques may not reliably detect previous thermal damage. They further advise that the Federal Aviation Administration may mandate inner wall replacement on all Rolls-Royce powered Boeing 777 aircraft.
