AAIB Special Bulletins / Interim Reports

SERIOUS INCIDENT

Aircraft Type and Registration:	Boeing 787-8, ET-AOP
No & Type of Engines:	2 General Electric GEnx-1B turbofan engines
Year of Manufacture:	2012 (MSN 34744)
Location	London Heathrow Airport
Date & Time (UTC):	12 July 2013, 1534 hrs UTC
Type of Flight:	Not applicable
Persons on Board:	None
Injuries:	Not applicable
Nature of Damage:	Extensive heat damage in upper portion of rear fuselage
Commander's Licence:	Not applicable
Commander's Age:	Not applicable
Commander's Flying Experience:	Not applicable
Information Source:	AAIB Field Investigation

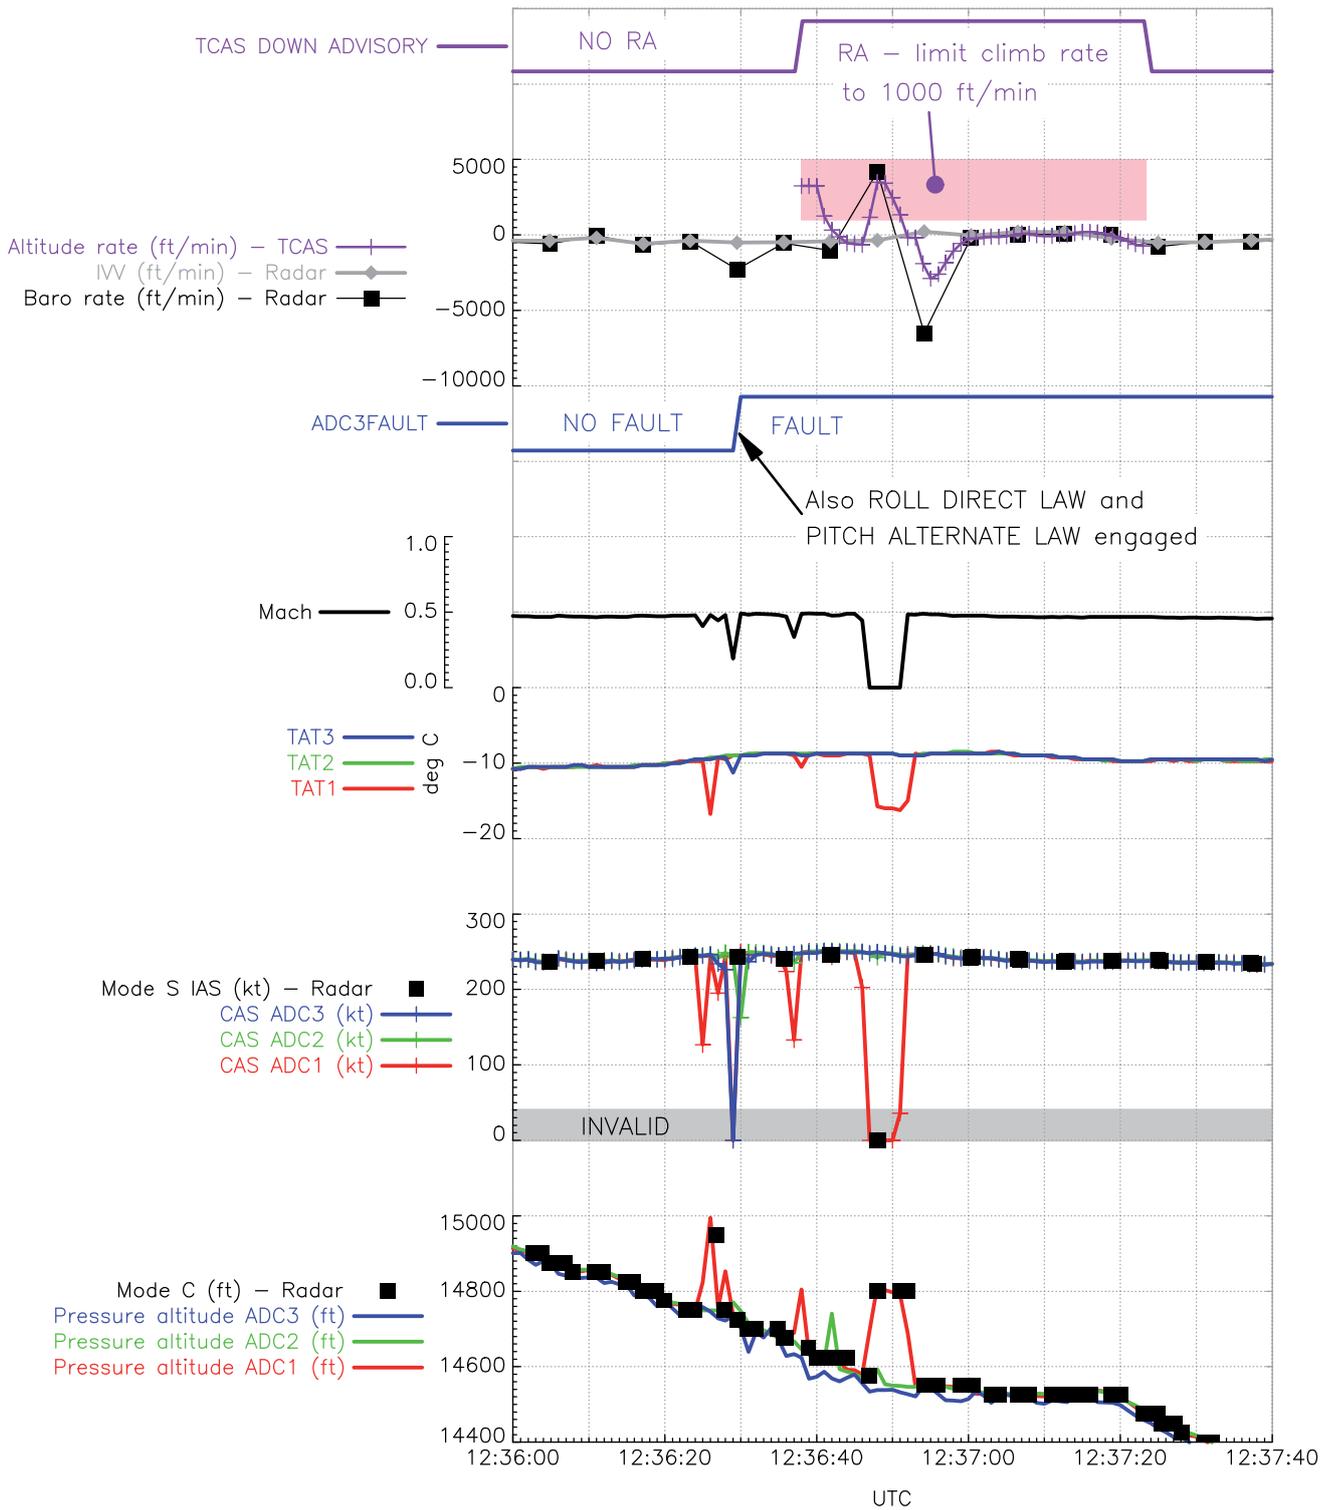
Figure 3

The recorded data showed problems associated with the air data of all three related systems on the aircraft, and a TCAS event. Pertinent parameters are shown in Figure 3.

The problems occurred whilst descending to a selected altitude of 14,000 ft within a hold north of London. Soon after passing 14,800 ft there was a period of approximately 27 seconds during which all three sources of altitude and airspeed data intermittently and independently jumped to either unreasonable but valid values or values indicating invalid data. This was associated with jumps in recorded air temperature and Mach number.

Pertinent parameters from the FDR, ACMS, TCAS and radar recordings

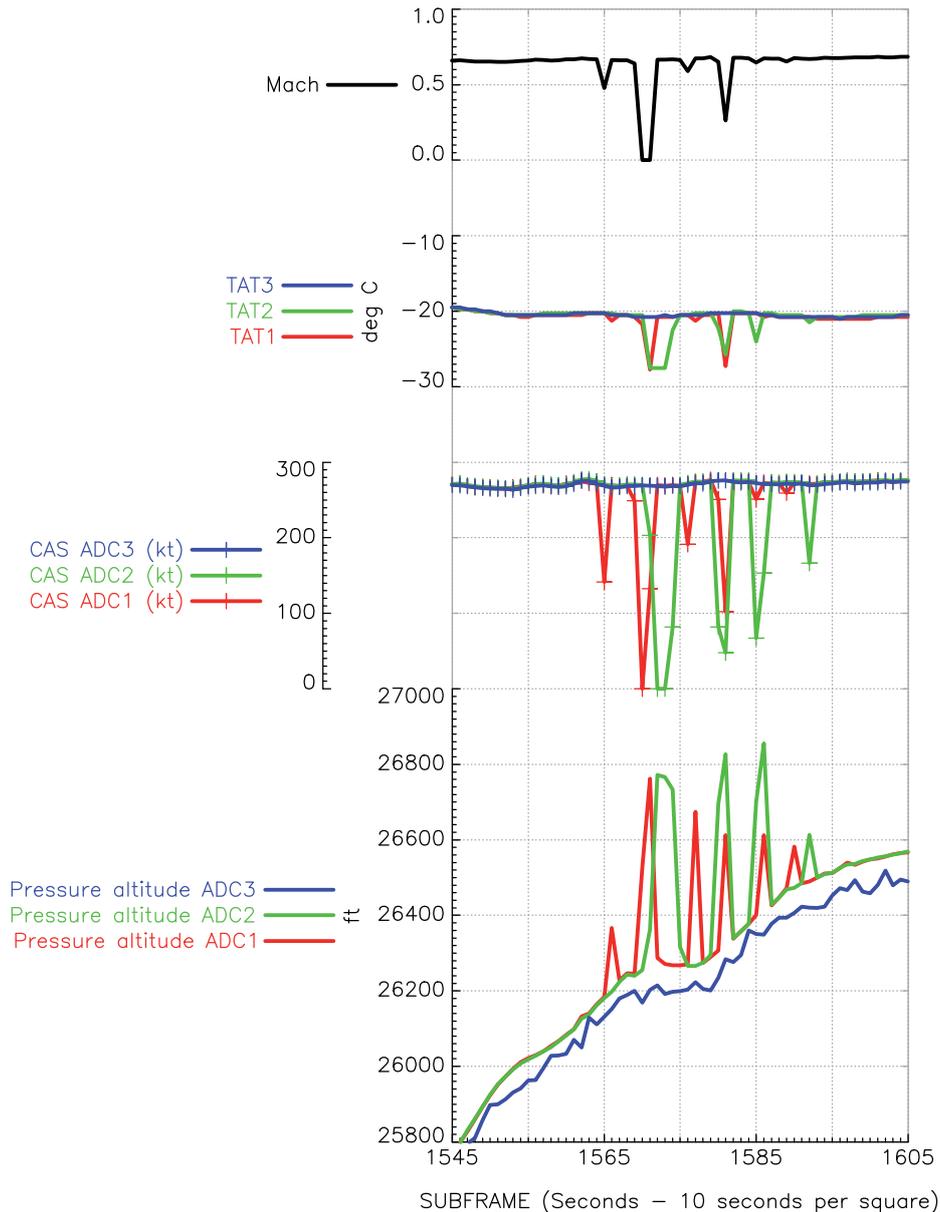
Figure 4

Pertinent parameters from the FDR, ACMS, TCAS and radar recordings

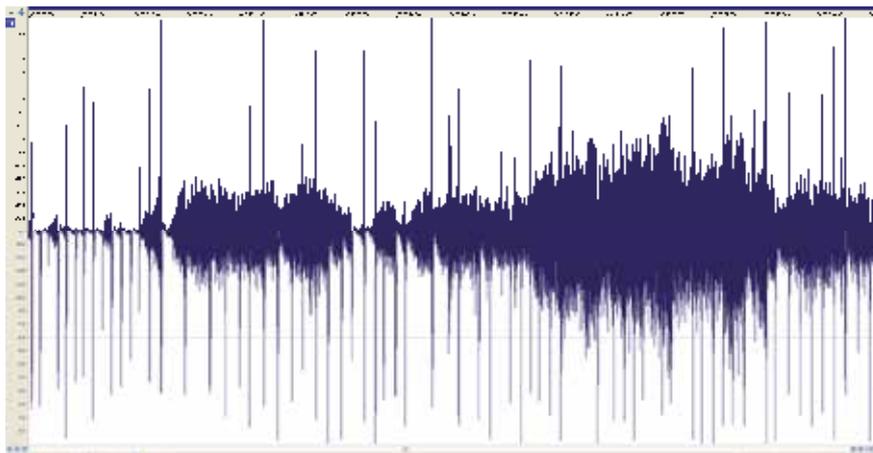
Figure 5

The pulses and their effect on the automatic gain control of the CAM channel amplifier resulted in the loss of the cockpit area ambient audio from the recording during intense periods of pulsing and significant degradation during the less intense periods.

Sample period of the CAM recording showing recorded pulses that were not heard by the crew

The CVR manufacturer has recreated a pulsing effect, similar to that recorded by the CVR, by applying electrostatic discharges to the CAM system components, suitably interconnected, in a workshop environment. This supports the theory that the source of the problem is outside of the CVR CAM components.

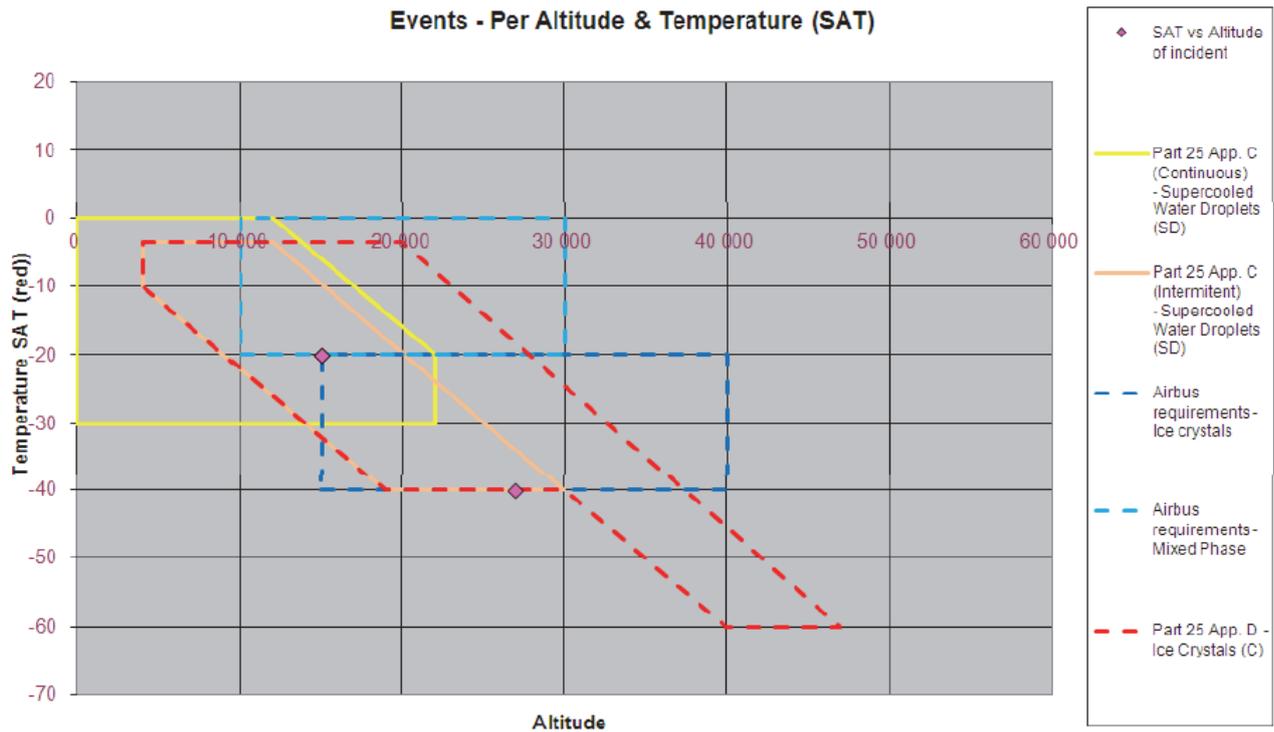
Altitude v SAT envelopes for the current and proposed requirements and the G-EUXM events.
The diamonds are the G-EUXM events

Airbus considers that even though the two G-EUXM airspeed indication problem events occurred on the same aircraft, albeit months apart, and on only one other of the operator's fleet during the same period, the events are not associated with any fault on the aircraft. They consider that the problems were consistent with their studies linking these events to obstruction of at least two pitot probes by ice crystals, and not any airframe-specific problem.

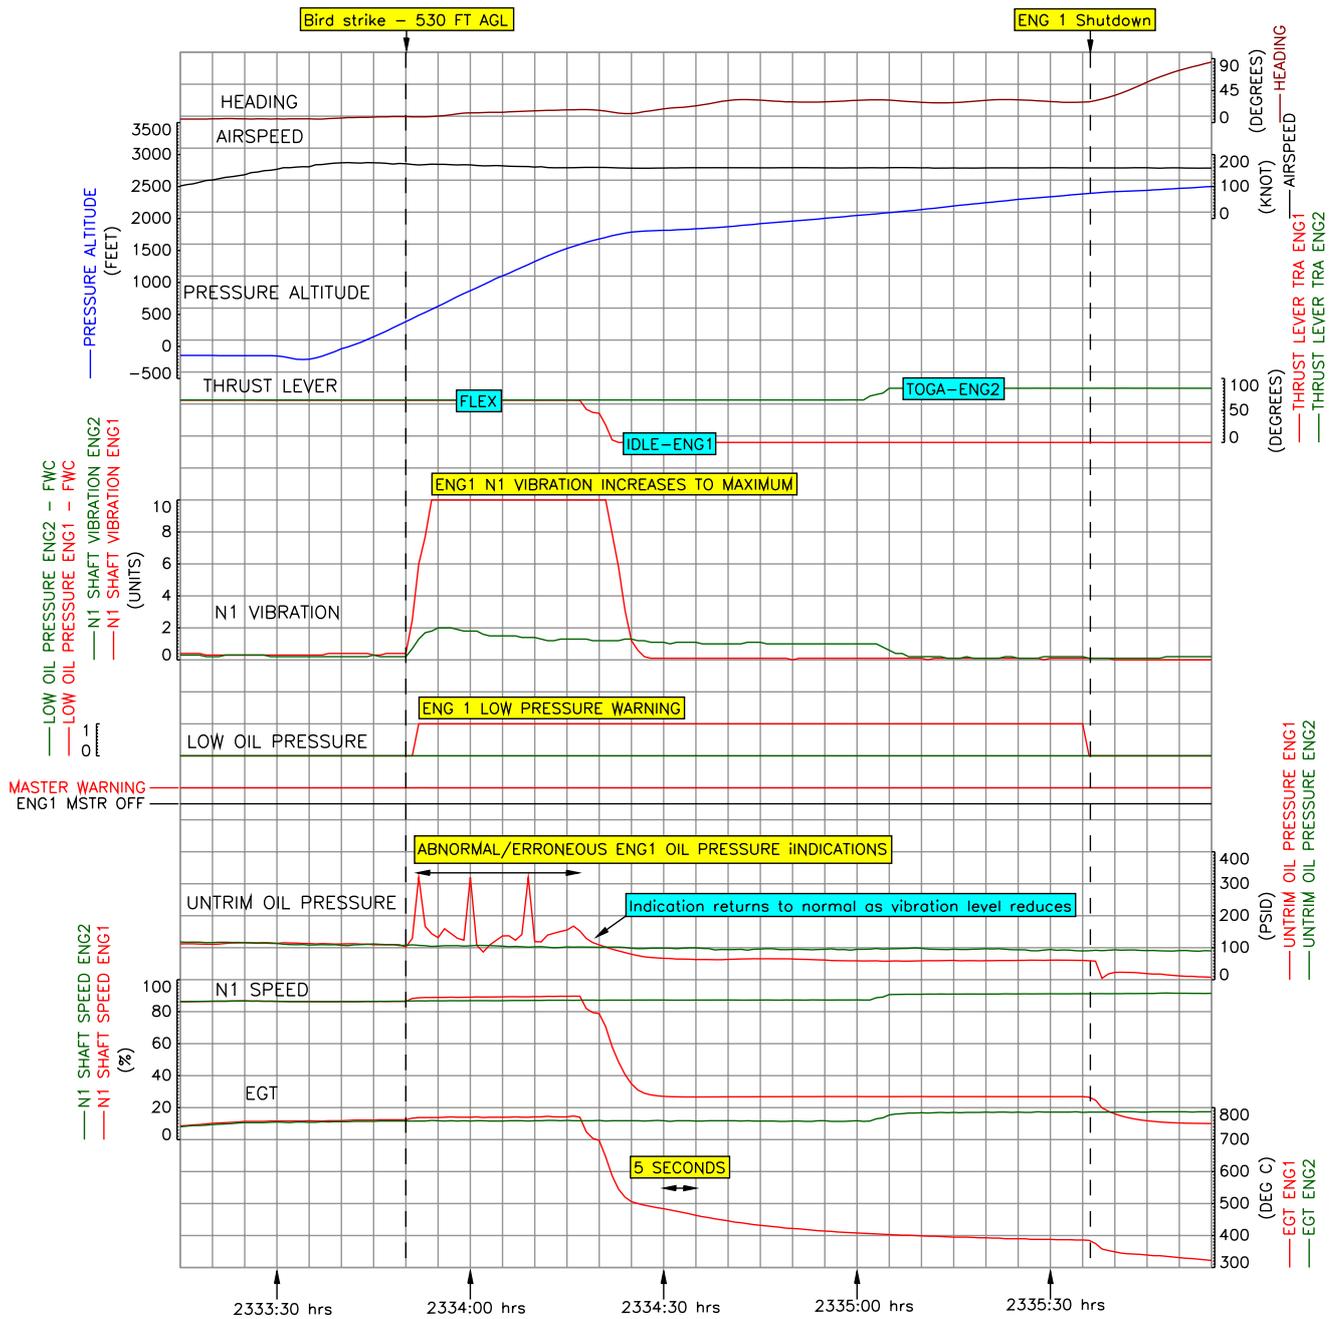
Figure 2
Data recorded between takeoff and engine shutdown

The aircraft levelled at 3,000 ft and MCT (Maximum Continuous Thrust) was selected on the right engine. The maximum recorded right engine N_1 shaft vibration during the flight was 2 units (below the ECAM N_1 shaft vibration advisory message trigger which is 3.3 units).

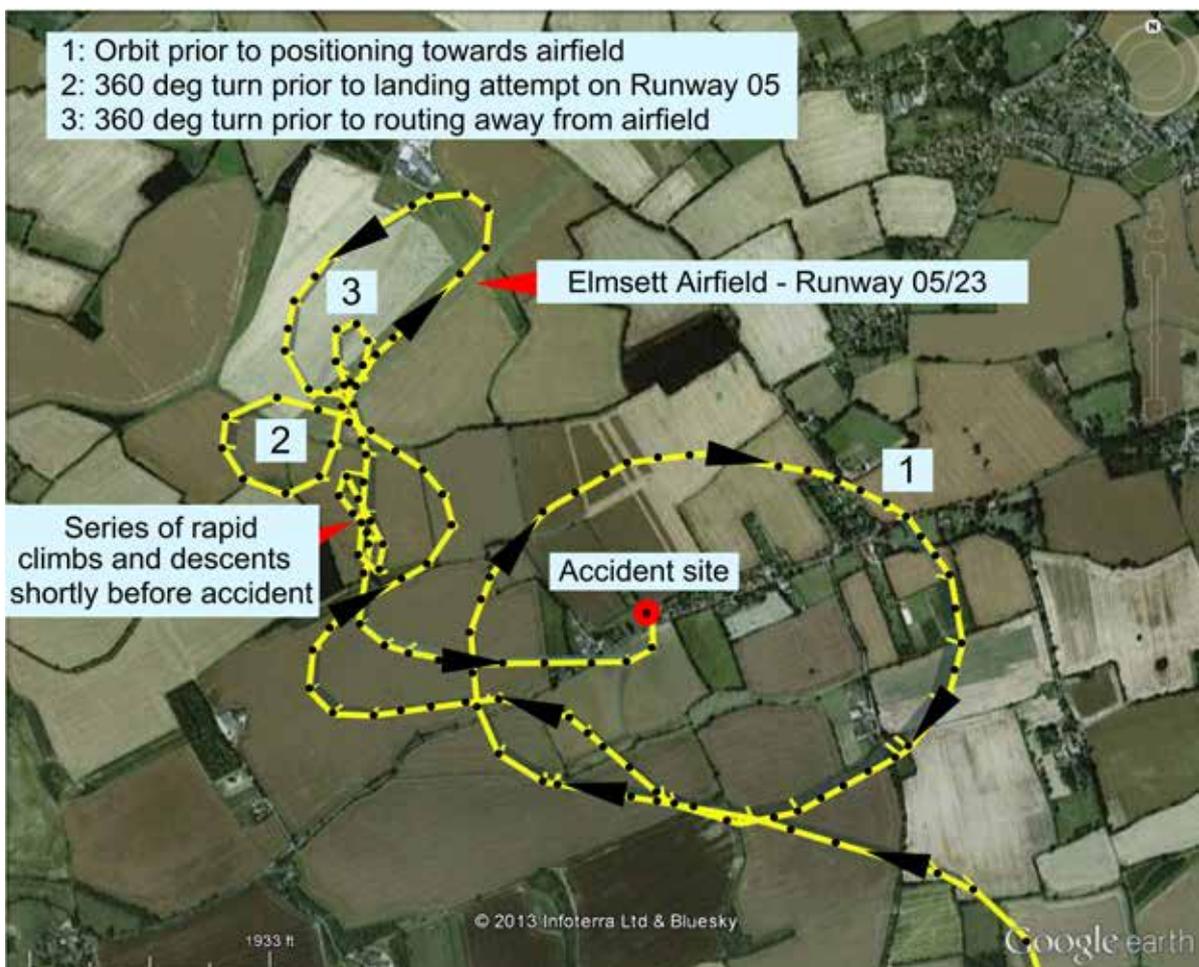
Figure 2 shows the last seven minutes of flight. Approximately 0.5 nm south-east of Elmsett Airfield, the aircraft flew an orbit down to about 260 ft, (Figure 2, Point 1) before making a series of turns ending almost overhead the threshold of Runway 05, at 200 ft aal. The aircraft tracked along the runway centre line, continuing to descend (Point 2). About two-thirds along the runway the aircraft had descended to approximately 50 ft, at a groundspeed of 58 kt. The aircraft then climbed in a left-hand turn, consistent with positioning for a further approach to Runway 05 (Point 3). Reaching the threshold, the aircraft flew a tight left-hand orbit at about 180 ft, and then flew south, away from the runway.

GPS-derived position and altitude of G-VILA - final seven minutes

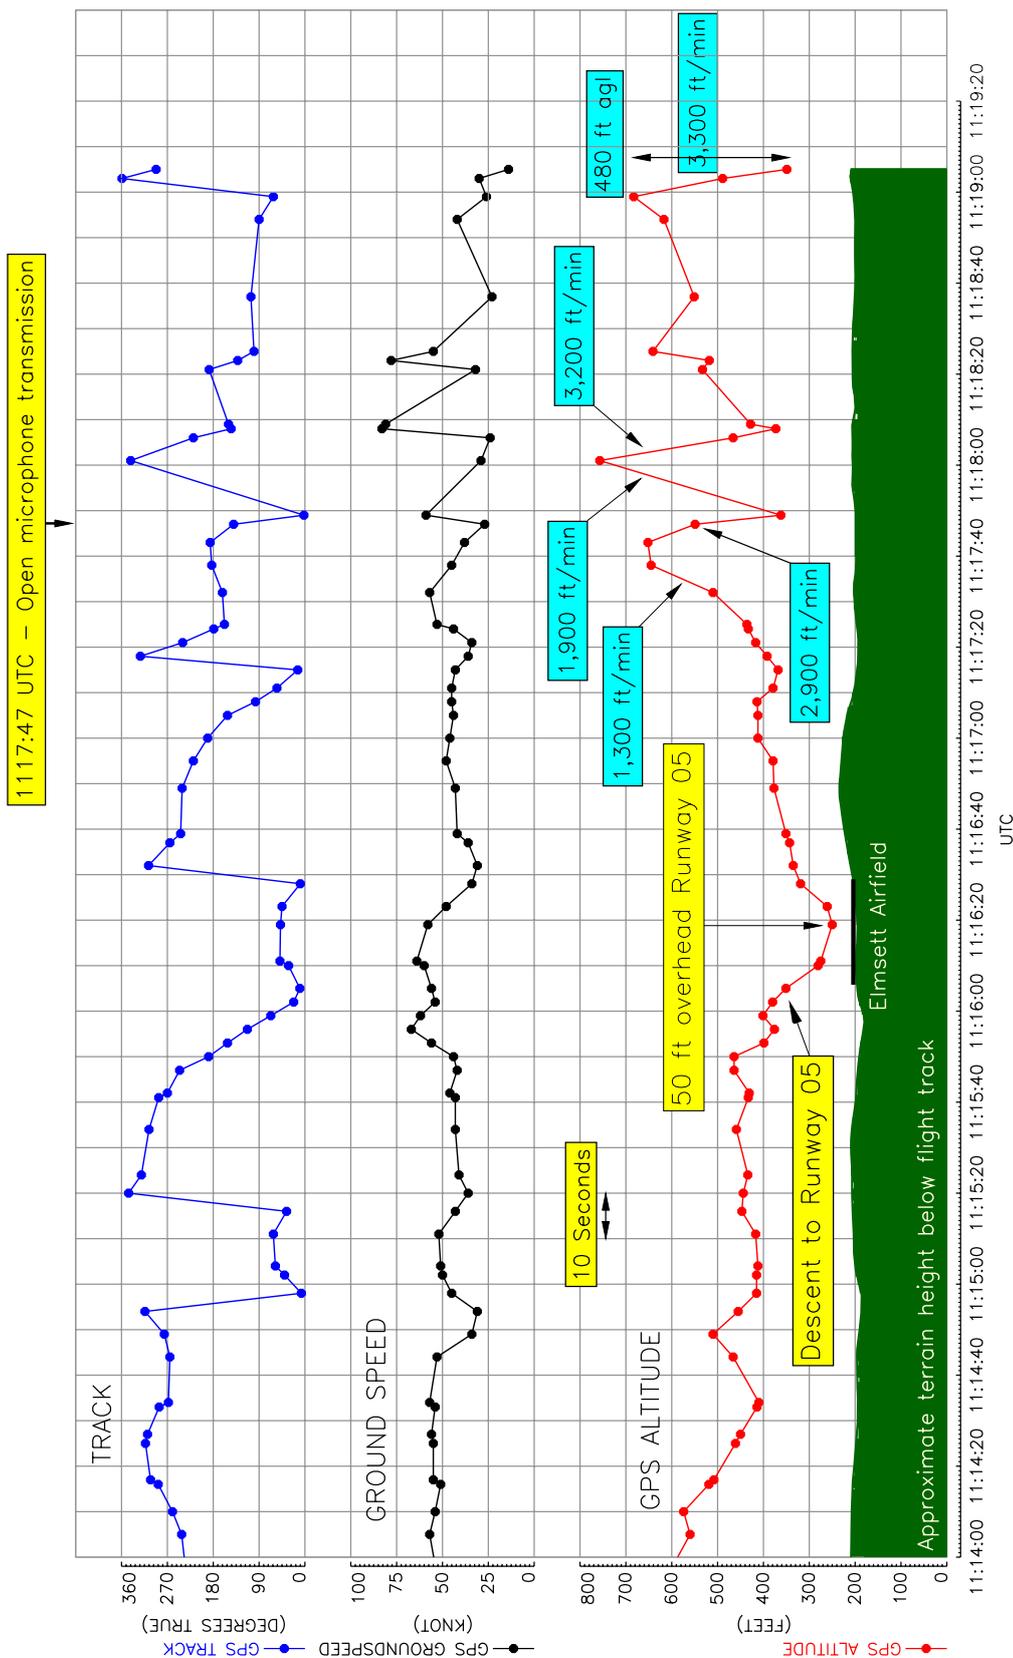
Figure 3

G-VILA - GPS track, altitude and groundspeed
