AAIB FIELD INVESTIGATIONS

AAIB Field Investigation reports

Aircraft Type and Registration:	1) Grob G115E Tutor, G-BYUB 2) Grob G115E Tutor, G-CGKC
No & Type of Engines:	1 Lycoming AEIO-360-B1F piston engine
Year of Manufacture:	1) 1999 2) 2009
Date & Time (UTC):	1) 23 August 2012 at 0834 hrs 2) 09 Jan 2013 at 1225 hrs
Location:	Fields adjacent to RAF Cranwell, Lincolnshire
Type of Flight:	Military Training
Persons on Board:	Crew - 2 Passengers - N/A
Injuries:	Crew - None Passengers - N/A
Nature of Damage:	(Both aircraft) Propeller counterweight assembly detached and severe damage to corresponding propeller blade and spinner
Commander's Licence:	Both aircraft were being operated by military personnel with service qualifications
Commander's Age:	N/K
Commander's Flying Experience:	N/K
Information Source:	AAIB Field Investigation

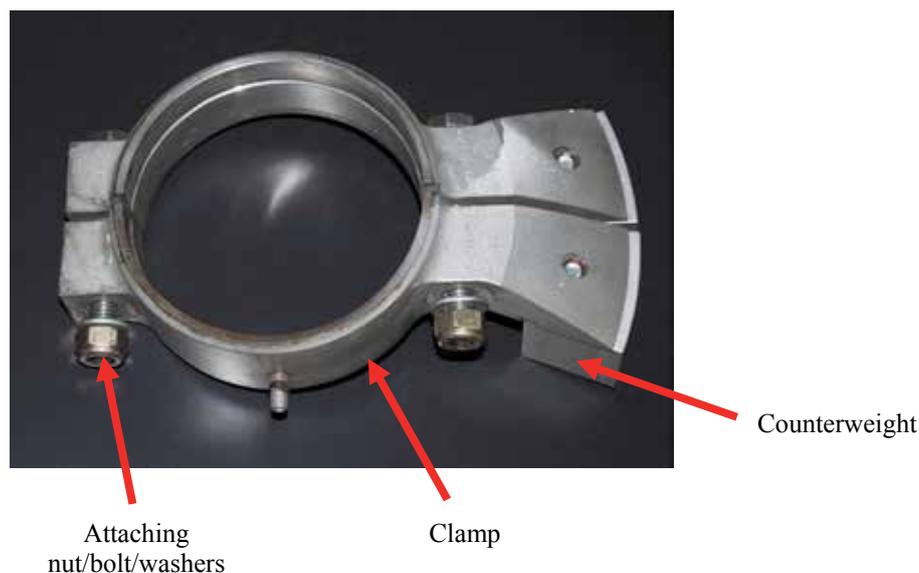
Figure 1

When the engine is operating, the counterweights each exert a centrifugal turning moment on the blade ferrule to which they are attached. This moment loads the bolt nearest the counterweight on each blade in tension. The tensile load produces a stress when operating, in addition to that created in static conditions by the tension force clamping the assembly to the ferrule.

Propeller blade counterweight assembly

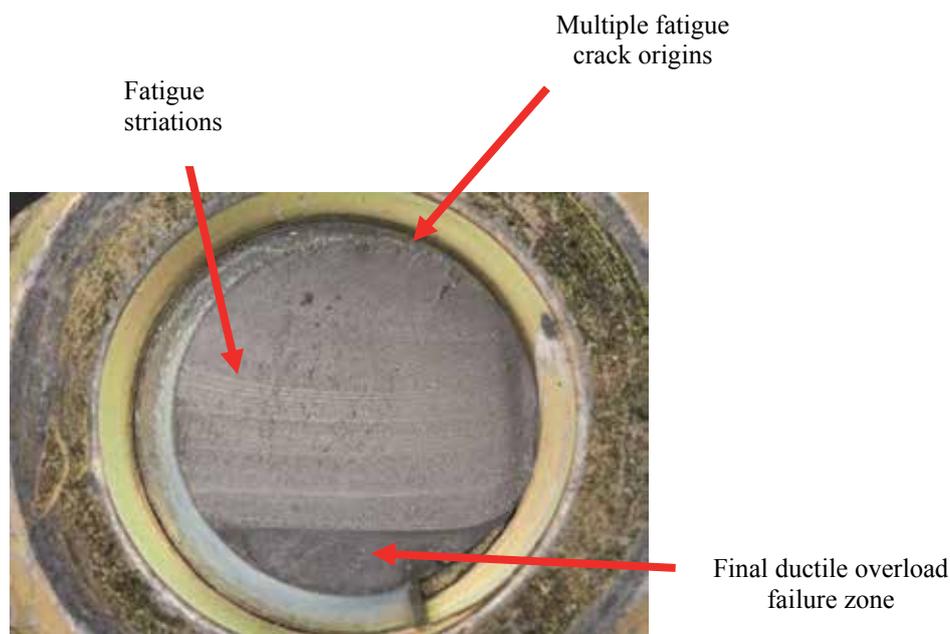
Figure 2

Examination of the recovered nut and threaded portion of bolt showed that the bolt had suffered a fatigue fracture in the plane of the face of the nut in contact with the counterweight clamp (Figure 2). The fatigue fracture exhibited multiple origins at the base of the thread form on one side of the bolt. The fatigue cracking had propagated over most of the bolt cross section; the remainder of the cross section had then failed in ductile overload. The nut contact face was confirmed on laboratory examination to be correctly perpendicular to the bolt axis.

The laboratory examination of the fatigue fracture face of the bolt revealed prominent beach marks with less prominent marks between them. The area closest to the origin had no clearly defined pattern but ten distinct beach marks were visible between there and the ductile

Fracture face of failed counterweight clamp bolt

failure zone. The most reasonable interpretation of the evidence on the bolt fracture face was that each of the final ten flight cycles had produced a distinct beach mark with lesser marks between these created by smaller load variations.

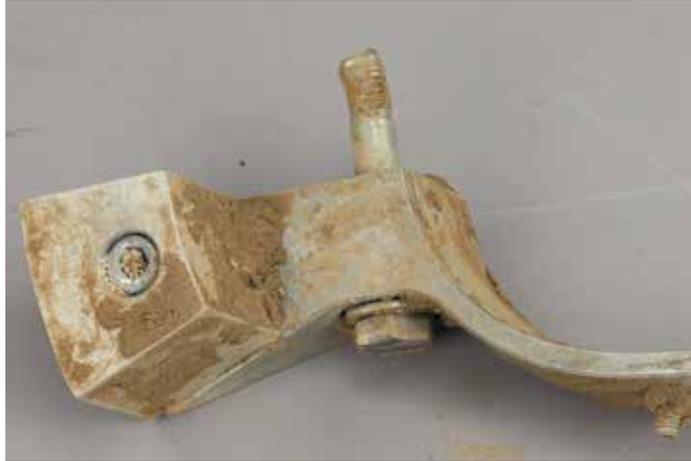
Figure 3

A further search was successful in locating a major proportion of one of the missing clamp halves (Figure 3), together with the remainder of the fractured bolt, which was heavily distorted. The section of recovered bolt was from the bolt hole nearest the counterweight. The other clamp half and bolt were not found. The recovered portion of clamp had its curved section deformed plastically to a much straighter, larger radius shape due to the effects of bending.

Examination of the fracture face of the broken bolt in the recovered portion of clamp revealed that it was the matching face to the portion of threaded bolt shank (with nut attached) recovered from beneath the aircraft after the landing. Smearing and damage to the thread forms of the bolt and slight bending of the bolt end were observed; this was consistent with the forces likely to have been imparted to the bolt during the separation sequence. Consideration of the geometry of the clamp and bolt assembly, in conjunction with the thread damage, enabled the rotational orientation of the bolt at the time of the bolt failure/clamp separation to be determined. From this it became clear that the multi-fatigue origin was located on the side of the bolt orientated furthest from the ferrule, ie the side closest to the counterweight.

Recovered portion of counterweight clamp and fractured bolt

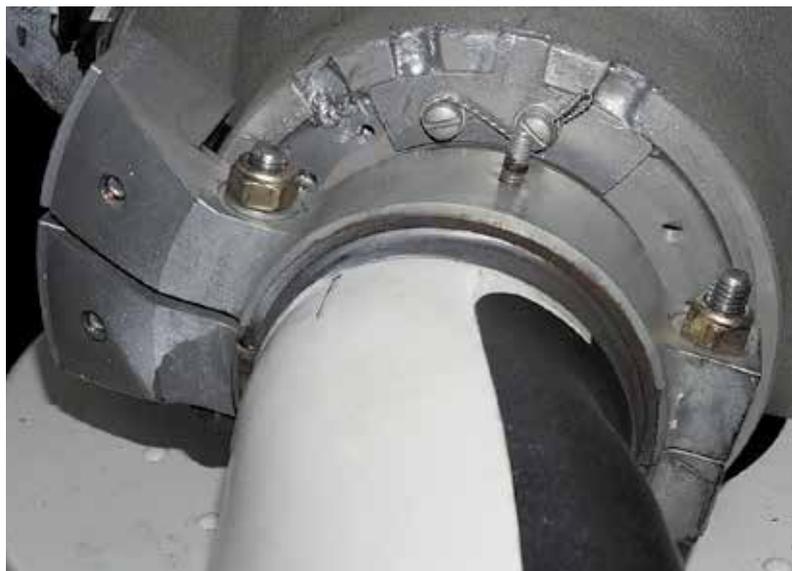
Figure 4

A possible way of creating the multi-origin feature would have been to have torque-tightened the nut/bolt combination without the contact faces of the clamp lying parallel. Under such circumstances the tensile stress in the bolt would be distributed eccentrically, thus concentrating a high stress on the one side of the bolt with a significantly lower stress on the opposite side.

The gap between the two assembled clamp halves on each blade permits the assembly bolts to be torque-tightened without the inner clamp faces lying completely parallel (Figure 4). The greatest extent of this loss of parallel orientation is permitted by the clamp geometry if the nut on the bolt furthest from the counterweight is screwed further along its bolt than the nut on the other bolt. Thus with the counterweights ‘spread’ further apart from ‘normal’, an eccentric stress distribution occurs on each bolt and the orientation of the bolt nearest to

Counterweight clamps assembled with faces not parallel
(note the uneven gap either side of ferrule)

the counterweight is such that a stress concentration would occur at the same location as the fatigue origins identified on the failed bolt.

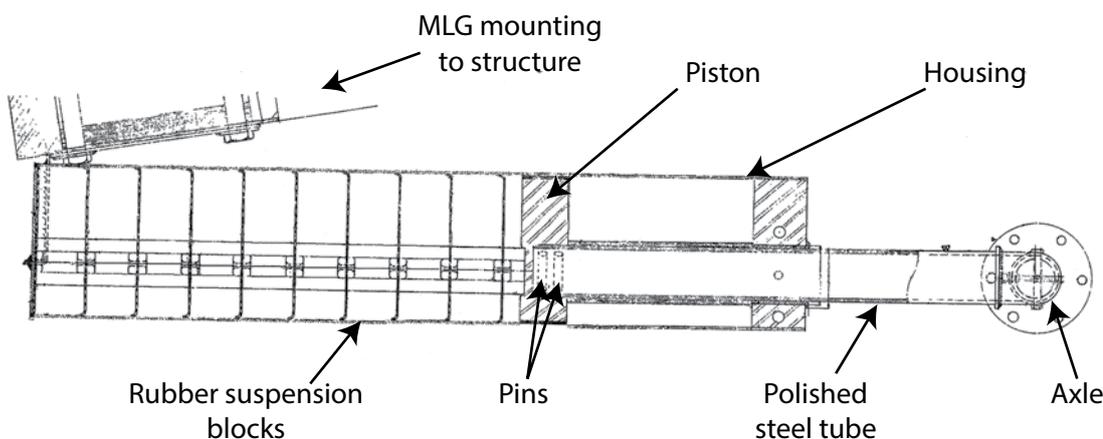
Figure 1

Minicab aircraft have two main landing gear (MLG) legs and a tailwheel. The MLG legs comprise a polished steel tube with the axle assembly welded to it (see Figure 1) and an aerofoil-shaped fixed housing which is bolted to the wing main spar. The upper part of the housing is filled with rubber blocks and separator plates which are compressed under landing loads by a Duralumin 'piston' attached to the top of the steel tube. These attachments comprise two mild steel pins which are a force fit into the piston, filed flush and then locked with a pin punch. They are additionally retained by two brass sealing strips which are attached to the piston using countersunk screws. It will be evident that the attachment pins also control the toe angle of the wheel, since it is they which prevent the tubular leg from rotating relative to the housing. Independent mainwheel braking is achieved by two cable-operated drum brakes actuated by heel pedals.

Drawing of Minicab MLG leg showing the Duralumin piston and steel pins which provide torsional location of the leg

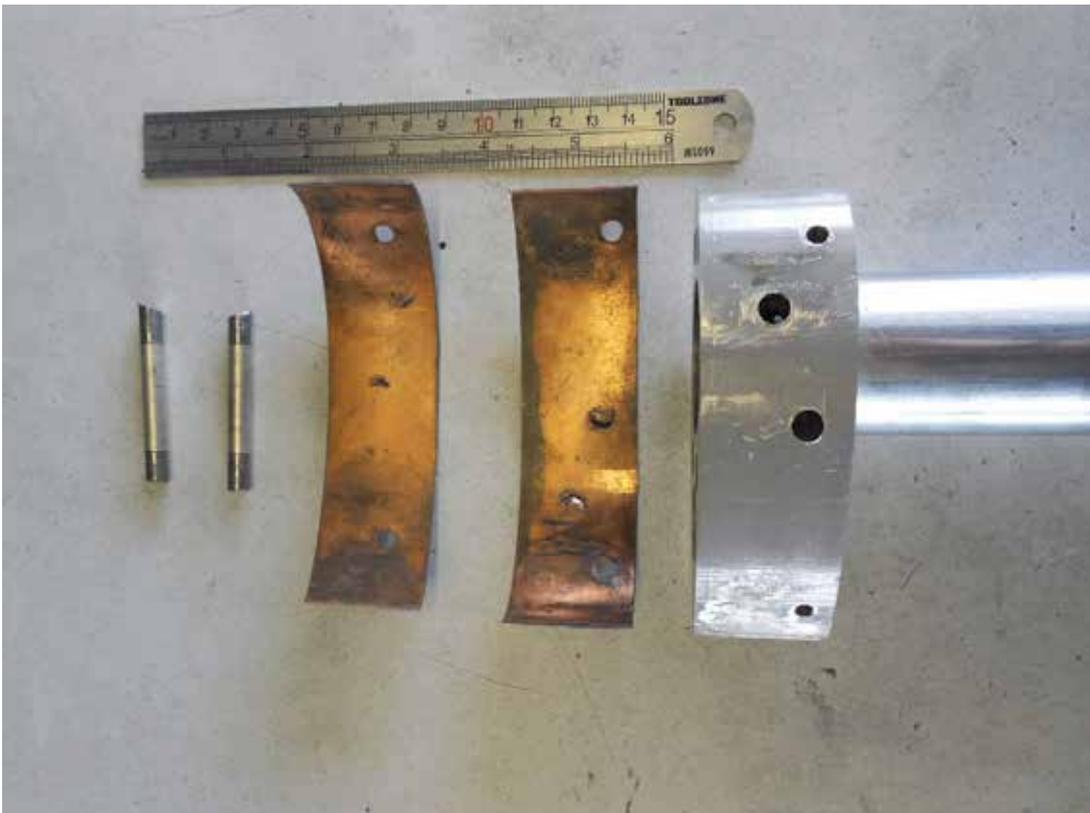
Figure 2

were unscrewed, the two pins fell out freely from the piston, exhibiting considerable wear as well as ovality of the holes in the piston (see Figure 2). The right MLG also exhibited rotational looseness, but this was limited to about $\pm 3-5^\circ$.

The owner advised that he had carried out an overhaul of both brake assemblies fairly recently but had not noticed the degree of play, probably because the aircraft had been jacked on the bottom of each MLG leg. He has notified the Light Aircraft Association of his findings with a recommendation that other Minicab owners should check for this condition.

Photograph of disassembled piston, showing wear to the pins, ovalisation of the holes and indentations on the brass sealing strips showing lateral movement of the pins
