CONTENTS

AAIB FIELD INVESTIGATIONS

Aircraft Type and Registration:	Beech B200 Super King Air, OO-LET	
No & Type of Engines:	2 Pratt & Whitney Canada PT6A-42 turboprop engines	
Year of Manufacture:	1994 (Serial no: BB-1473)	
Date & Time (UTC):	28 July 2012 at 1540 hrs	
Location:	Cambridge Airport	
Type of Flight:	Aerial Work	
Persons on Board:	Crew - 4	Passengers - None
Injuries:	Crew - None	Passengers - None
Nature of Damage:	Extensive to propellers, engines, undercarriage doors and luggage pod	
Commander's Licence:	Commercial Pilot's Licence	
Commander's Age:	68 years	
Commander's Flying Experience:	13,180 hours (of which 3,111 were on type) Last 90 days - 187 hours Last 28 days - 74 hours	
Information Source:	AAIB Field Investigation

Aircraft Type and Registration:	BN2A MK.III-2 Trislander, G-BDTO	
No & Type of Engines:	3 Lycoming O-540-E4C5 piston engines	
Year of Manufacture:	1976	
Date & Time (UTC):	27 March 2012 at 0724 hrs	
Location:	27 nm north-east of Alderney, Channel Islands	
Type of Flight:	Commercial Air Transport (Passenger)	
Persons on Board:	Crew - 1	Passengers - 7
Injuries:	Crew - None	Passengers - None
Nature of Damage:	Uncontained engine failure with associate

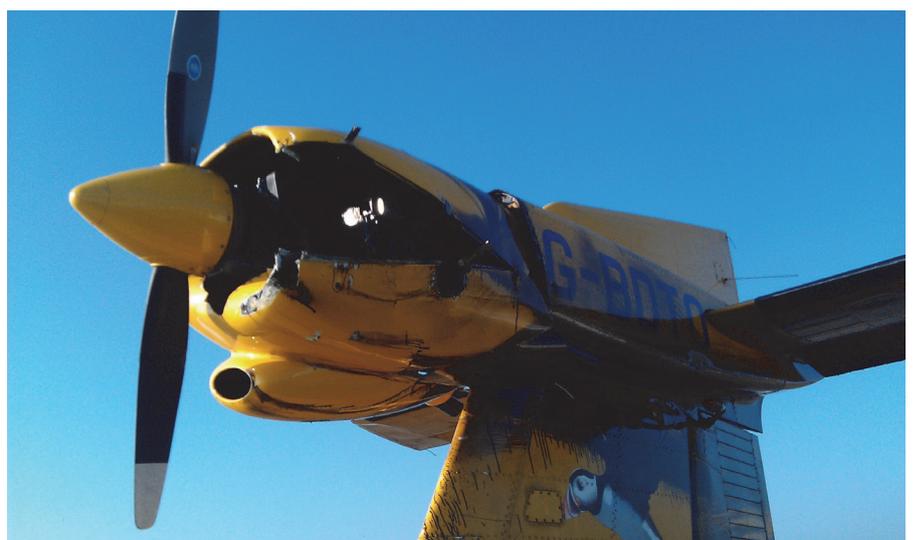
Figure 2

On landing, the operator's maintenance provider inspected the aircraft. They reported that a large section of the engine cowling was missing on the left side of the engine (Figure 2). The remaining cowling and aircraft empennage were heavily stained with oil released from the engine during the failure.

Engine cowl damage and oil staining

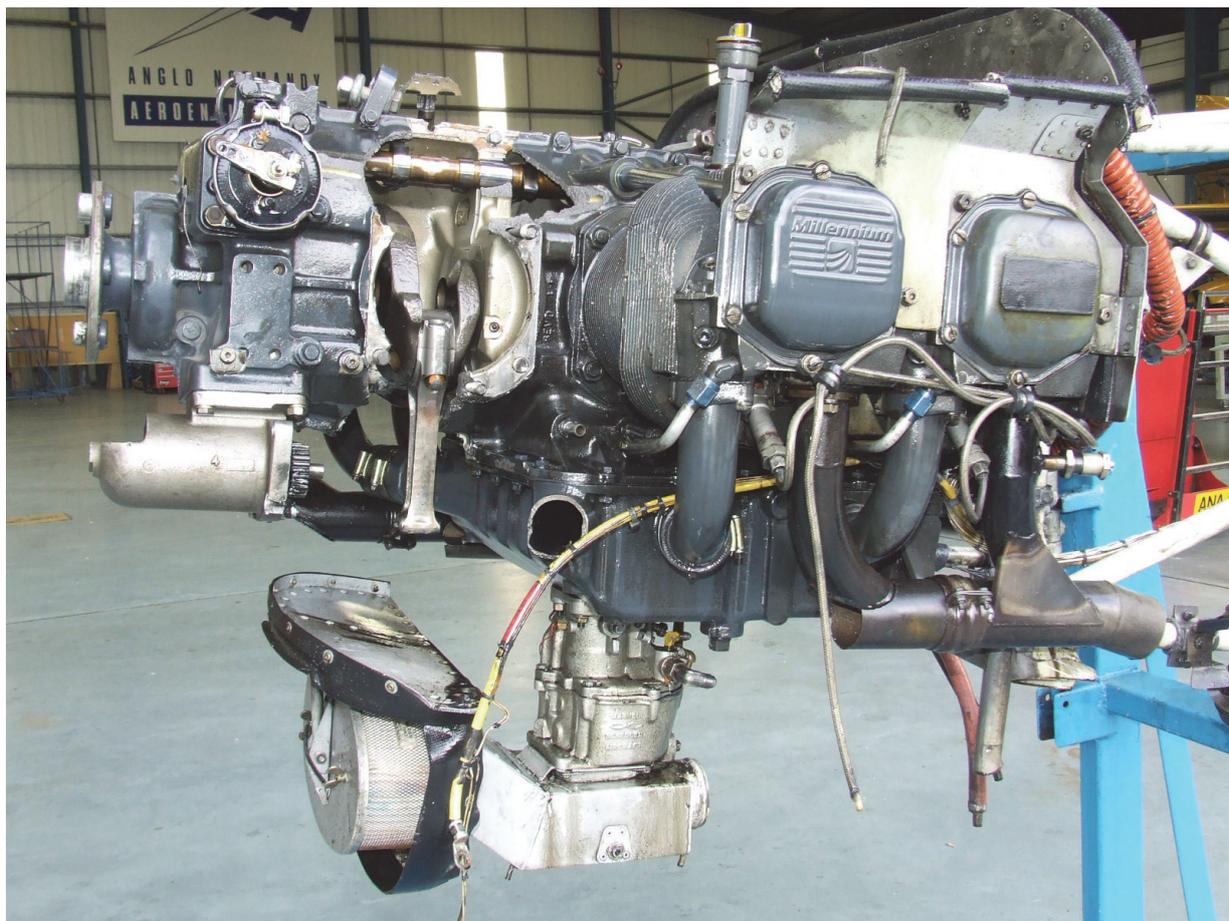
Figure 3

Following removal of the engine from the aircraft, it was clear that the No. 2 cylinder had released from

the crankcase after failure of the mounting studs. This had resulted in damage to the surrounding crankcase from the flailing connecting rod. The piston head and push rods were missing, as was the inlet pipe from the manifold and the section of exhaust pipe from the cylinder head to the exhaust manifold. The starter motor had been dislodged from the engine, but remained attached by its power lead and the guide tube for the propeller-feathering unit Teleflex control cable was damaged (Figure 3).

Missing cylinder and associated damage

The operator identified that the propeller had most likely initially failed to feather due to damage to the Teleflex cable guide conduit, preventing the control cable within it from moving freely when the pilot attempted to move the No 2 propeller control lever through the feather gate on the console. They considered the damage may have been caused by the release of the starter motor, which distorted the guide tube. The propeller did eventually feather some time after the pilot shut down the engine. When oil was lost from the engine through the hole in the crankcase, it is likely that there was an associated loss of oil pressure in the blade pitch control piston, allowing the feathering spring and counterweights to move the blades to the feather position.

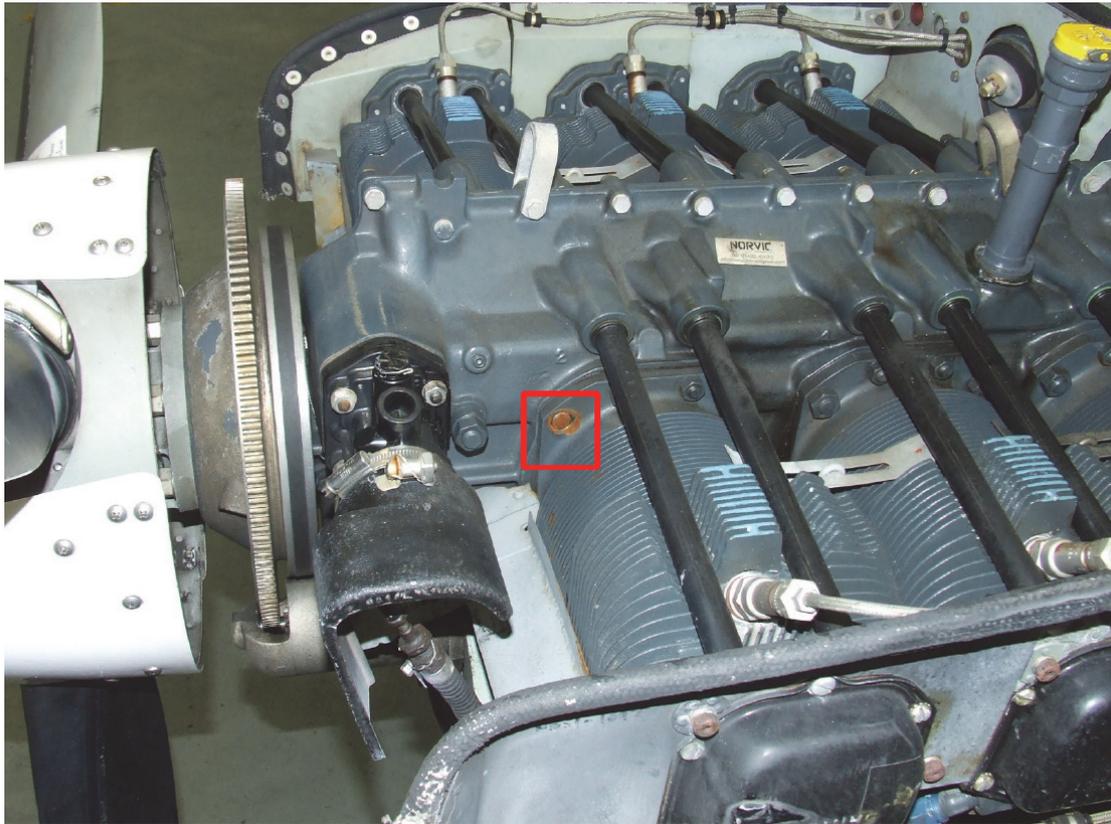
Figure 4

Two months after the initial incident, a routine maintenance check of the No. 3 engine fitted to another aircraft (G-RLON) from the same operator's fleet, identified another stud failure (Figure 4). This engine had operated 9,041 hours since new and 460 hours since its last overhaul. Only a single stud had failed and the released section of the stud and 'hold down' nut were found trapped in the baffle between the No 2 and No 4 cylinder barrels. The released section of the stud was sent for independent metallurgical assessment, while

Second mounting stud failure (G-RLON)

Analysis of the failed stud from the engine fitted to G-RLON confirmed that it had also failed in high cycle fatigue initiating from a corrosion pit in the thread root. Again no cadmium coating was found on the section of the stud inspected, although traces of cadmium coating were present on the 'hold down' nut. The inspection techniques could not confirm whether the lack of cadmium coating had been due to corrosion or mechanical action

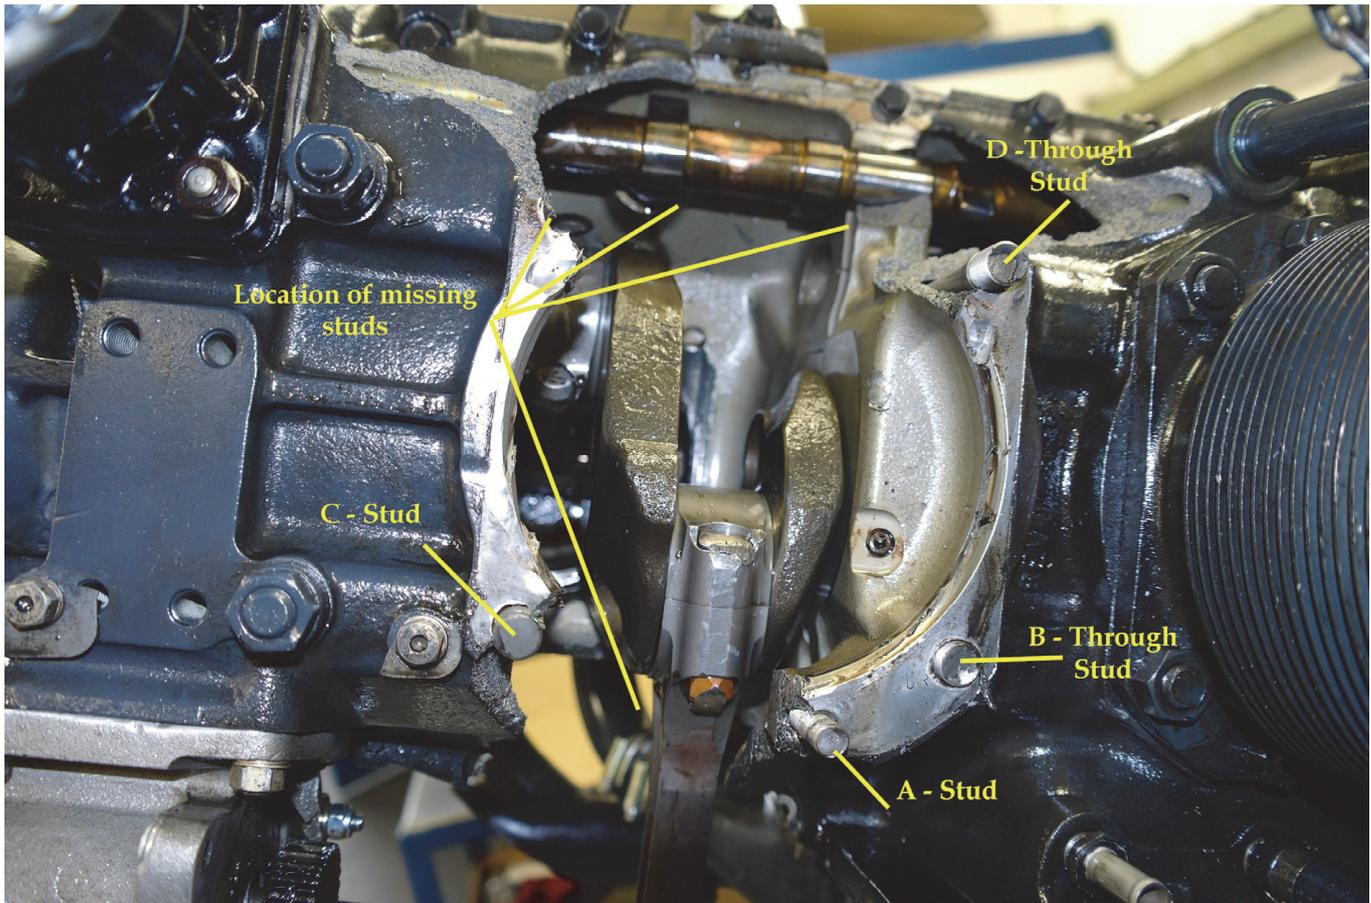
Figure 5

Independent metallurgical analysis using optical and Scanning Electron Microscope (SEM) techniques was conducted on the four failed studs that were recovered from G-BDTO's engine following the incident. The studs were annotated A to D for ease of reference (Figure 5).

The laboratory analysis determined that stud C had suffered a fatigue fracture, which initiated from a single point, coincident with corrosion pitting in one of its thread roots. The stress concentration caused by the pitting had been superimposed onto that provided

by the thread root itself. As the pitting grew in depth, the combined stress concentration had exceeded the threshold value for fatigue crack initiation. A primary high cycle fatigue crack initiating from the pitting then propagated across the diameter of the stud, with the continued loading from operation of the engine. The primary crack joined with two secondary fatigue cracks, also initiating from corrosion pits. Eventually, a point was reached when the remaining uncracked ligament of stud C became overloaded and failed. Although the exact time to failure could not be determined from the fracture surface features, the metallurgist advised that in his opinion it was possible for the corrosion pit to develop and the crack to have propagated to failure within the time between engine overhaul of 3,000 hours.

Location of failed studs

Laboratory analysis of stud C confirmed evidence of remains of a protective coating of cadmium on the coarse threaded section of the stud. However, no evidence was present of cadmium coating where the corrosion pit developed, on the fine threaded section. The stud material also tested outside the manufacturer's specification for hardness.

In contrast to stud C, the fatigue fractures of studs A, B and D had all initiated from multiple sites in thread roots which were not associated with pre-existing material defects. These were typical of failure of threaded fasteners from abnormal cyclic loading. In this case, the most likely cause of the abnormal loading was following the separation of stud C. However, it was not

Review of stud C from G-BDTO's fracture surface confirmed the primary fatigue crack had initiated directly from a corrosion pit before it joined with the two secondary cracks; although, the chronology of each crack initiation was not significant, given that all three cracks were initiated by the same mechanism.

Therefore, the investigation determined that the cause of the loss of the No 2 cylinder during the incident to G-BDTO was the presence of corrosion pitting in the thread root of a cylinder mounting stud. This initiated the growth of fatigue cracks, under the cyclic load of routine operation of the engine, until the stud failed in overload. The same failure mechanism was evident on the stud found on G-RLON.

Safety Recommendation 2013-001

It is recommended that Lycoming introduce additional maintenance requirements to ensure that the cadmium coating on the cylinder mounting studs, fitted to O-540-E4C5 engines, is not permitted to degrade to a level where corrosion of the base stud material can result in failure of the stud.

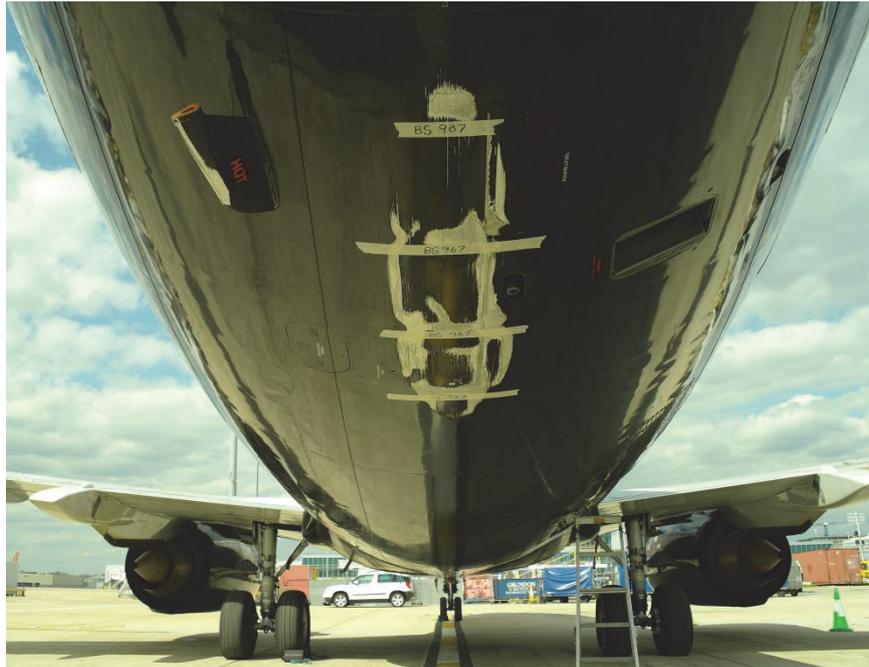
Figure 1

Damage to the aircraft was confined to deep longitudinal scoring of the rear fuselage skin, over a length of 1.9 m, from just forward of fuselage station BS927 to just aft of BS987 (Figure 1). The lateral extent of the damage was limited to the two lowermost fuselage stringers. The damaged area was within the pressurised section of the fuselage, beneath the aft end of the rear baggage hold. On the 737-300 variant of the aircraft this area is not protected by a tail bumper.

The fuselage skin had been fully abraded at stations BS927 and BS947, resulting in slight scoring of the supporting fuselage frames at these positions. This damage created a small leak path for pressurised cabin air to escape to atmosphere, although the rate of leakage was small and insufficient to affect cabin pressurisation during the flight to Gatwick.

Damage to the lower fuselage skin and drain mast

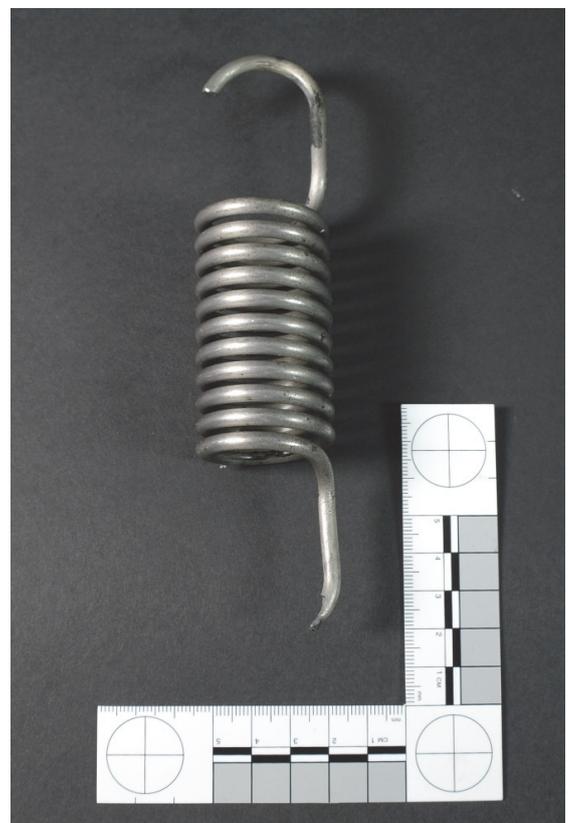
Figure 2

During the initial investigation it was reported to the AAIB that the pitch forces on G-ZAPZ were particularly light. No aircraft technical log entry regarding this had been made prior to the accident, but shortly after the aircraft was repaired and returned to service an entry was made by a flight crew member reporting that the elevator feel force was “light”. The operator carried out the ‘Low Control Forces’ troubleshooting actions from Chapter 27-31-00 of the aircraft maintenance manual, which revealed that a spring had broken within the aircraft’s elevator feel and centering unit. The unit was removed from the aircraft and sent to the AAIB for further investigation. During strip inspection, the outer main spring within the unit was found to have fractured (Figure 2). The

Broken outer main spring from the elevator feel and centering unit

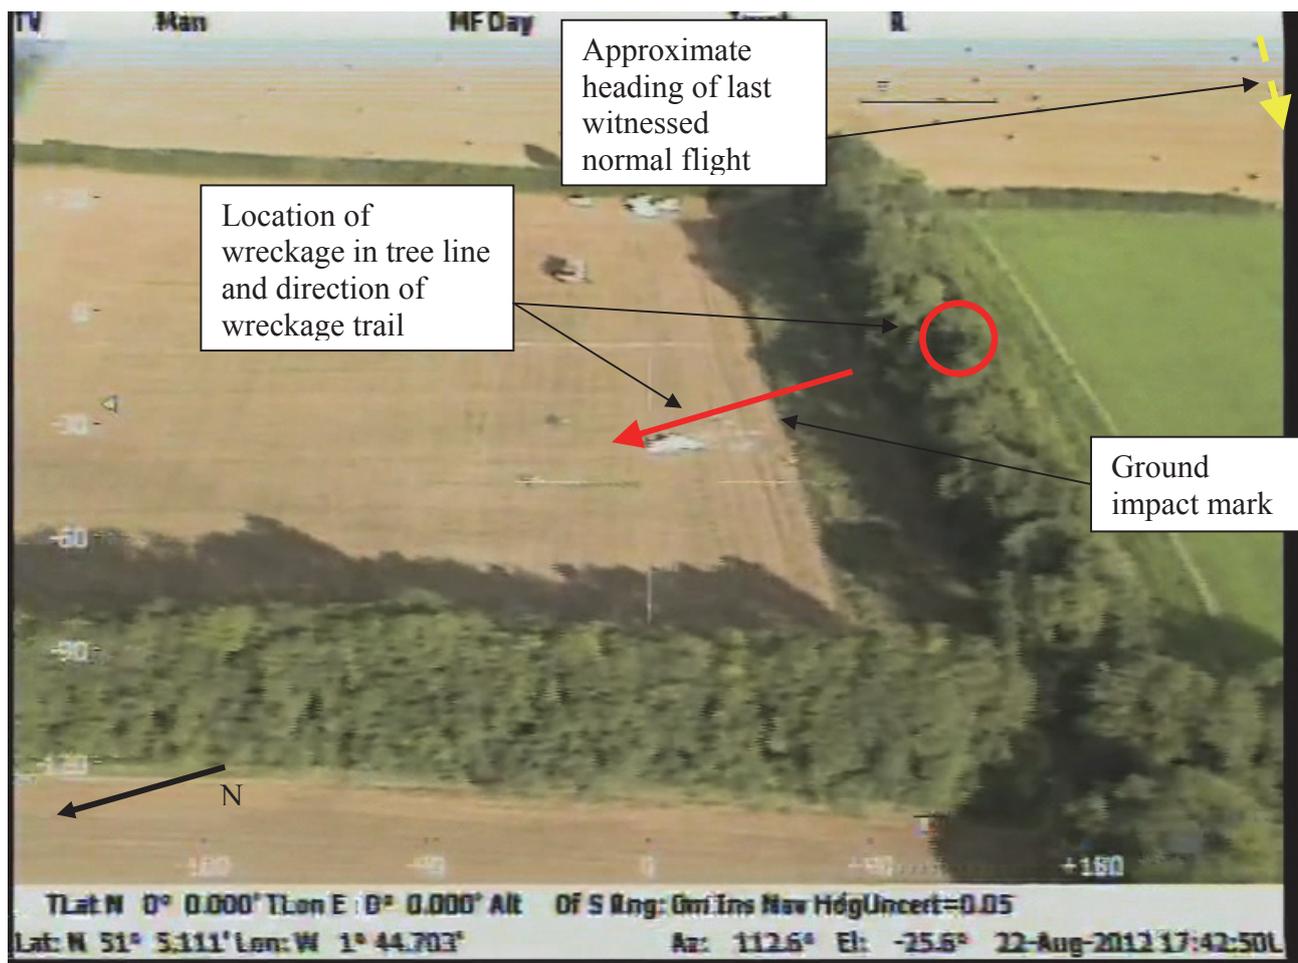
Figure 2

A small section of wing leading edge structure was lodged in one of the trees, with associated damaged branches visible. Further small sections from the wing were scattered throughout the undergrowth on the same side of the tree line as the main wreckage. No items of wreckage were found on the opposite side of the tree line. The larger items of wreckage were distributed across the field, beginning at the edge of the cultivated section and extending from the ground impact mark on a bearing of 358°. (Figure 2)

The initial part of the trail was formed predominantly from sections of the wing leading edge 'D' nose structure, which had completely fragmented. The remaining wing and fuselage structure were located together some 10 metres away, inverted and pointing roughly perpendicular to the line of the wreckage trail. The cabin structure was heavily disrupted and detached, with only the seats and engine mount structure, with the engine attached, remaining connected to the wing and tail boom. The tail boom was bent upwards and to the left, whilst the horizontal stabiliser was damaged on the right side. The right main landing gear leg had been bent inwards under the aircraft. The wing structure itself was heavily disrupted, with the leading edge corner of the left wingtip crumpled inwards. Due to the extent
