CONTENTS**SPECIAL BULLETINS**

S2/2012 EC225 LP Super Puma	G-REDW	10 May 2012	1
-----------------------------	--------	-------------	---

ACCIDENT

Aircraft Type and Registration:	EC225 LP Super Puma, G-REDW	
No & Type of Engines:	2 Turbomeca Makila 2A1 turboshaft engines	
Year of Manufacture:	2009 (serial no 2734)	
Location:	20 nm east of Aberdeen	
Date & Time (UTC):	10 May 2012 at 1114 hrs	
Type of Flight:	Commercial Air Transport (Passenger)	
Persons on Board:	Crew - 2	Passengers - 12
Injuries:	Crew - None	Passengers - 2 (Minor)
Nature of Damage:	Damage to be assessed following salt water immersion	
Commander's Licence:	Airline Transport Pilot's Licence	
Commander's Age:	To be advised	
Commander's Flying Experience:	To be advised	
Information Source:	AAIB Field Investigation

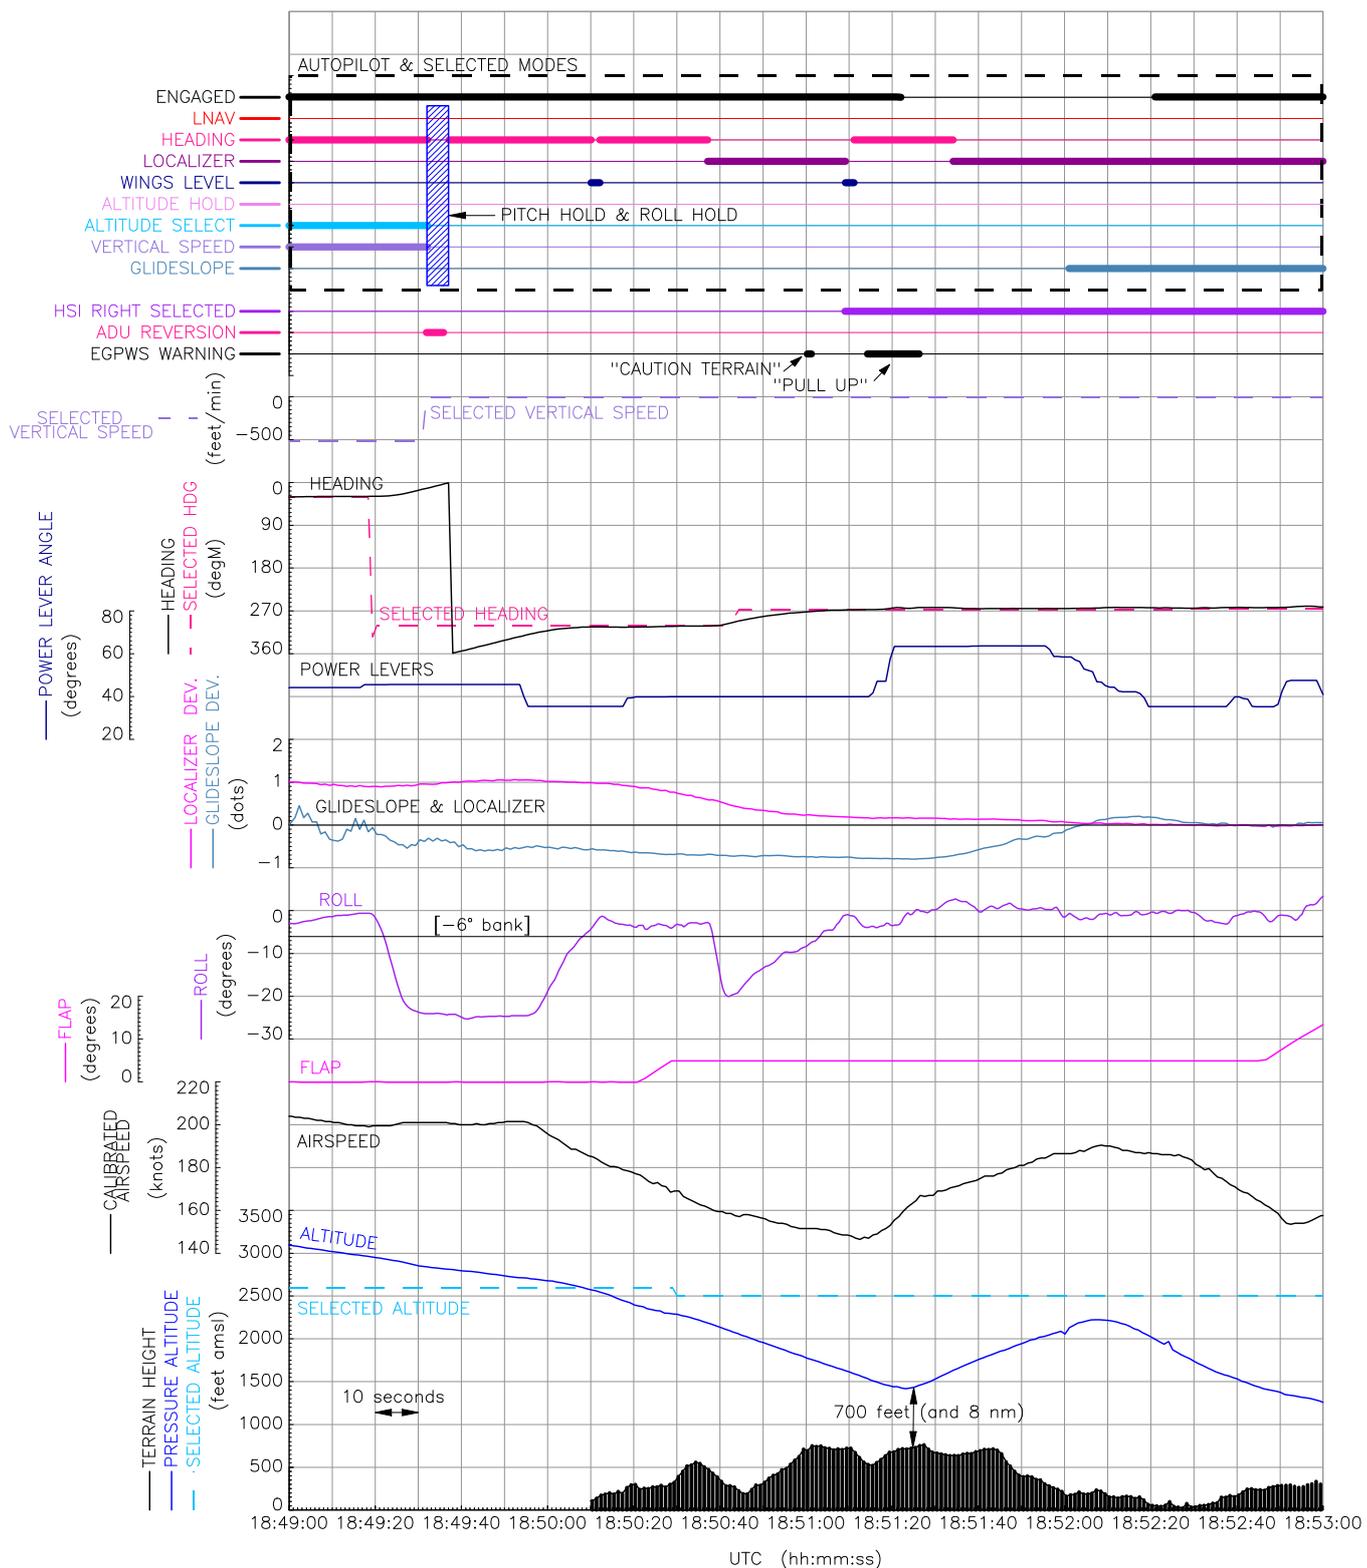
Figure 1
Salient FDR parameters

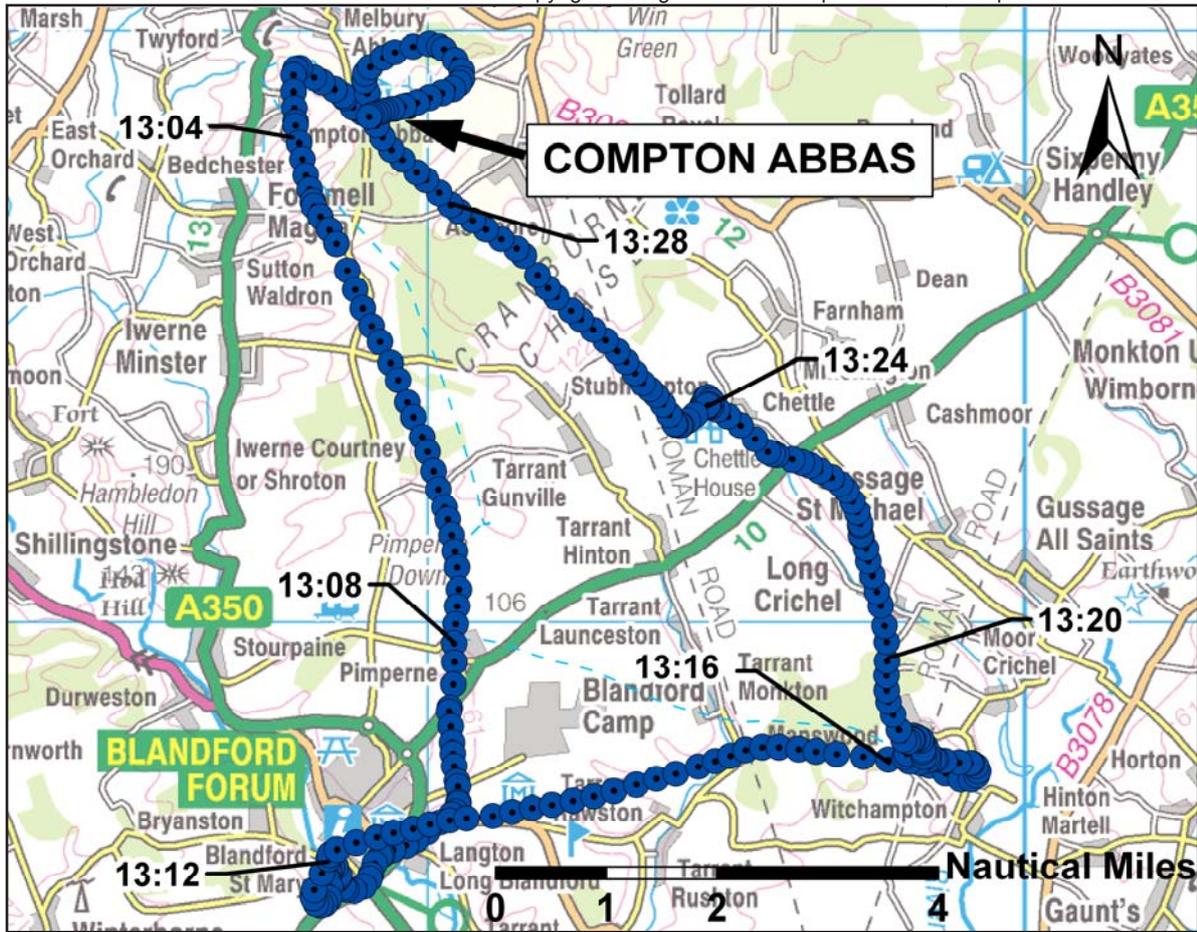
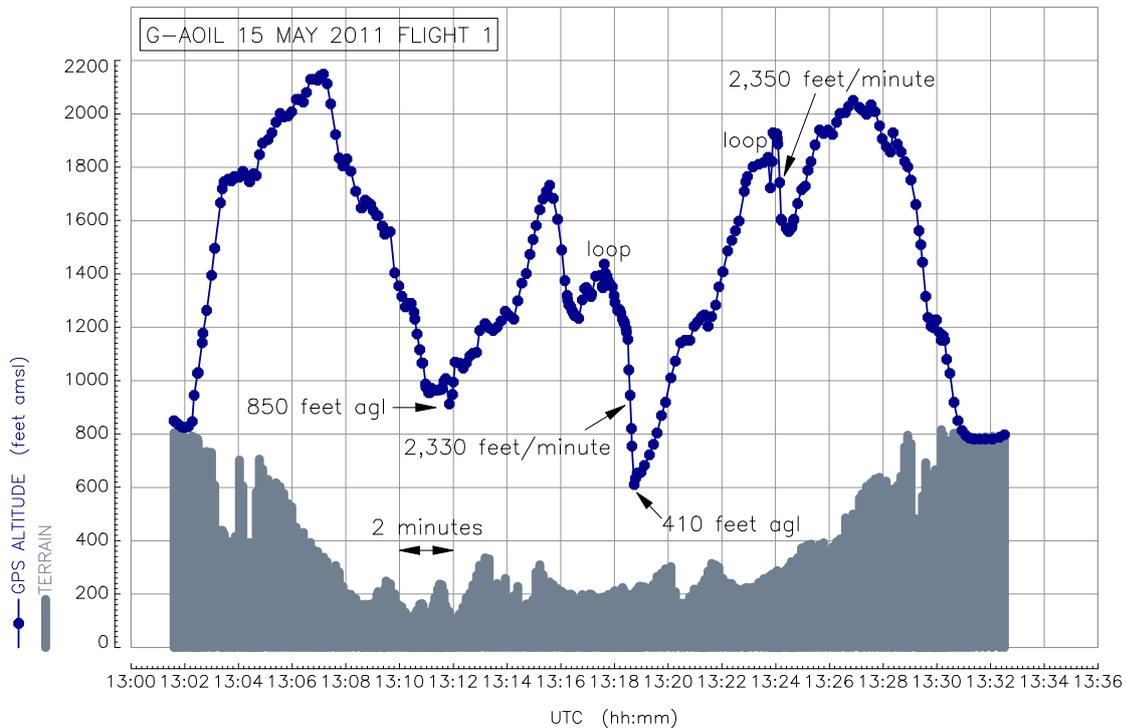
Figure 1

GPS track and altitude data for first flight of G-AOIL on 15 May 2011

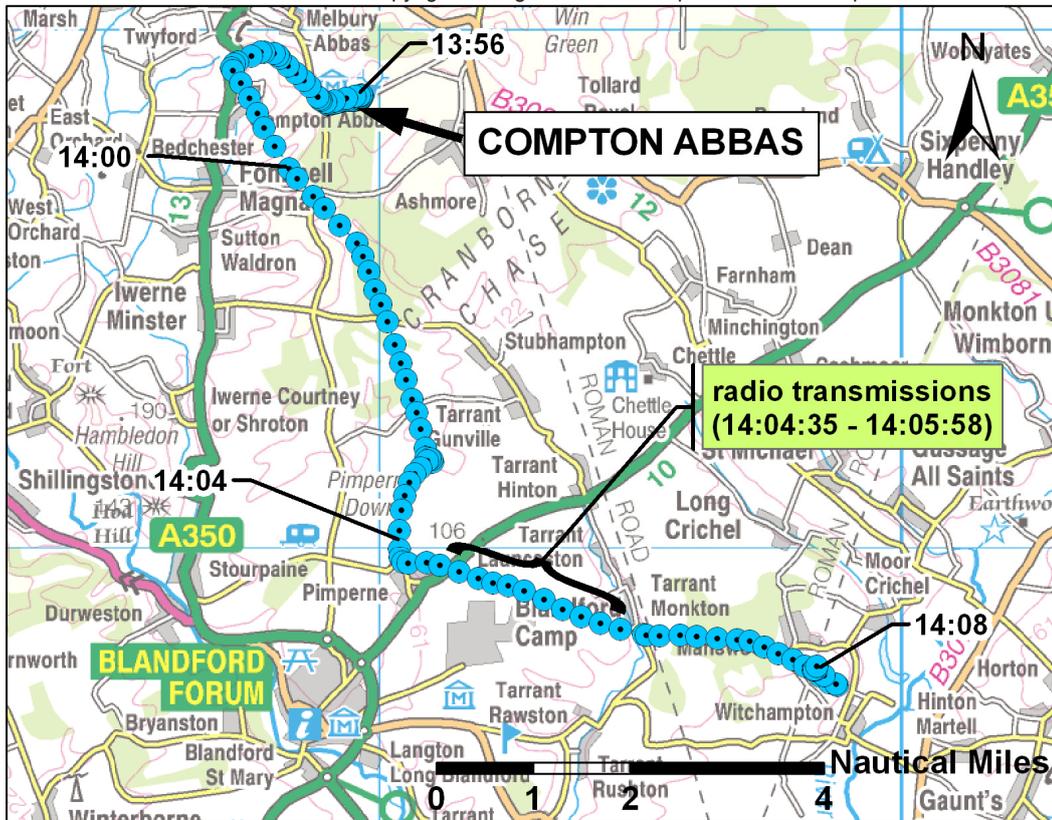
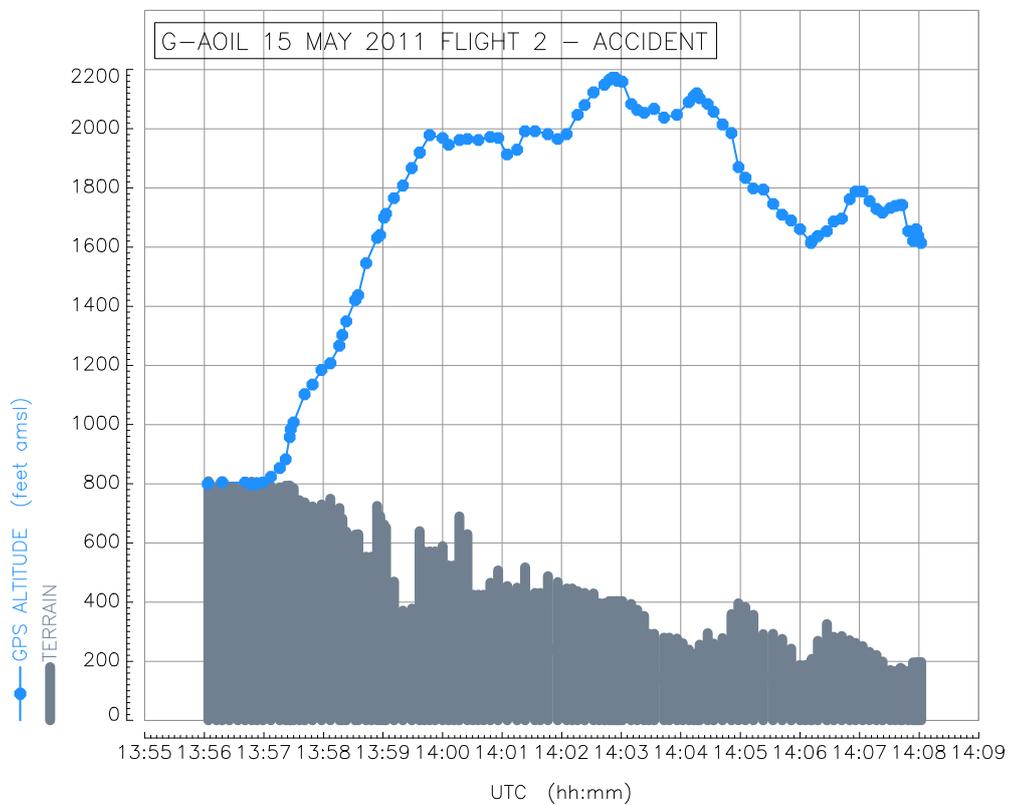
Figure 2

GPS track and altitude data for accident flight of G-AOIL on 15 May 2011

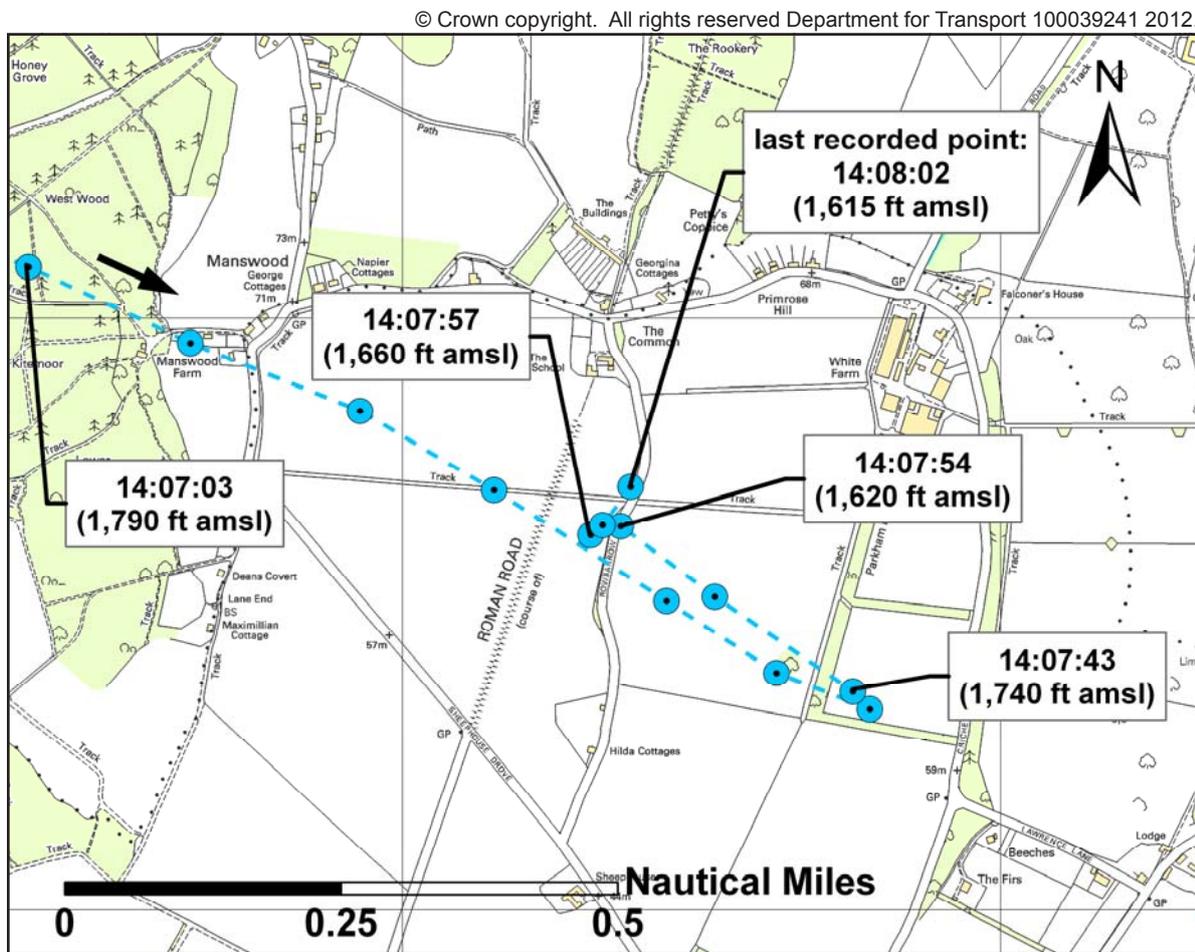
Figure 3

GPS track for the last one minute of the accident flight

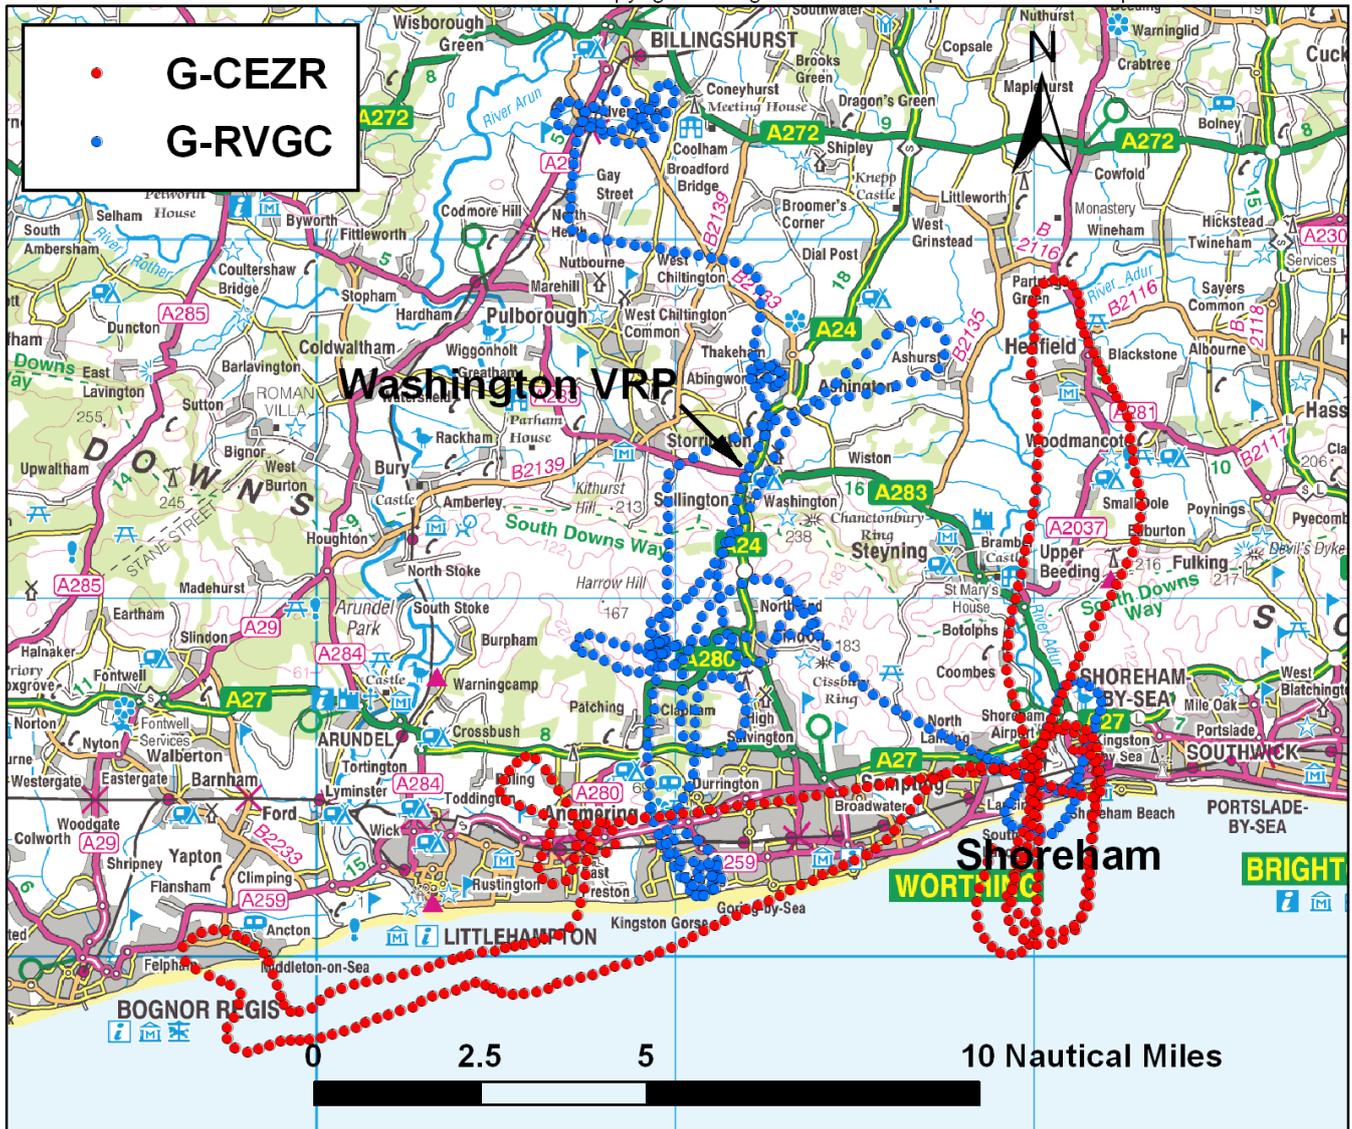
Figure 1

Radar tracks of G-CEZR and G-RVGC from 1444 hrs to the collision at 1527:18 hrs

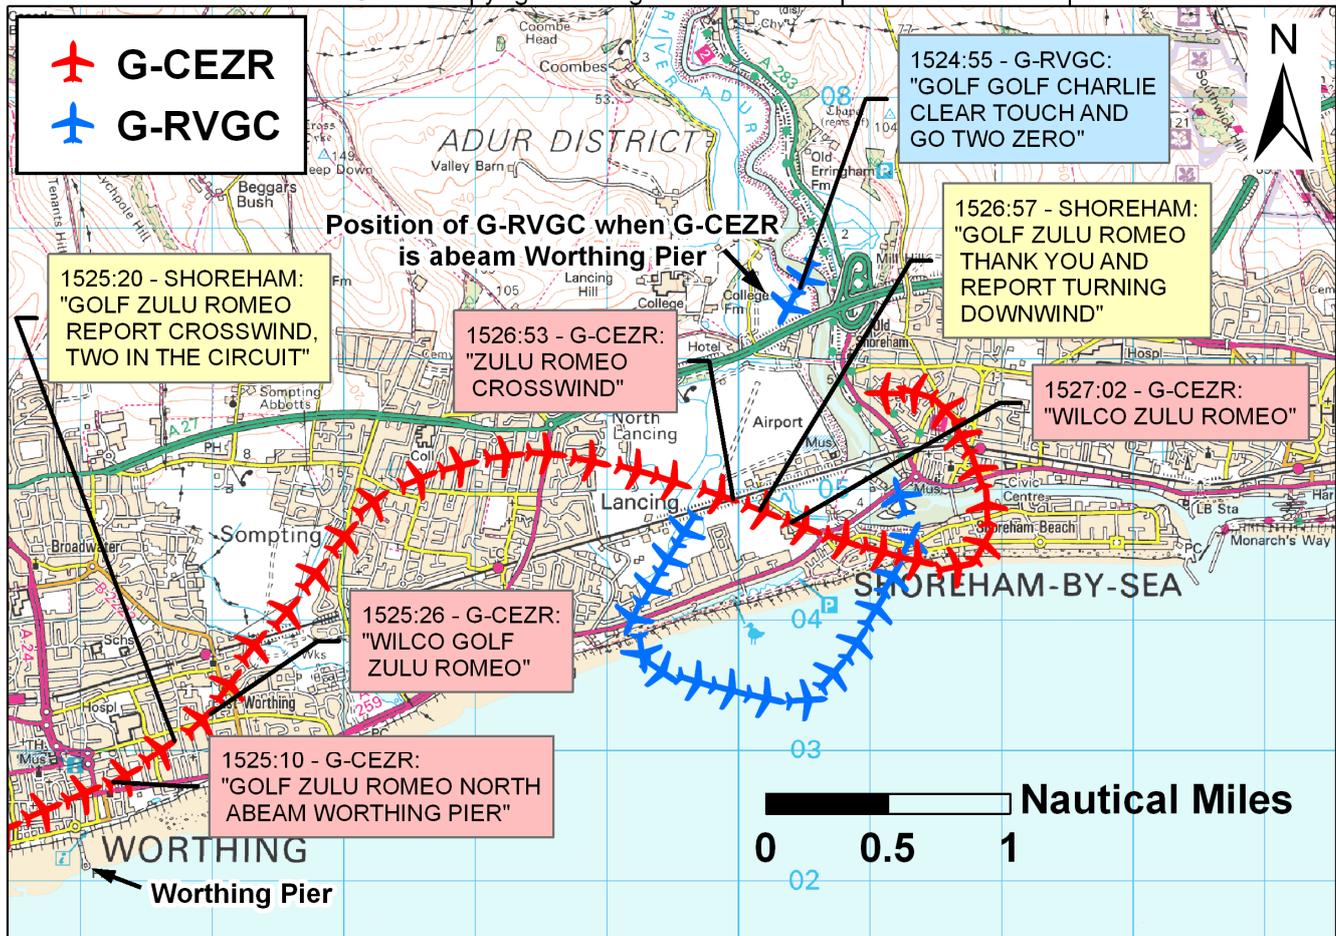
Figure 2

Radar tracks of G-CEZR and G-RVGC from 1524:55 hrs, with relevant radio calls

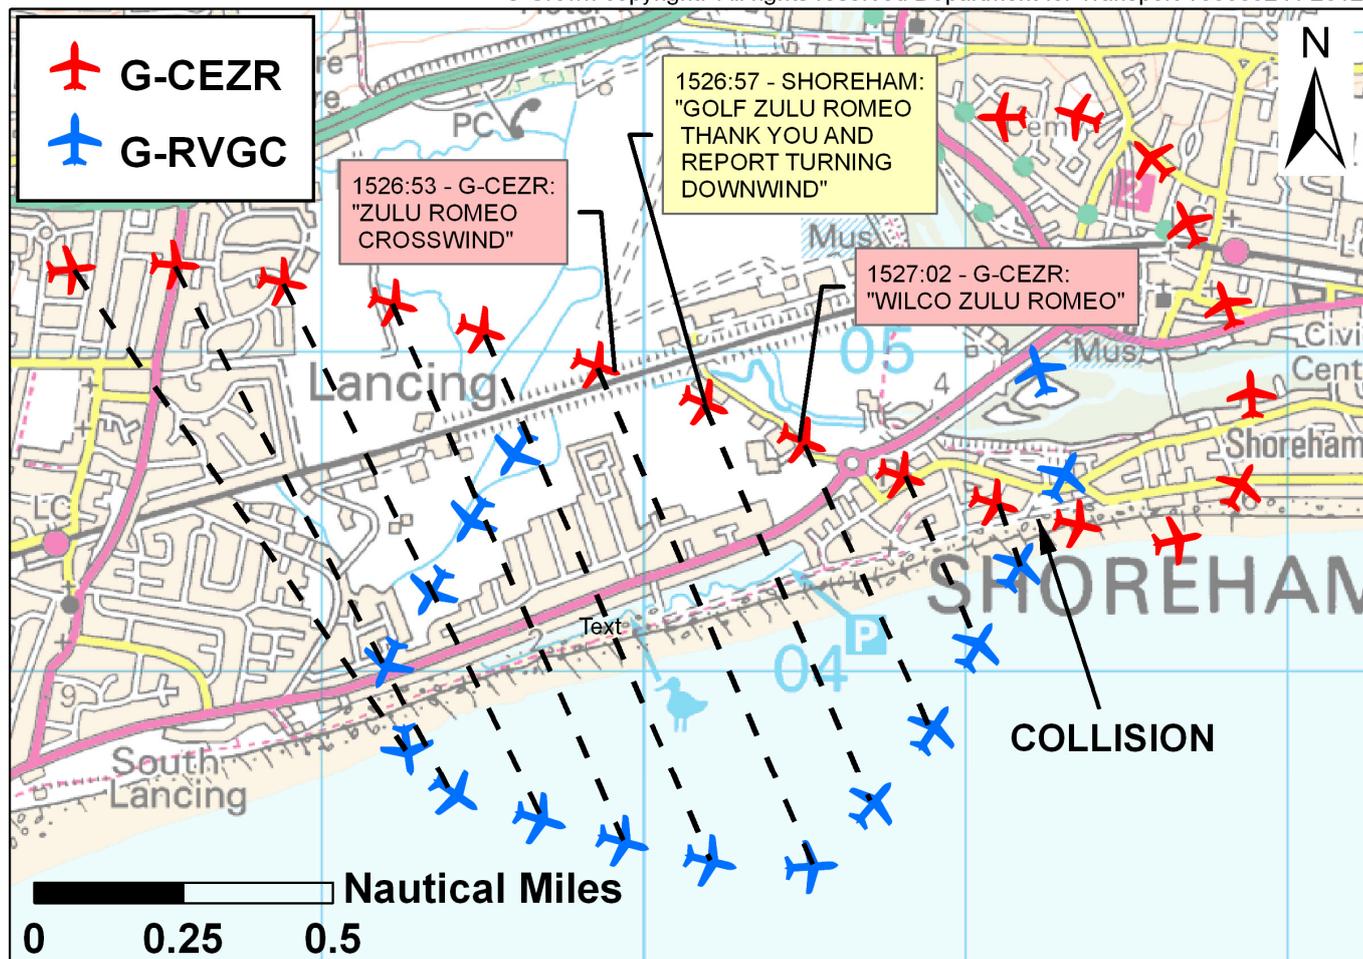
Figure 3

The figure shows that as ZR was about 1 nm from the airfield, on a track to pass over the upwind end of

Close up of radar tracks with G-CEZR joining, and G-RVGC, in the circuit, through to the collision

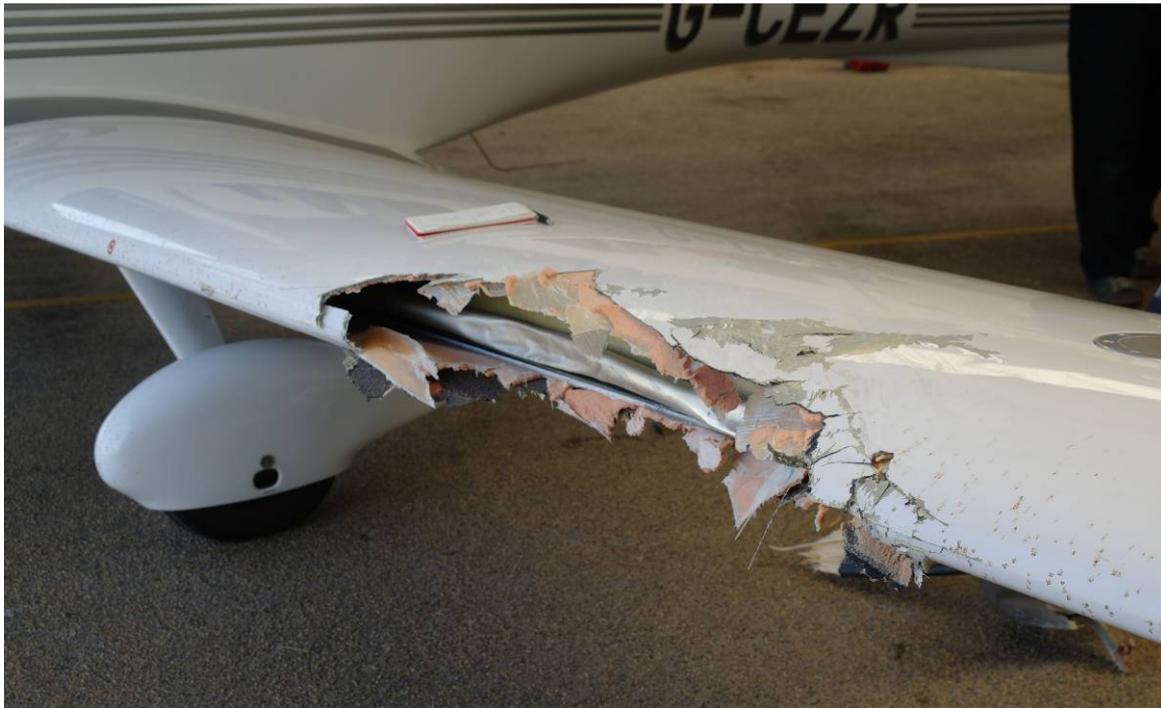
Figure 4

Leading edge damage to G-CEZR

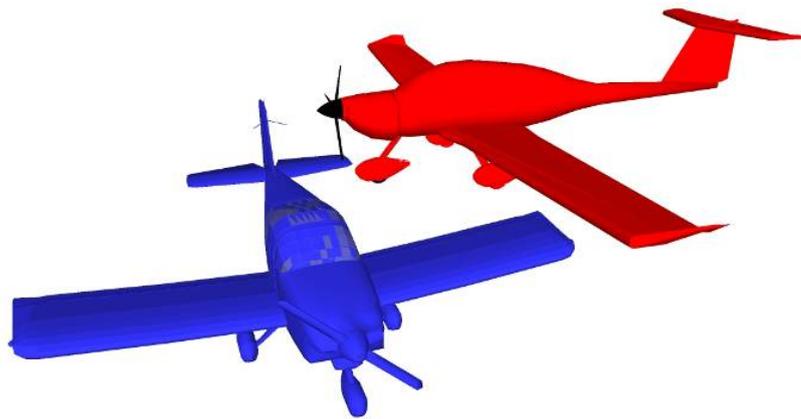
Figure 6a

The first contact was between one propeller blade of ZR (rotating clockwise when viewed from behind) and the tailplane and elevator of GC, removing the tips of the left tailplane and elevator and destroying the wooden propeller blade of ZR (see Figure 6a).

Modelling of collision sequence (G-CEZR in red and G-RVGC in blue)

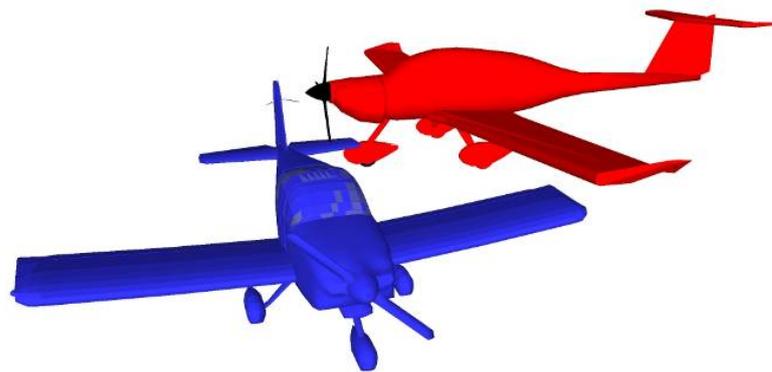
Figure 6b

As relative movement of both aircraft continued, a second propeller blade from ZR was in contact with the elevator further inboard, separating it into two halves (see Figure 6b). The severe out-of-balance forces rapidly fractured ZR's reduction gear casing and the propeller detached.

Modelling of collision sequence

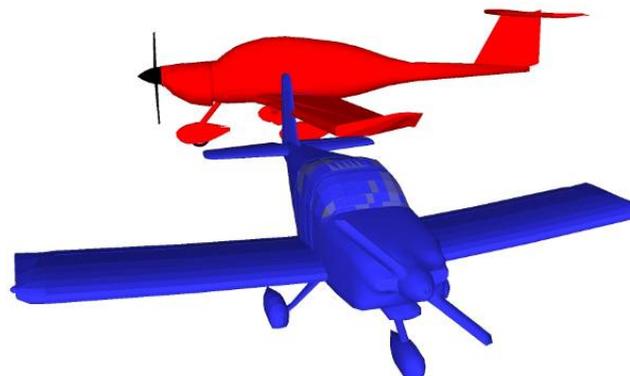
Figure 6c

Modelling of collision sequence
