SPECIAL BULLETINS

BAE Systems Jetstream 31	G-CCPW	08-Mar-12	1
--------------------------	--------	-----------	---

ACCIDENT

Aircraft Type and Registration:	BAE Systems Jetstream 31, G-CCPW	
No & Type of Engines:	2 Garrett Airesearch TPE 331-10UGR-5164 turboprop engines	
Year of Manufacture:	1987	
Location:	Runway 26, Isle of Man Airport	
Date & Time (UTC):	8 March 2012 at 1757 hrs	
Type of Flight:	Commercial Air Transport (Passenger)	
Persons on Board:	Crew - 2	Passengers - 12
Injuries:	Crew - None	Passengers - None
Nature of Damage:	Right main landing gear yoke pintle fractured, right engine and propeller blades damaged	
Commander's Licence:	Airline Transport Pilot's Licence	
Commander's Age:	58 years	
Commander's Flying Experience:	About 6,000 hrs (of which about 1,500 hrs were on type)	
Information Source:	AAIB Field Investigation

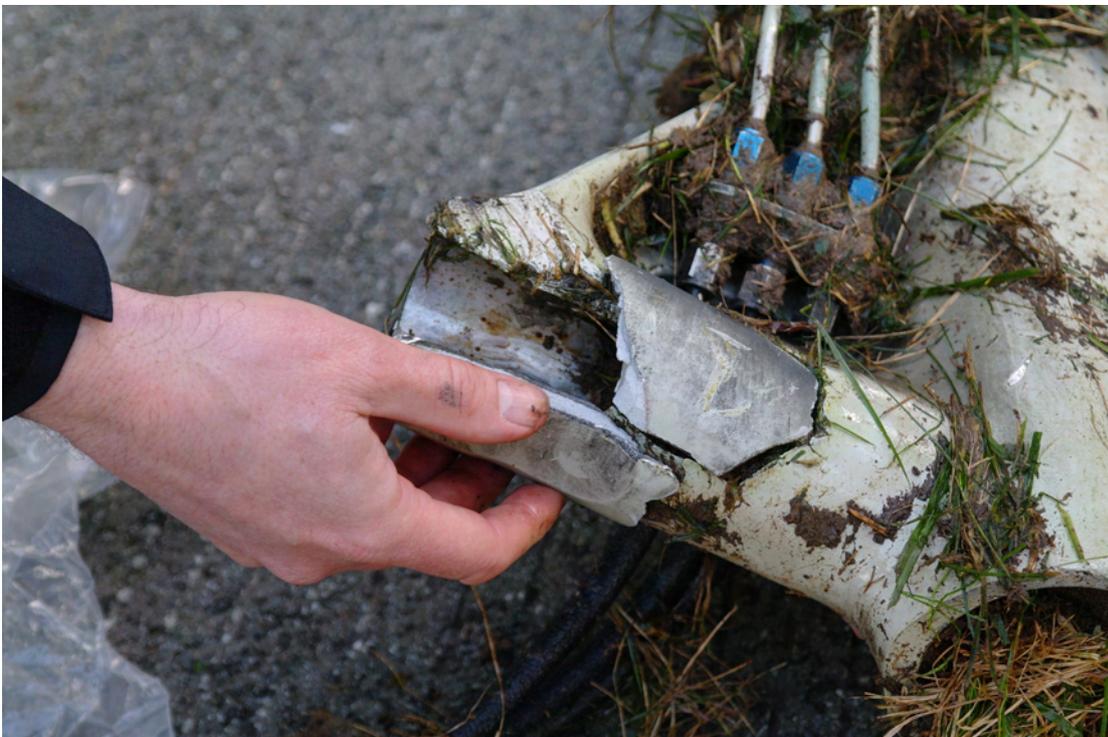
Figure 2

The right landing gear had broken away from its trunnions as a result of a failure of the forward yoke pintle housing (refer to Figure 2). However, the landing gear remained attached to the aircraft by the radius arm (retraction jack) and hydraulic pipelines. The downlock microswitch, which is fitted to the radius arm, remained intact and when electrical power was selected ON all three green landing gear position lights illuminated.

Right main landing gear yoke forward pintle

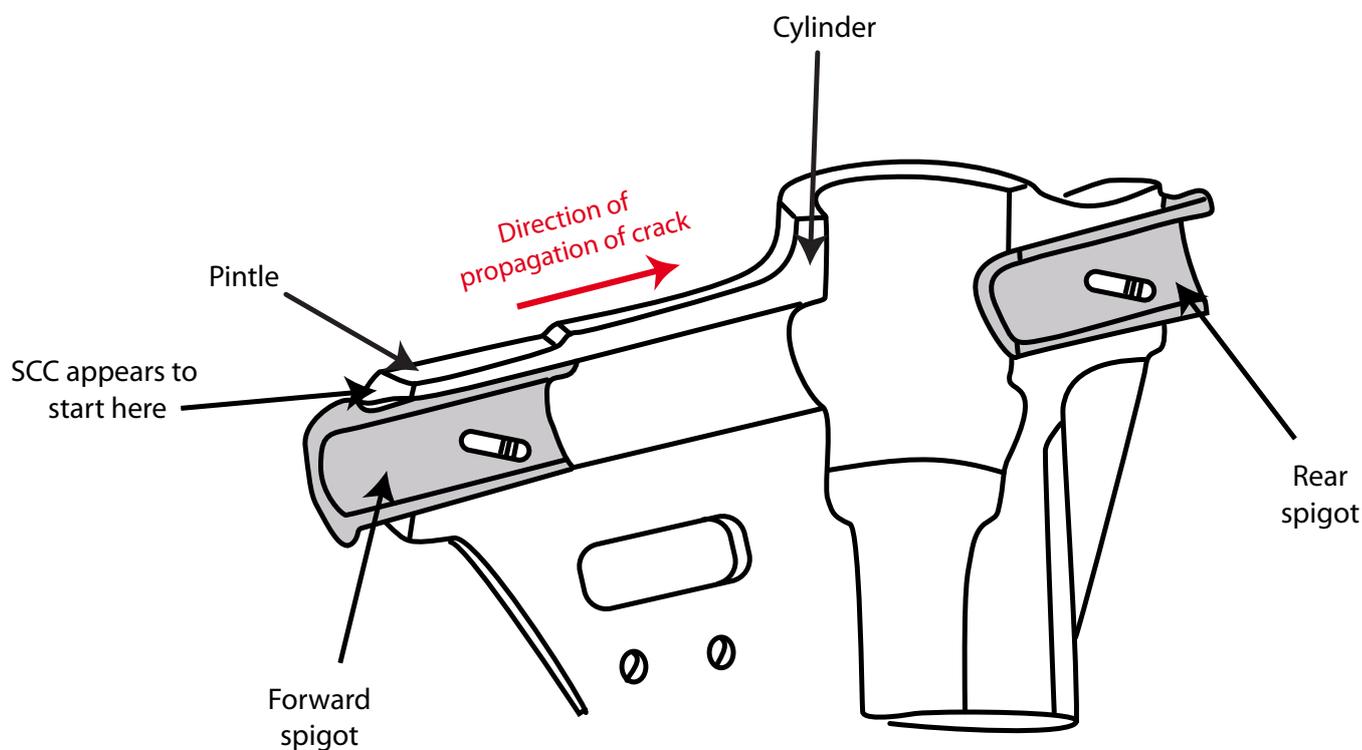
Figure 3

Examination established that the failure initiated at the top outer edge of the forward yoke pintle (see Figure 3) and the crack extended along the top of the pintle for approximately 120 mm before final failure occurred. The first 10 mm of the crack was heavily corroded and lighter deposits of corrosion were found along the remainder of the crack. Scanning Electron Microscopy (SEM) of the first 10 mm of the crack showed evidence of inter-granular failure consistent with SCC. A microsection through the first 35 mm of the crack identified branching crack growth which is a characteristic of SCC. The remainder of the crack showed a combination of both ductile overload and patches of SCC. Corrosion was also found on the steel spigot. Energy-dispersive X-ray spectroscopy (EDX) of the fracture surface of the crack in the yoke pintle identified the presence of cadmium that had leached into the crack from the corroded steel spigot.

Main landing gear diagram

The metallurgy determined that a crack, emanating from the top edge of the forward yoke pintle, grew to approximately 120 mm before the remainder of the pintle failed in ductile overload. The first 10 mm of the crack occurred as a result of SCC and the heavy corrosion deposits indicated that this damage had been present for some time. The failure mechanism of the remainder of the crack is less clear. The patches of ductile overload and SCC, and the presence of cadmium in the crack, suggest that the crack grew over a period of time. Whilst the investigation has not yet determined how long the crack took to grow to failure, the amount of corrosion in the crack and on the steel spigots suggests that it was present during the last visual inspection carried out 11 days earlier and may have been present during the last eddy current inspection undertaken ten months earlier.

It is recommended that the European Aviation Safety Agency review the effectiveness of Airworthiness Directive G-003-01-86 in identifying cracks in the yoke pintle housing on landing gears fitted to Jetstream 31 aircraft.

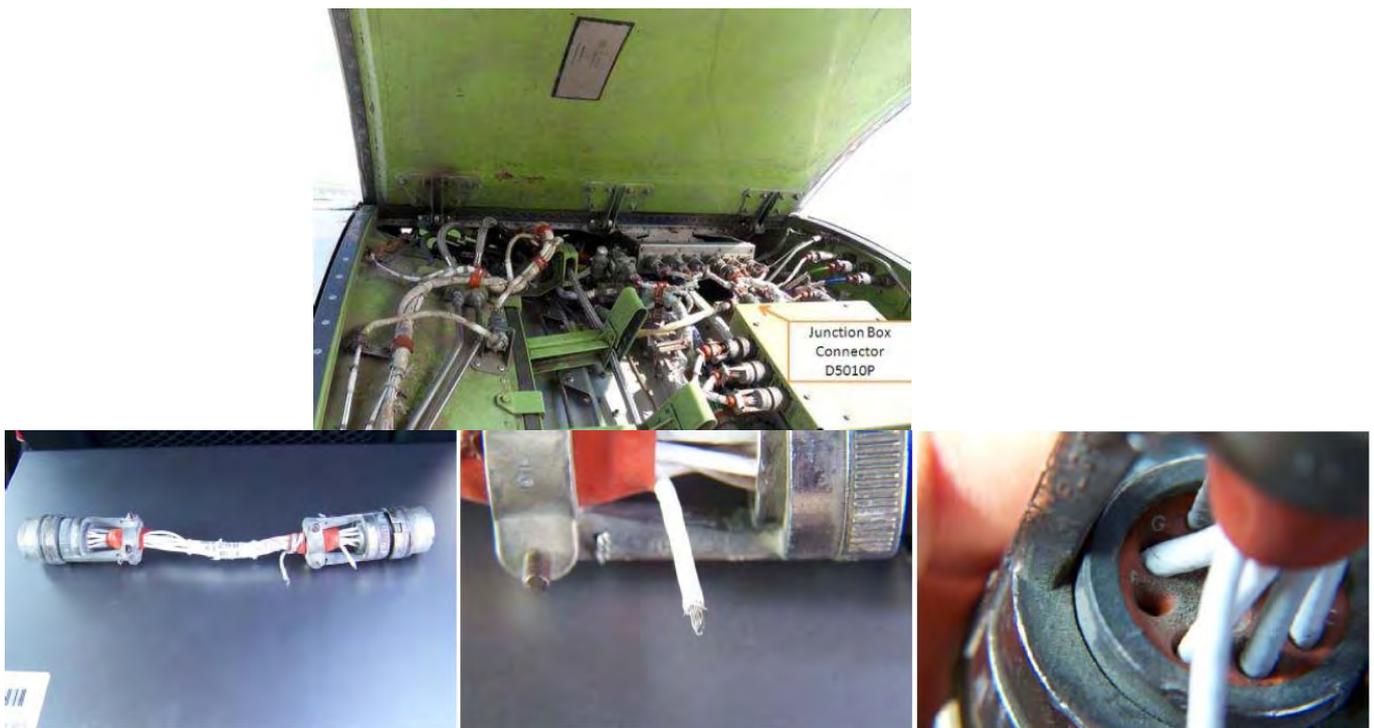
Figure 4

Relay 46 KM was tested and it functioned correctly and conformed to specifications. Testing and internal examination of the synchronous locks did not reveal any evidence of a crash engagement, which would be apparent if the solenoids had instantaneously de-energised while the reverser sleeves were in transit.

Loose wire at Pin F of connector D5010P in the auto-restow circuit

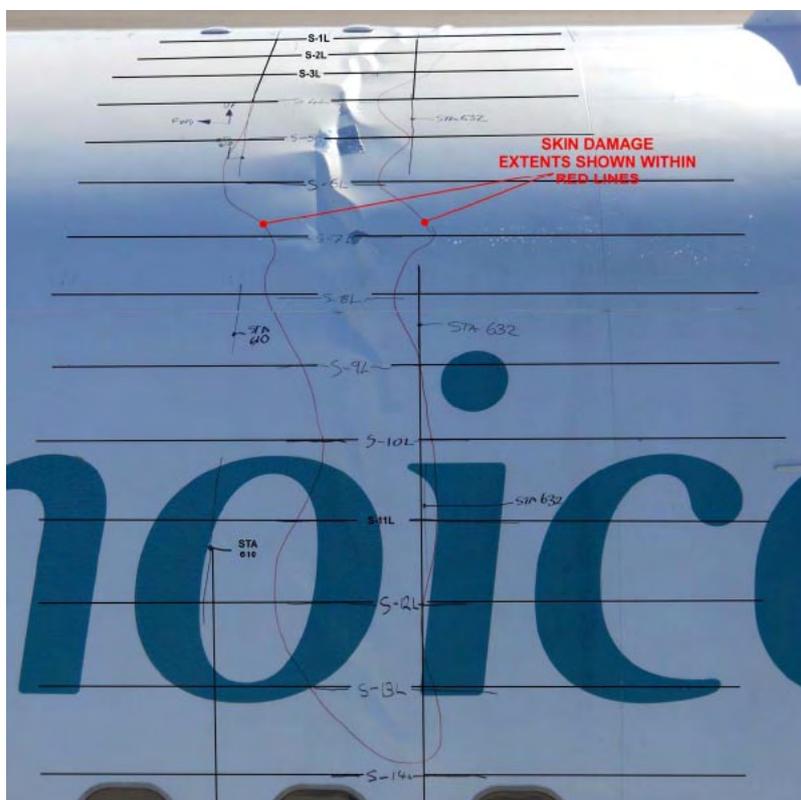
Figure 5

Buckling of skin between STA 610 and STA 632

After reviewing the flight data, the aircraft manufacturer determined that the damage to the aircraft was consistent with the aircraft either landing on the nose wheel or the nose wheel making contact with the runway following a rapid de-rotation.

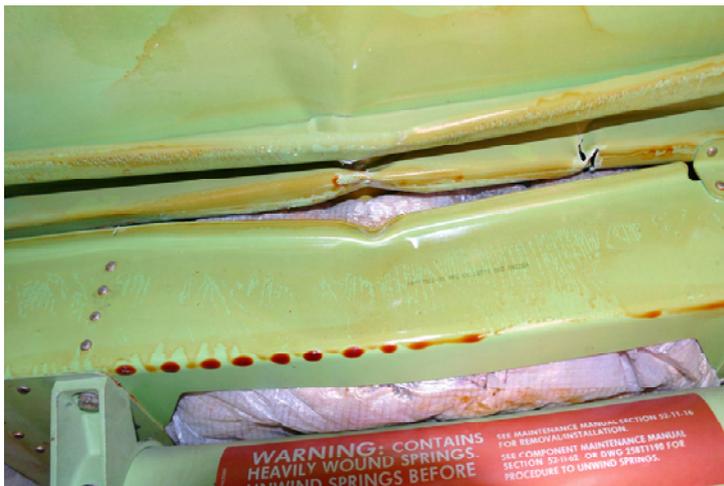
Figure 6

Buckling of intercostal and cracking of frame

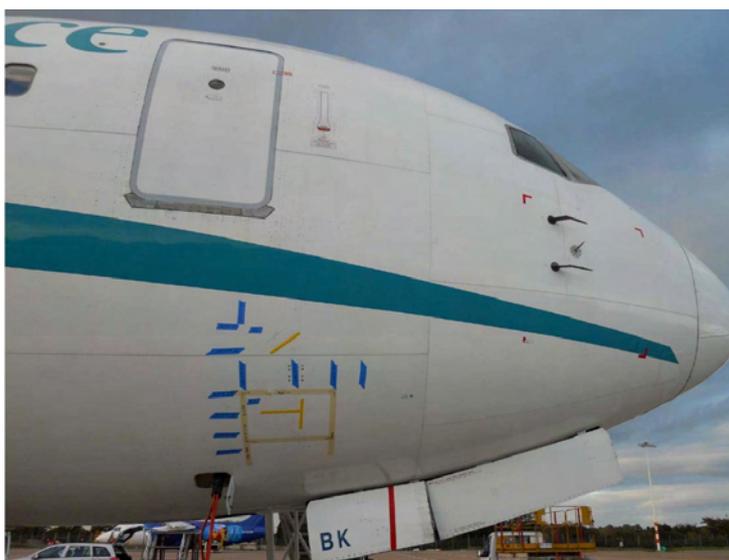
Figure 7

There was light creasing in the skin above and below the nose jacking point, though it was not possible to establish if this damage had occurred during this

Damage adjacent to nose jacking point

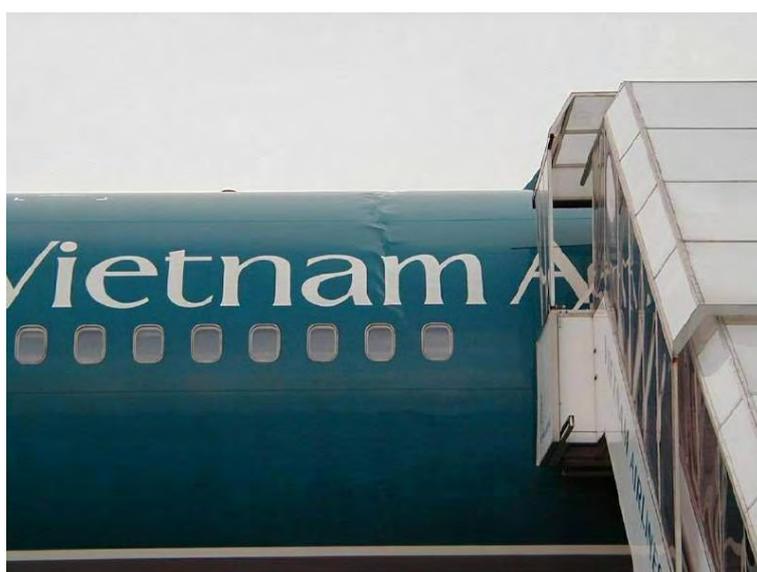
Figure 8

Previous damage to the crown skins

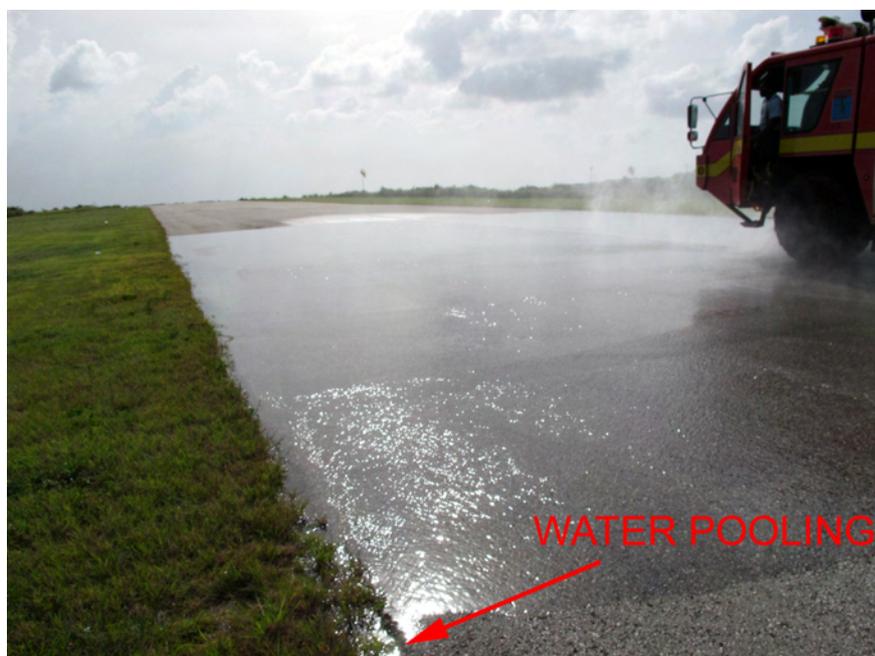
Figure 3

The runway surface consisted of un-grooved asphalt and it was cambered to assist water drainage to the sides. A fire truck was used to spray water on the runway surface which revealed that the water drained to the sides of the runway, but there was some pooling of water at the runway edges where the surface joined the grass (Figure 3). Some runways at other airports have carrier drains, sometimes consisting of stone aggregate, between the runway surface and the grass surface which aids drainage.

Water sprayed onto the runway surface revealed some pooling at the edges

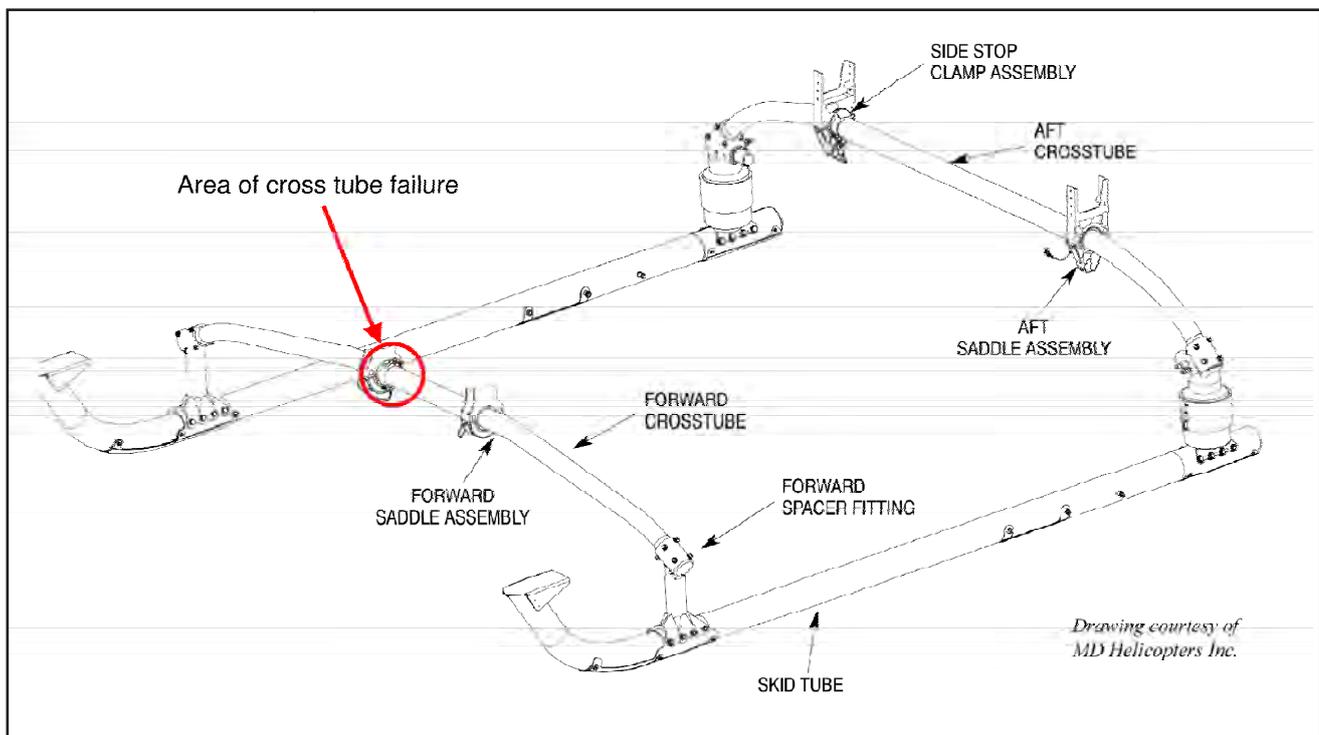
The forward cross tube is constructed from drawn 7075 T6 aluminium alloy tubing, with a nominal outer diameter of 2.4” and a nominal wall thickness of 0.350”. After forming and chemical milling operations, the cross tube’s inner and outer surfaces are chemically film-treated to MIL-DTL-5541. The production drawing for the forward cross tube requires that both the inside and outside surfaces of the tube are painted with an epoxy primer, prior to exterior paint finish application. The areas of cross tube beneath the side stop clamps had not been primed or painted, due to the requirement for electrical bonding to the side stop clamps.

Figure 1
MD900 landing gear showing location of the forward cross tube failure

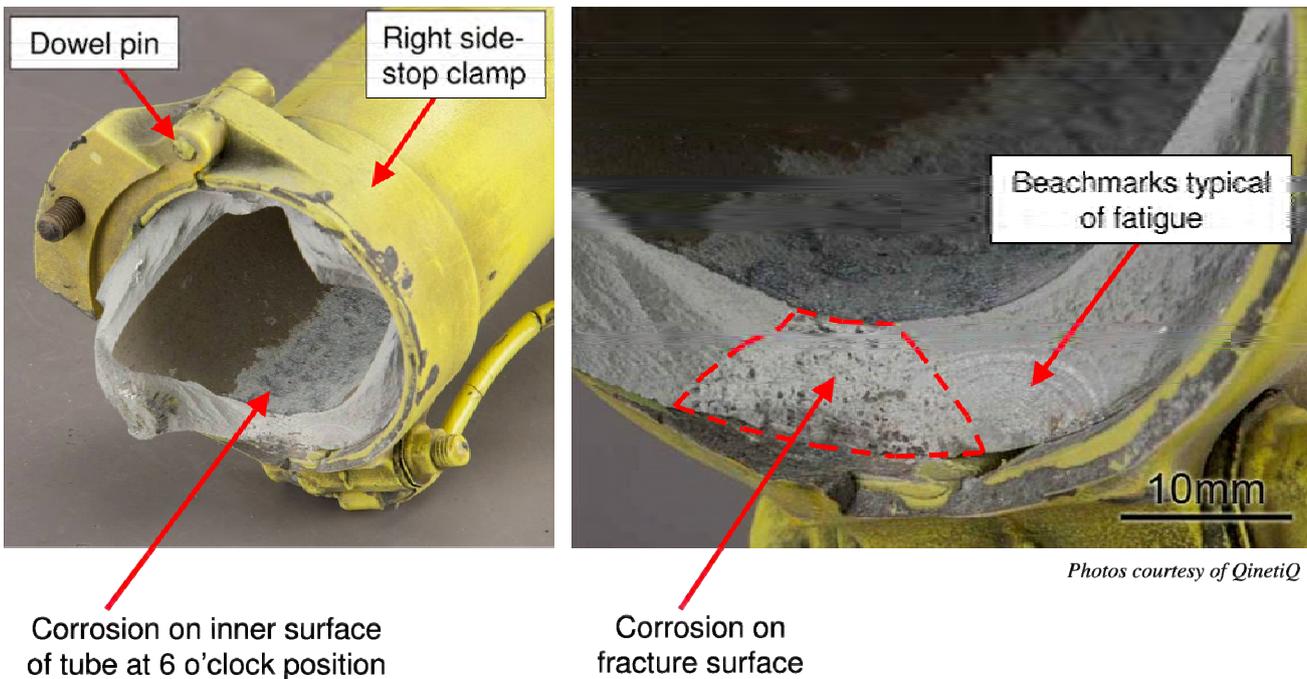
Figure 3

The fatigue crack origin was examined using both visual and scanning electron microscopy (SEM) which showed that, despite the presence of local corrosion pits, the fatigue crack had actually initiated from a shallow, curved machining mark in the tube's outer surface (Figure 5). The SEM analysis showed that the crack had initially propagated in fatigue, with at least 16 separate visible 'beachmarks', before subsequently progressing through a series of five 'static jumps' (Figure 6). A static jump is a ductile overload phenomenon in which a high load event causes a fatigue crack to propagate by localised tensile overload, before reverting back to progressive fatigue propagation under lower cyclical loading conditions. Analysis of the fracture surface away from the fatigue region revealed three 'arrest' marks within the overload failure surface.

Visual examination of the inboard side of the fracture surface

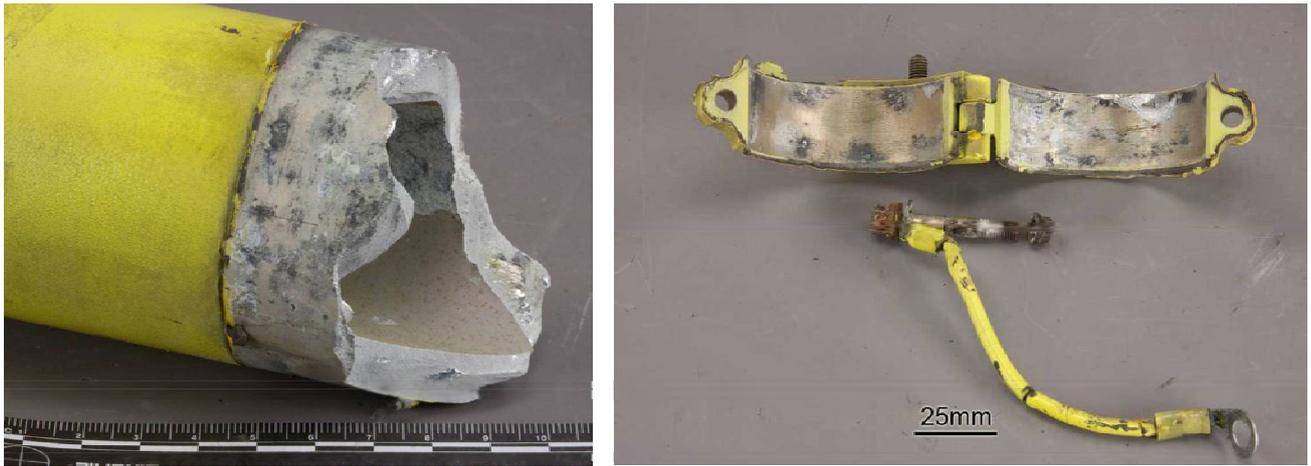
Figure 4

Surface corrosion beneath right side stop clamp

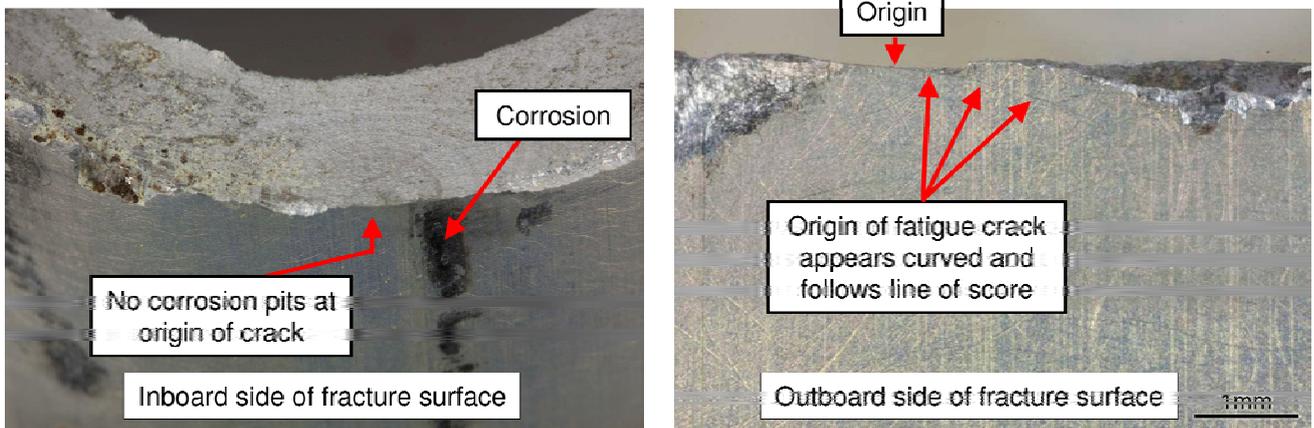
Figure 5

Visual examination of the fatigue crack origin

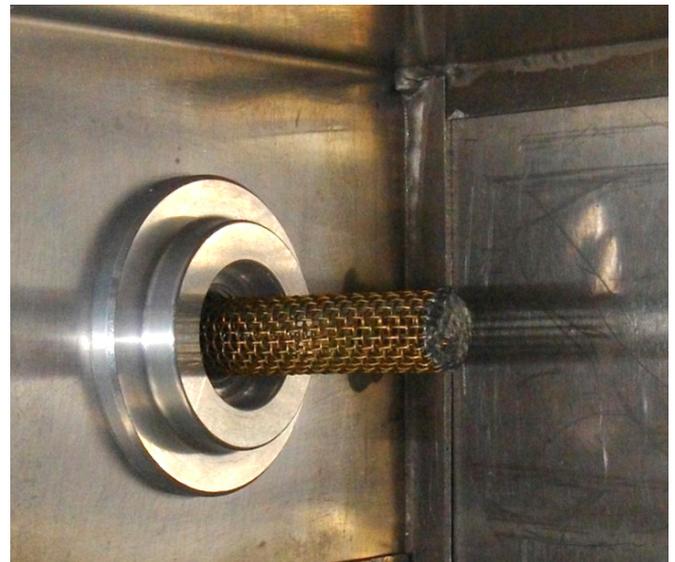
Figure 3

Strainer modification fitted to the fuel tank outlet
(Breezer Service Bulletin SB11-002)

The Safety Alert was applicable to the Breezer CR, CL and B600. The manufacturer has also designed a fuel strainer modification that is being incorporated in all newly-built aircraft and has published a Service Bulletin (SB11-002) for a strainer retrofit kit for existing aircraft. The manufacturer has also introduced further checks in the assembly process to ensure that the placard on the fuel sender is removed prior to installation.

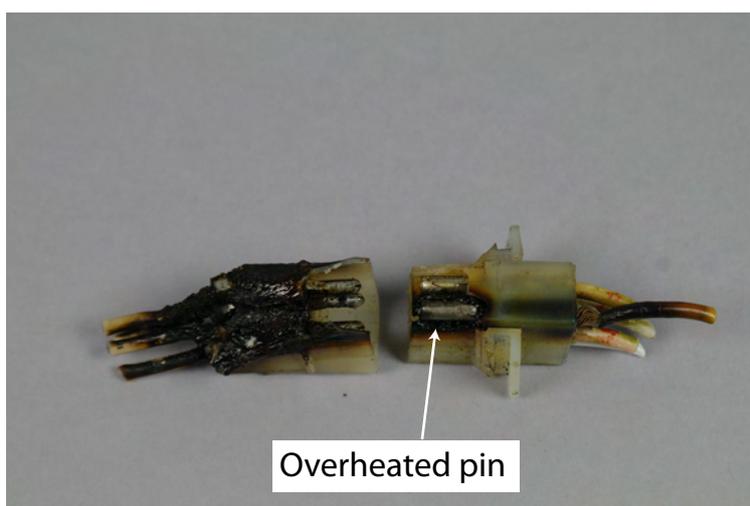
Due to the extent of the damage it was not possible to identify why the pin had overheated. However, the organisation that maintained G-BOCG, and 12 other PA-34 aircraft, advised the investigation that the connector is frequently disconnected in order to inspect the flying control cables that run under the console. During this maintenance activity they have, on a number of occasions on different aircraft, found loose and corroded pins, and evidence of overheating. The affective parts were replaced on all these occasions.

Figure 1
Electrical connector
