AAIB Special Bulletins / Interim Reports

ACCIDENT

Aircraft Type and Registration:	EC225 LP Super Puma, G-REDW
No & Type of Engines:	2 Turbomeca Makila 2A1 turboshaft engines
Year of Manufacture:	2009 (Serial no: 2734)
Date & Time (UTC):	10 May 2012 at 1114 hrs
Location:	20 nm east of Aberdeen
Type of Flight:	Commercial Air Transport (Passenger)
Persons on Board:	Crew - 2 Passengers - 12
Injuries:	Crew - None Passengers - 2 (Minor)
Nature of Damage:	Damage to be assessed following salt water immersion
Commander's Licence:	Airline Transport Pilot's Licence
Commander's Age:	To be advised
Commander's Flying Experience:	To be advised
Information Source:	AAIB Field Investigation

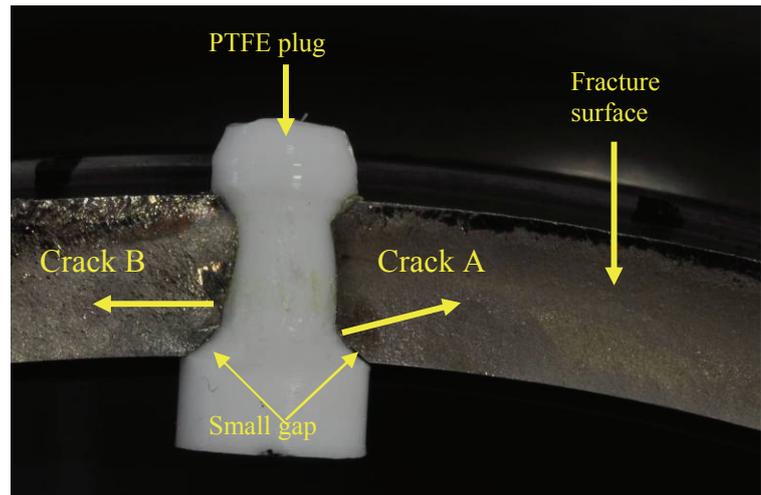
Figure 2

4.2 mm diameter hole in the weld

Examination of the fracture surface on both parts of the bevel gear vertical shaft revealed the presence of three cracks, identified as 'A', 'B' and 'C' (see Figure 2). Cracks 'A' and 'B' started from the 4.2 mm diameter hole in the weld and there was evidence of beachmarks and striations along both cracks, which are indicators of a fatigue failure. Crack 'A' was 336 mm long² and extended for approximately 250° around the circumference of the shaft. This crack appeared to have initiated from a small corrosion pit, approximately 60 µm

deep, on the inner countersink. Crack ‘B’ was 106 mm long and extended for approximately 80° around the circumference. This crack appeared to have initiated at a small defect in the internal surface of the hole. Crack ‘C’ was 42 mm long and extended for approximately 30° around the circumference. One end of this crack joined Crack ‘A’ and the other end ran under Crack ‘B’. While there were striations on the surface of Crack ‘C’, there was no evidence of any beachmarks.

In total, approximately 99% of the fracture surface on the bevel gear vertical shaft had failed in fatigue and 1% of the surface had failed in overload.

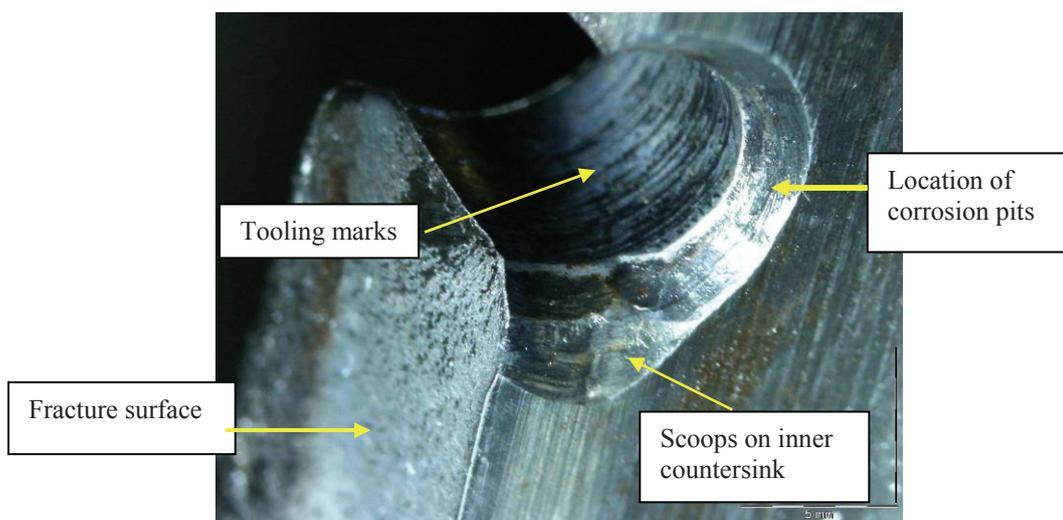
The diameter of the 4.2 mm hole was within the design specification. However, there was evidence of tooling marks and, what appeared to be, a spiral scratch that ran along the length of the hole. The geometry of the inner and outer countersinks was found to be outside the design specifications and there were a number of ‘scoops’ in the inner countersink (see Figure 3). There were patches of very small corrosion pits around the inner countersink,

in the area where there is a gap (crevice) between the PTFE plug and the countersink. These corrosion pits were only initially detected using a scanning electron microscope.

Figure 3
Condition of the 4.2 mm hole and countersink

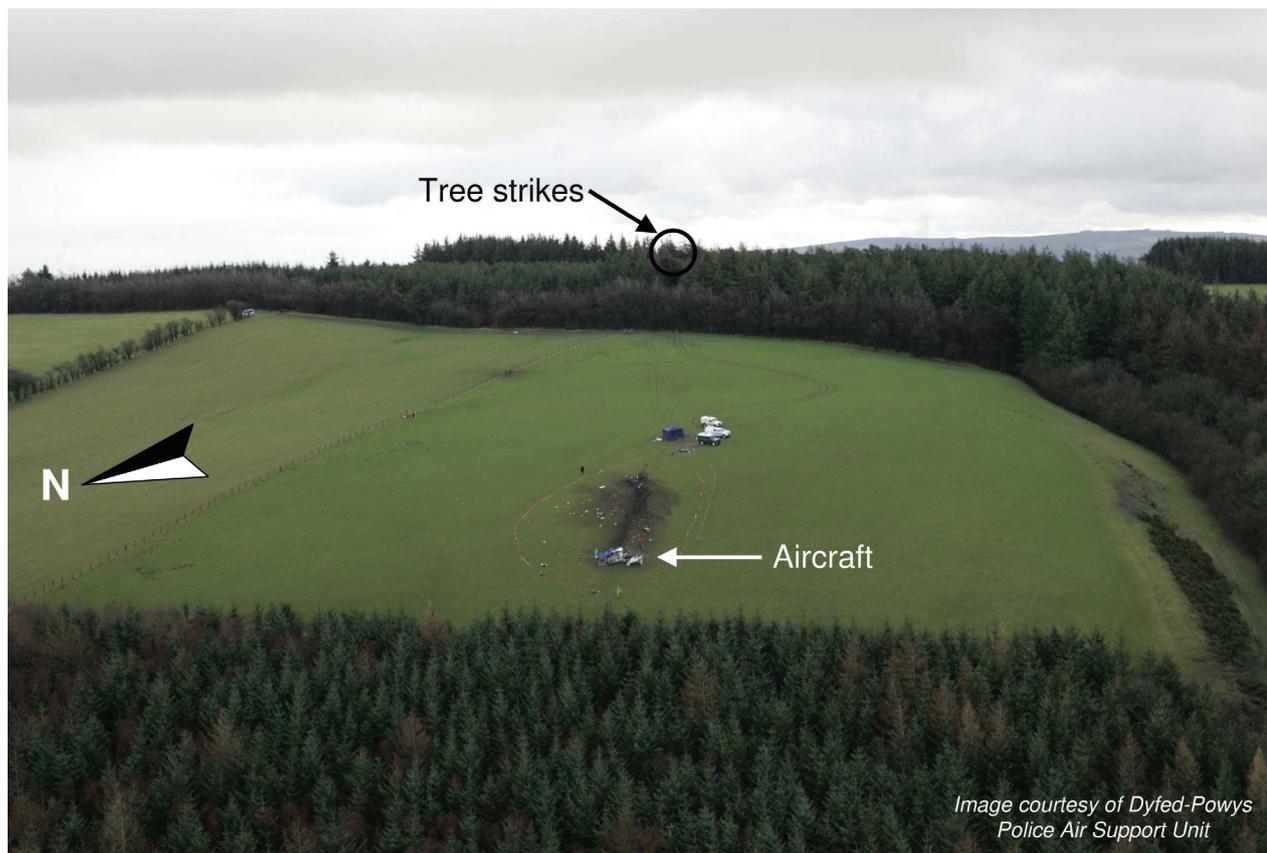
The aircraft's left wing had struck two 80 ft pine trees approximately 20 ft below treetop height, causing the outer 2.2 m of the left wing, outboard of the left flap, to fragment and detach. Witness marks on the severed tree trunks indicated that the roll attitude of the aircraft at impact with the trees was wings level.

The wreckage trail, from the point of the initial tree strikes to the aircraft's final resting position, was 230 m in length and was orientated on a heading of 298°M. Parts of all major sections of the structure and flying controls were identified at the accident site. The first ground impact scar was 185 m beyond the initial tree strike and had been made by the right wingtip; it was 20 cm wide and the narrowness of this mark indicated that the roll angle at ground impact was approximately 90° right wing low. The ground impact marks and distribution of the wreckage indicated that following the right wingtip strike, the right engine hit the ground and detached, shortly after which the aircraft impacted heavily on its nose. The absence of any significant ground scars between the nose impact crater and the main wreckage indicated that the aircraft then bounced a distance of 34 m, before finally coming to rest facing uphill. The wings were resting in a leading edge down orientation and the majority of the fuselage was lying inverted, with the tail furthest up the slope. An intense fuel fire had consumed approximately 60% of the aircraft, including the majority of the fuselage and empennage.

Figure 4
Accident site

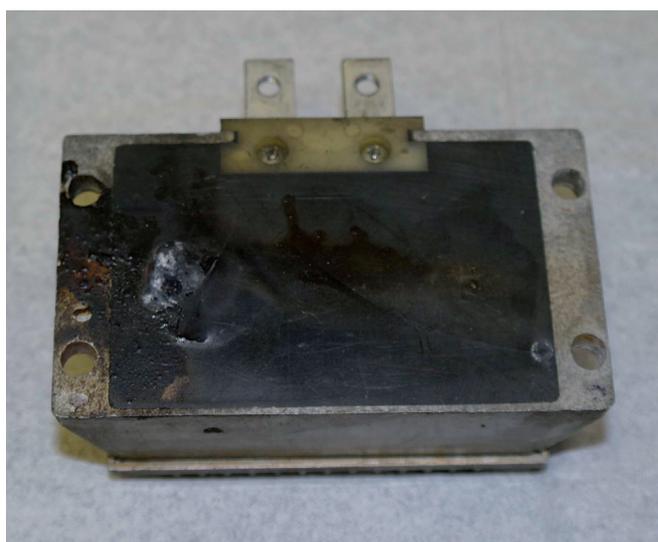
Figure 1

Examination of the aircraft revealed that there had been an internal failure of the alternator regulator, with the underside of the casing having sustained visible heat damage (Figure 1). The regulator was located behind the engine compartment firewall and in front of the instrument panel. Access was gained by means of a panel in the nose close to the right side of the windscreen. It was apparent that the smoke had originated from a layer of cabin insulation material that was in close proximity to the regulator. This material exhibited extensive charring, with the smoke having left visible residue on the inside of the windscreen.

View of underside of regulator, showing heat damage

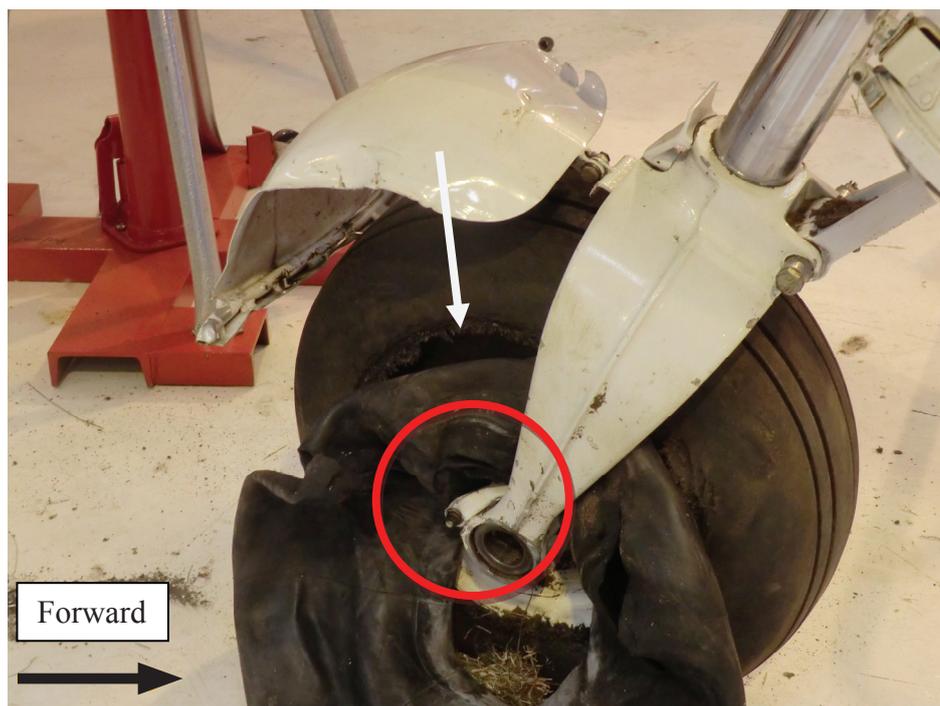
Figure 1

bottom used a shaped tubular brace which attached to the forks either side of the axle. The mudguard had remained attached at the top but had been buckled with the braces at the bottom broken. On the right side, the broken bracing tube had rotated through almost 180° and become jammed between the fork and the tyre (Figure 1). This was consistent with the pilot's recollection of a "whining noise" followed by severe vibration and shimmy as the tyre deflated.

There was no immediately apparent reason for the failure of the bracing tube. Circumstantially, it is most likely that it was damaged either during taxiing or ground handling, since the attachments were intact.

View of deflated nosewheel tyre showing worn tyre sidewall (arrowed) and broken mudguard bracing tube jammed between nosewheel fork and tyre (circled).

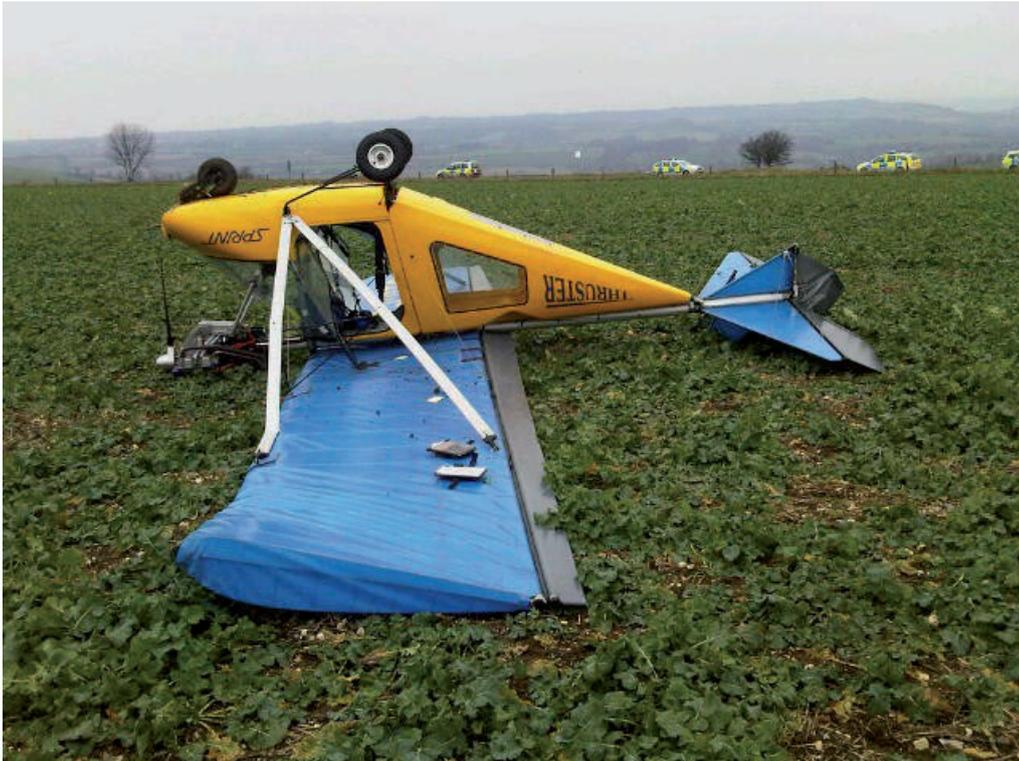
Figure 1

G-CBIO following the accident

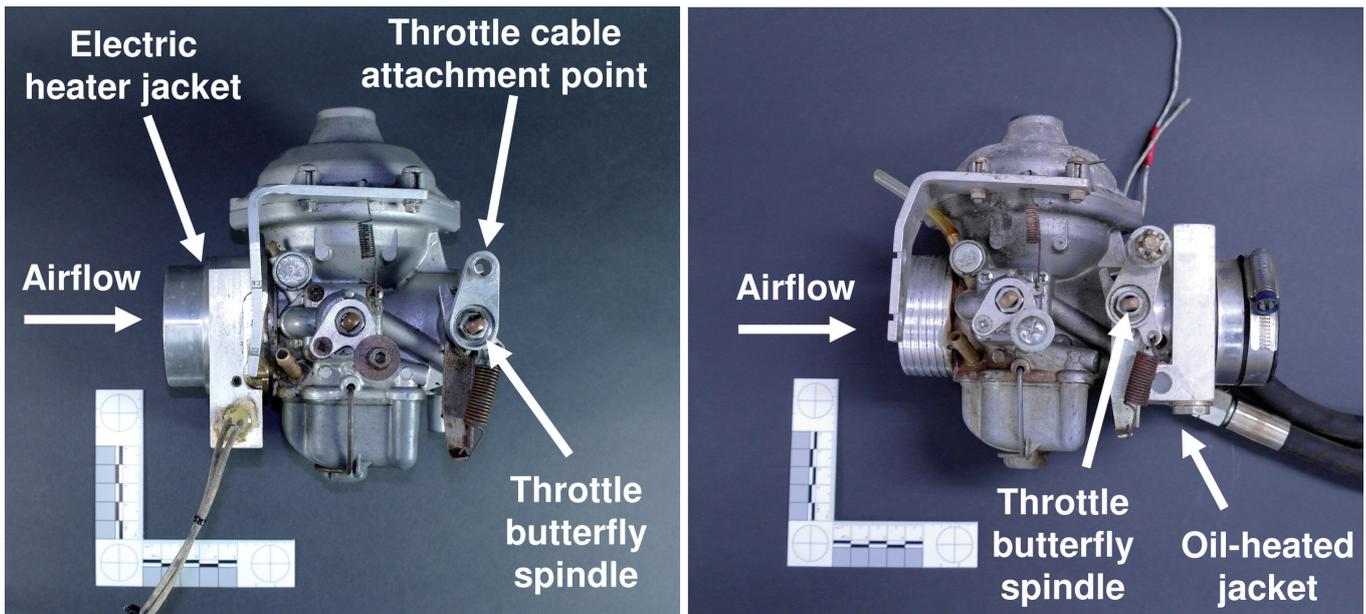
The aircraft was fitted with a carburettor heat system comprising an electrically heated jacket fitted to the inlet throat of the carburettor body, Figure 3(a). This differed from the production standard carburettor heat system installed when the aircraft was manufactured in 2002, in which hot engine oil is circulated through a hollow jacket attached to the exit throat of the carburettor body, in close proximity to the throttle butterfly Figure 3(b).

(a) G-CBIO carburettor heat configuration

(b) Production configuration
