SPECIAL BULLETINS

COMMERCIAL AIR TRANSPORT

SERIOUS INCIDENT

Aircraft Type and Registration:	Airbus A300B4-605R, G-MAJS	
No & Type of Engines:	2 General Electric CO CF6-80C2A5 turbofan engines	
Year of Manufacture:	1991	
Date & Time (UTC):	26 July 2011 at 1035 hrs	
Location:	London Gatwick Airport	
Type of Flight:	Commercial Air Transport (Passenger)	
Persons on Board:	Crew - 12	Passengers - 335
Injuries:	Crew - None	Passengers - None
Nature of Damage:	None	
Commander's Licence:	Airline Transport Pilot's Licence	
Commander's Age:	49 years	
Commander's Flying Experience:	12,074 hours (of which 8,680 were on type) Last 90 days - 147 hours Last 28 days - 74 hours	
Information Source:	Aircraft Accident Report Form submitted by the pilot and further enquiries by the AAIB

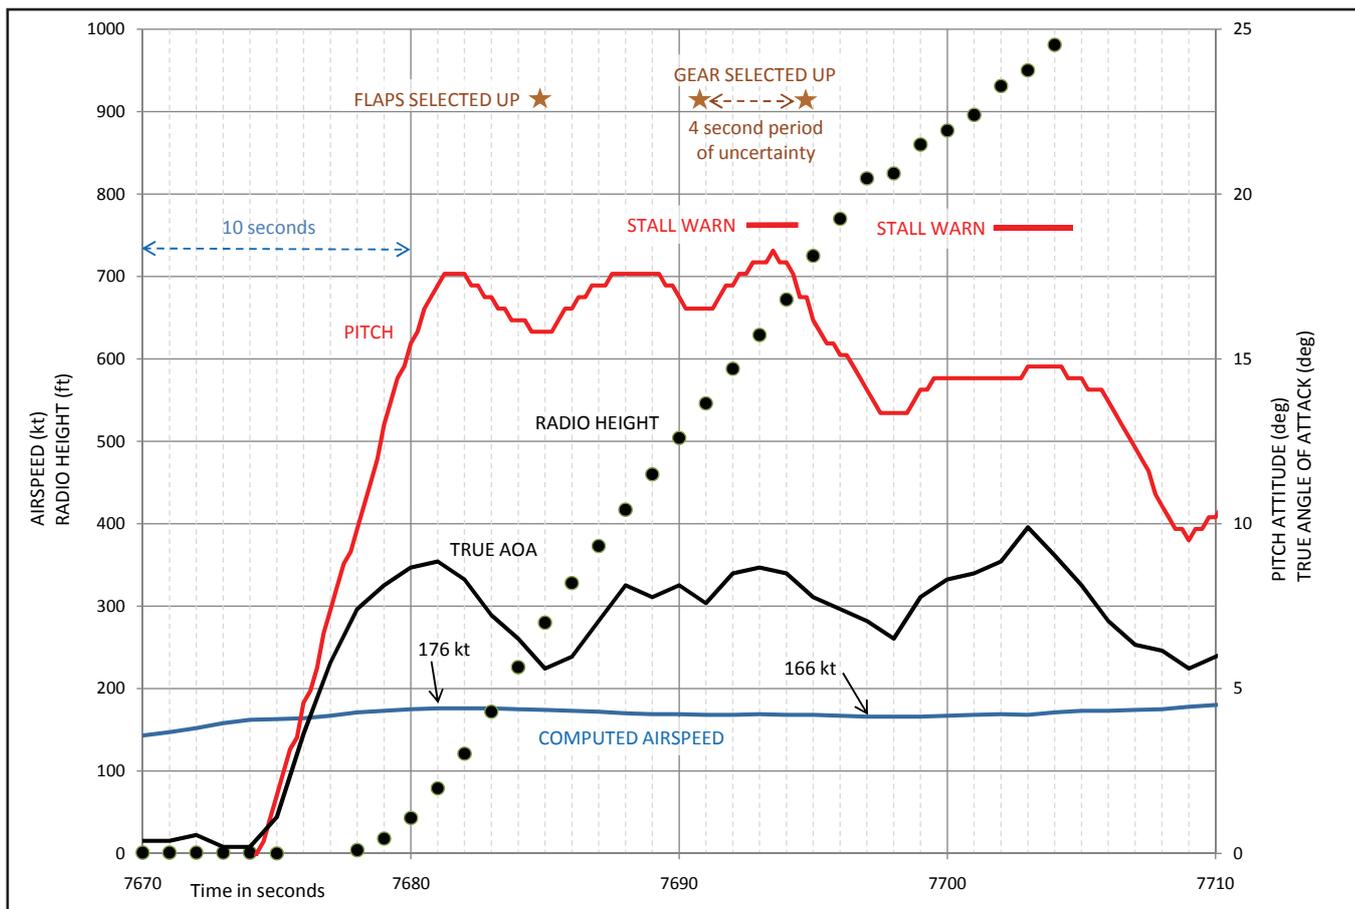
Figure 1

The co-pilot operated the slat/flap lever about eight seconds after takeoff and the slats and flaps started to retract. At this point the true angle of attack (TAOA) was 5.6° and the aircraft was climbing through 280 ft agl. During the following three seconds, the TAOA increased to approximately 8° and, apart from a three-second interlude, remained above 7.5° for the following 18 seconds during which time the slats and flaps fully retracted. The stall warning system operated twice during this period. The airspeed decayed from 176 KCAS to 166 KCAS during the 12 second period after the slats/flaps lever was first moved but increased thereafter. Relevant aircraft parameters are shown in Figure 1.

Flight parameters

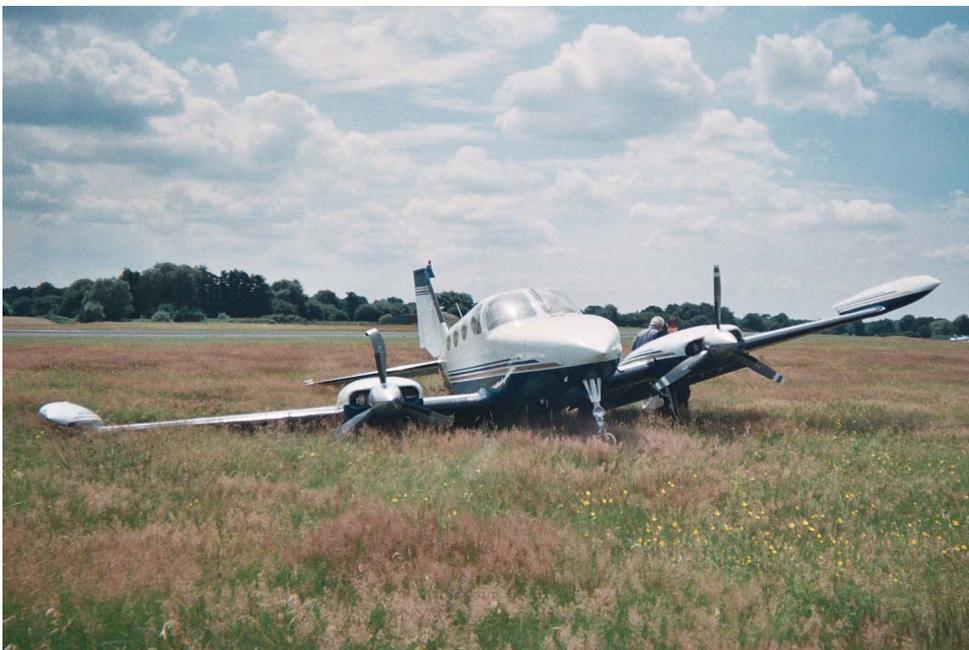
Figure 1

During the landing roll, the aircraft's right main landing gear retracted and the aircraft departed from the right side of the paved runway, damaging the aircraft. The damage sustained by the landing gear components was consistent with the right main landing gear side brace folding, as weight was transferred onto the right main landing gear during the landing. The cause of the landing gear collapse was not positively identified.

The aircraft following the right landing gear collapse

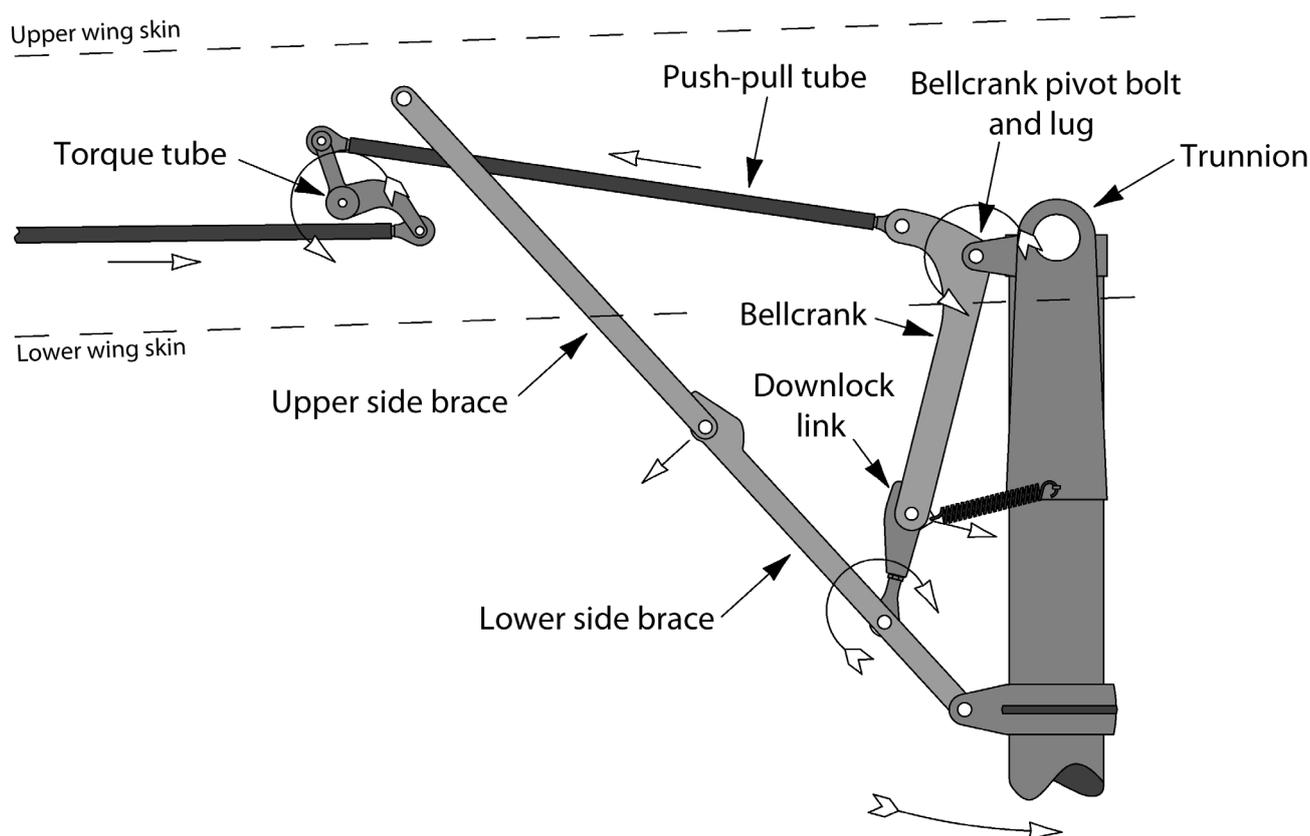
Figure 2

When the main landing gear leg is down and locked, the downlock link and bellcrank should be in an over-centre position, to prevent the side brace from folding. A microswitch, mounted to the downlock link, closes when it is over-centre and illuminates the green DOWN instrument panel light for that landing gear leg.

Schematic of the right main landing gear downlock mechanism, showing direction of motion as the landing gear locks down

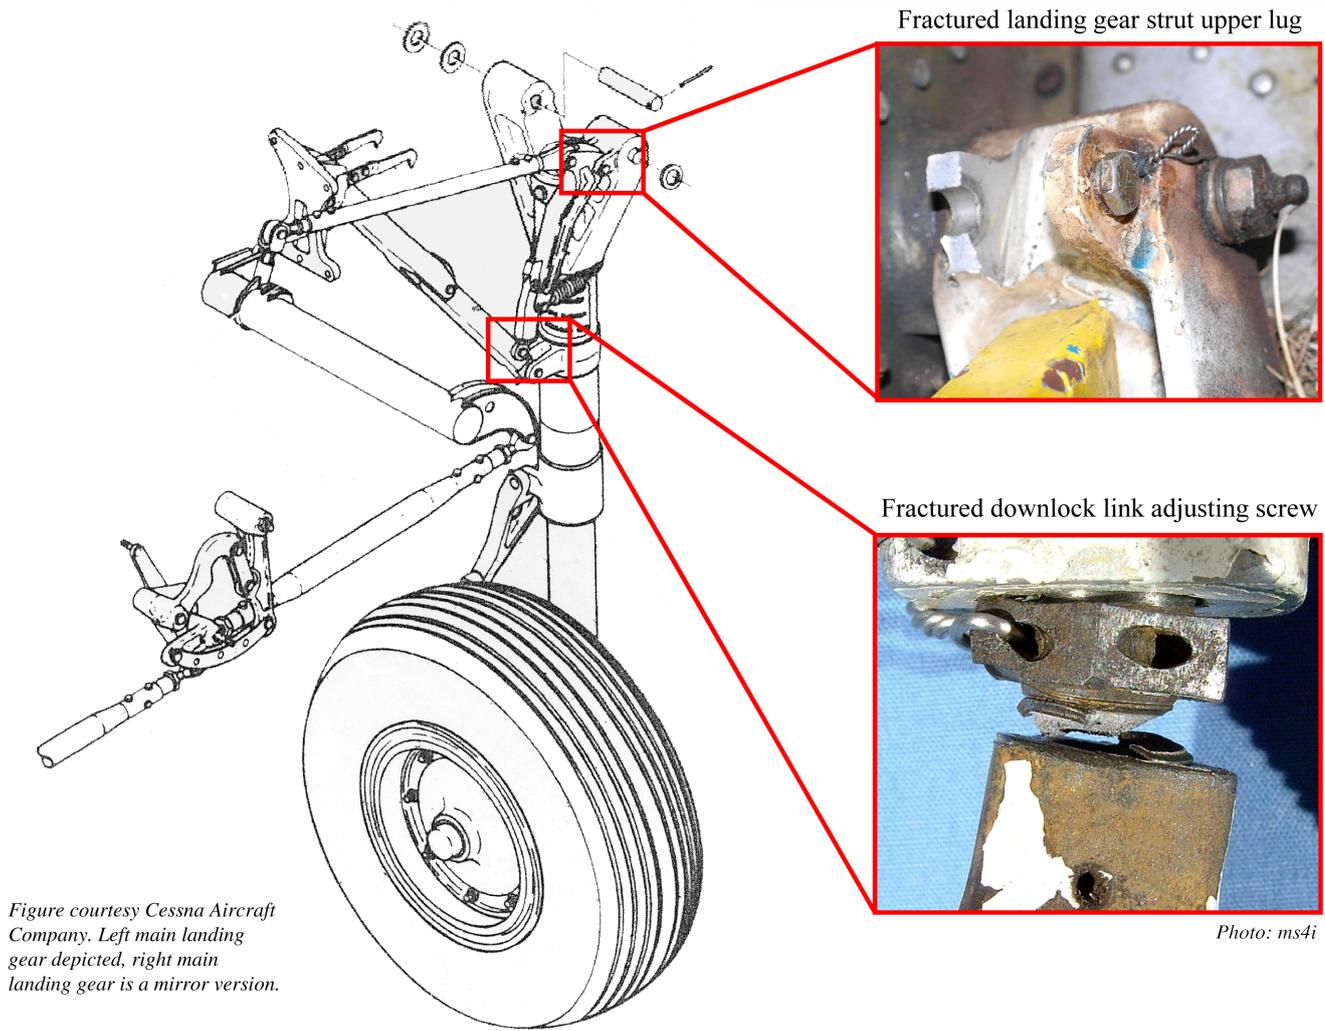
The aircraft sustained damage to its right wingtip and right flap as a result of the landing gear collapse, in addition to damage to the right propeller and shock-loading of the right engine. The right landing gear was inspected and it was apparent that the downlock link had separated from the lower side brace due to fracture of the downlock link adjusting screw (Figure 3). Additionally, the forward lug on the upper landing gear strut, at its attachment to the bellcrank pivot bolt, had broken off and the fracture surface was dull with a rough texture, indicative of tensile overload. The bellcrank pivot bolt had sheared, such that the bellcrank was no longer attached to the landing gear strut.

Figure 3
Location of right main landing gear leg broken components

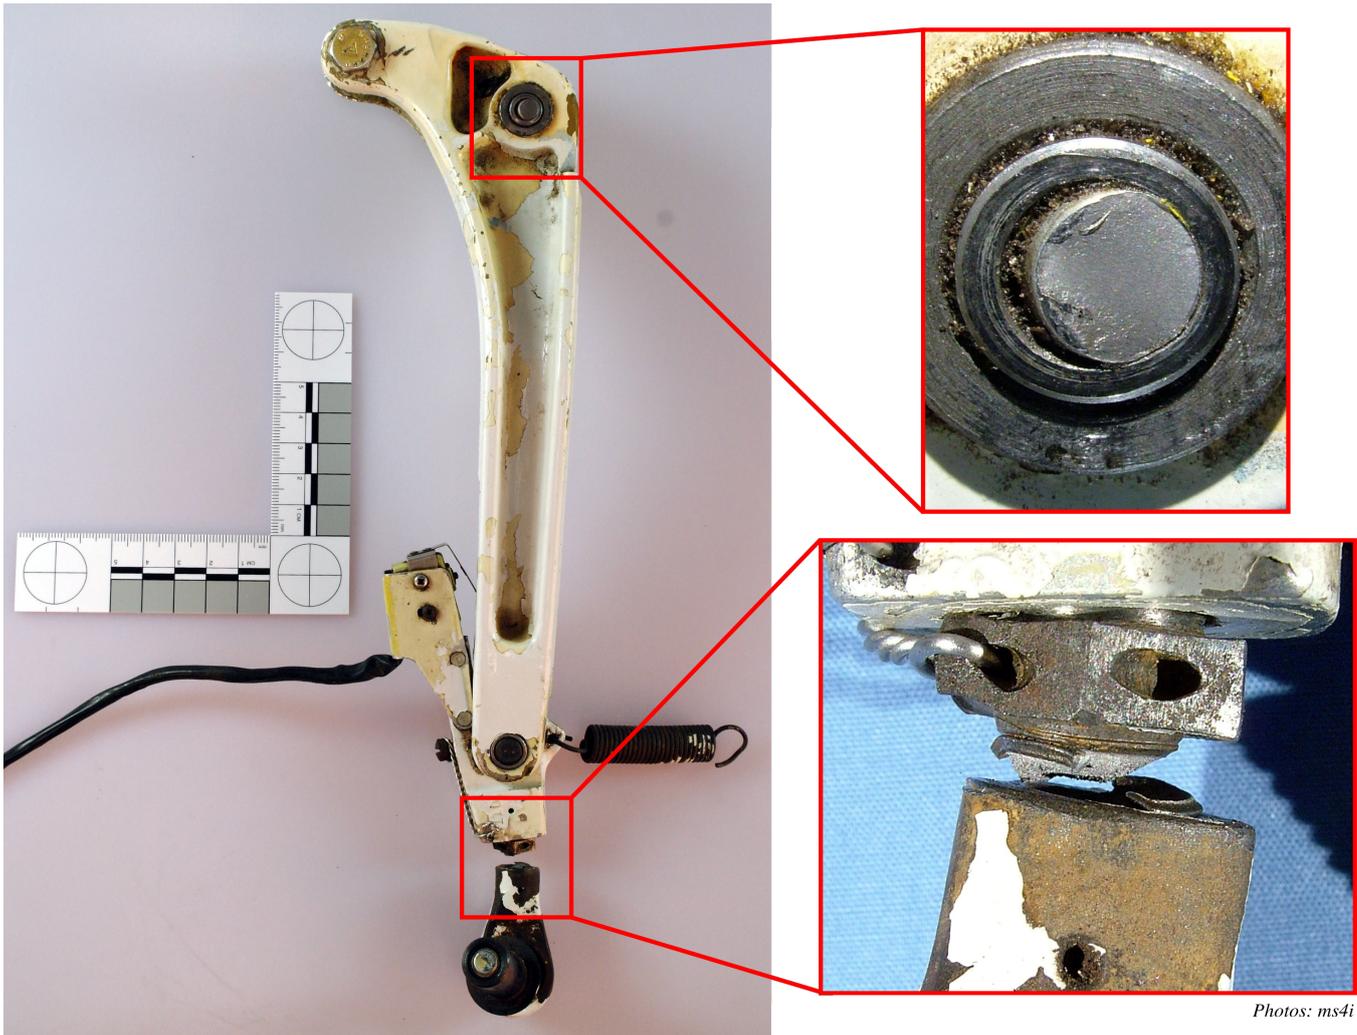
Figure 4

A visual metallurgical analysis of the fractured downlock link adjusting screw and bellcrank pivot bolt was performed by an independent metallurgist (Figure 4), in addition to hardness testing of the adjusting screw material.

The metallurgist concluded that the downlock link adjusting screw had failed in a single, non-reversed, bending overload event. The fracture surfaces did not show any macroscopic evidence of pre-existing cracks, material defects or anomalies associated with crack initiation, and there was no evidence of slow crack growth mechanisms such as fatigue or stress corrosion cracking. The adjusting screw's material was found to

Fracture surfaces of the bellcrank pivot bolt and downlock link adjusting screw

The bellcrank pivot bolt was determined to have failed in single shear, resulting from a single overload event, and the fracture surface did not show any evidence of pre-existing cracking or material defects.

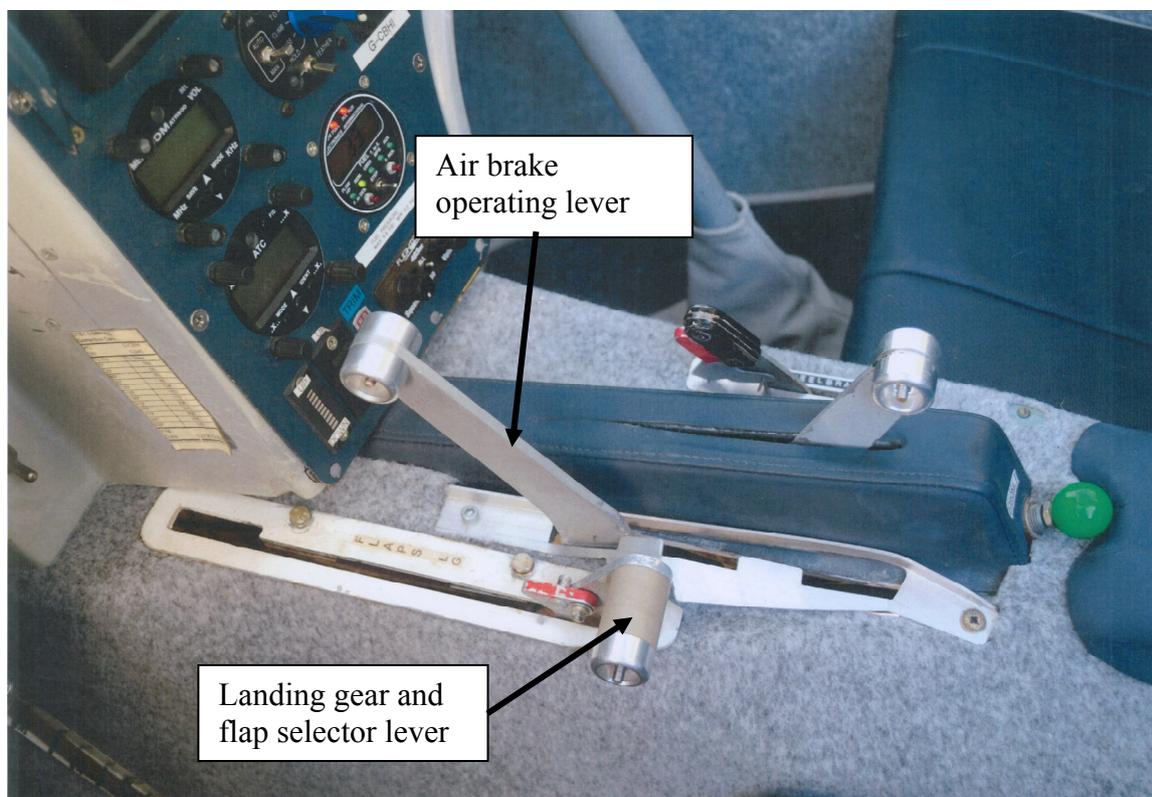
Figure 1

landing gear are operated by a single lever mounted on the centre console located between the seats (see Figure 1). Moving this lever rearward causes the flaps and landing gear to extend. At normal approach speeds, with the flaps retracted, the aircraft adopts a high-nose attitude which reduces the pilot's view of the runway. Selecting the landing gear and flaps to the extended position results in the aircraft adopting a significant nose-down attitude, which alerts the pilot to the fact that the gear has been extended. It was for this reason that it had been perceived that there was no requirement for a gear warning system.

Location of landing gear and flap operating lever

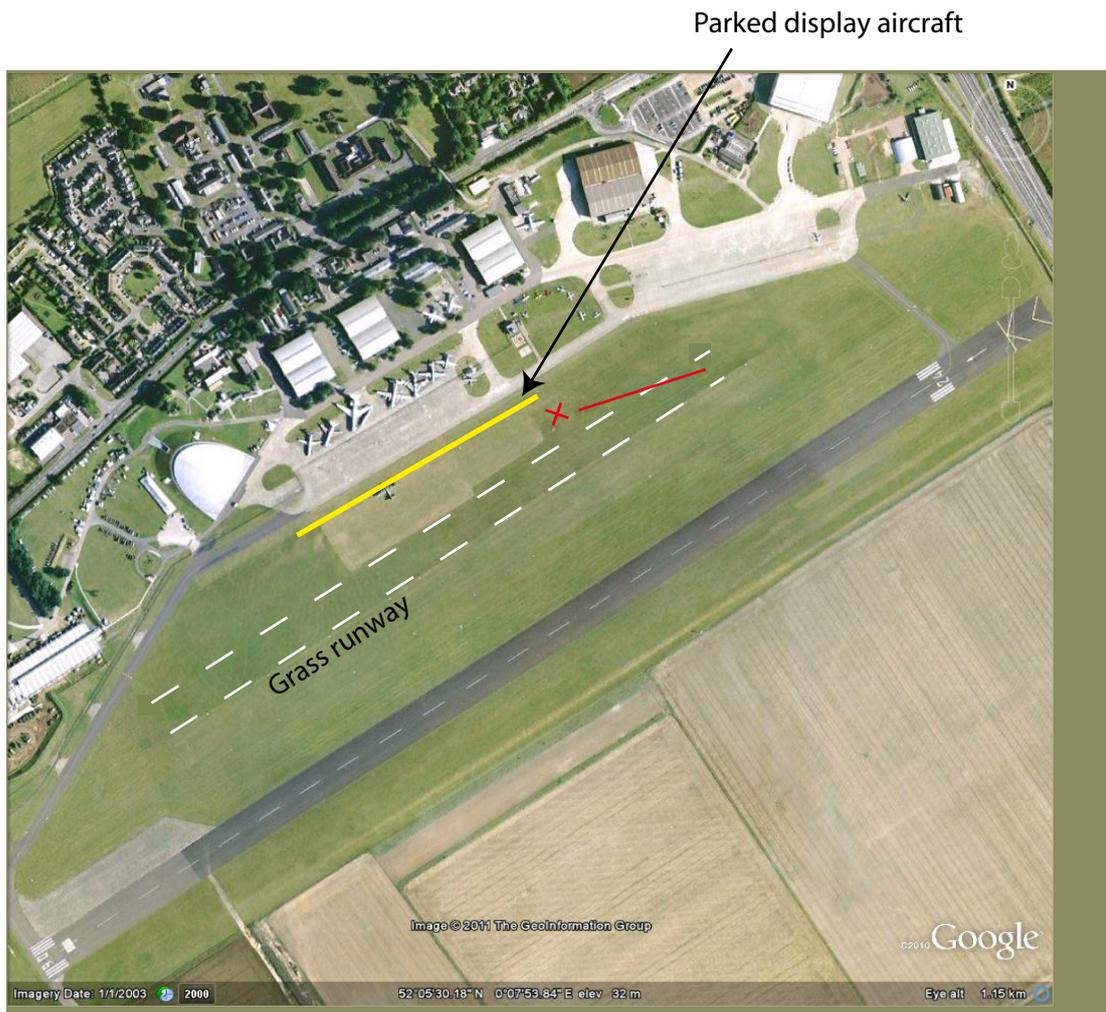
Figure 1

This heading meant that the latter part of the landing roll took the aircraft closer to a line of parked display aircraft, mostly WWII 'warbird' types, which were parked with their tails towards the runway. As he passed behind a Hawker Sea Fury, its engine was started and the pilot of SE-XXZ stated that the propeller wash caused him to lose directional control. The left landing gear tyre rolled off the rim, which dug into the ground and caused the aircraft to pitch forward coming to rest with the tail upright. The pilot was uninjured and was able to evacuate the aircraft with the assistance of the first people to arrive at the location.

Landing roll of SE-XXZ interpreted from a sketch provided by the pilot
