CONTENTS

AAIB Special Bulletins and Interim Reports

Aircraft Type and Registration:	EC225 LP Super Puma, G-REDW
No & Type of Engines:	2 Turbomeca Makila 2A1 turboshaft engines
Year of Manufacture:	2009 (Serial no: 2734)
Date & Time (UTC):	10 May 2012 at 1114 hrs
Location:	20 nm east of Aberdeen
Type of Flight:	Commercial Air Transport (Passenger)
Persons on Board:	Crew - 2 Passengers - 12
Injuries:	Crew - None Passengers - 2 (Minor)
Nature of Damage:	Salt water immersion
Commander's Licence:	Airline Transport Pilot's Licence
Commander's Age:	40 years
Commander's Flying Experience:	3,060 hours (of which 2,740 hours were on type)
Information Source:	AAIB Field Investigation

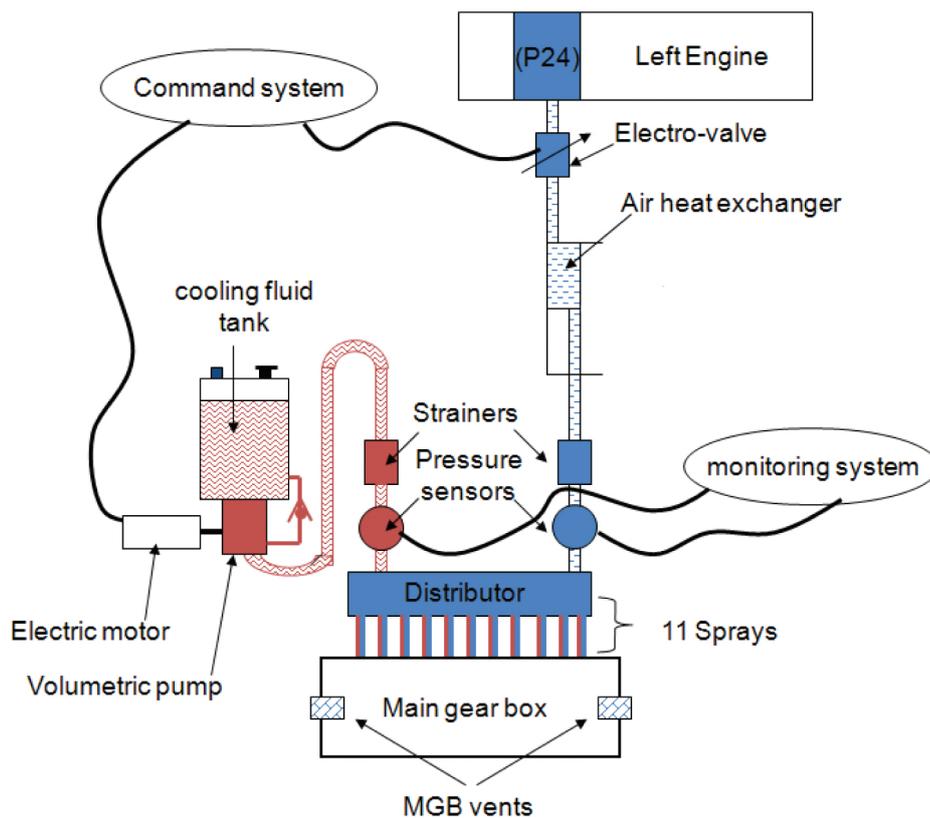
Figure 1

emergency lubrication system (see Figure 1). The latter comprises: a bleed air supply from the left engine, a Hydrosafe 620 supply from an 11 litre reservoir, a series of small pipes around and inside the MGB, to deliver the Hydrosafe 620 in a spray, and monitoring and command systems on a dedicated Printed Circuit Board (PCB).

When the emergency lubrication system is activated an electro-valve, called the P2.4 valve, opens and bleed air from the left engine enters the system, after passing through an air heat-exchanger. At the same time, an electric pump supplies Hydrosafe 620 from the reservoir. There are two similar sensors that monitor the pressure in the Hydrosafe 620 pipes and bleed air lines; these sensors are mounted on the MGB. A MGB EMLUB caption will illuminate if low pressure is detected in either the Hydrosafe 620 pipes or the bleed air lines. This warning is inhibited for approximately 30 seconds after the system is activated, to allow the system to reach a steady state.

Schematic of the Emergency Lubrication System

The evidence indicates that the emergency lubrication system had activated and remained operating for the remainder of the flight. Thus the system had given the crew a false warning of system failure. This warning resulted in the crew ditching the helicopter in the sea.

It is recommended that the European Aviation Safety Agency requires Eurocopter to review the design of the main gearbox emergency lubrication system on the EC225 LP Super Puma to ensure that the system will provide the crew with an accurate indication of its status when activated.

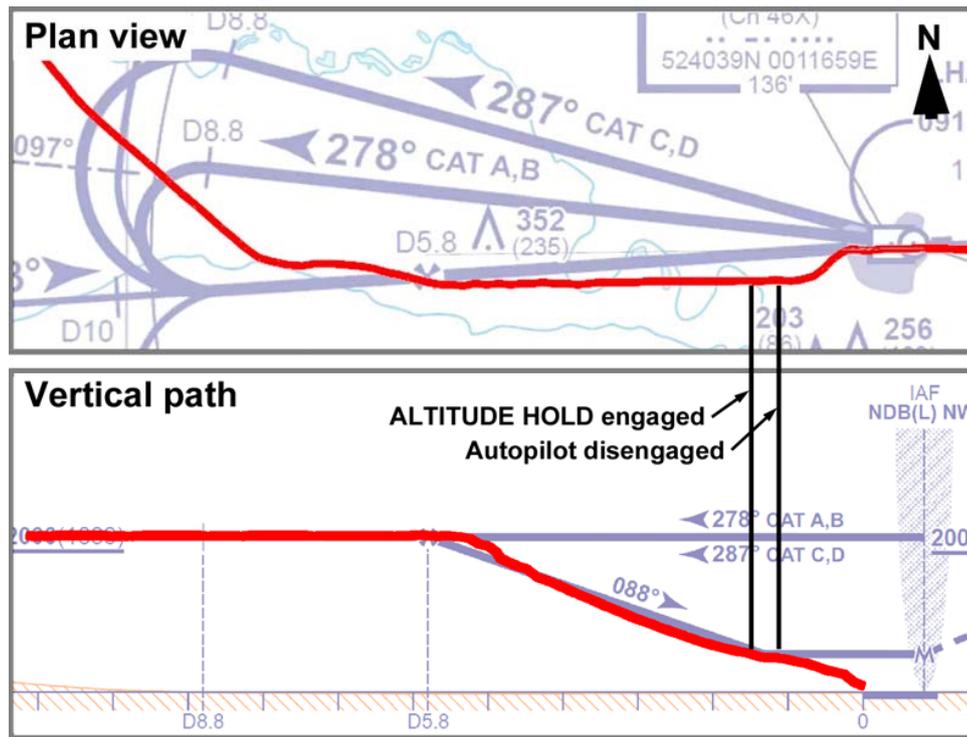
Figure 1

Excerpt from NDB/DME approach plate, Runway 09 at Norwich, with flight path overlay

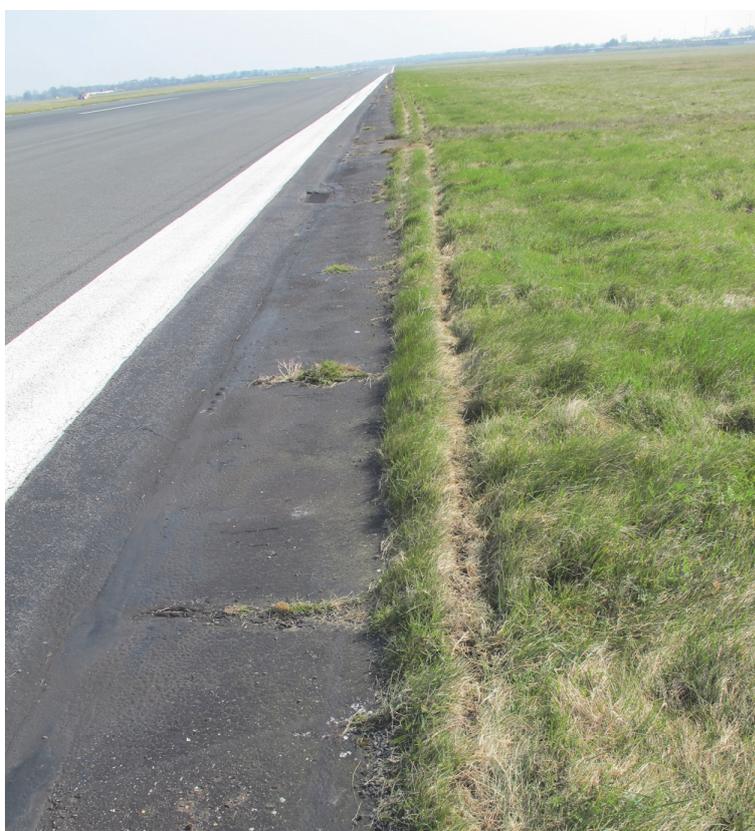
Figure 2

The airfield was inspected by the airport operator and the AAIB. Tyre marks from G-BWWT were found on the runway and grass, with a broken lens from a runway edge light. Tyre tracks from the right landing gear wheels are shown at Figure 2.

Photograph of runway excursion by right main landing gear

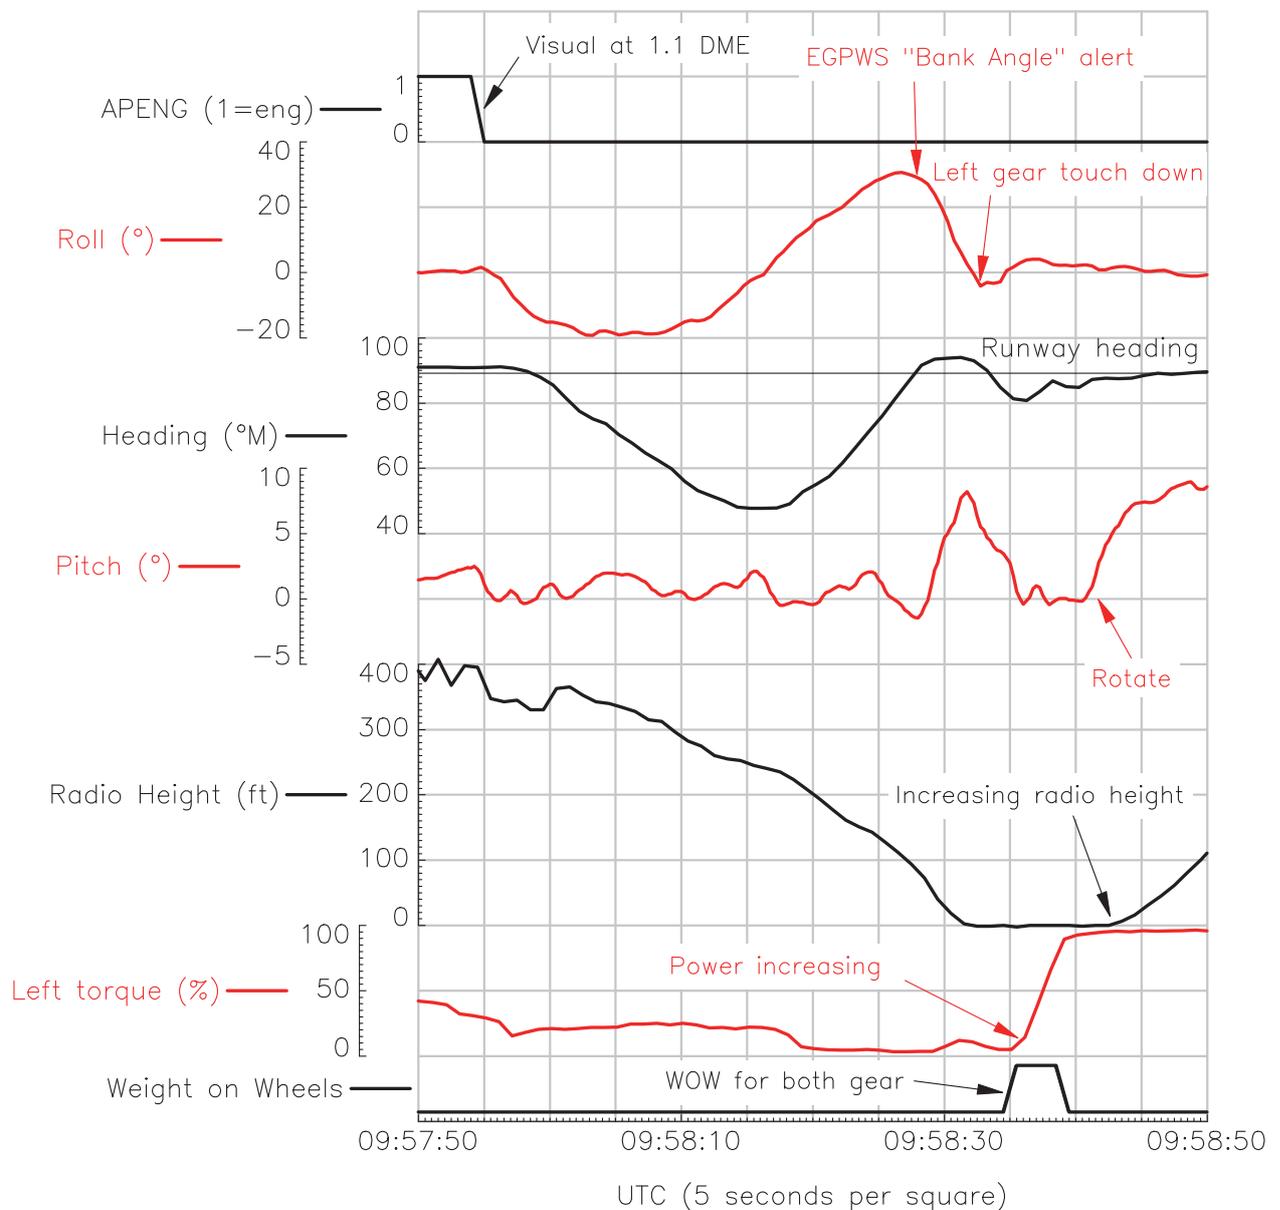
Figure 3

The aircraft was fitted with an FDR and a CVR but the CVR evidence was over-written before the AAIB had been notified of the incident. The FDR recording captured the event flight, including the first approach, shown in Figure 3.

The recordings showed that the A/P was engaged with a lateral mode of HEADING SELECT for the whole approach. The A/P pitch mode transitioned from ALT HOLD to VERTICAL SPEED for the descent but at approximately 460 ft aal switched back to ALT HOLD. After a further 10 seconds the autopilot was disengaged and control inputs to correct the aircraft's position were initiated. This is considered to be the point at which the crew became visual with the runway.

FDR plot of final approach
