CONTENTS

SPECIAL BULLETINS

COMMERCIAL AIR TRANSPORT

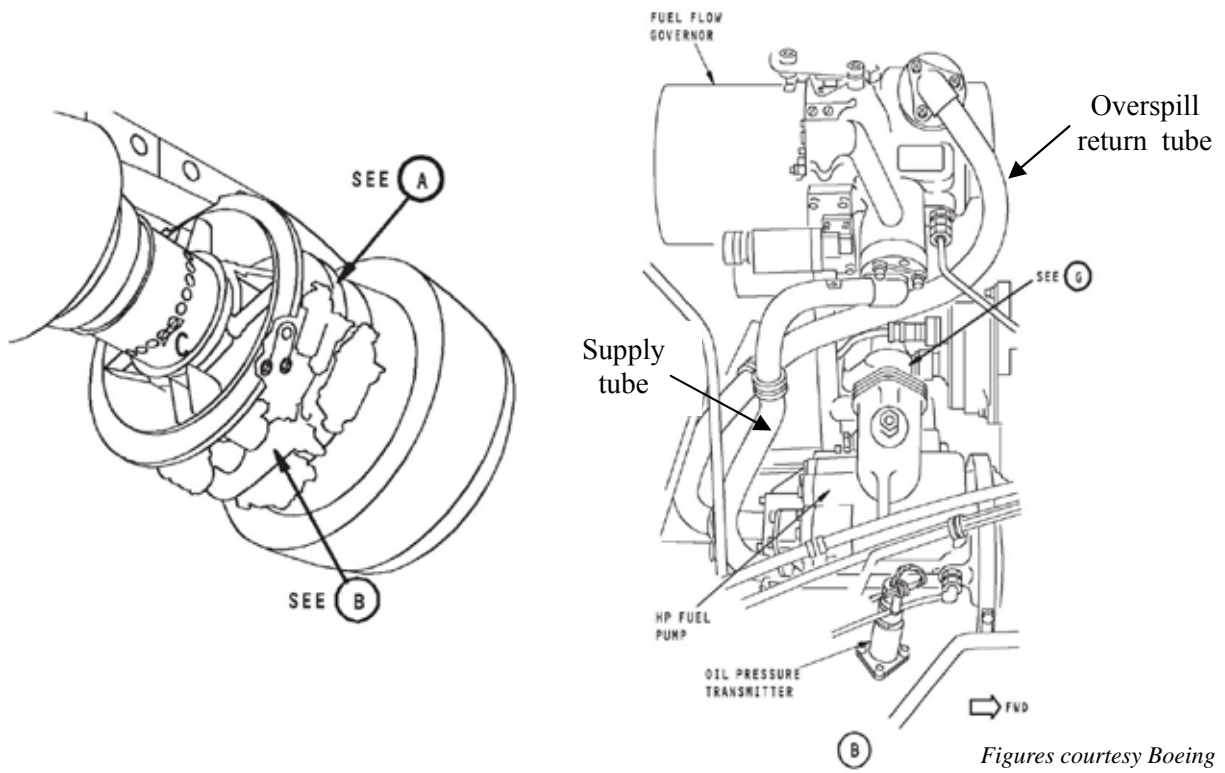
Figure 1

The operator's maintenance engineer traced the fuel leak to the seal ring between the HP fuel pump and the fuel flow governor (FFG) to HP fuel pump overspill return tube on the left-hand engine (shown in Figures 1 and 2). He therefore replaced this seal ring on both engines in accordance with the aircraft maintenance manual and a second maintenance engineer conducted a duplicate inspection, following which both engines were ground run at maximum static EPR to check for leaks. No fuel leaks were observed during this test and the aircraft was released to service.

Location of the HP fuel pump and FFG on the RB211-535E4 engine

In response, the engine manufacturer introduced a further SB, RB.211-73-G230, in November 2009 that increased the width of the seal ring groove from 2.60 mm to 4.15 mm. No engines incorporating this SB have subsequently experienced fuel leaks at the HP fuel pump fuel tube couplings. The engine manufacturer comments that compliance guidance contained in this SB currently recommends embodiment of this modification when the engine is disassembled for refurbishment or overhaul. The modification is currently optional on-wing, when the parts require renewal or when the fuel tube connections are disturbed during maintenance.

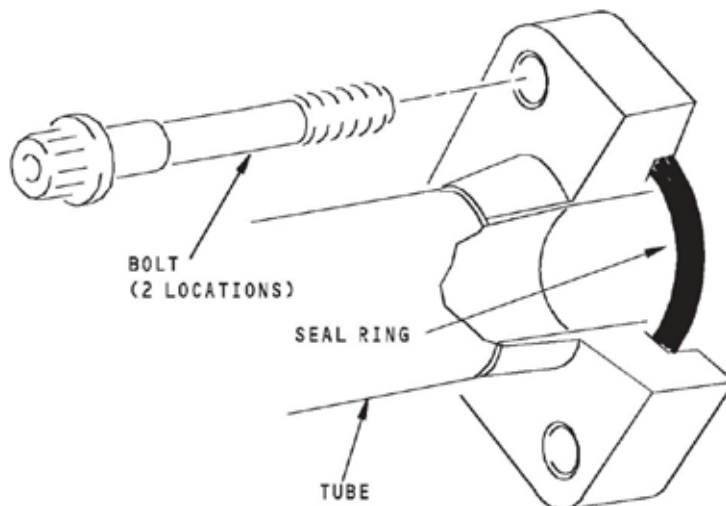
Figure 2

Investigation undertaken by the engine manufacturer determined that the width of the seal ring groove in the fuel tube end adapter was insufficient to allow the seal ring to seat properly in the groove when the joint was compressed during torque tightening of the assembly. If the seal ring did not seat correctly, it was possible for it to become pinched at the corners of the groove. The action of vibration and fuel pressure fluctuations caused portions of the pinched seal ring to erode, resulting in a loss of sealing capability.

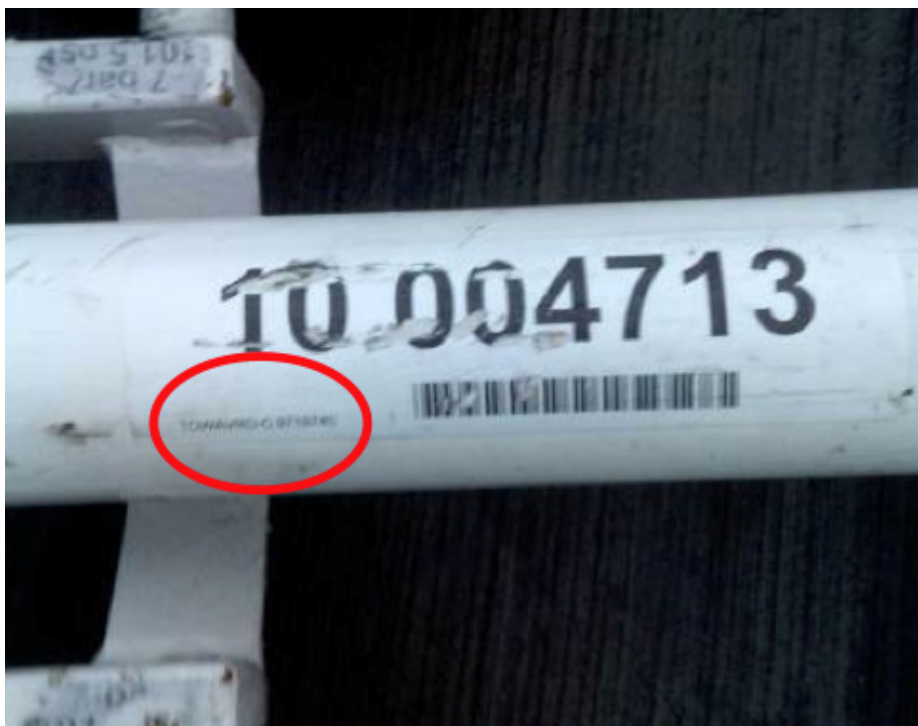
Figure 2

Avro RJ towbar markings circled
(*photograph courtesy of ground handling company*)

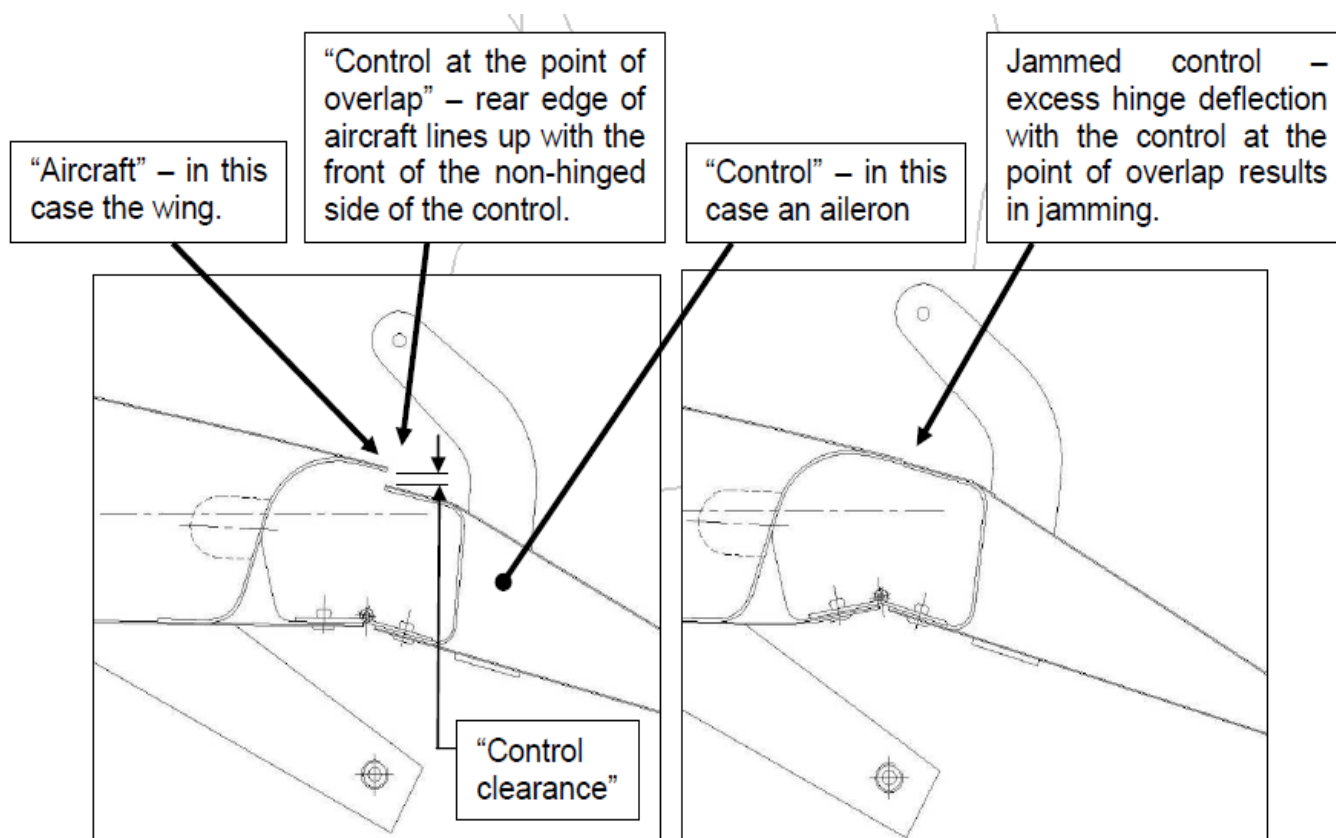
Figure 1 shows a generic control surface and how hinge deflection can result in a jammed condition. In this example it can be seen that a lack of clearance will result in rubbing, with a jam occurring when the surface moves to the point where there is no longer any overlap.

Illustration of a normal and jammed control, taken from JSB 019-2

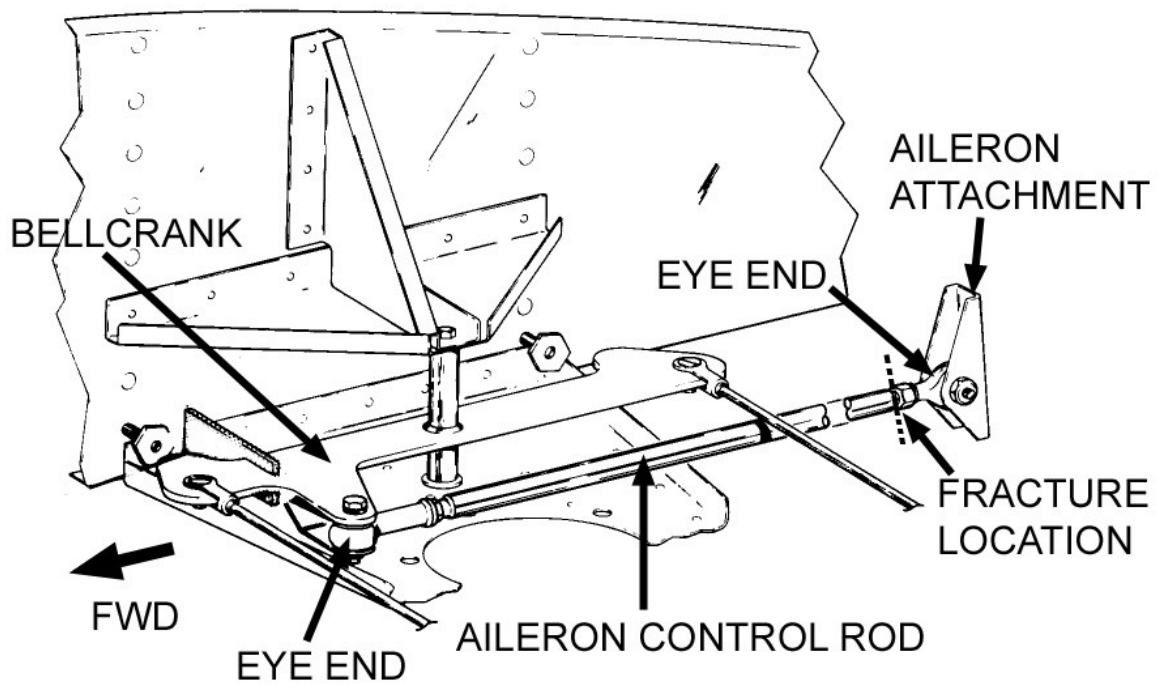
Figure 1

Shortly after departure the pilot noticed a loss of aileron control and made an uneventful diversion and landing using the rudder to control bank and heading. The eye end on the right aileron control rod had failed at the aileron due to reverse bending fatigue. This was caused by the bearing in the eye end having seized, due to corrosion and an absence of lubrication.

Location of aileron control rod and fractured eye end
