CONTENTS

SPECIAL BULLETINS

SERIOUS INCIDENT

Aircraft Type and Registration:	ATR 72-202, EI-SLG	
No & Type of Engines:	2 x Pratt and Whitney PW124B turboprop engines	
Year of Manufacture:	1990	
Date & Time (UTC):	15 March 2011 at 2130 hrs	
Location:	Near Edinburgh Airport	
Type of Flight:	Commercial Air Transport (Non-Revenue)	
Persons on Board:	Crew - 2	Passengers - None
Injuries:	Crew - None	Passengers - N/A
Nature of Damage:	None	
Commander's Licence:	Air Transport Pilot's Licence	
Commander's Age:	45 years	
Commander's Flying Experience:	TBA	
Information Source:	AAIB Field Investigation

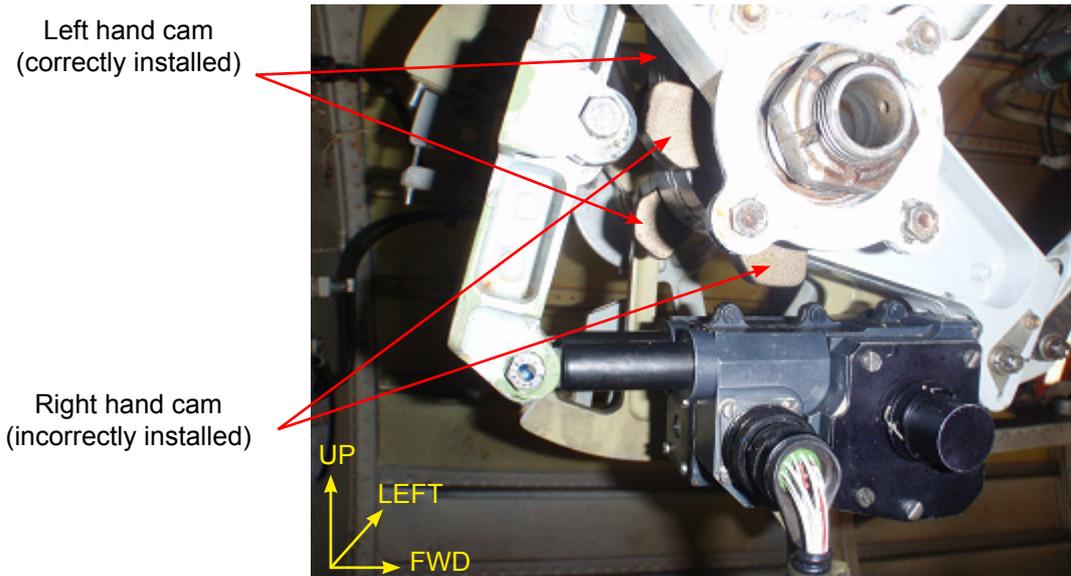
Figure 3

The factors that led to the incorrect installation of the cam and the failure to identify this condition prior to flight are the subject of the ongoing investigation.

The rudder rear quadrant shaft on which the cams are mounted is a splined shaft; a master locating spline ensures correct alignment of all components. Teeth on the internal bore of the cams correspond to the profile of the splined shaft, with a missing tooth in the position of the master spline. During reassembly, the orientation of right hand cam was transposed through 180° (such that the inboard face of the cam was facing outboard). As the missing tooth on the cam is not located centrally between the two cam lobes, but is offset by

Travel Limitation Unit with right hand cam incorrectly installed – rudder in neutral position
(Note that the lobes of the right hand cam are not aligned with the lobes of the left hand cam and that the right hand roller is facing the upper lobe of the right hand cam)

It is recommended that ATR immediately informs all operators of ATR aircraft equipped with a Travel Limitation Unit that it is possible to install the cams on the rear rudder quadrant shaft in the incorrect orientation.

It is recommended that ATR amends all relevant Aircraft Maintenance Manual tasks to include a warning to highlight that the cams on the rear rudder quadrant shaft can be installed incorrectly.

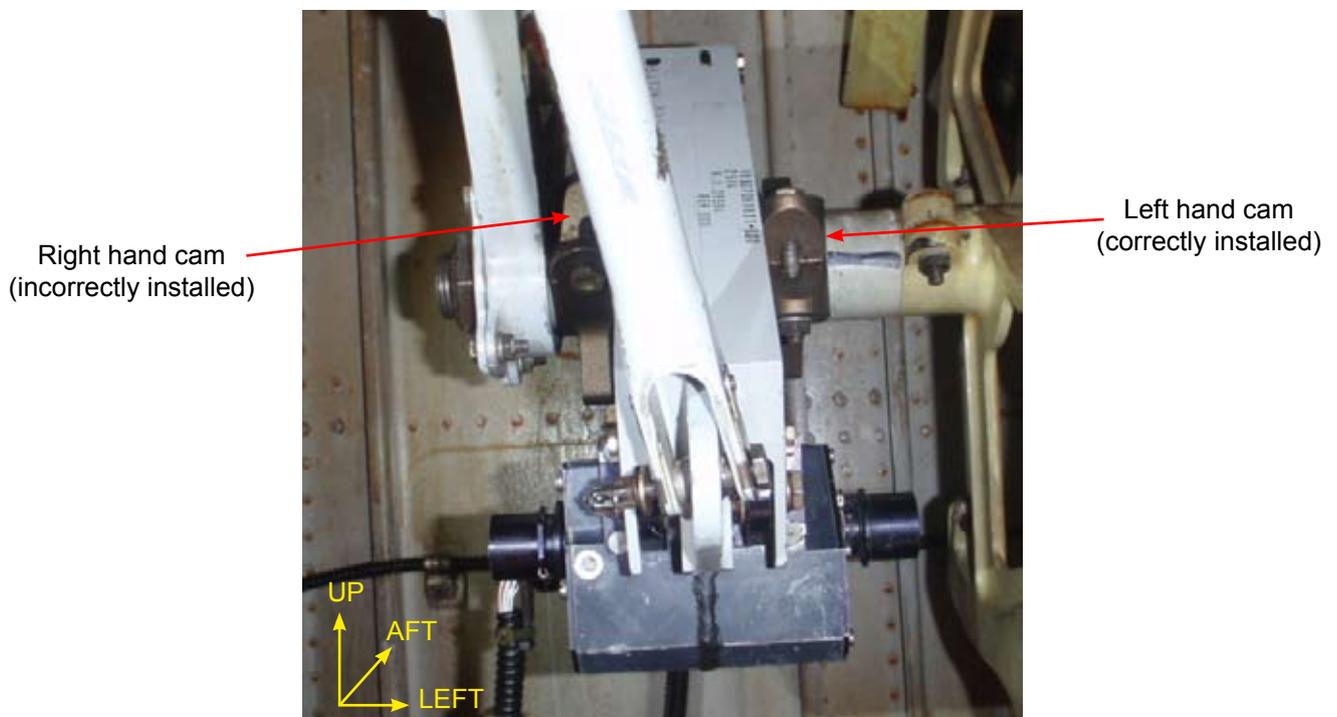
Figure 4

View looking aft on Travel Limitation Unit with right hand cam incorrectly installed - rudder in neutral position

engaging in the vee groove of the cams and caused an uncommanded rudder input and corresponding rudder deflection.

When the AMM operational test was performed with the right hand cam incorrectly installed, rudder pedal travel was found to be restricted in an asymmetric sense. A FLT CTL fault light was generated only if the PTT button was depressed for a minimum of 25 seconds. The AMM task does not state how long the test button should be depressed.

It is recommended that ATR amends the Aircraft Maintenance Manual task '*Operational Test of the Rudder Travel Limitation Unit*' to state that: (1) the test should be carried out for a minimum of 30 seconds and (2) should an asymmetric restriction of the rudder pedals be detected or if the FLT CTL light illuminates, further inspection of the TLU system should be conducted.

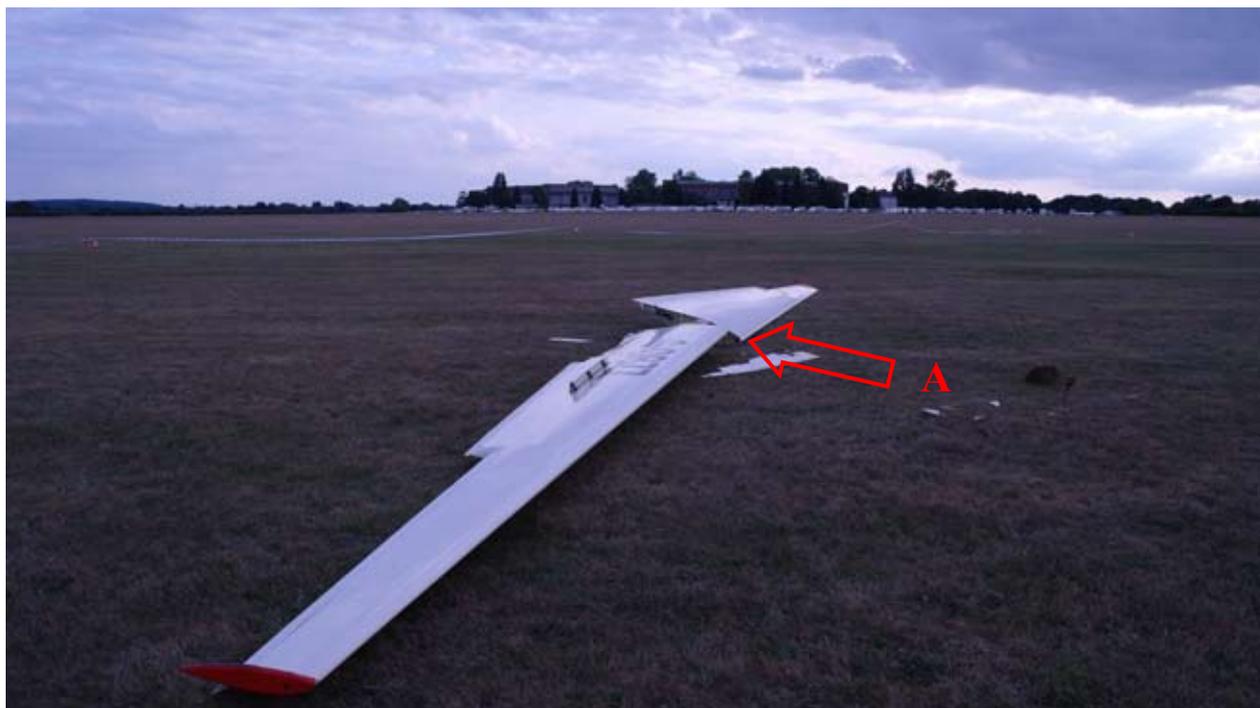
The wings (Figure 7), which were still attached to each other, were largely intact except for a 2.15 m section of the left wing inboard trailing edge, which had detached on impact with the ground. Examination of the wing root fitting in the as-found inverted position, revealed that the lower bevel bolt was only partially engaged in the lower right wing attachment lugs and the lower left wing attachment lug was disengaged from the lug stack (Figures 8a and 8b).

Figure 7
G-DBZZ Wing assembly (inverted)

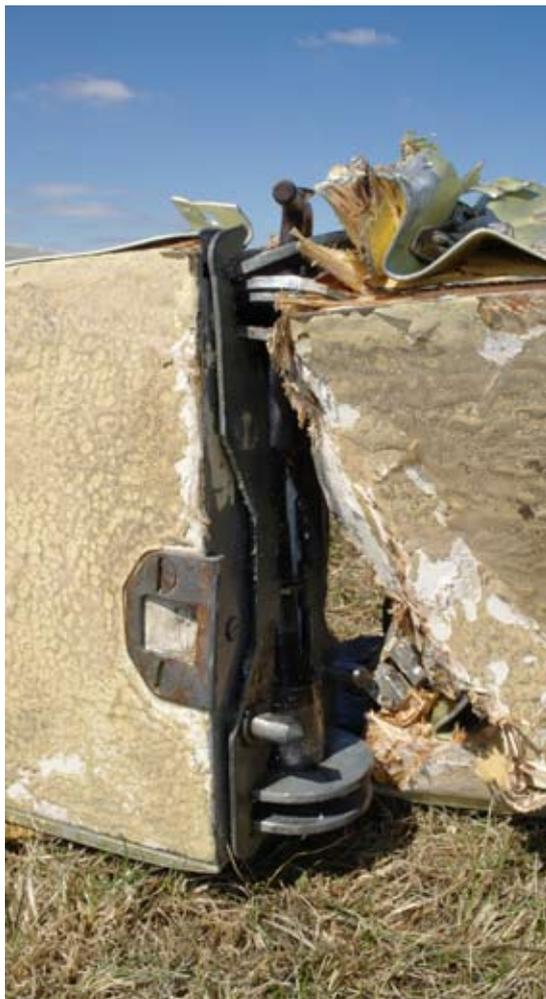
Figure 9

diameter of the threaded screw and locked in position (Figure 9). Both the T-wrench and the threaded screw of the wing main fitting were distorted where they passed through the upper bevel bolt and lug stack.

It was noted that the upper and lower bevel bolts had not expanded symmetrically along the threaded screw and the central collar of the threaded screw had been dislodged from the cut-out in the guide plates.

Wing main fitting in correct orientation

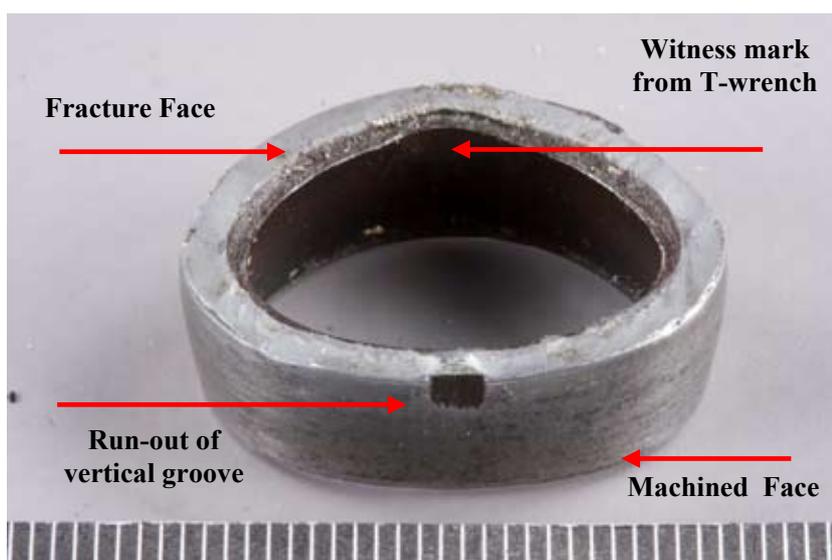
Figure 10

It was noted that the inner diameter of the sheared section exhibited an area of mechanical damage (Figure 10), which is consistent with contact with the end of the T-wrench during the failure of the bevel bolt.

Fractured section of lower bevel bolt
