CONTENTS

COMMERCIAL AIR TRANSPORT

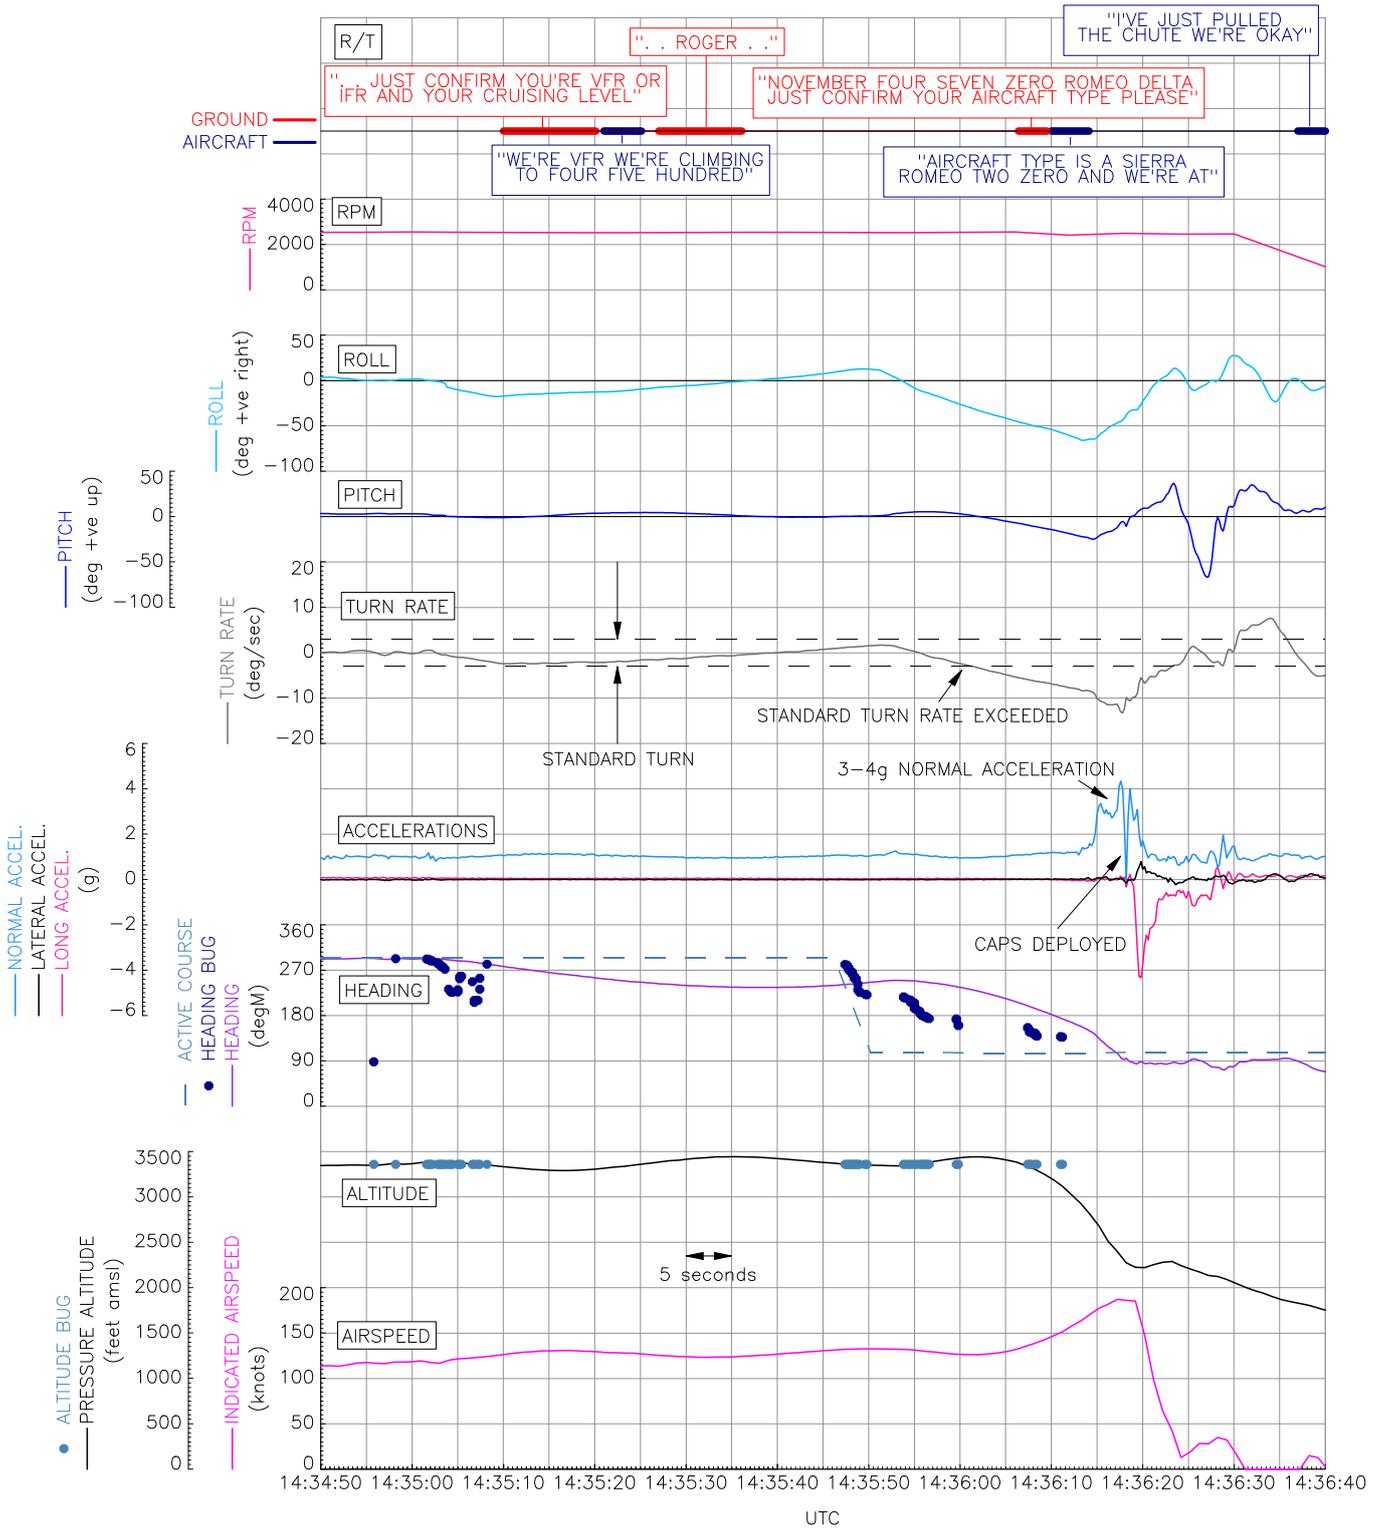
Between times 1434:55 hrs and 1436:15 hrs, the aircraft’s flight path and attitude were not stable.

The altitude climbed gradually by about 50 ft while oscillating two and a half times through ± 75 ft, with corresponding oscillations in pitch ($\pm 3^\circ$) and airspeed (± 5 kt and increasing by 10 kt). The roll was less oscillatory (and also not in phase with the pitch oscillations), initially rolling to 18° left wing down then to 13° right wing down, and then to the left again.

Figure 3
Salient recorded parameters from the PFD and MFD from top of climb to the CAPS deployment

A corresponding heading change can be seen as the aircraft initially turned to the left from 295°M through 50°, at less than the standard turn rate of 3°/sec. As the aircraft started to turn there were a number of changes to the heading bug over a period of seven seconds. On reaching 235°M in the left turn, the aircraft started a similarly gentle turn to the right through 15° during which the active course changed from 295°M to 197°M. The heading bug also changed in stages to 221°M. The aircraft then started another turn to the left, during which the turn rate exceeded the standard value and continued to increase. A similar divergence was recorded in the aircraft's attitude as it banked left and pitched down, with increasing airspeed and loss in altitude. Further heading bug changes were recorded, to a final value of 137°M.

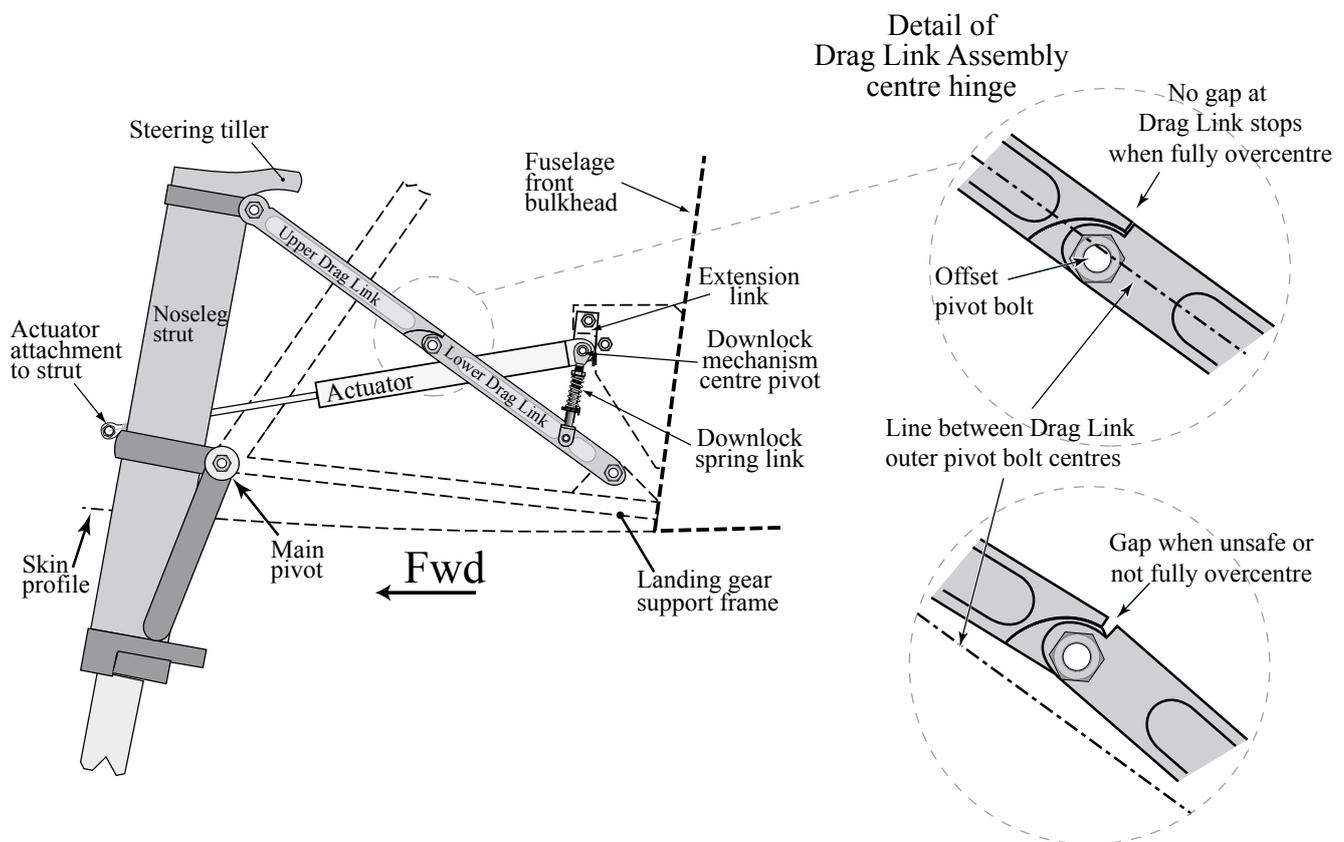
Figure 1

downlock mechanism. There are no locking hooks for either position. When the NLG is extended and under load it is prevented from collapsing by the drag link assembly (Figure 1). When the NLG is fully extended, the offset drag link centre pivot is below the centre line of the two end pivots, preventing the drag link assembly from collapsing when the landing gear is under load.

The geometry of the NLG is such that the aircraft’s weight on the nosewheel applies a compressive load to the drag link assembly, which will tend to drive it more firmly into the safe over-centre condition when the gear is properly extended. However, should the drag link assembly be in an under-centre condition, the applied load will tend to cause the drag link to fold and the gear to retract.

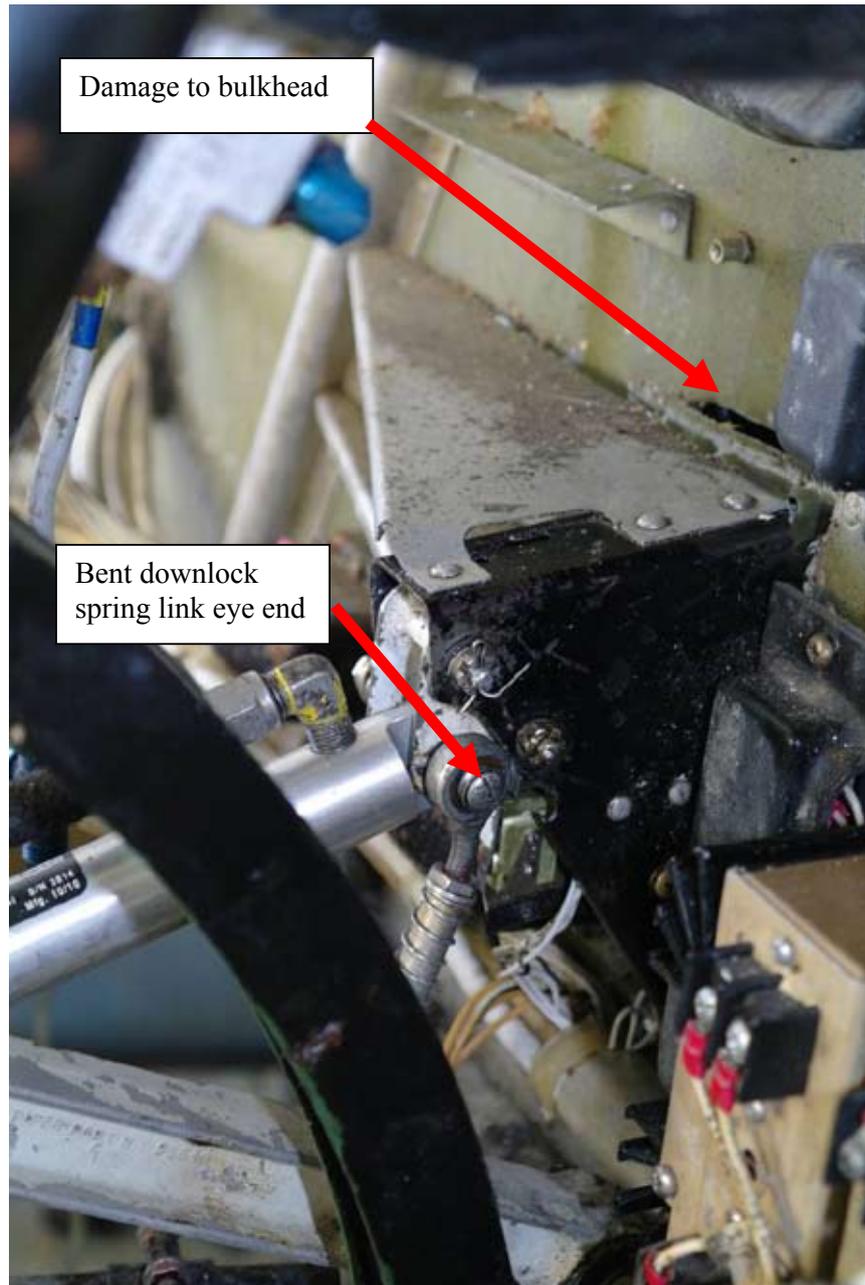
Figure 2

After the nose of the aircraft was raised, the nose landing gear was pulled into the locked-down position. It was then apparent that the upper eye end of the downlock link (Figure 1) was severely distorted, with additional damage to the front bulkhead, which can be seen in the photograph at Figure 2.

It is likely that the damage to the bulkhead and eye end was the result of the drag brace folding during the collapse, which would transfer the loads from the nose leg into the actuator and its attachment, at its upper end, to the bulkhead.

View of upper end of actuator attachment to structure, showing damage to bulkhead and bent eye end of downlock link

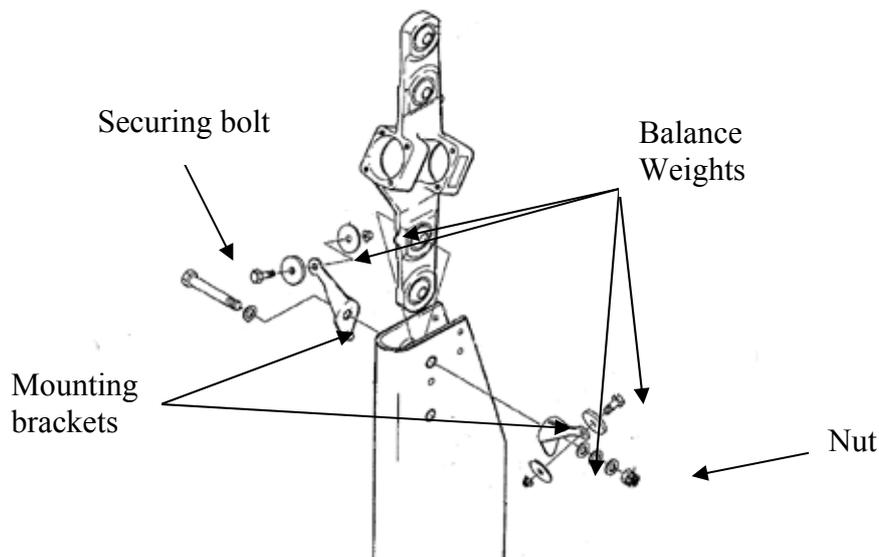
Figure 1

PAN and made a precautionary landing on an area of grass beside the runway at London City Airport. An inspection of the helicopter revealed that a tail rotor balance weight assembly had detached from one of the tail rotor blades. The balance weight assembly, together with a fractured section of its securing bolt was discovered close to the helicopter.
