CONTENTS

(ALL TIMES IN THIS BULLETIN ARE UTC)

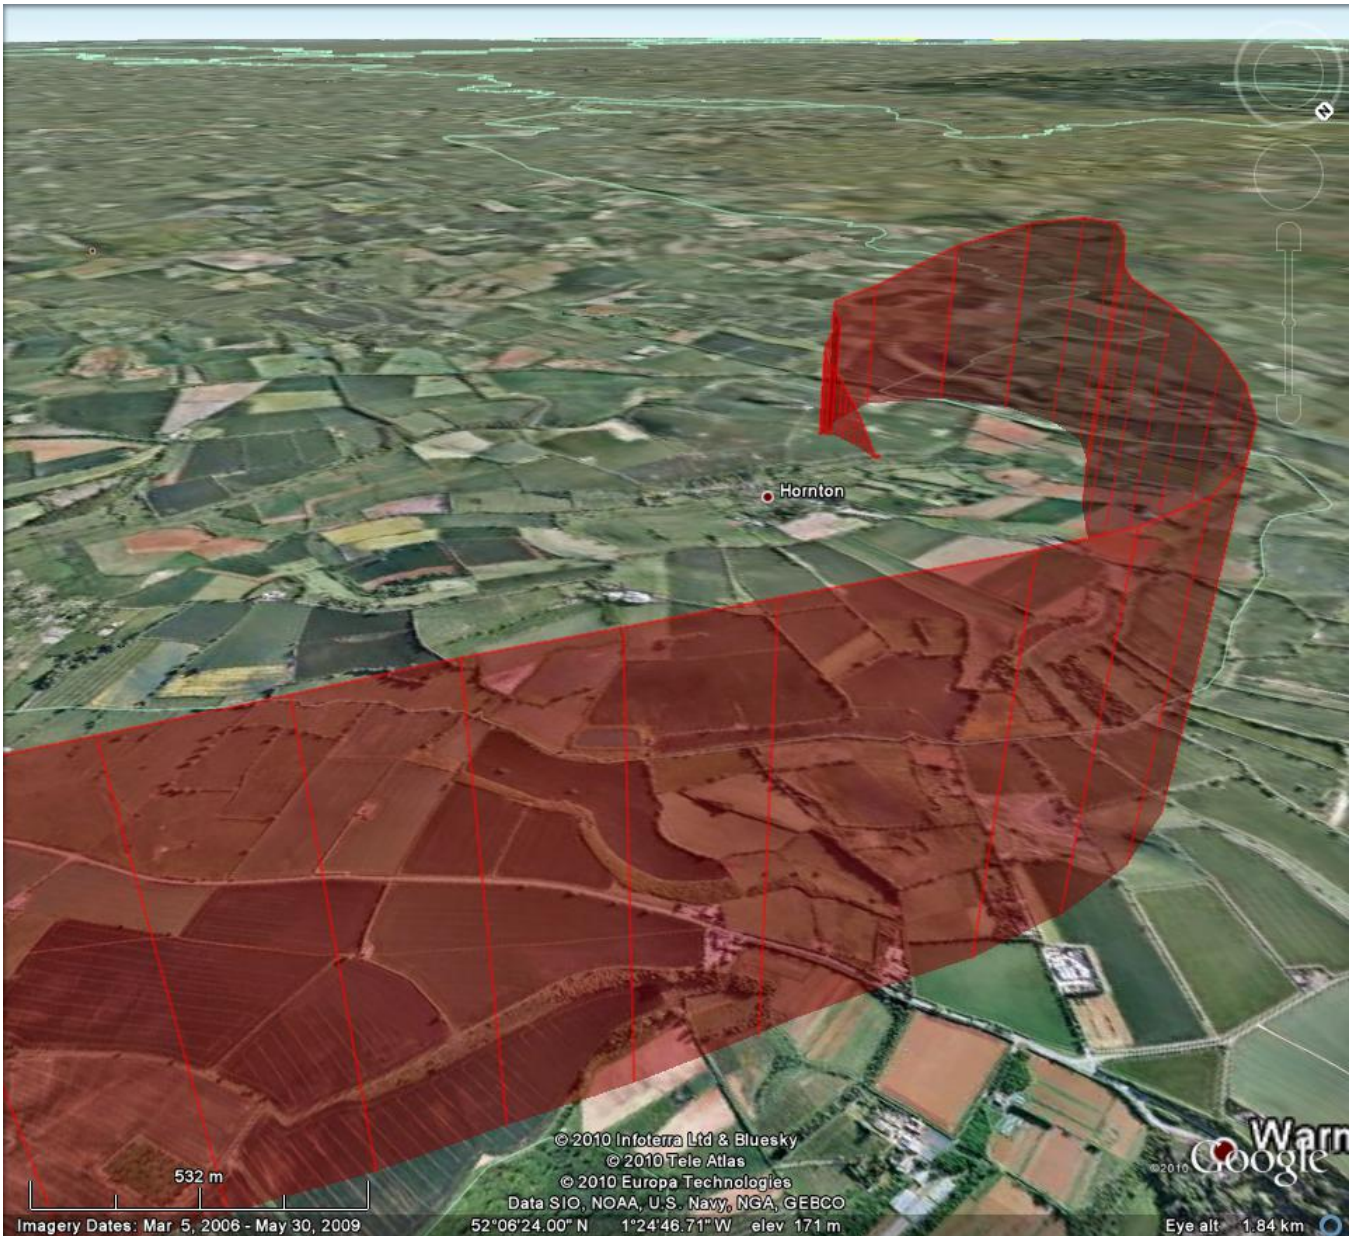
Figure 1

3D view of the latter part of the aircraft’s track from GPS position and recorded pressure altitude

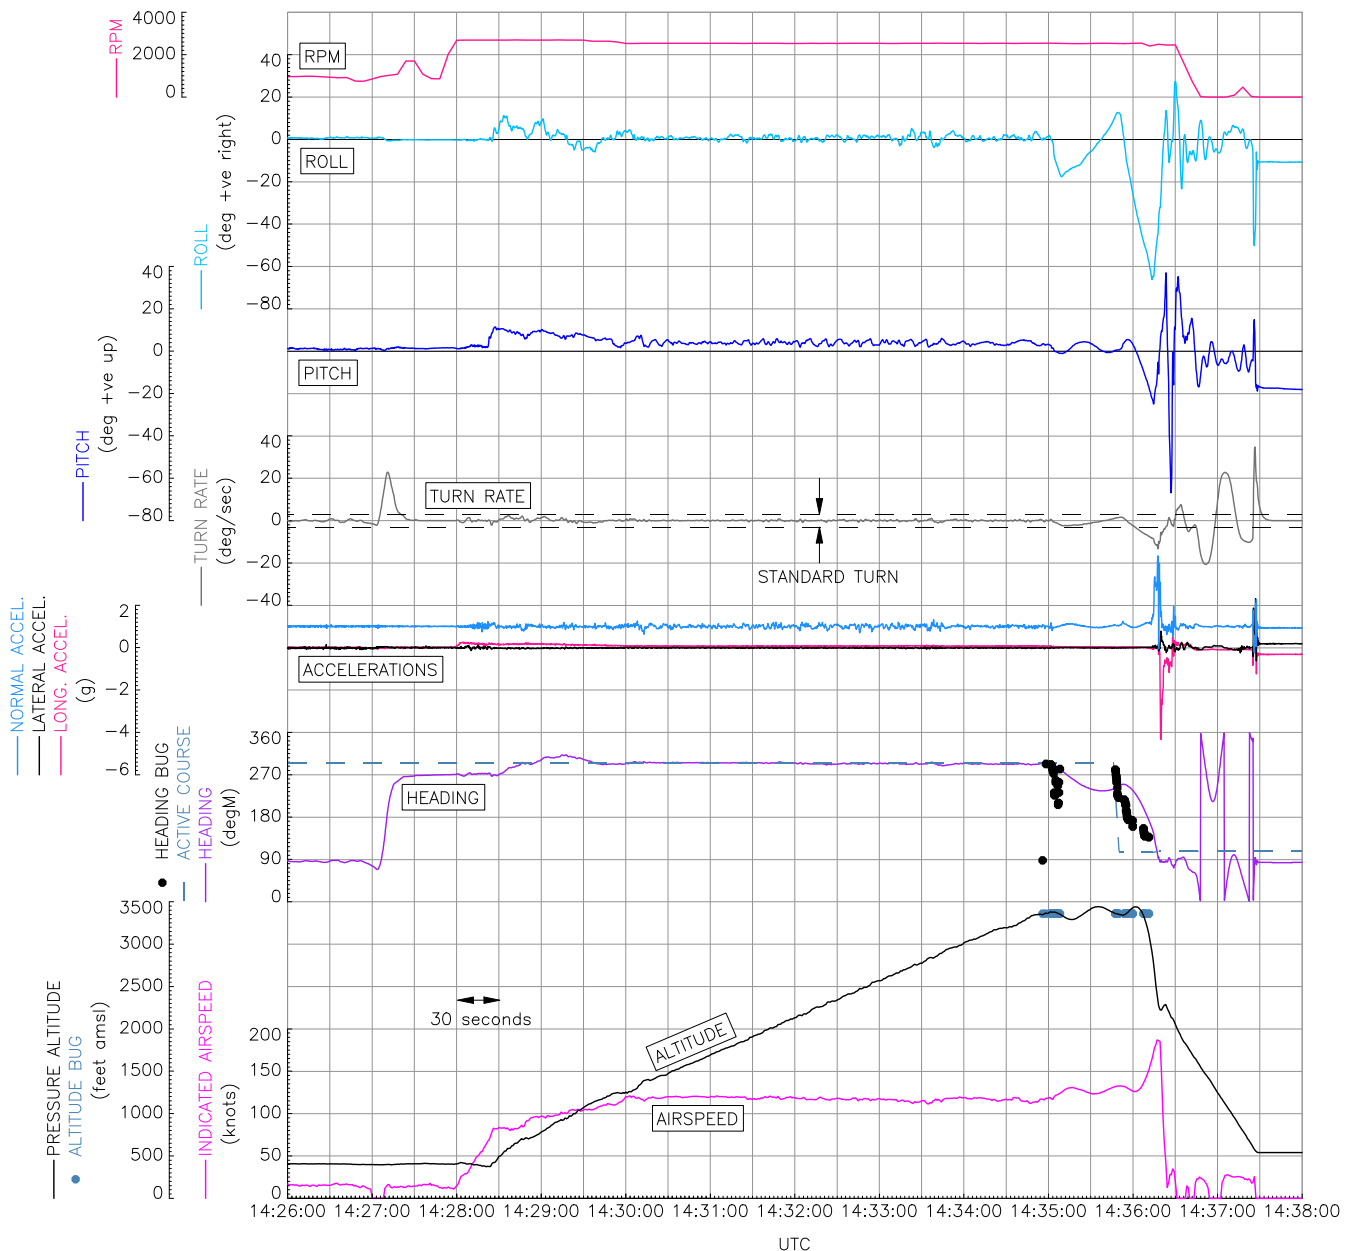
Figure 2 shows that between 1430:30 hrs and 1434:30 hrs, the aircraft was climbing at a constant 400 ft/min on a heading of 295°M. The recorded engine speed was 2,530 rpm and the indicated airspeed

Salient recorded parameters from the PFD and MFD showing the whole flight

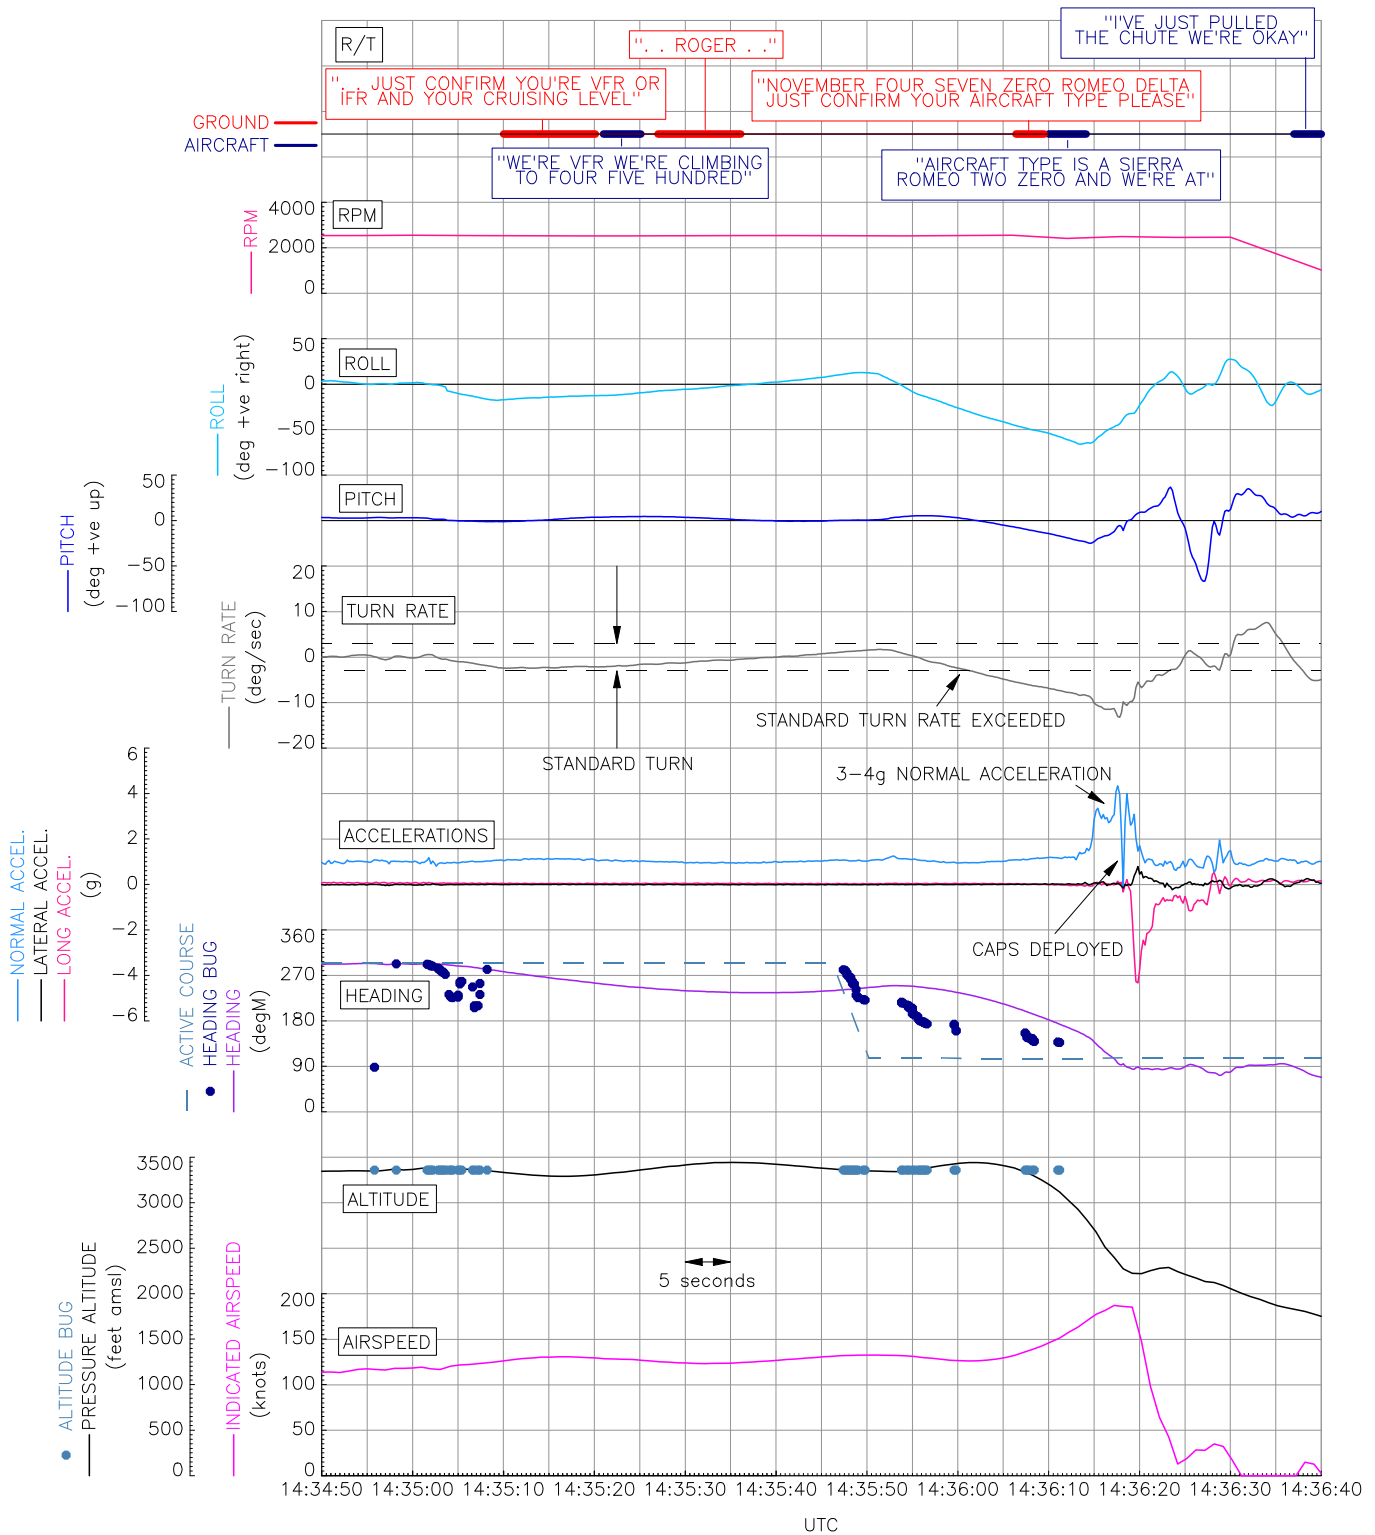
Figure 3
Salient recorded parameters from the PFD and MFD from top of climb to the CAPS deployment

Between times 1434:55 hrs and 1436:15 hrs, the aircraft’s fight path and attitude were not stable.

The altitude climbed gradually by about 50 ft while oscillating two and a half times through ± 75 ft, with corresponding oscillations in pitch ($\pm 3^\circ$) and airspeed (± 5 kt and increasing by 10 kt). The roll was less oscillatory (and also not in phase with the pitch oscillations), initially rolling to 18° left wing down then to 13° right wing down, and then to the left again.

A corresponding heading change can be seen as the aircraft initially turned to the left from 295°M through 50°, at less than the standard turn rate of 3°/sec. As the aircraft started to turn there were a number of changes to the heading bug over a period of seven seconds. On reaching 235°M in the left turn, the aircraft started a similarly gentle turn to the right through 15° during which the active course changed from 295°M to 197°M. The heading bug also changed in stages to 221°M. The aircraft then started another turn to the left, during which the turn rate exceeded the standard value and continued to increase. A similar divergence was recorded in the aircraft's attitude as it banked left and pitched down, with increasing airspeed and loss in altitude. Further heading bug changes were recorded, to a final value of 137°M.

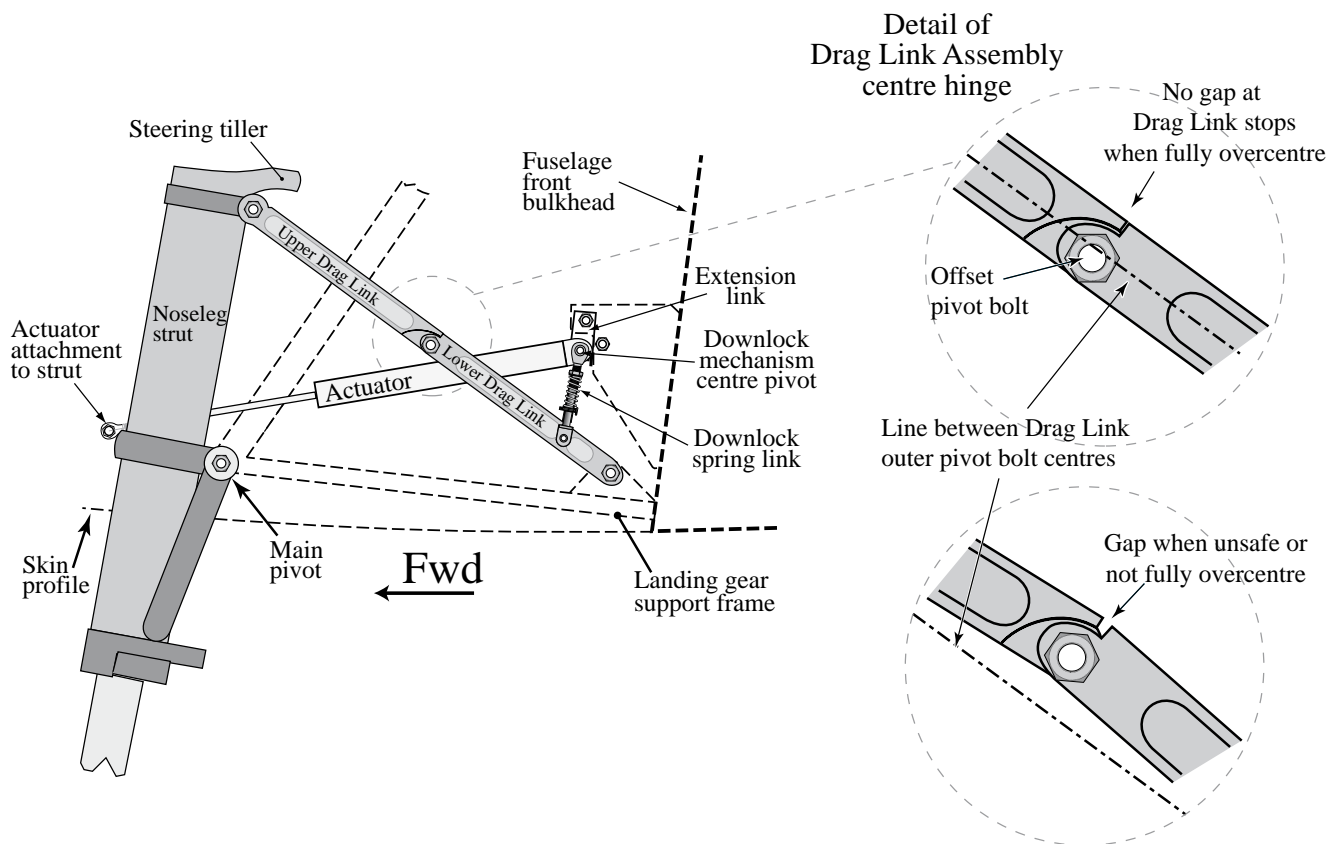
Figure 1

downlock mechanism. There are no locking hooks for either position. When the NLG is extended and under load it is prevented from collapsing by the drag link assembly (Figure 1). When the NLG is fully extended, the offset drag link centre pivot is below the centre line of the two end pivots, preventing the drag link assembly from collapsing when the landing gear is under load.

The geometry of the NLG is such that the aircraft’s weight on the nosewheel applies a compressive load to the drag link assembly, which will tend to drive it more firmly into the safe over-centre condition when the gear is properly extended. However, should the drag link assembly be in an under-centre condition, the applied load will tend to cause the drag link to fold and the gear to retract.

PA-34 nose landing gear side view showing main components in extended position

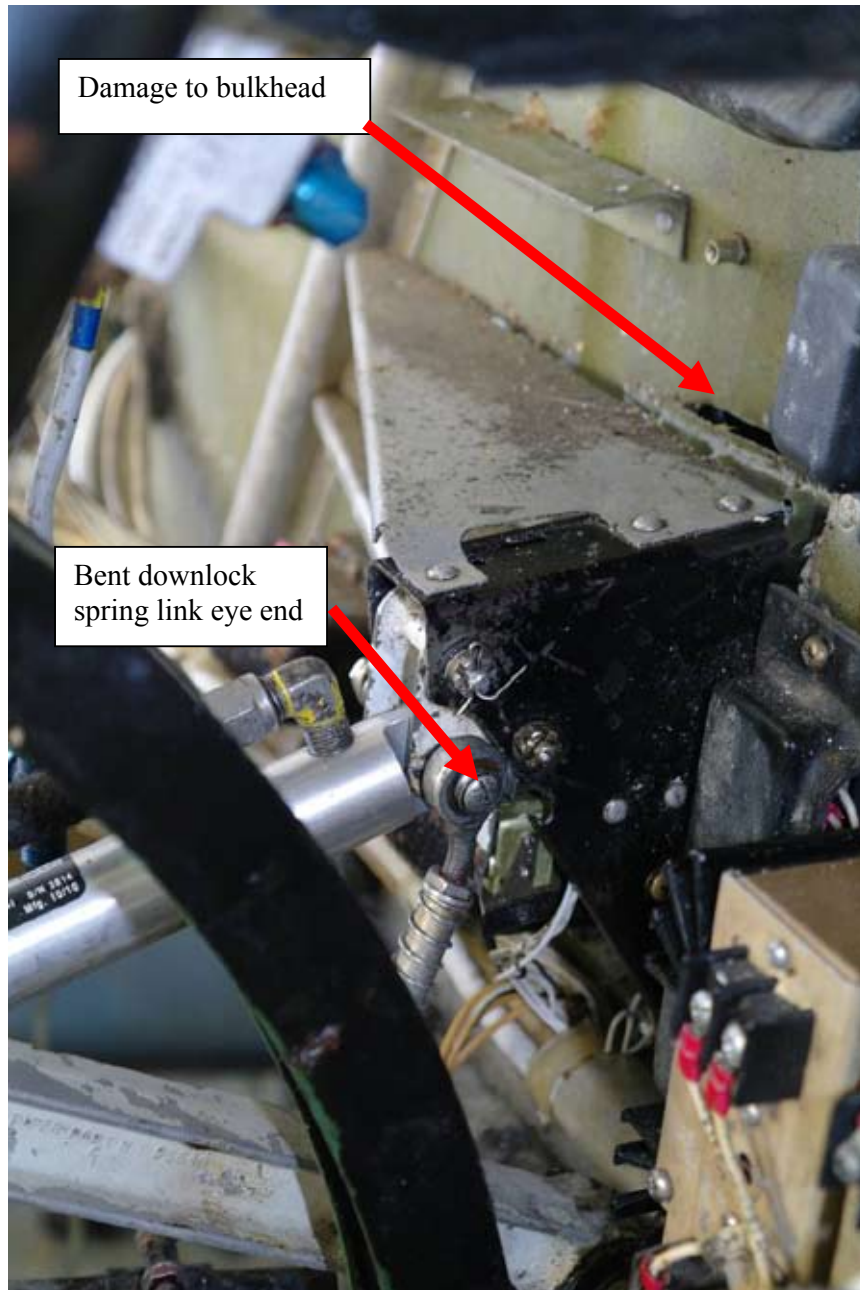
Figure 2

After the nose of the aircraft was raised, the nose landing gear was pulled into the locked-down position. It was then apparent that the upper eye end of the downlock link (Figure 1) was severely distorted, with additional damage to the front bulkhead, which can be seen in the photograph at Figure 2.

It is likely that the damage to the bulkhead and eye end was the result of the drag brace folding during the collapse, which would transfer the loads from the nose leg into the actuator and its attachment, at its upper end, to the bulkhead.

View of upper end of actuator attachment to structure, showing damage to bulkhead and bent eye end of downlock link

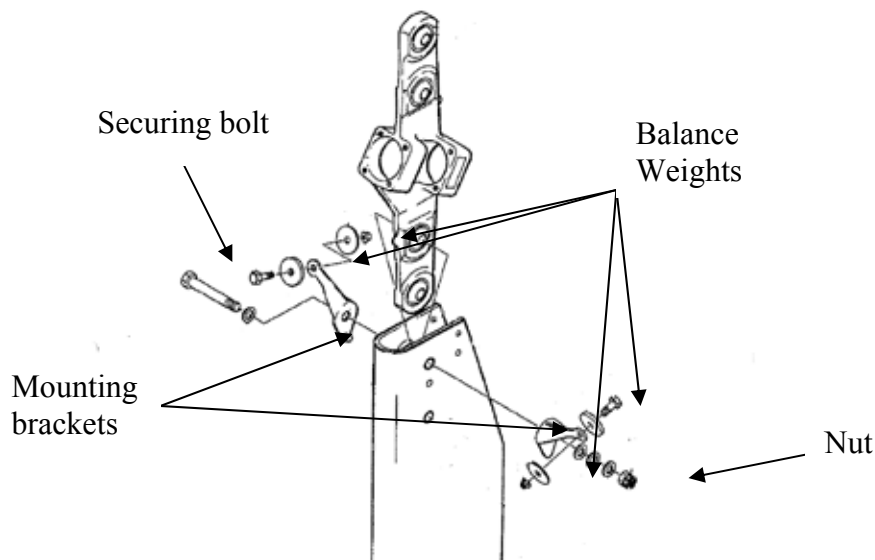
Figure 1

Each tail rotor blade is balanced by the use of individual weights mounted on a bracket to form an assembly. Two such assemblies are installed on each blade, one either side of the blade root, see Figure 1. They are held in place by a bolt which passes through both

Tail rotor balance weights and brackets
(Courtesy of Bell Helicopters)

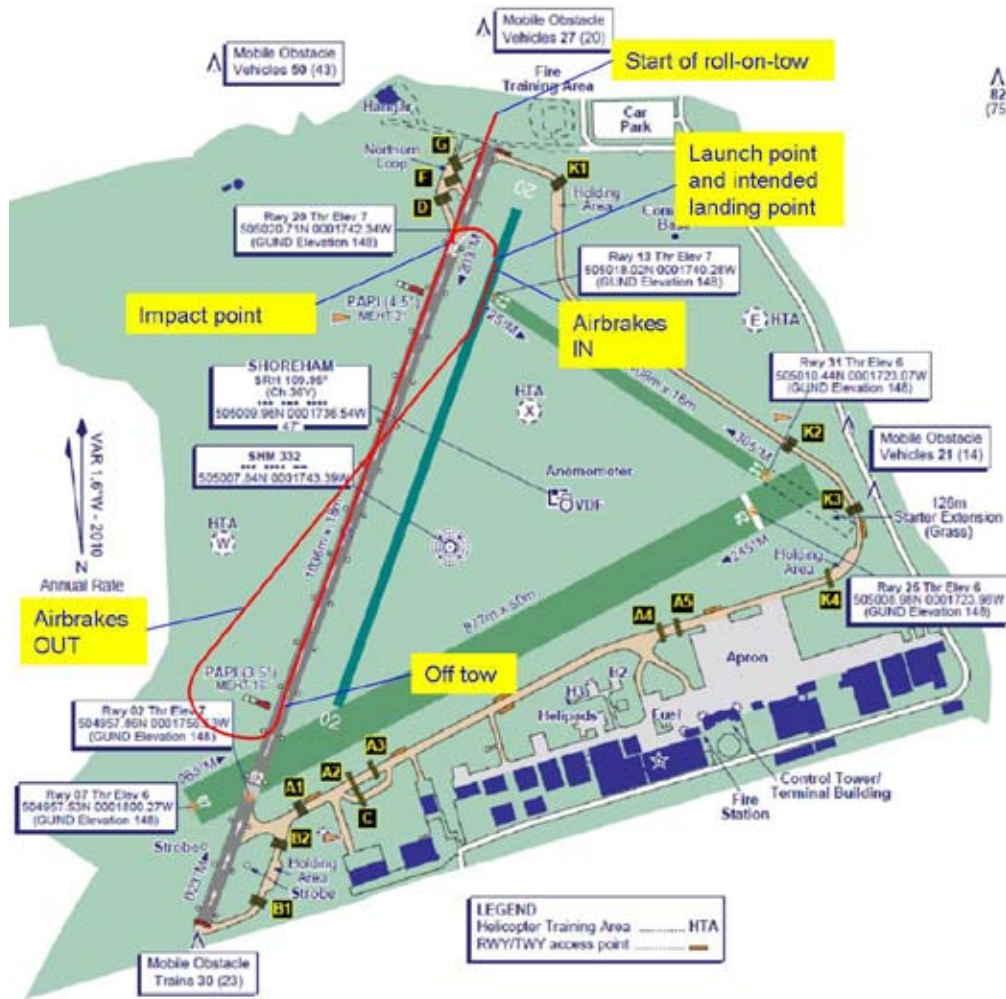
Figure 1

Ground track flown by G-IZII
