CONTENTS

SPECIAL BULLETINS

(ALL TIMES IN THIS BULLETIN ARE UTC)

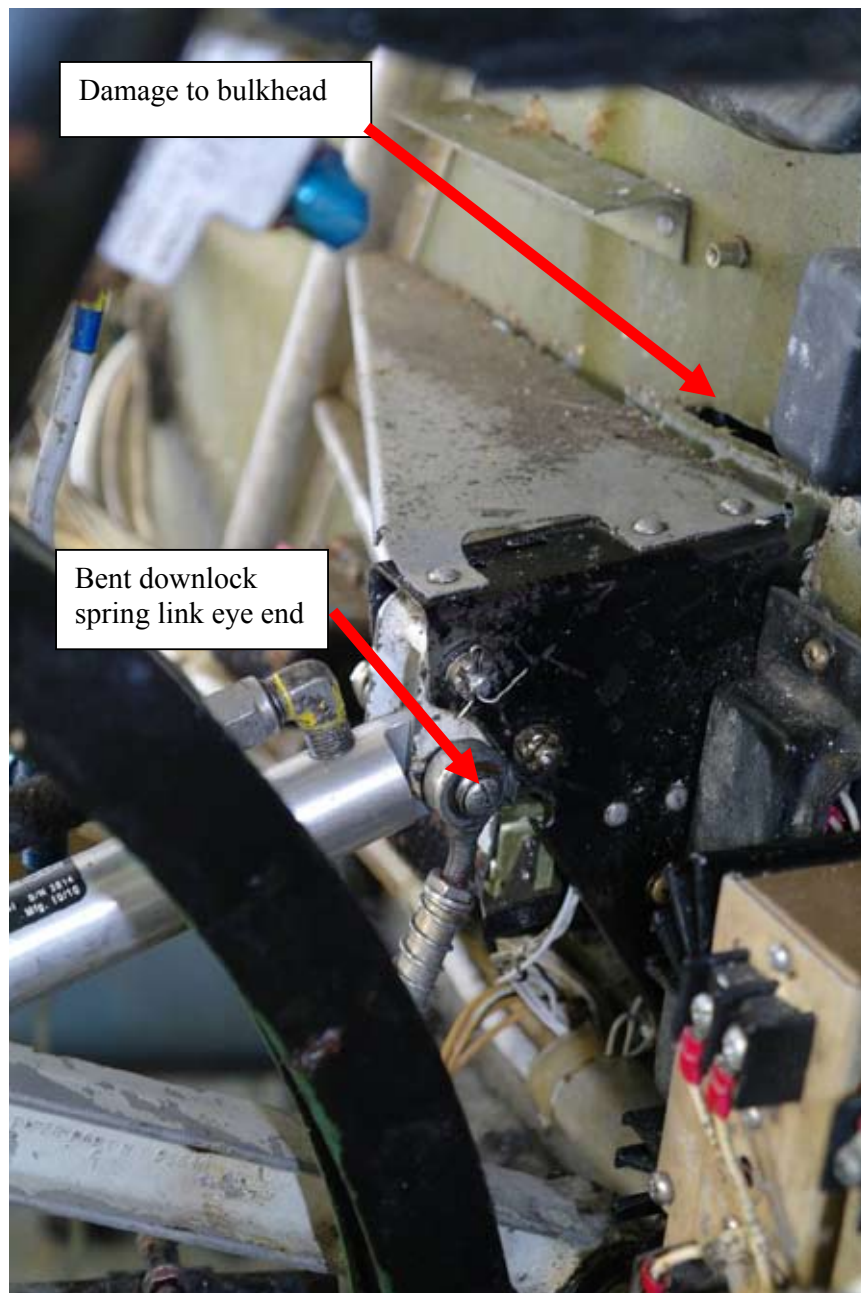
Figure 2

After the nose of the aircraft was raised, the nose landing gear was pulled into the locked-down position. It was then apparent that the upper eye end of the downlock link (Figure 1) was severely distorted, with additional damage to the front bulkhead, which can be seen in the photograph at Figure 2.

It is likely that the damage to the bulkhead and eye end was the result of the drag brace folding during the collapse, which would transfer the loads from the nose leg into the actuator and its attachment, at its upper end, to the bulkhead.

View of upper end of actuator attachment to structure, showing damage to bulkhead and bent eye end of downlock link
