CONTENTS

AAIB FIELD INVESTIGATIONS

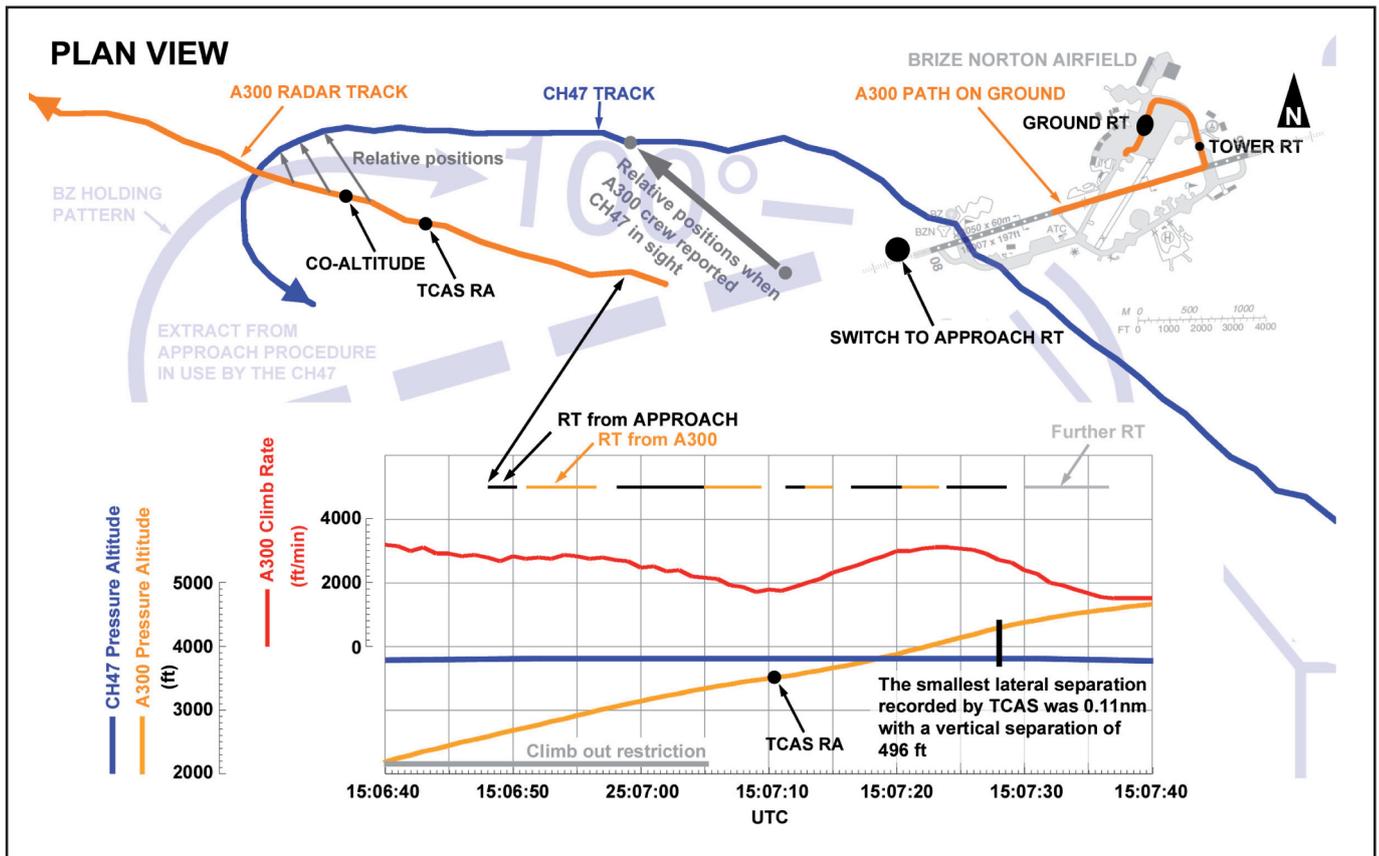
Figure 1
A300 and Chinook tracks

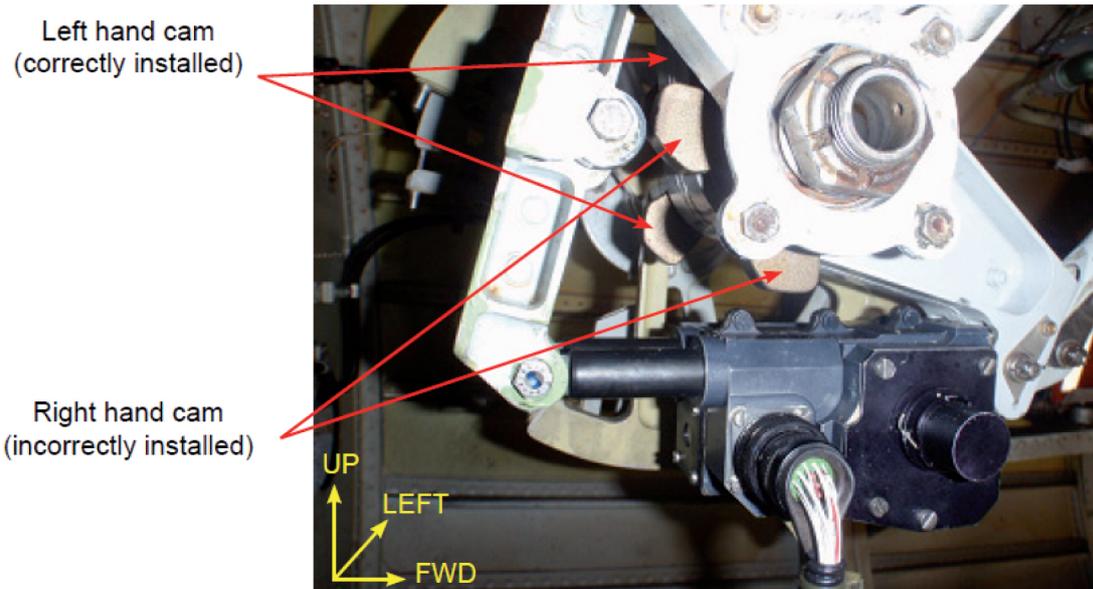
With the right cam incorrectly installed, it was demonstrated that when the TLU was actuated towards the reduced authority position, both rollers were prevented from engaging in the cams. Instead, the right roller was observed to push upwards on the upper lobe of the right cam, causing the rudder rear quadrant shaft to rotate, deflecting the rudder surface and pedals. The maximum rudder deflection produced during testing on the ground (in the absence of flight loads) was 21°.

Figure 5
TLU with right cam incorrectly installed

It is recommended that the European Aviation Safety Agency require ATR to modify the cams on the rudder Travel Limitation Unit on all applicable aircraft, to reduce the risk of incorrect assembly.

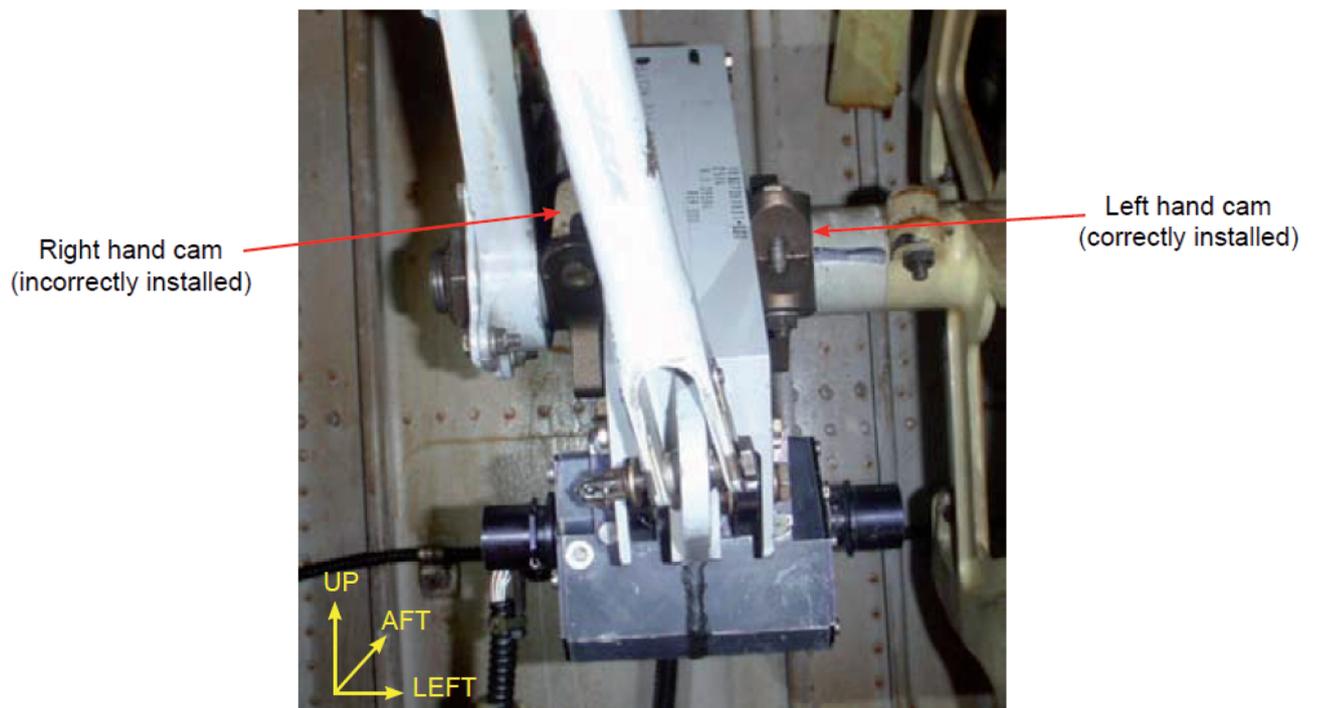
Figure 6
View looking aft on TLU – right cam incorrectly installed

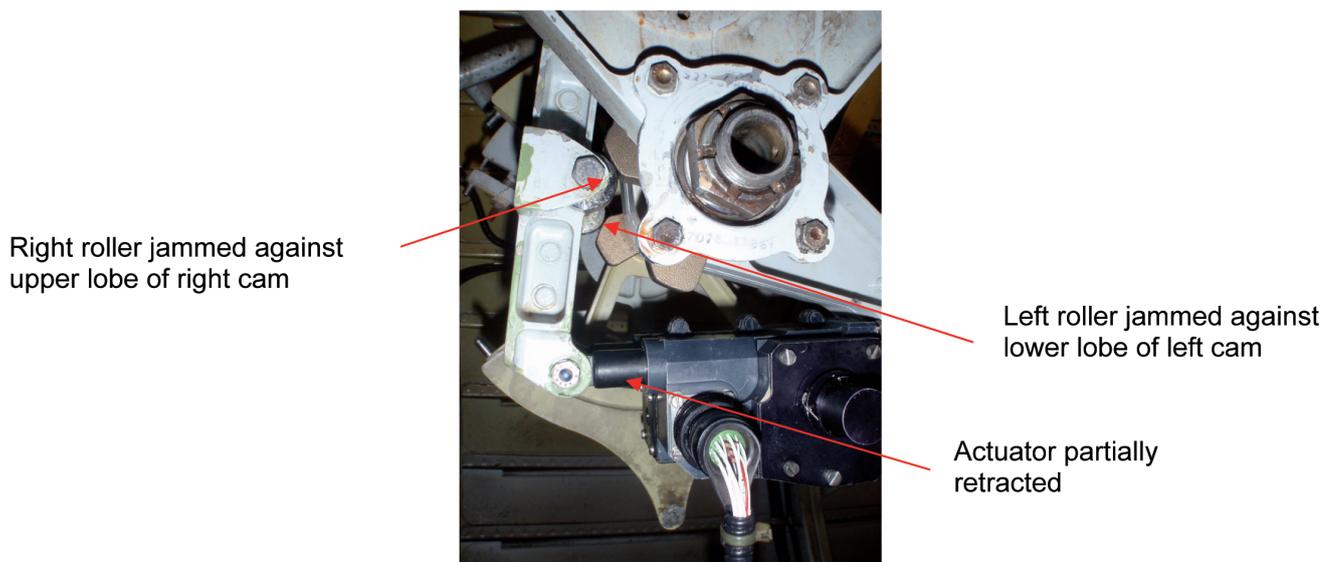
Figure 7

A condition could be produced where the right roller was pushing up against the upper lobe of the right cam and the left roller was pushing down against the lower lobe of the left cam, effectively creating a condition

where the rudder surface and pedals were jammed in the deflected position (Figure 7).

TLU partially retracted – rollers jammed against cams

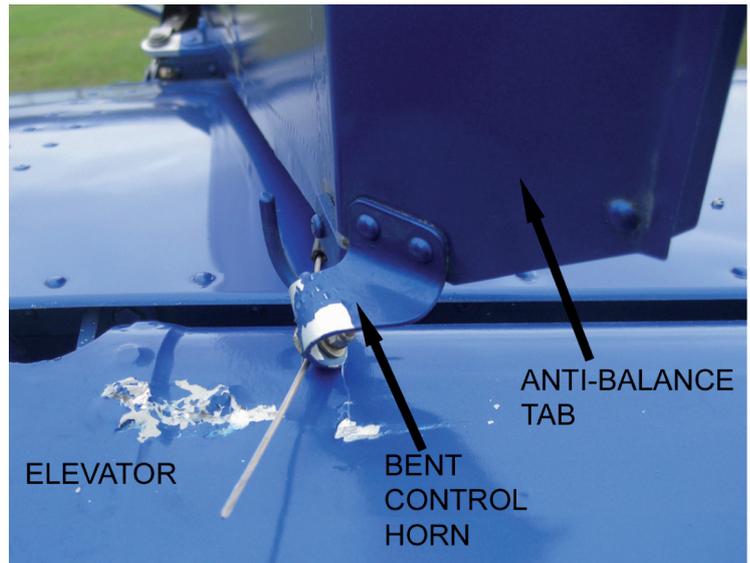
Figure 3

G-CEWR was examined by an engineer from the Light Aircraft Association (LAA). He discovered that the control horn, which connects the cable to the tab, had bent downwards and had impinged on the elevator, leading to damage to the elevator's upper surface and restricting movement of the rudder (Figure 3). He also

discovered that the anti-balance tab's spring hinge had seized, which meant that there was no spring return force and therefore the tab could flap freely from left to right. After the spring hinge was cleaned and lubricated the spring force returned and the tab operated correctly during rudder movement. The control horn was then

Bent control horn and damaged elevator on G-CEWR
(photograph courtesy Light Aircraft Association)

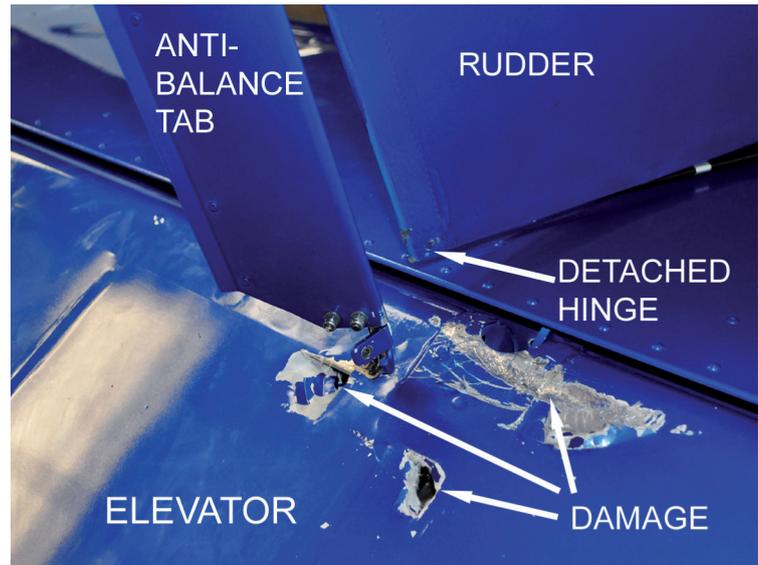
Figure 3

G-CGWP was examined by an engineer from the Light Aircraft Association (LAA). The anti-balance tab was found to have separated from the rudder at the lower hinge (Figure 3), allowing the tab to move aft and damage the elevator. The damage to the elevator was consistent with it having been caused by the control horn which had bent downwards (Figure 4). The control horn cable was also found to have failed. The single screw and nut which had attached the lower tab hinge was missing. The top two hinge screws were found to be loose and there was evidence of rubbing on the tab leading edge. The tab was free to move and the spring hinge was working, although there was a clicking noise during rotation, indicating some extra resistance at one point in the tab's range of movement.

The LAA engineer was not able to determine the initiating cause of failure but theorised that if the lower hinge screw had failed or separated first, then that would explain the aft movement of the tab and the rudder flutter due to a reduction of spring force from the spring hinge. The rudder movement would then have stopped once the control horn jammed inside the elevator skin, thus also causing the elevator to jam. The cyclic loads that overloaded the pitch horn probably also caused a fatigue failure of the cable. Alternatively, the lower hinge screw could have failed or separated due to a 'flutter' event caused by some other factor. The evidence of rubbing on the leading edge of the tab could indicate an over-close fitment when the aircraft was manufactured, or it could have been a result of the loose hinges found.

Damaged elevator and separated anti-balance tab hinge on G-CGWP

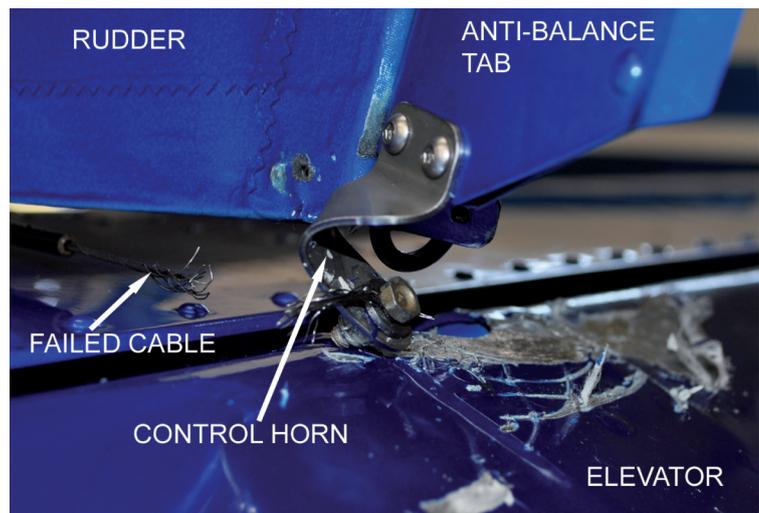
Figure 4

Bent control horn and failed cable on G-CGWP
