CONTENTS

COMMERCIAL AIR TRANSPORT

| Boeing 757-28A | G-STRY | 25-Aug-10 | 1 |
| Bombardier DHC-8-102 | SX-BIO | 24-Apr-10 | 17 |

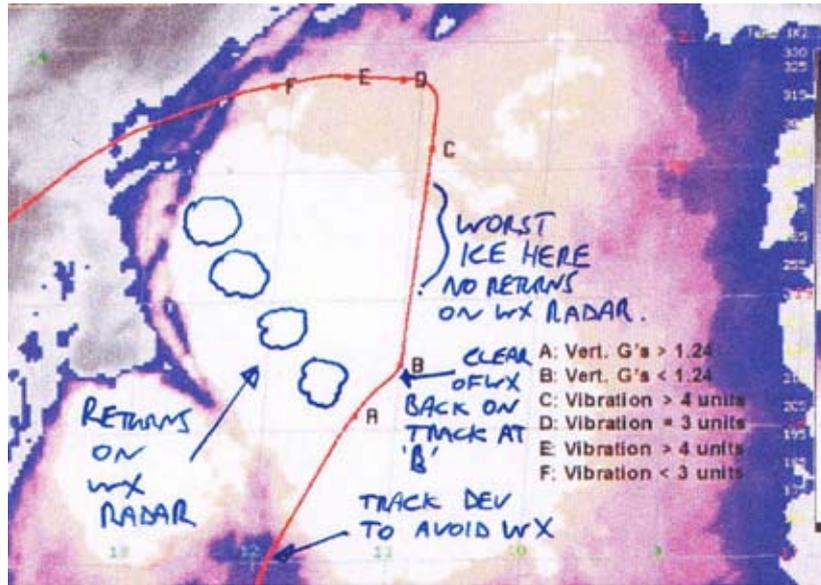
Figure 3

En route, the crew were able to monitor the conditions ahead of track using the aircraft weather radar. They made several deviations to the east of the flight planned track to avoid flying into areas of strong convective activity. In the process of the investigation a colour enhanced infrared satellite image, timed at 0100 hrs, with the track of the aircraft superimposed upon it, was constructed. This image showed the height of cloud, based on a colour coded scale, with the white areas being the highest level. The commander subsequently sketched the approximate position of the weather activity he had observed on the weather radar onto this image (see Figure 3).

Infrared satellite image with sketch of en-route weather (for scale, each vertical graticule is 60 nm ie the distance from A to C is approximately 120 nm)

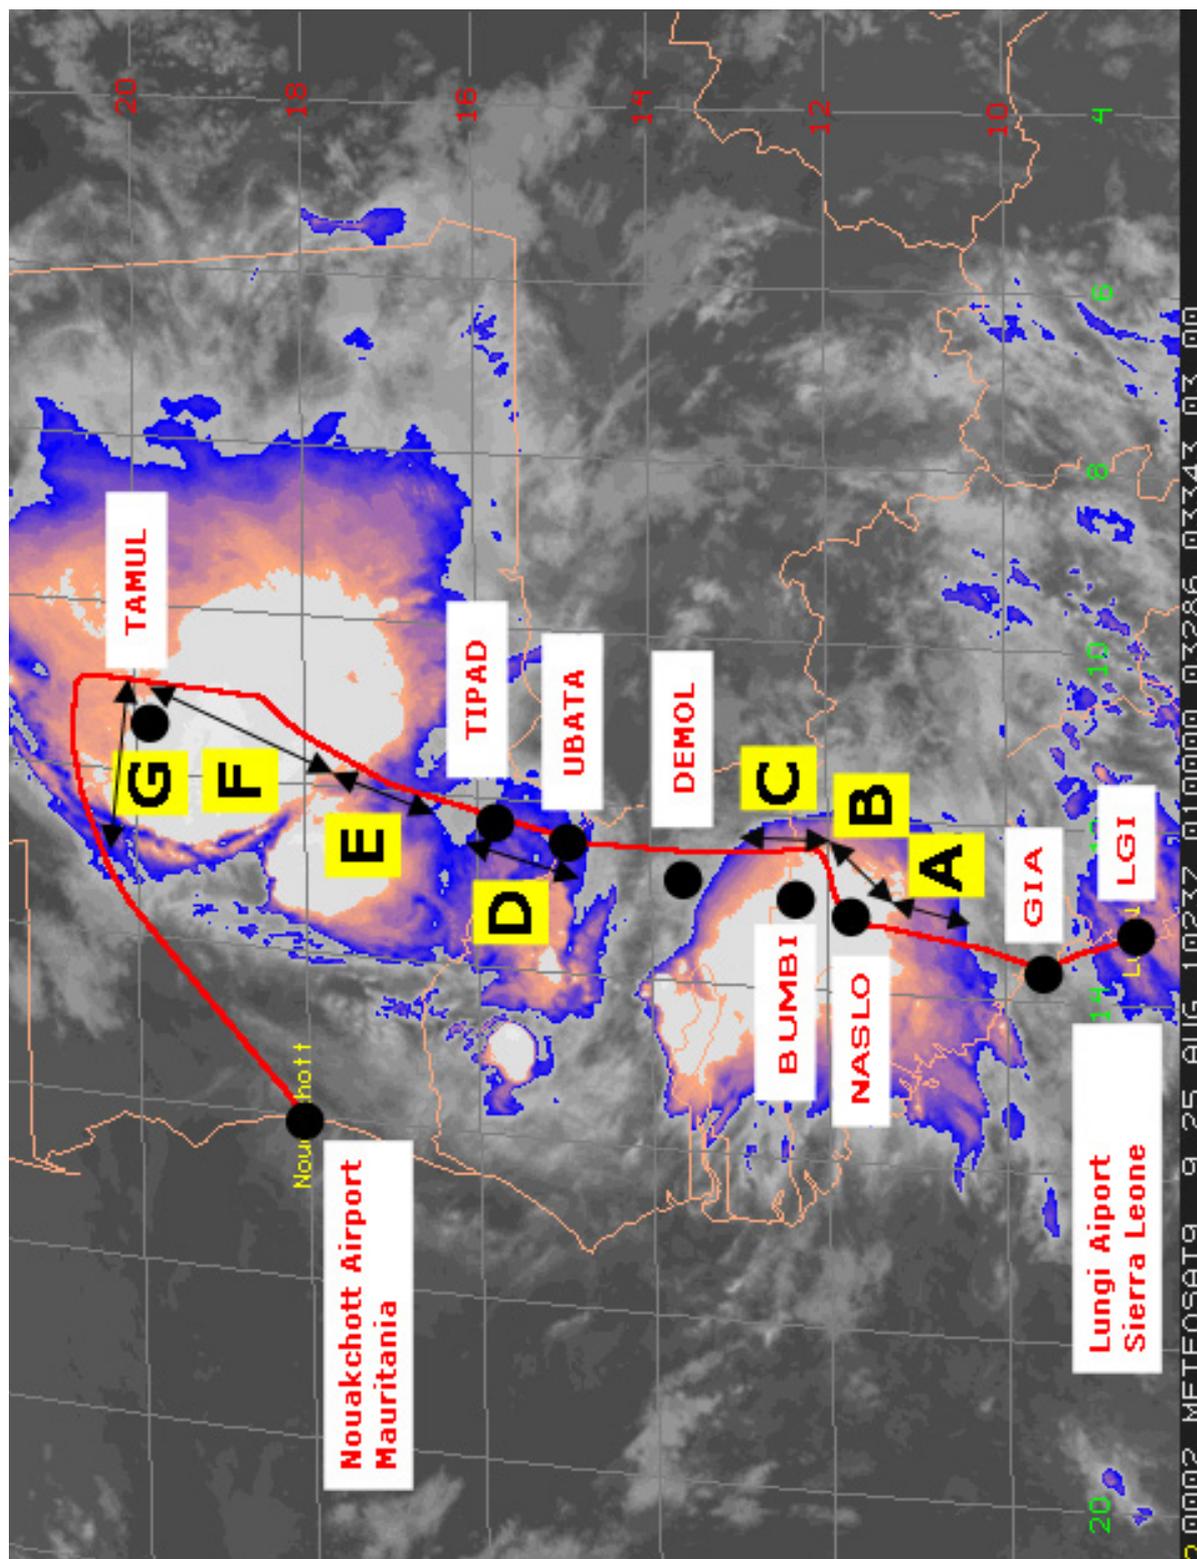
Figure 5

Satellite image of MCS areas over Africa and G-STRY flight track and waypoints
(Points A to G refer to the relative aircraft positions detailed in Figure 4)

At 0041 hrs, as the aircraft approached waypoint UBATA (situated near to the border between Senegal and the Islamic Republic of Mauritania), it entered the southern tip of the second MCS. The MCS extended to the north by approximately 480 nm and was between 170 nm and 350 nm wide. Twenty minutes later, the aircraft entered the area of the MCS having the highest clouds (see Figures 4 and 5 – area F) and there was an increase in turbulence. Several minutes later, the EPR on both engines was progressively reduced, from 1.6 to 1.4. This was accompanied by a reduction in right engine vibration, with the N_3 shaft becoming the source of maximum vibration at 1.1 units. During the next four minutes, as the autothrottle attempted to stabilise the airspeed, the EPR on both engines was progressively increased to 1.7. As EPR increased, the right engine maximum vibration source changed to the N_1 shaft and there was an increasing trend in both left and right engine N_1 shaft vibration levels. As the left engine reached 2 units and the right 2.5 units, the flight crew selected both EAI systems to ON. Both engine N_1 shaft vibration levels continued to increase, before stabilising at about 2.6 units. The trend over the next five minutes was a slight reduction in the left engine N_1 shaft vibration, before both engine N_1 shaft vibration levels further increased to 3 units. The aircraft was just leaving the highest cloud level within the MCS at this time (see Figures 4 and 5 – area G).

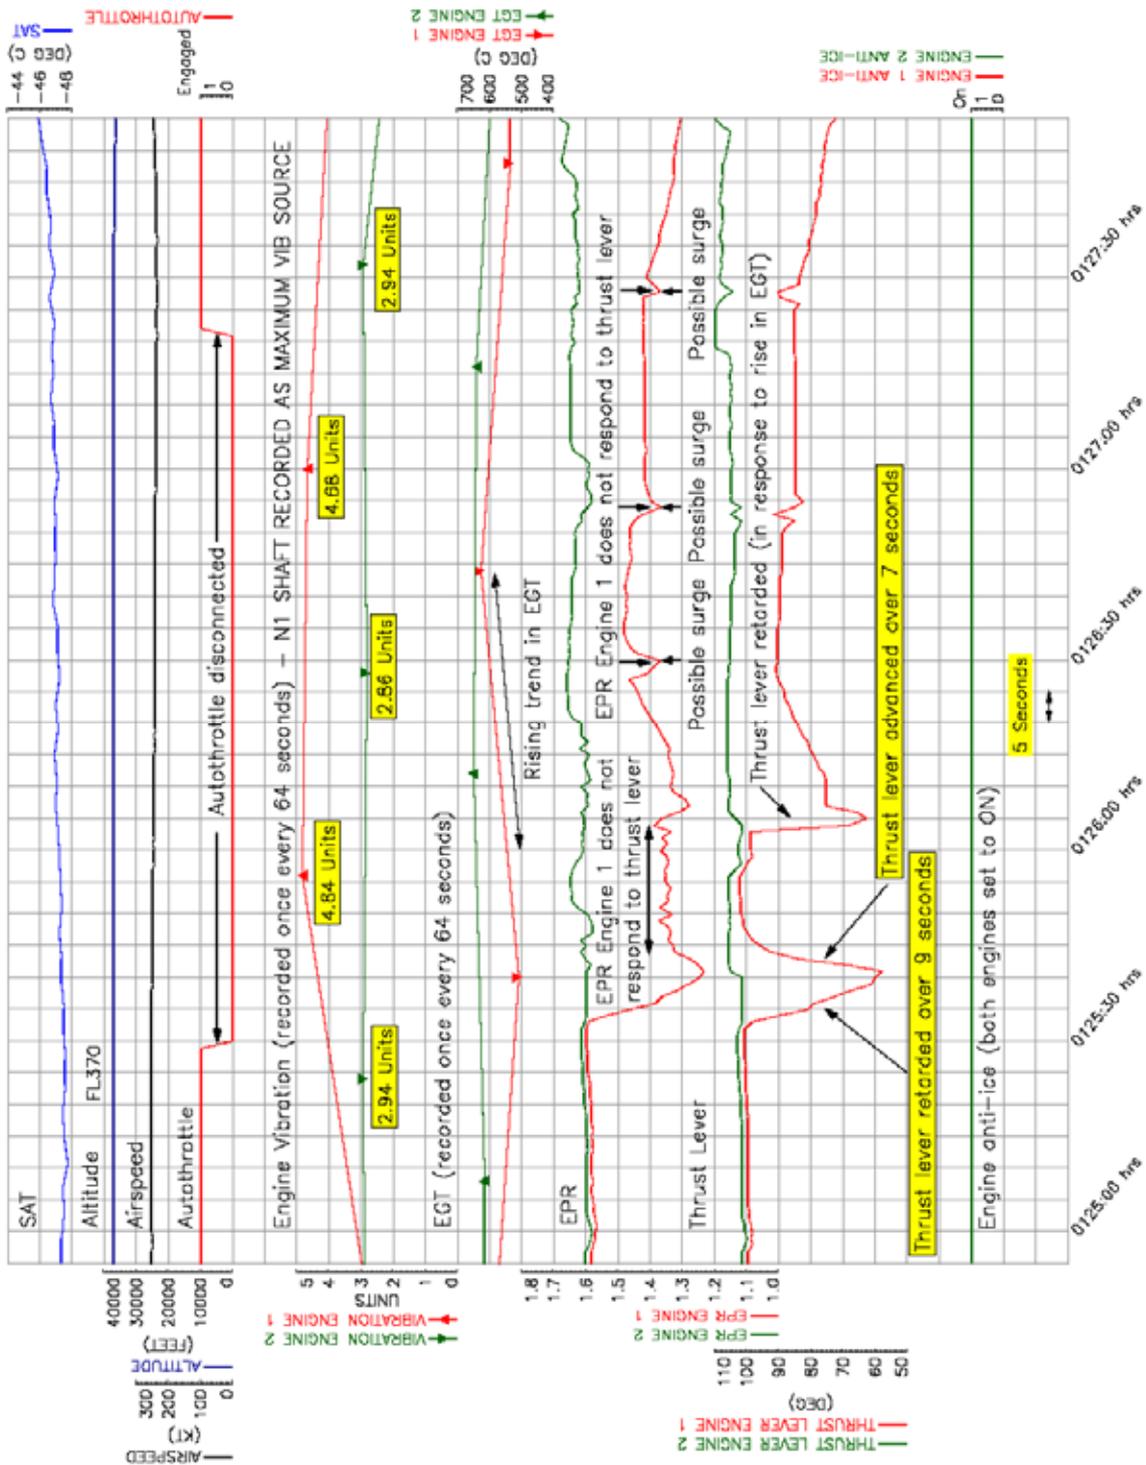
Figure 6

Recorded data during period of manual thrust reduction whilst in the cruise

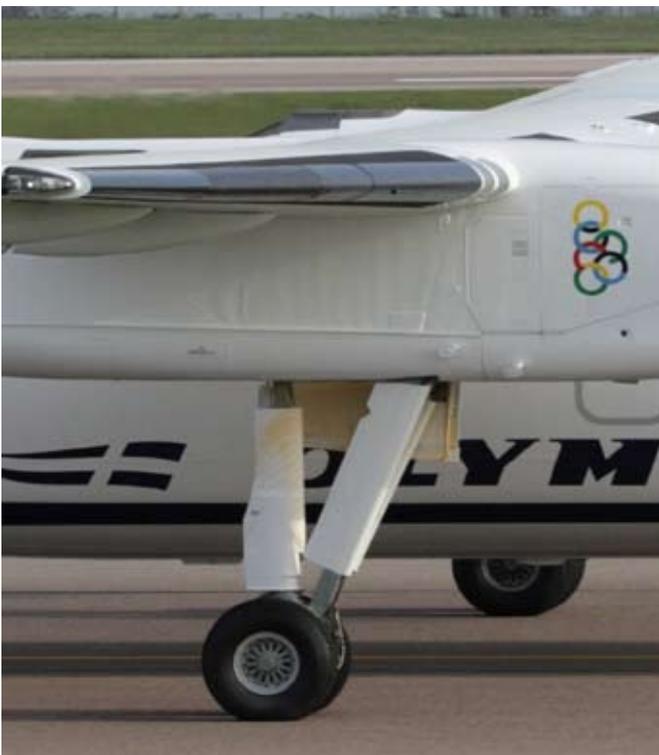
Figure 1

The start-up, taxi and departure were all described by the crew as normal. However, photographs taken by an aviation enthusiast at 0654 hrs show some signs of oil leaking from both engines as the aircraft taxied out (Figures 1 and 2).

Oil leak visible on right main gear leg during taxi at East Midlands on 24 April 2010 (photograph courtesy Dave Sturges/ AirTeamImages.com)

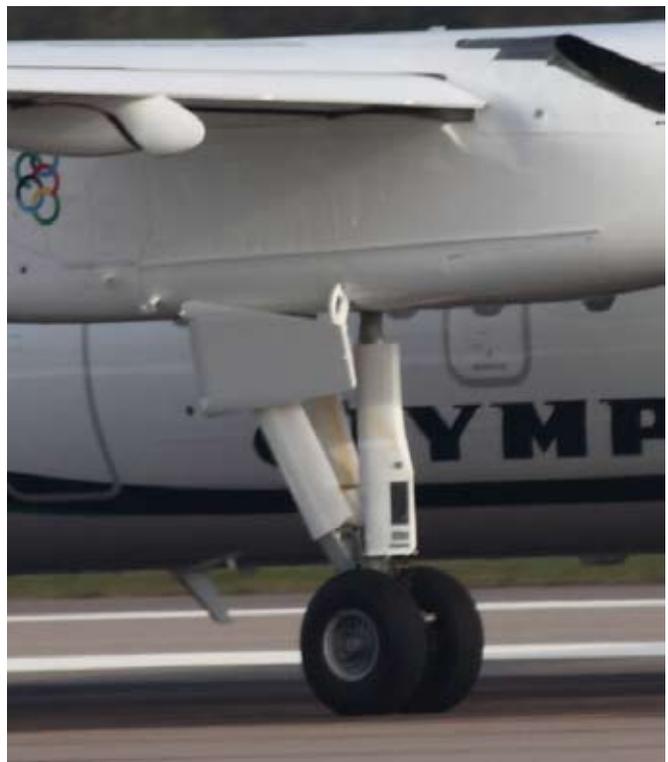
Figure 2

Oil leak visible on left main gear leg during taxi at East Midlands on 24 April 2010 (photograph courtesy Dave Sturges/ AirTeamImages.com)

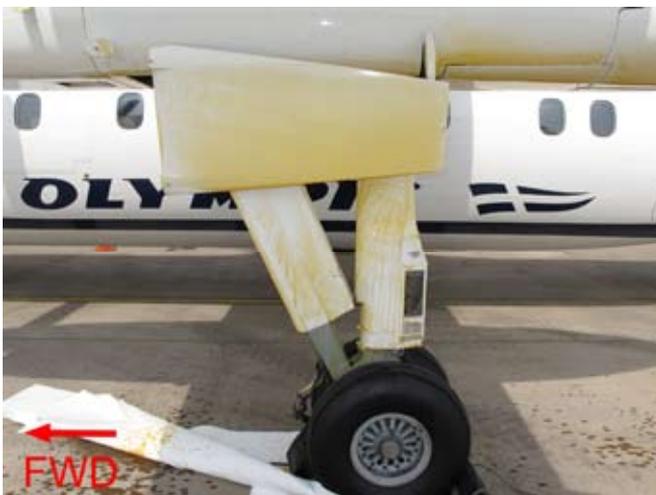
Figure 3

Left engine nacelle and landing gear leg after landing at Bristol

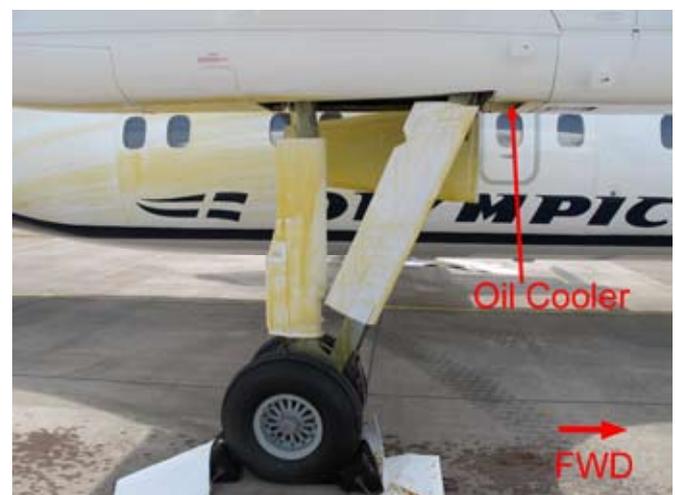
Figure 4

Right engine nacelle and landing gear leg after landing at Bristol

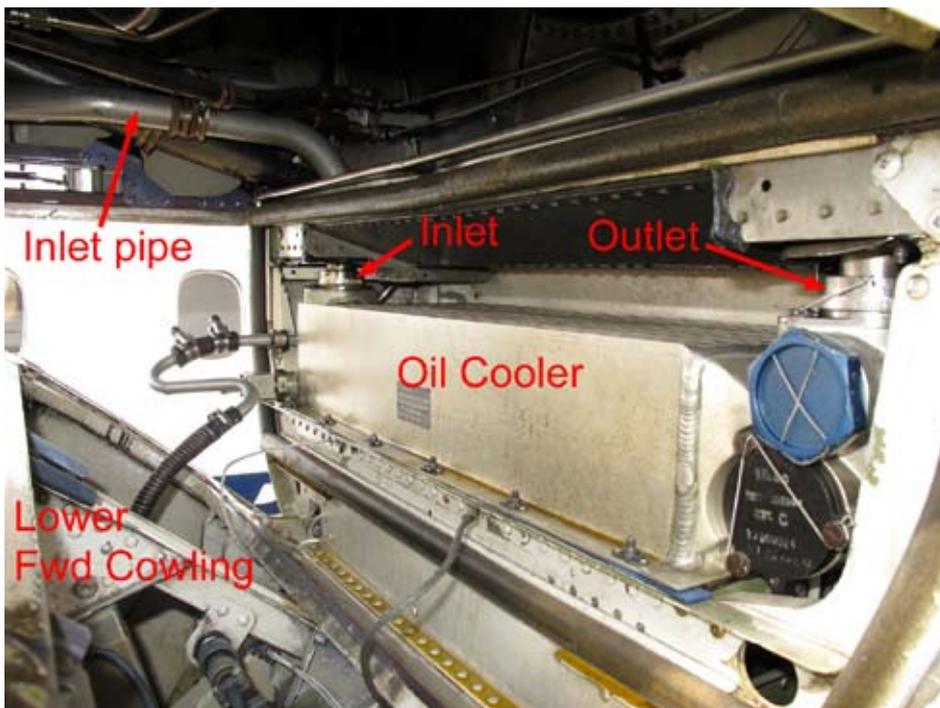
The engine cowlings were removed to identify the source of the oil leaks. The left engine oil cooler is shown in Figure 5 with the lower forward cowling lowered. There was oil along the lower forward surface of the oil cooler and along the lower forward cowling hinge line. Oil was also seen slowly weeping from around the knurled nut where the inlet pipe connects to the oil cooler. When the inlet pipe was disconnected and the oil cooler removed, it was revealed that two O-ring seals were fitted inside the groove of the pipe; the smaller O-ring was split and the larger O-ring contained a cut (Figures 6 and 7). The larger O-ring was of the correct size and type for the installation, but the smaller O-ring should not have been fitted. One O-ring, of the correct size, was fitted to the outlet pipe of the oil cooler and this O-ring was undamaged.

Left engine oil cooler with lower forward cowling lowered.
Slow oil seepage from oil cooler inlet nut

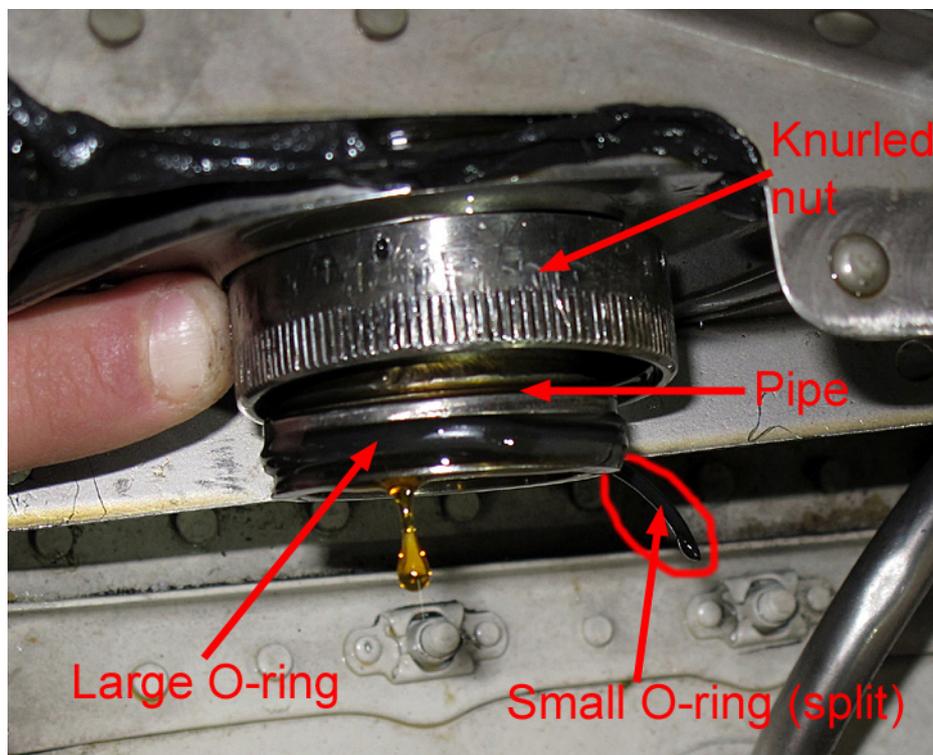
Figure 6

Left engine oil cooler inlet (inboard) pipe connector, showing large O-ring seal, and small O-ring seal, which had split, part of which can be seen hanging down (highlighted in red)

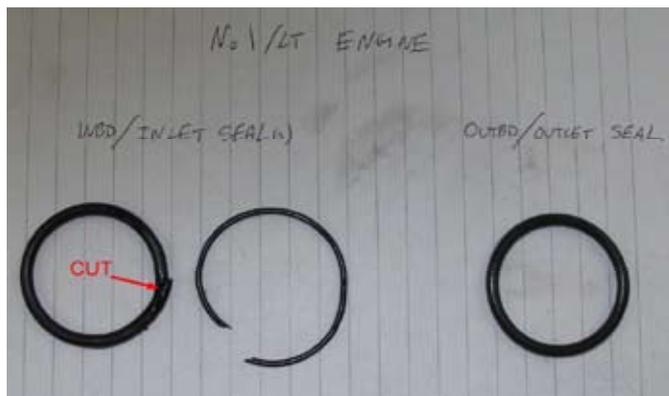
Figure 7

Left engine oil cooler inlet and outlet seals; large inlet seal contained a cut; small inlet seal was split

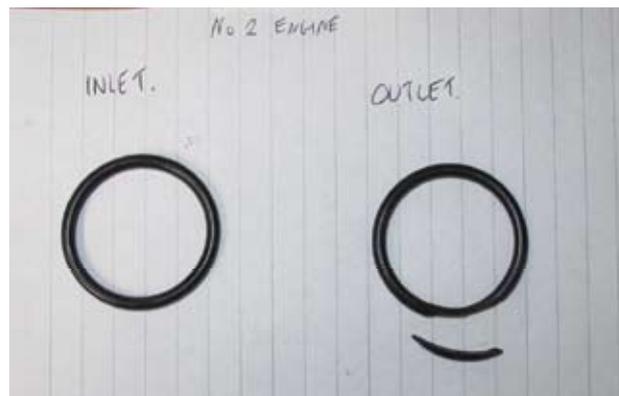
Figure 8

Right engine oil cooler inlet and outlet seals; outlet seal had been cut; severed piece shown below it

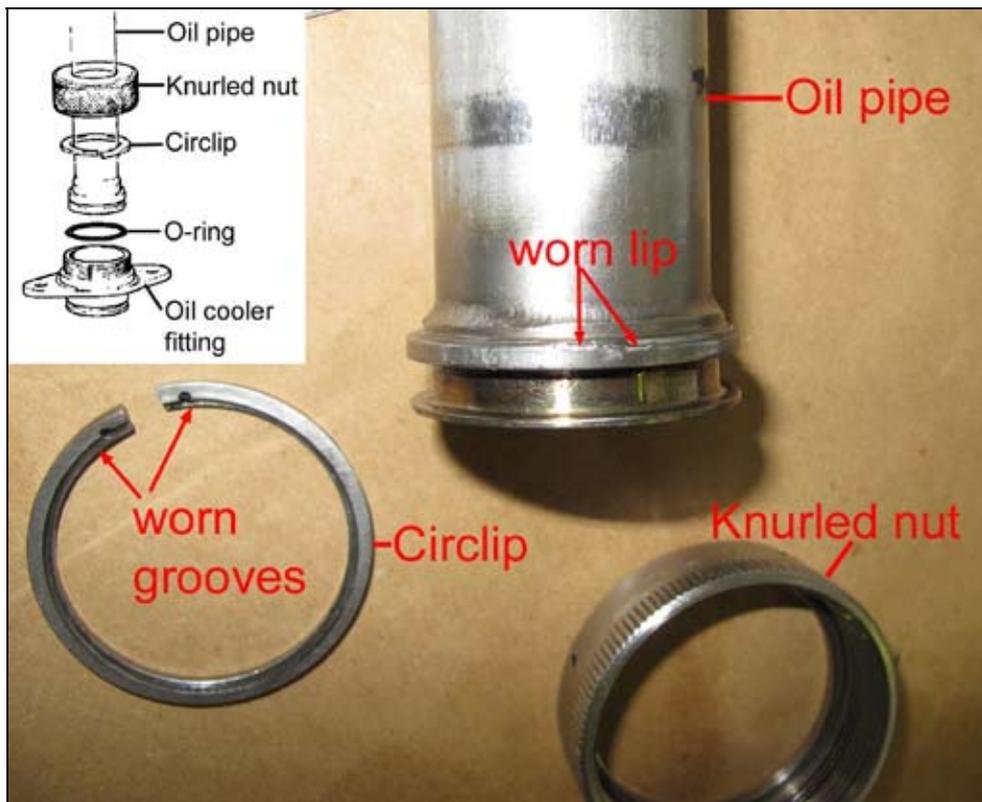
Figure 9

The circlips, which retained each knurled nut on the pipe, contained grooves where the nut had squeezed the circlip hard against the lip of the pipe (Figure 9). The knurled nuts also had score marks on their outer circumference consistent with having been tightened with a pair of grips. This was evidence that the knurled nuts on both pipes from both oil coolers had at some point been over-tightened. The maintenance manual calls for the nuts to be tightened ‘by hand’.

Worn grooves on circlip retaining knurled nut
(left oil cooler inlet pipe shown; similar wear found on the other three circlips)

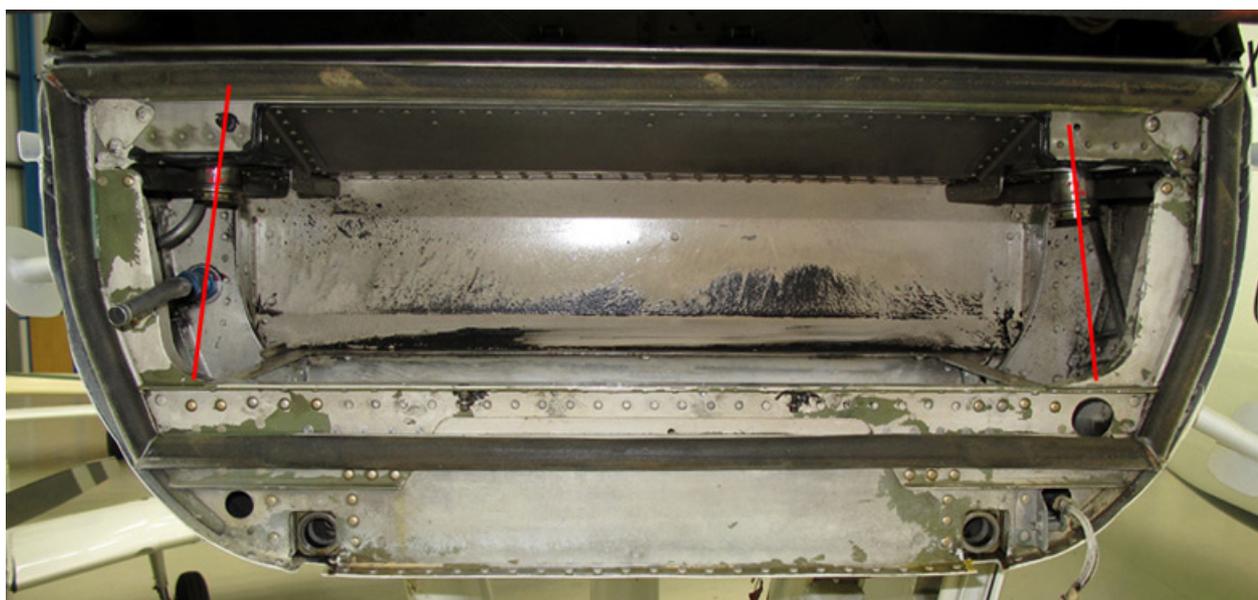
Figure 10

Following the right engine oil cooler removal, it was noticed that the inlet and outlet pipes were not aligned perpendicular to the oil cooler but were canted outwards (Figure 10). This orientation of the pipes would have

View looking aft beneath the right engine where the oil cooler had been installed.
Note that the oil cooler inlet and outlet pipes are not orientated at 90° but are canted outwards

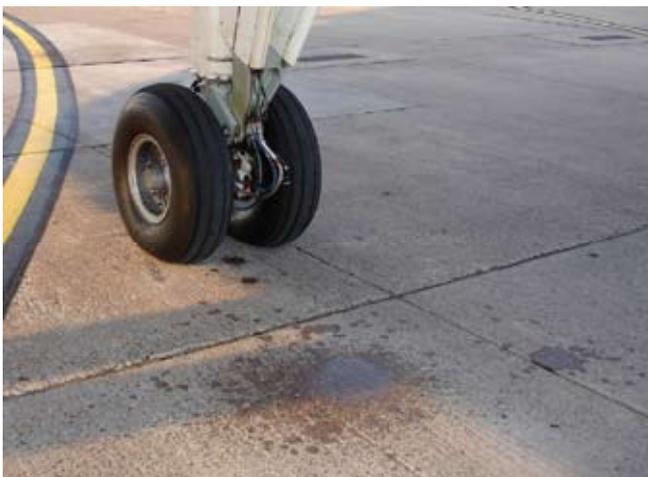
Figure 11

Oil spots on ground beneath left engine nacelle after arrival at East Midlands on 16 April 2010

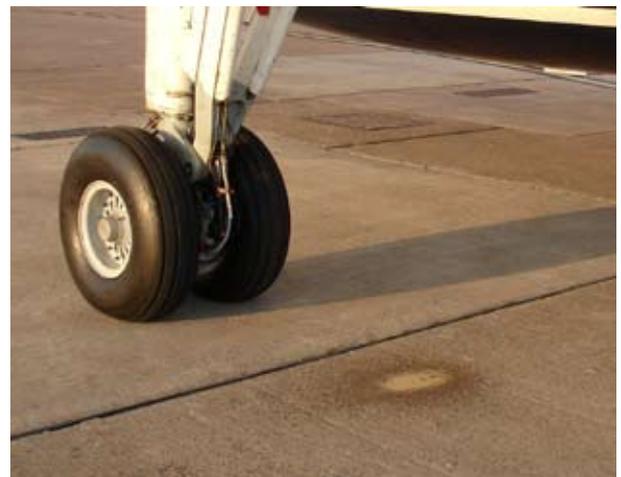
Figure 12

Oil spots on ground beneath right engine nacelle after arrival at East Midlands on 16 April 2010

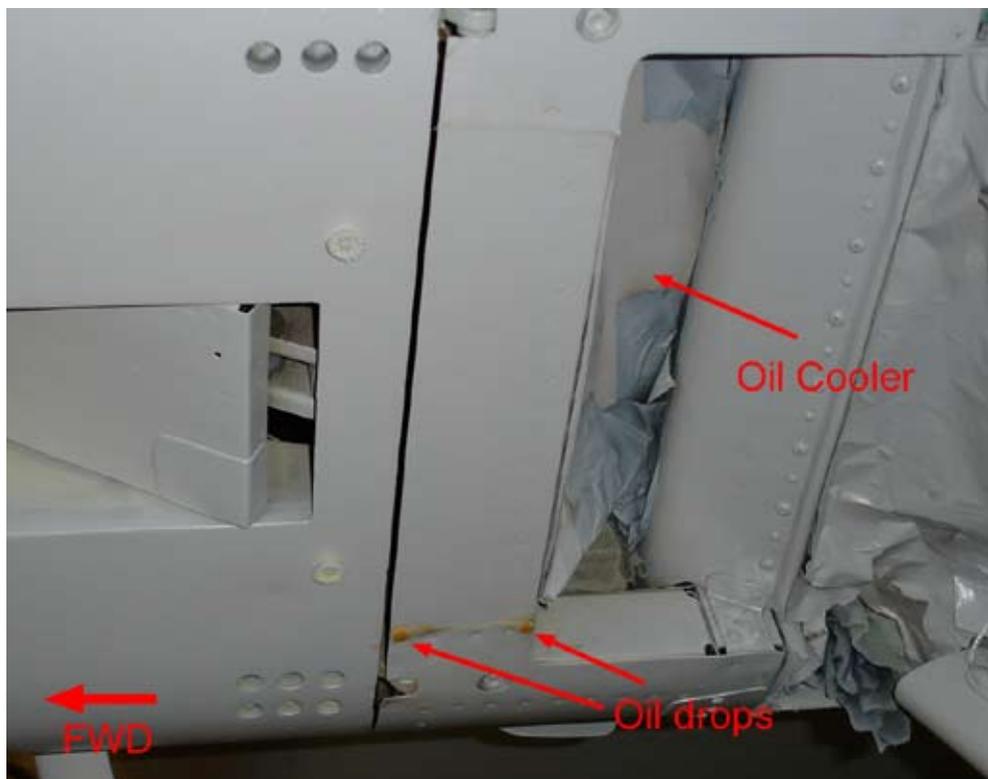
Figure 13

Oil seepage from butt joint beneath right engine oil cooler
(photograph taken on 20 April 2010 during painting at East Midlands)

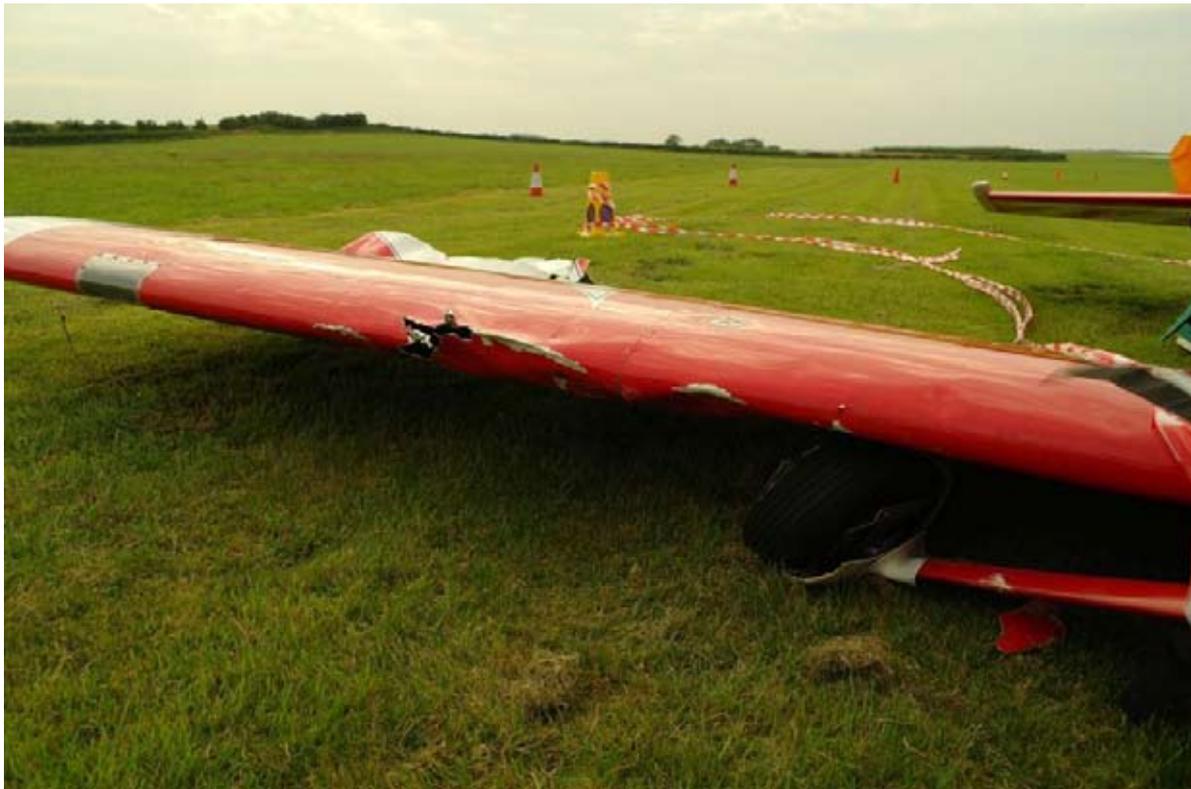
Figure 5

The leading edge of the right wing exhibited impact damage over a length of 0.6 m, with the damage centred at approximately mid wingspan (Figure 5). The right aileron was extensively damaged and the inboard 40 cm of aileron was missing aft of the aileron spar, which itself was bent forwards, consistent with being struck from behind. The right wing's lower skin was heavily scored with marks running in the outboard direction, towards the wing tip. The nature of these markings indicated that they had not occurred during the landing ground roll. The forward section of the right mainwheel spat had detached and photographs taken of the aircraft during landing showed that the right main landing gear leg was bent upwards, with the right wheel almost in contact with the right wing lower surface, immediately prior to touchdown.

Damage to the RV-4's right wing

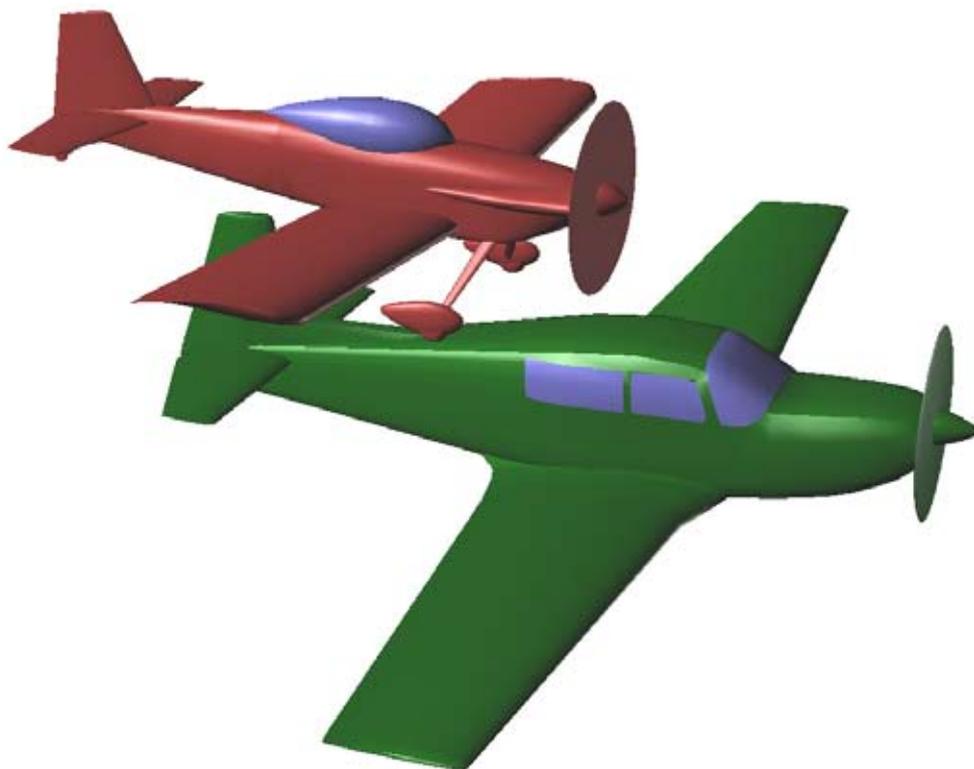
Figure 7
Initial contact

In order to correlate the pattern of damage sustained by both aircraft during the collision, simple three-dimensional Computer Aided Design (CAD) models of each aircraft were created. The pitch angles of both aircraft were set to be consistent with the airspeed and climb rates recorded on the GPS recorders carried on the aircraft immediately prior to the collision. The analysis showed that the initial contact between the aircraft was between the RV-4's right wheel spat and the top section of the Mooney's rear fuselage, at the forward end of the dorsal fin (Figure 7).

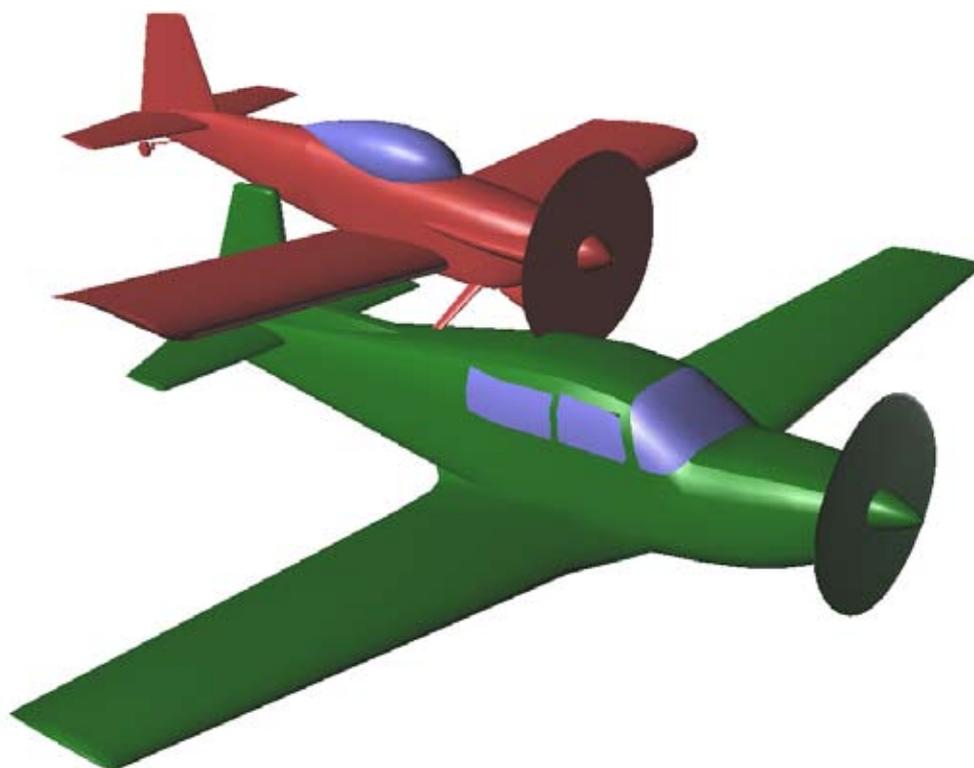
Figure 8
Propeller contact with Mooney's cabin roof

This initial contact was likely to have been followed almost immediately by contact between the RV-4's propeller and the left side of the Mooney's cabin roof skin, above the rear cabin seats (Figure 8). It is likely that the large section of cabin roof skin found in the wreckage trail detached from the aircraft at this point in the accident sequence.

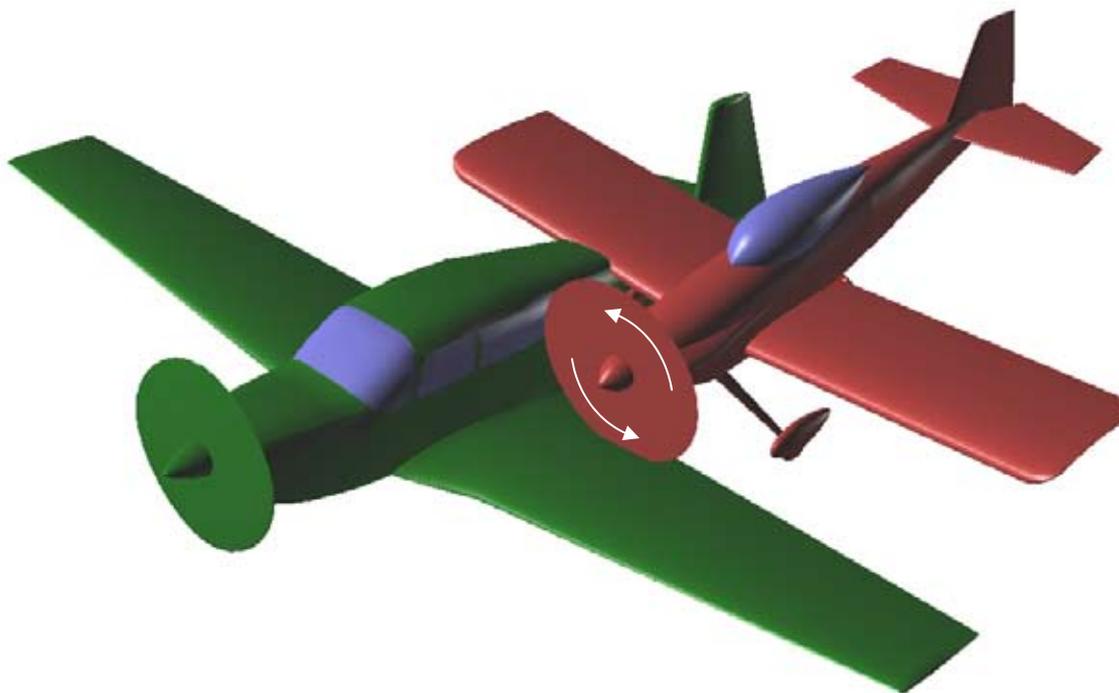
Figure 9

Propeller contact with the Mooney's left wing, showing the RV-4's propeller rotation direction
