CONTENTS

COMMERCIAL AIR TRANSPORT

Cessna 501 Citation	G-VUEM	19-Nov-10	1
Cessna 680 Citation Sovereign	G-CJCC	30-Sep-10	17
Piper PA-31-350 Navajo Chieftain	N678BY	02-Apr-11	24

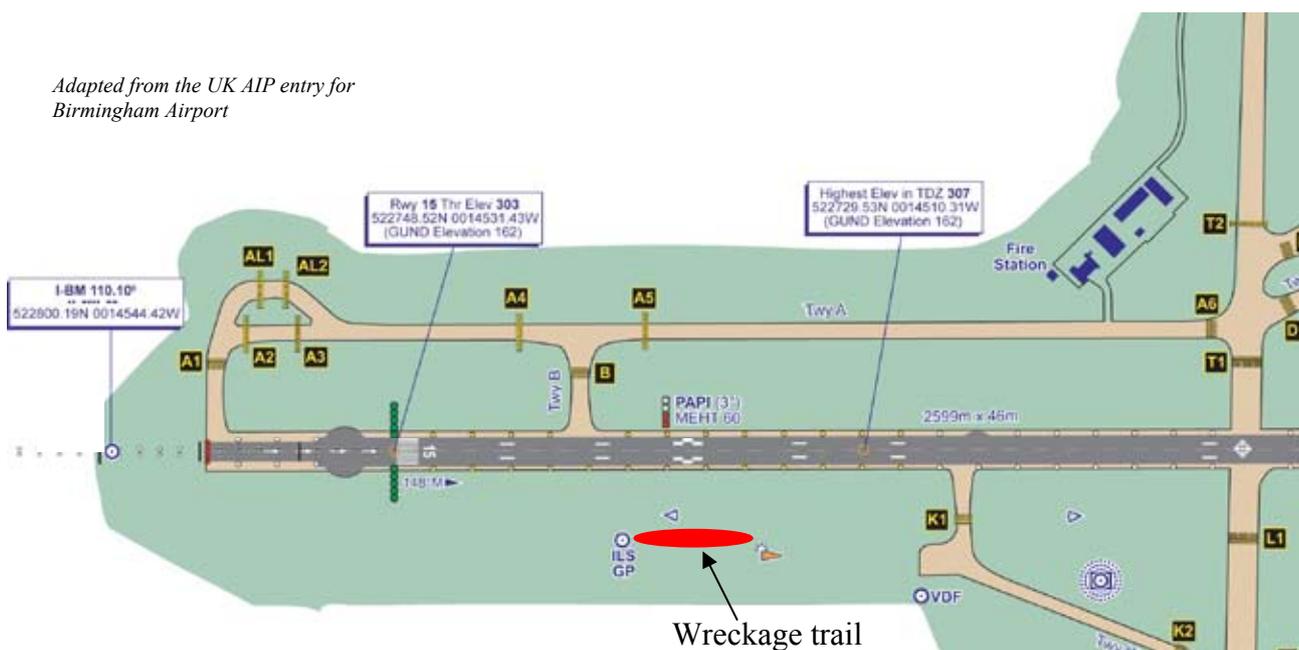
Figure 1

Accident site location

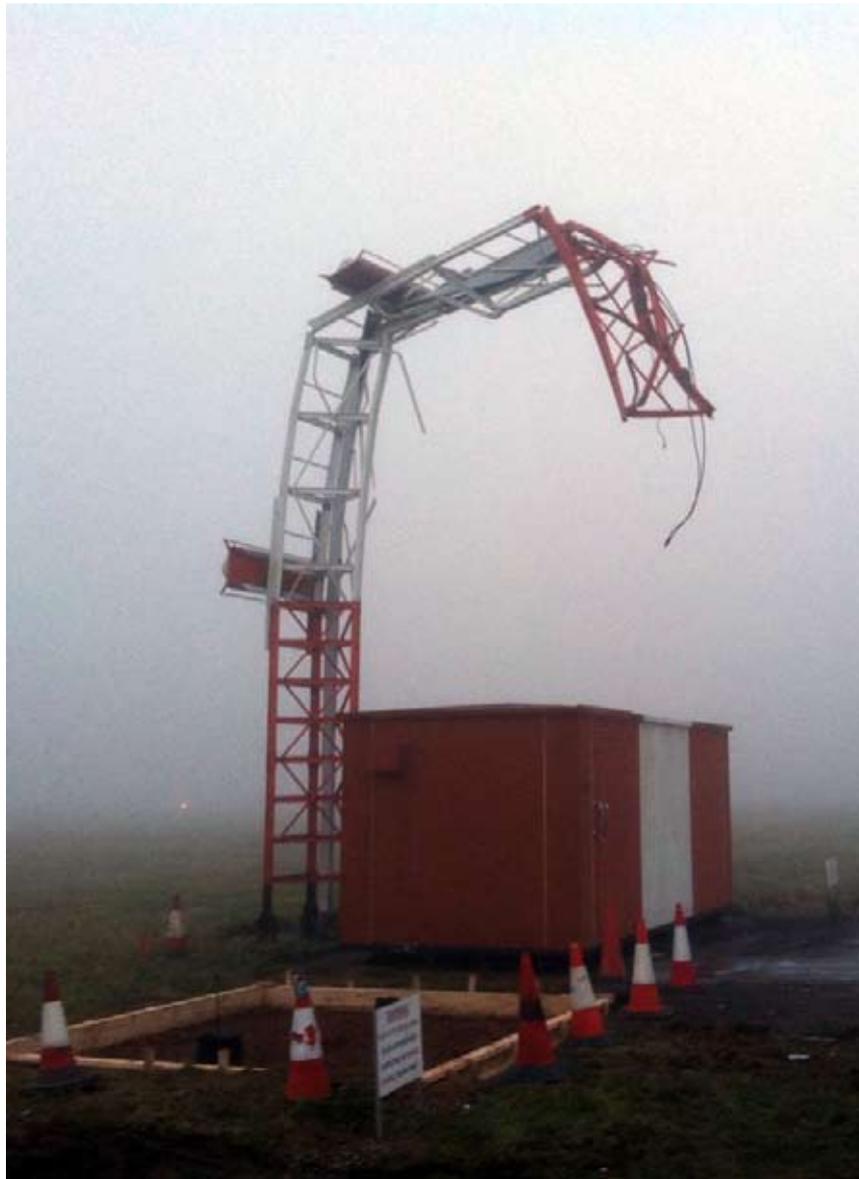
Figure 2

The Runway 15 ILS glideslope antenna tower, which was 15 m tall prior to the accident, had sustained extensive damage due to being struck by the aircraft approximately 1 m from the top of the tower. The uppermost antenna had been detached from the tower during the impact, and the tower had been bent backwards by approximately 170°. The position light mounted at the top of the antenna tower had been torn off, exposing live electrical cables.

Runway 15 ILS glideslope antenna tower after the accident

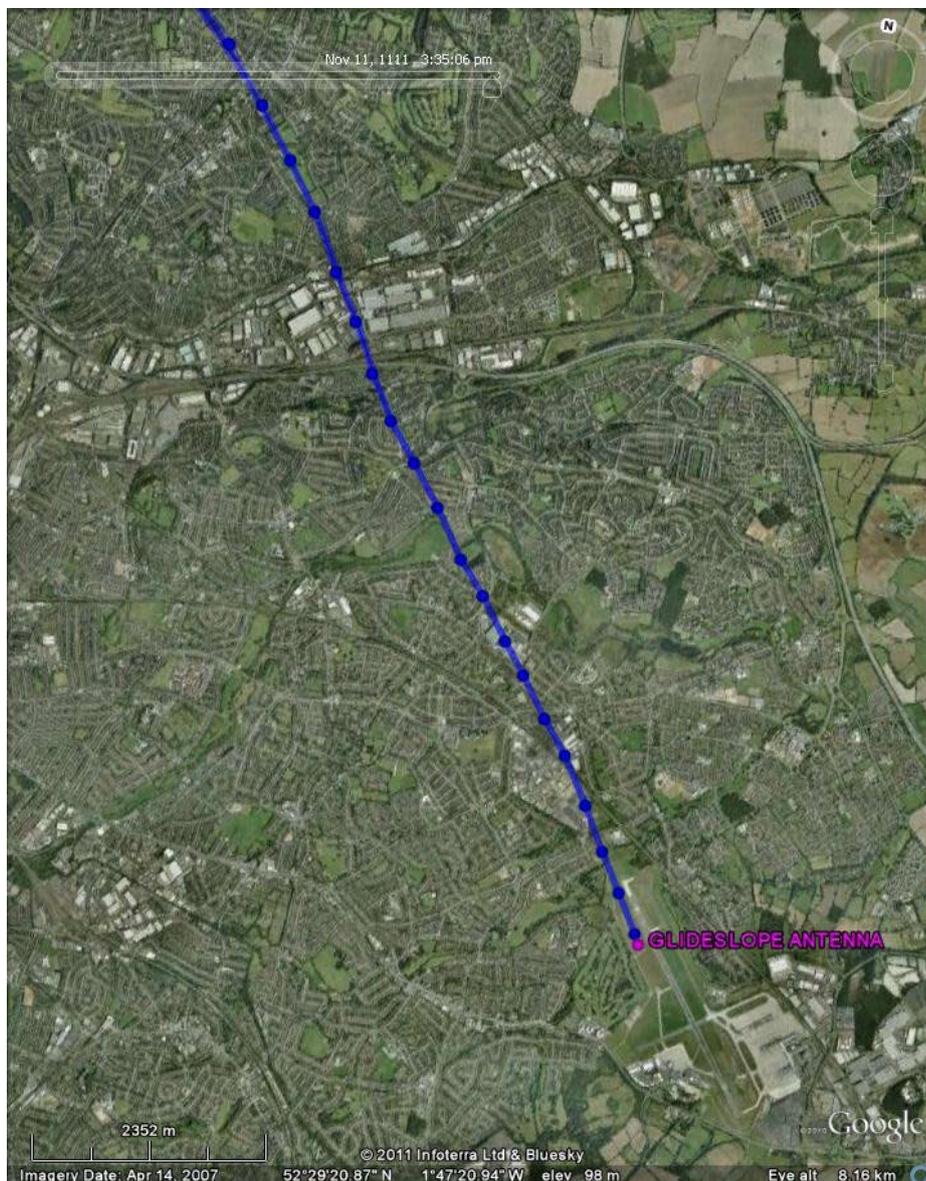
The aircraft was fitted with a Mode S transponder, so this radar data included altitude information which, for this installation, had a resolution of ± 50 ft. Figure 3 illustrates the approach to Runway 15 from about 5 nm out, with the last radar return (1535 hrs) placing the aircraft about 100 m from the glideslope antenna (shown).

Approach to Runway 15 from about 5 nm of G-VUEM based radar information

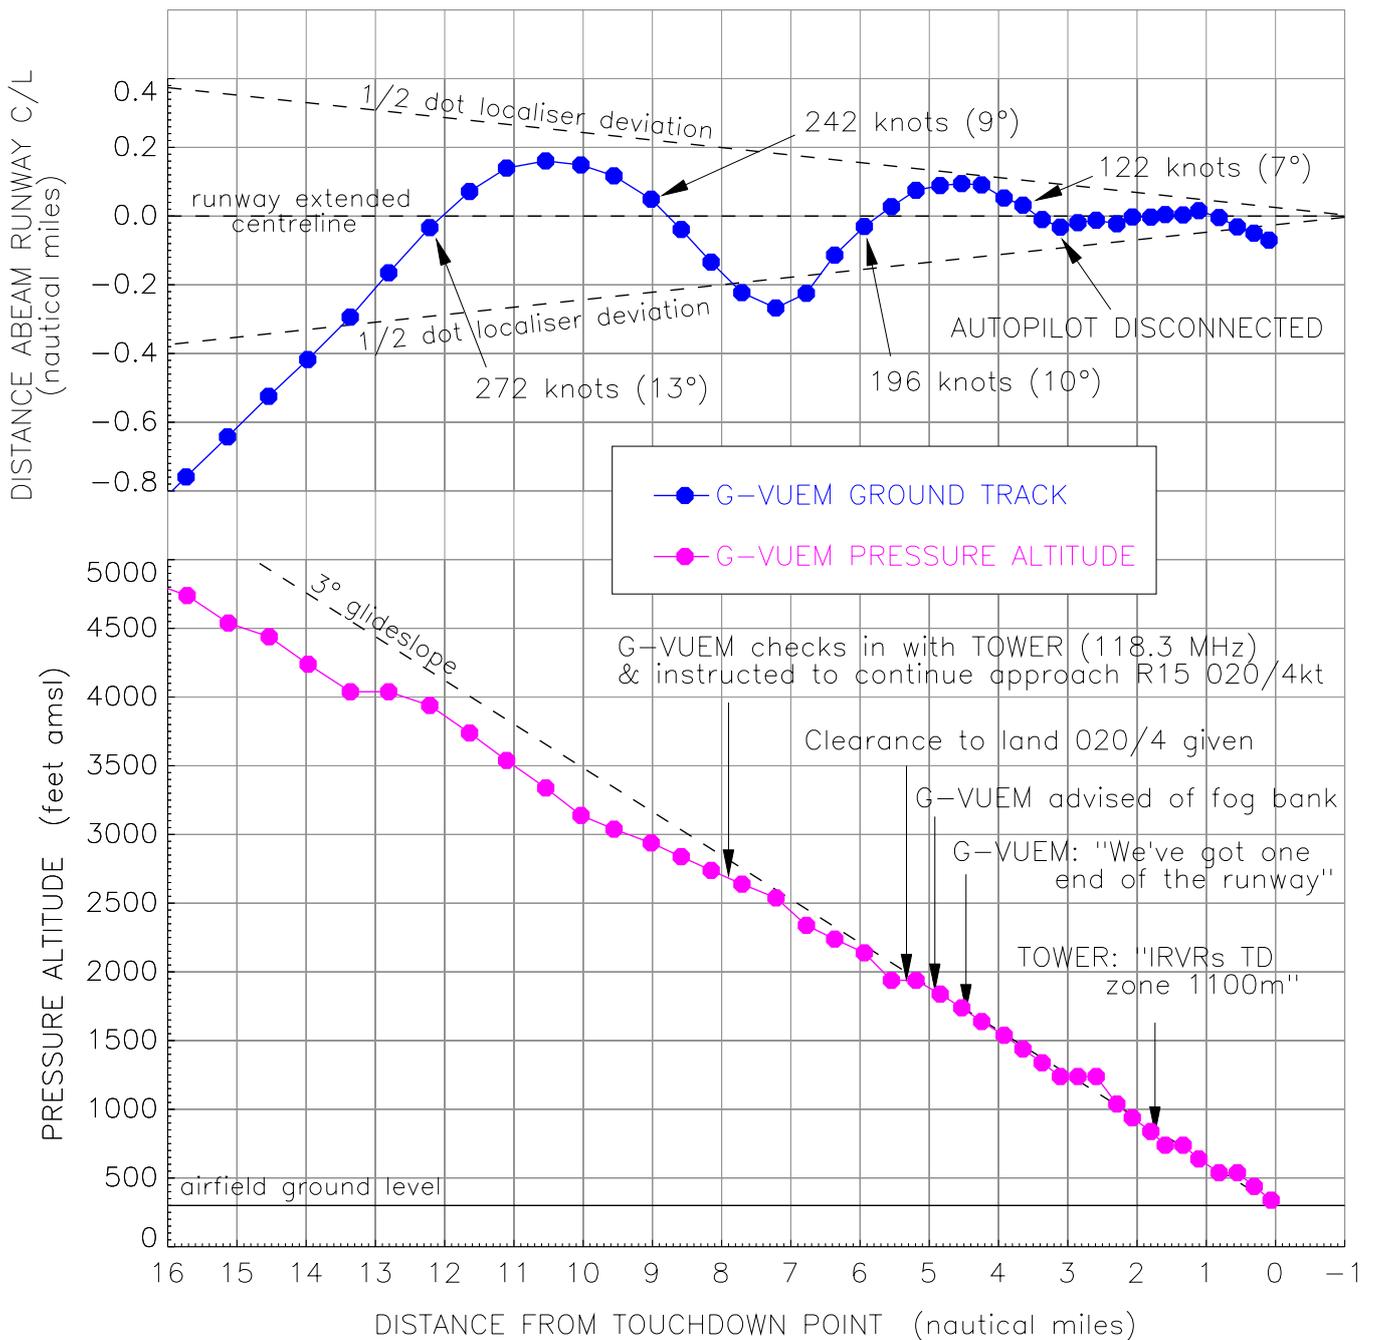
Figure 4 plots the approach of G-VUEM relative to the 3° glideslope and localiser ($\frac{1}{2}$ dot deviation lines are indicated). The aircraft's (calculated) groundspeed and intercept angle at the points where the track crosses the runway centreline are also shown, together with any significant R/T extracts. With about 3 nm to touchdown, there is a reduction in the precision and predictability of the flight path, consistent with a change from autopilot to manual flying. This point is highlighted.

The position and height of G-VUEM relative to the glideslope and localiser (based on radar information) during the approach to Runway 15

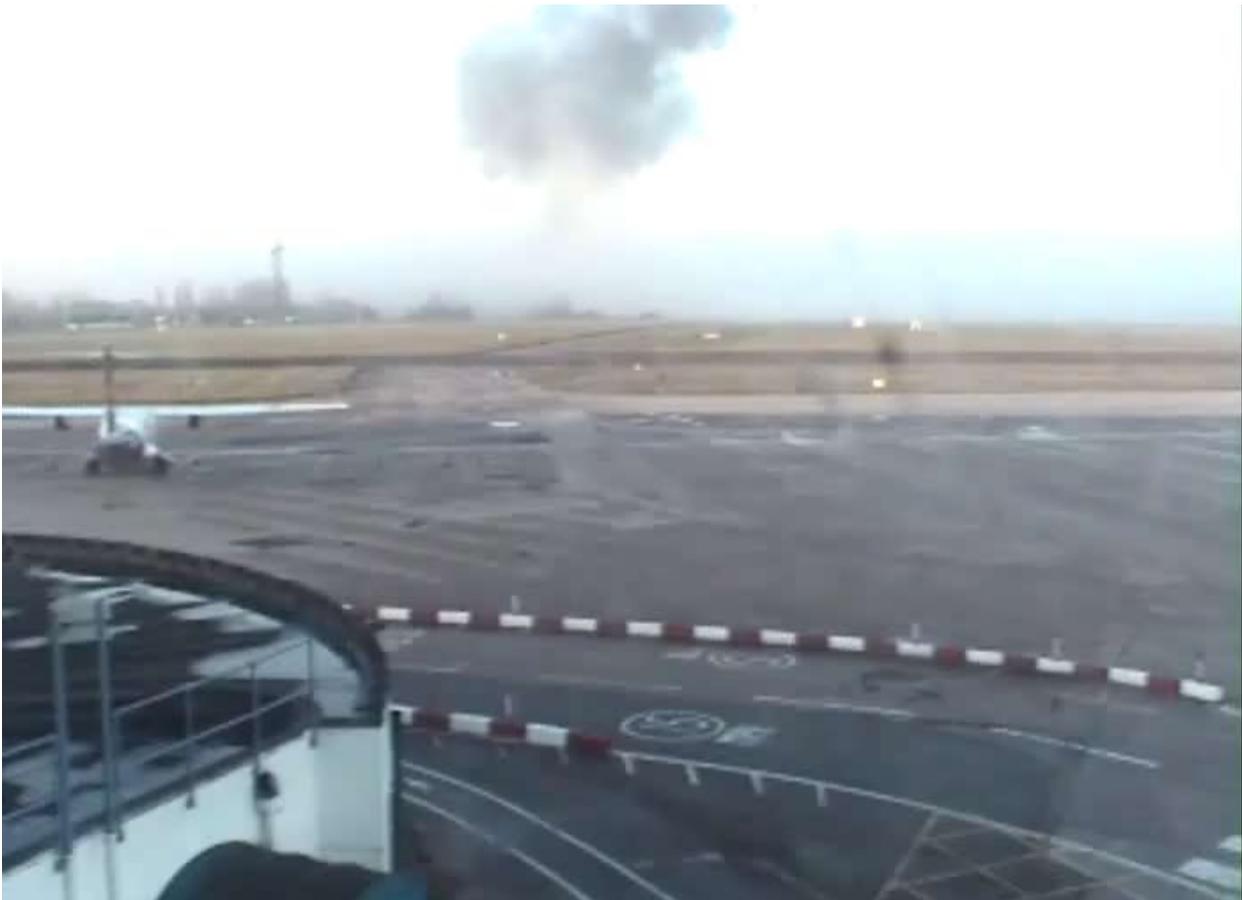
Figure 5

Frame from CCTV footage showing the fog bank and mushroom cloud from the post-crash fire

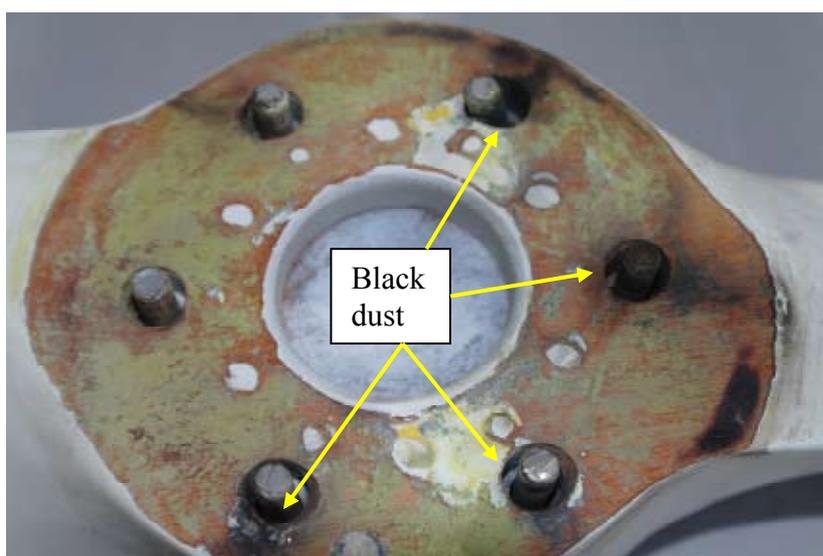
Figure 1

the propeller to the attachment plate on the engine crankshaft had all failed at the end of the threaded portion. The remaining threaded portion of the bolts remained in the inserts (lugs) fitted to the attachment plate. An examination of the fracture surfaces on two of the bolts revealed evidence of fatigue cracking emanating from the threads, with the bolt finally failing in ductile overload. Other bolts showed evidence of overload, one of which was covered in a black dust consistent with the oxidisation of fine particles that are generated when a bolt is subjected to fretting. The black dust was also apparent in three of the other holes through which the bolts were fitted, Figure 1.

Black dust around bolts.

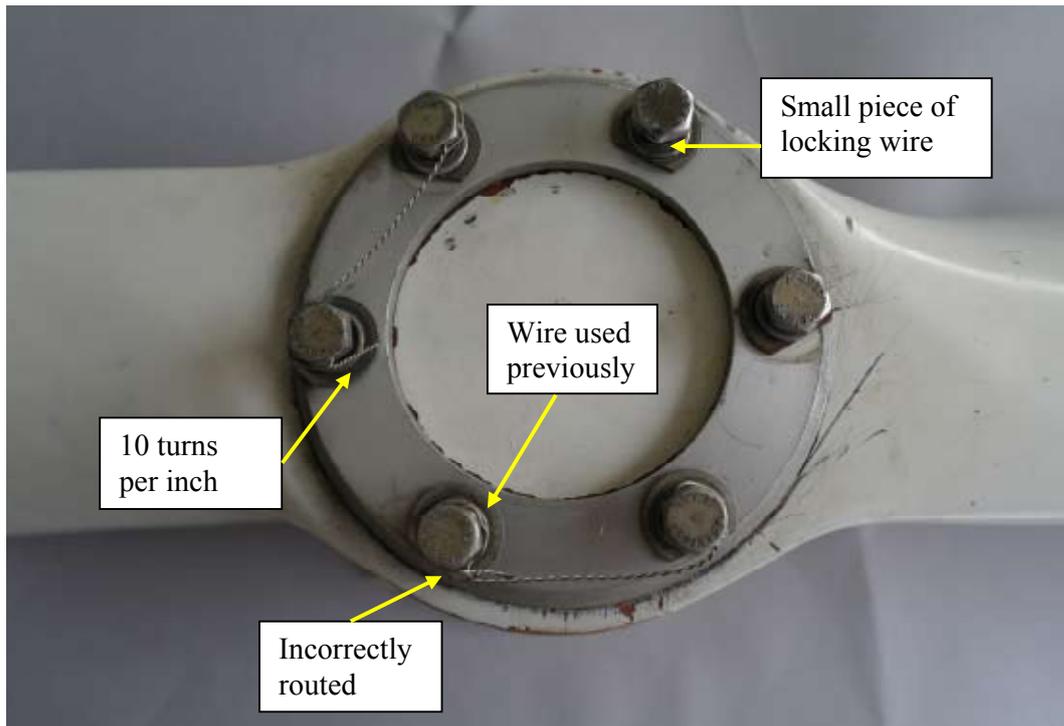
Figure 2

From a photograph of the heads of the bolts, taken after the spinner was removed, it can be seen that only two pairs of the bolts had been wire locked; however, a small piece of locking wire remained in the hole in the head of one of the unlocked bolts, Figure 2. The wire locking of one pair of bolts was incorrectly routed and the distortion of the wire around the head of one of the bolts indicated that this section of wire had been twisted at least once before. There were approximately 6 twists

Wire locking on propeller bolt heads

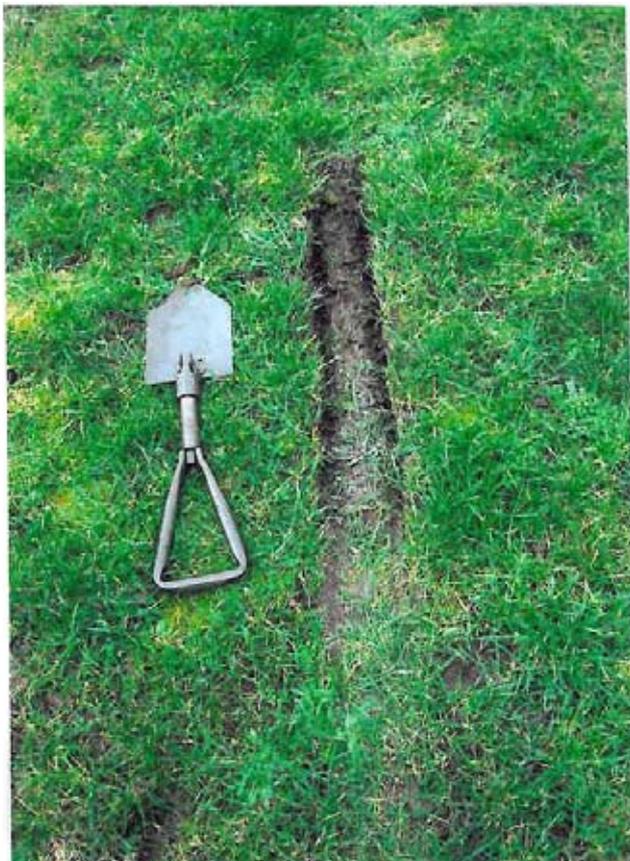
After consultation with other pilots and the aircraft owner, the pilot considered that the most likely cause of the initial depression was the nosewheel sinking into soft ground, with the aircraft then pitching up as the wheel contacted firmer ground again. He considers

Figure 1
Initial depression

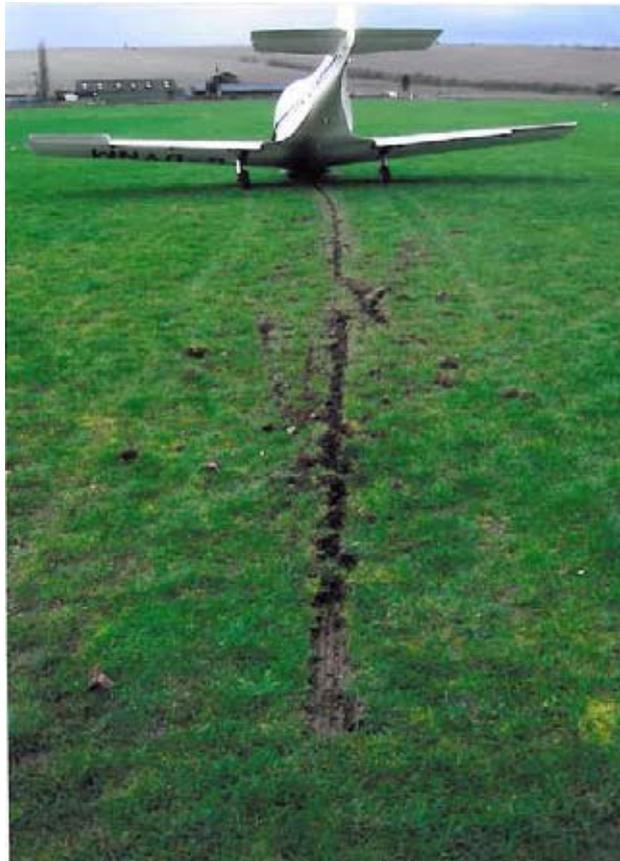
that this may have damaged the nose gear causing the nosewheel to detach, though he could not rule out pre-existing damage to the nose gear.

Figure 2
Ground marks
