## CONTENTS

### SPECIAL BULLETINS

S2/2011 Britten-Norman BN2A-26 Islander	VP-MON	22-May-11	1
---	--------	-----------	---

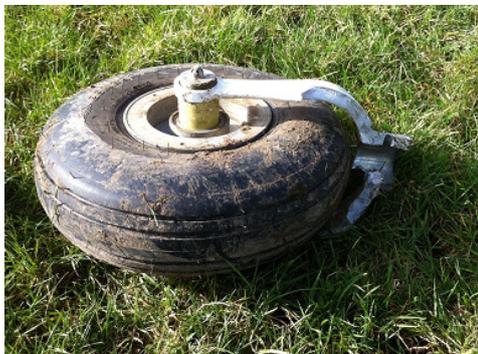
**Figure 2**  
Nosewheel

Photographs of the accident site provided to the AAIB show ground markings consistent with a heavy nosewheel touchdown (Figure 1). The nosewheel (Figure 2) was found approximately 10 m to the right of the runway centreline. Subsequent propeller strikes and a furrow caused by the nose landing gear leg contacting the ground are also evident (Figure 3).

The nosewheel yoke had fractured causing the nosewheel to separate from the landing gear. The fracture surfaces of the yoke were examined using a binocular microscope and a scanning electron microscope to determine the failure mechanism. Two distinct regions of fracture were evident indicating a two-stage failure process, resulting from overload of the component. It was concluded that a crack had initially propagated upwards from the base of the yoke due to tensile overload caused by excessive drag loading on the nosewheel. There was also evidence of compressive loading consistent with a hard landing. It is likely that the nosewheel buckled under the compressive loading after one of the bounces, causing compressive failure on one side of the yoke. Drag loading is likely to have arisen from the nosewheel impact shown in Figure 1; the depth of this mark also indicates the presence of significant compressive loading.

There was no evidence of fatigue propagation; nor were there any indications of pre-existing damage within the structure of the component.

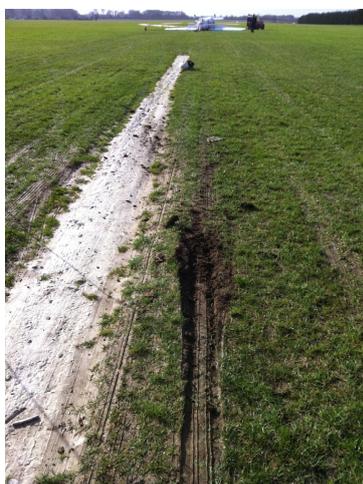
**Figure 1**  
Nosewheel impact mark

Ground marks indicate that the aircraft landed heavily on its nose landing gear after bouncing, causing the nosewheel to detach. The pilot elected to continue the landing rather than initiating a go-around and his attempts to correct the bounces were unsuccessful. Metallurgical examination of the failed nosewheel yoke did not reveal any evidence of fatigue propagation or pre-existing defects which may have contributed to its failure.
