CONTENTS

SPECIAL BULLETINS

(ALL TIMES IN THIS BULLETIN ARE UTC)

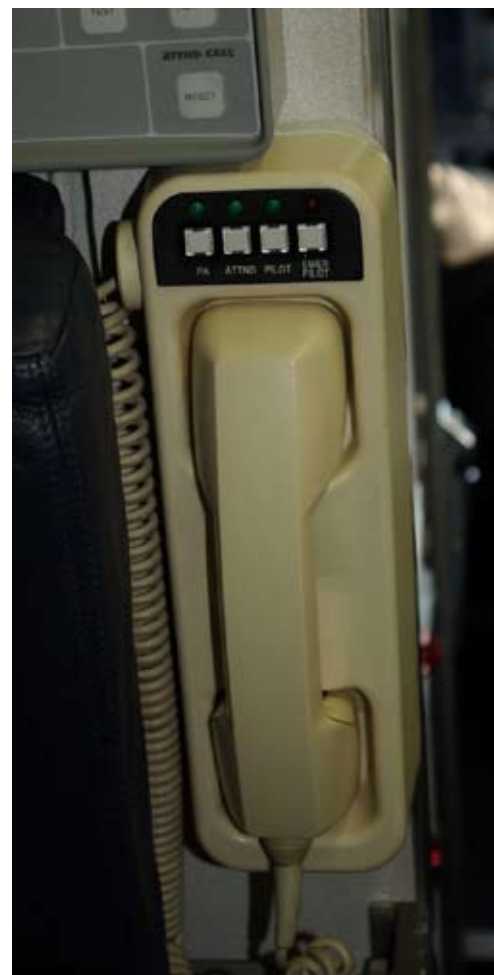
Figure 1

Cabin interphone handset at front galley

It is recommended that Embraer (Empresa Brasileira de Aeronautica SA) modify the functioning of the interphone systems of Embraer 190 family aircraft to provide crew with the facility to make both normal and emergency calls when the aircraft is supplied only with emergency electrical power.

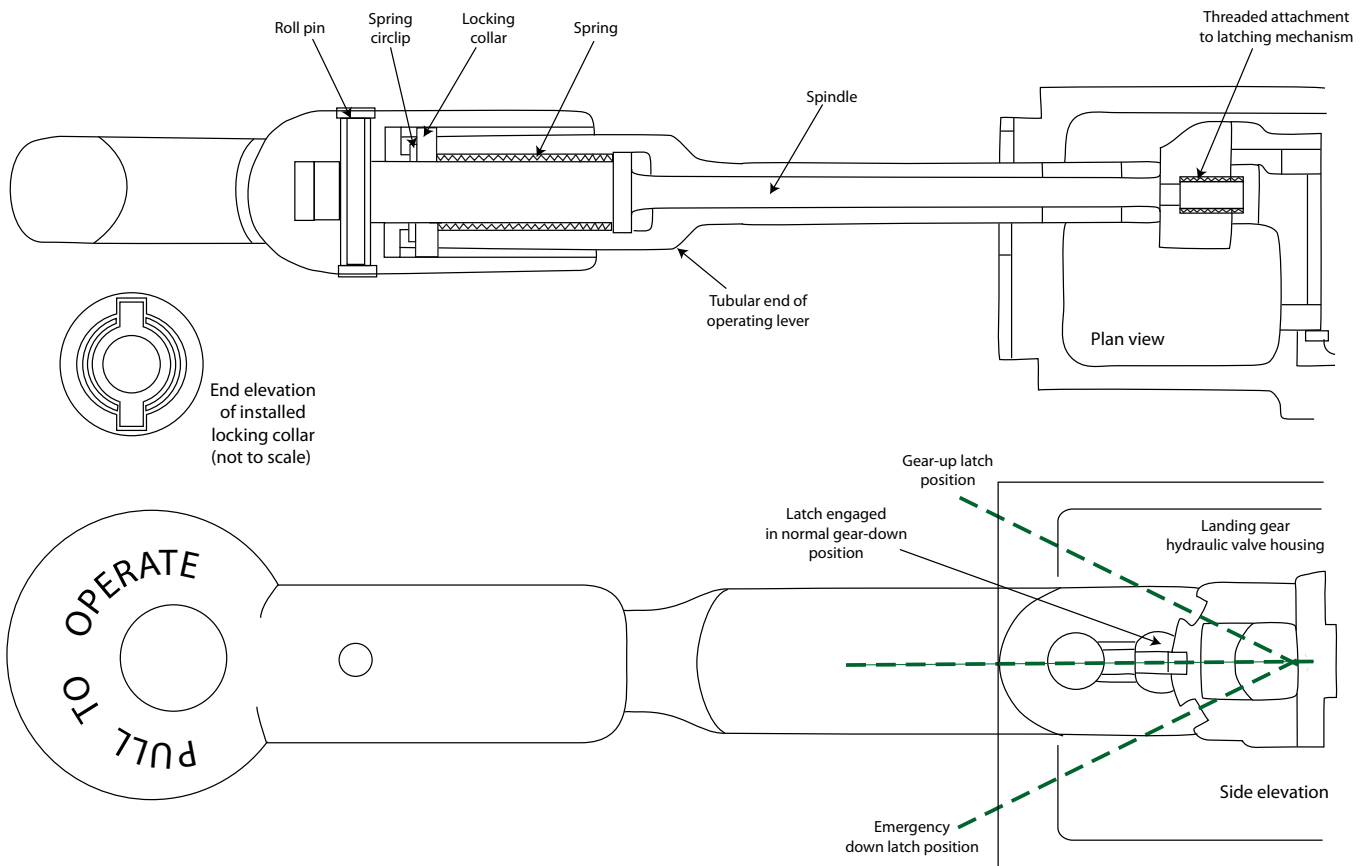
Figure 1
Landing gear selector assembly

The landing gear selector assembly was removed and examined by the component manufacturer in the presence of representatives from the aircraft manufacturer and the AAIB. On disassembly, it was found that the spring circlip had come out of its locating groove, permitting the locking collar to move longitudinally and disengage, freeing the handle and spindle to rotate. The circlip

and groove were undamaged and it was surmised that the circlip may have been incorrectly located during assembly of the mechanism. Records showed that the selector assembly had been overhauled by the component manufacturer approximately two years before the incident. There was no record of any difficulties having been experienced when assembling the unit. According to the aircraft maintenance records the unit had been recently fitted to G ELTE.

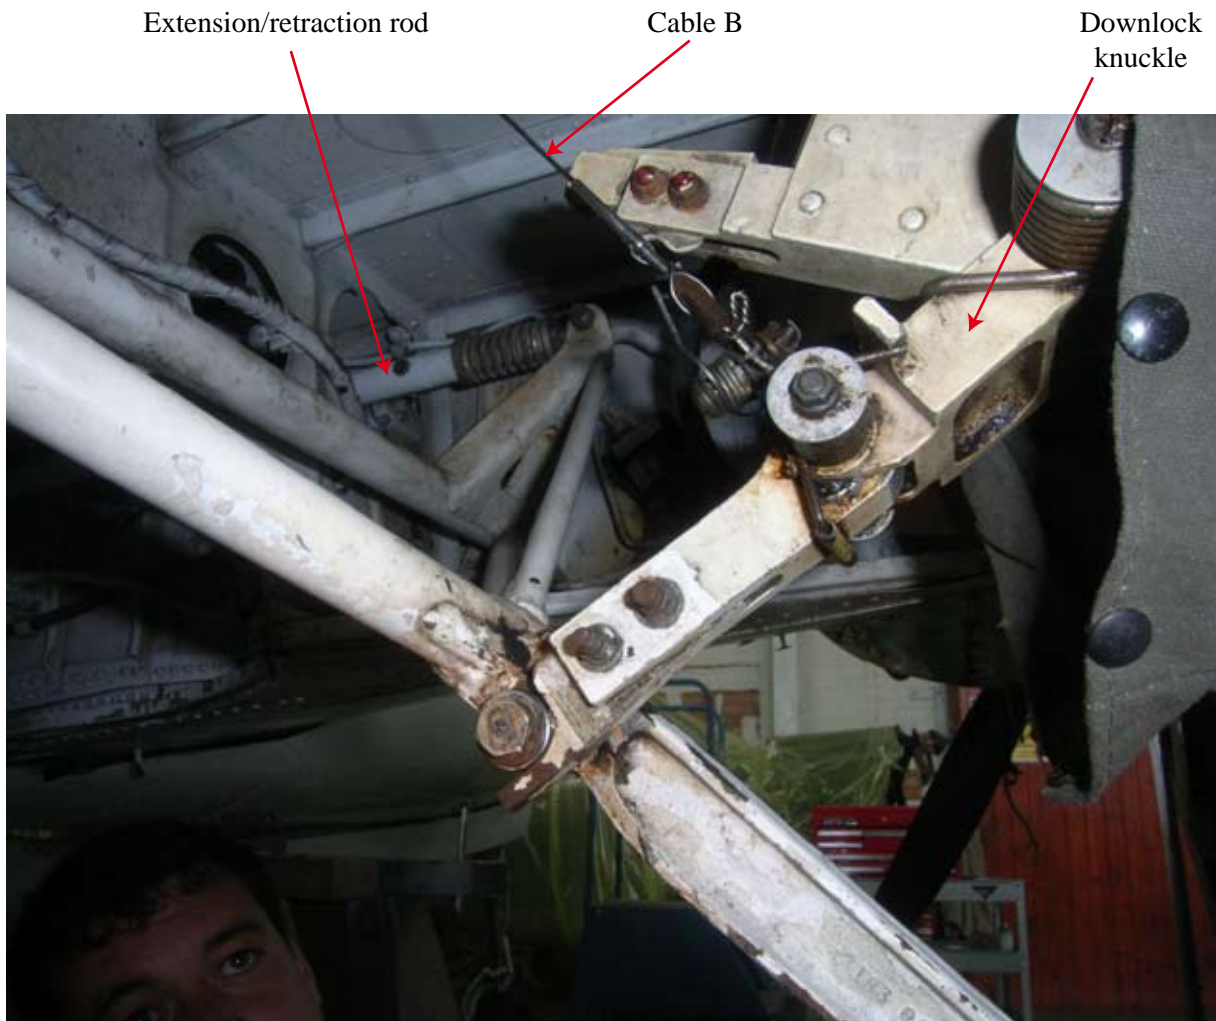
Figure 1
Gear down and locked

downlocked upon landing, the gear will start to fold and buckle the actuator rod, as it cannot backdrive the actuator. It will also damage the inboard door, which is only open during extension/retraction cycles.

Maintenance Manual (MM) requires this gap to be only 0.010 – 0.020 inches. In Figure 1 it can be seen that the secondary lock is hard up against the roller, whereas the MM specifies the same clearance. Both left and right gear rollers were found to have seized solid and could not be freed. A third roller of the same type in the nose landing gear mechanism was also seized.

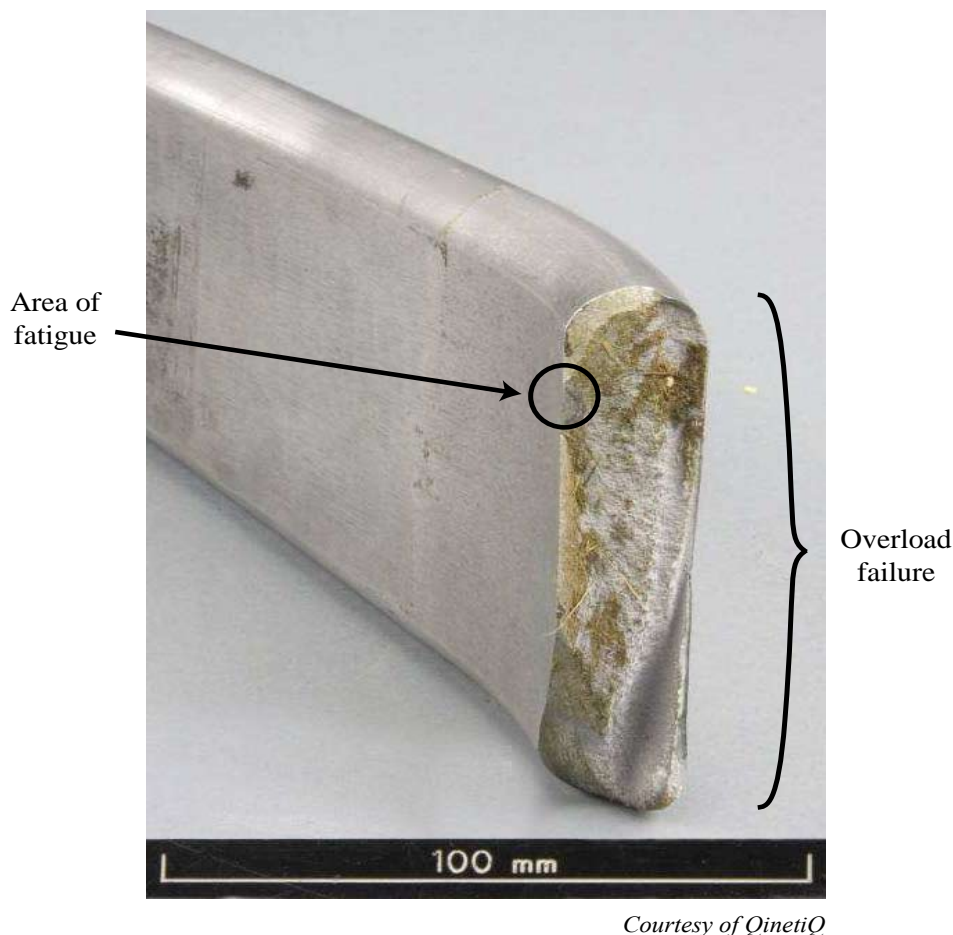
Figure 1

Initial examination of the failure surface of the aluminium landing gear indicated an area of fatigue (Figure 1).

Landing gear leg, G-CBUA
