CONTENTS

COMMERCIAL AIR TRANSPORT

(ALL TIMES IN THIS BULLETIN ARE UTC)

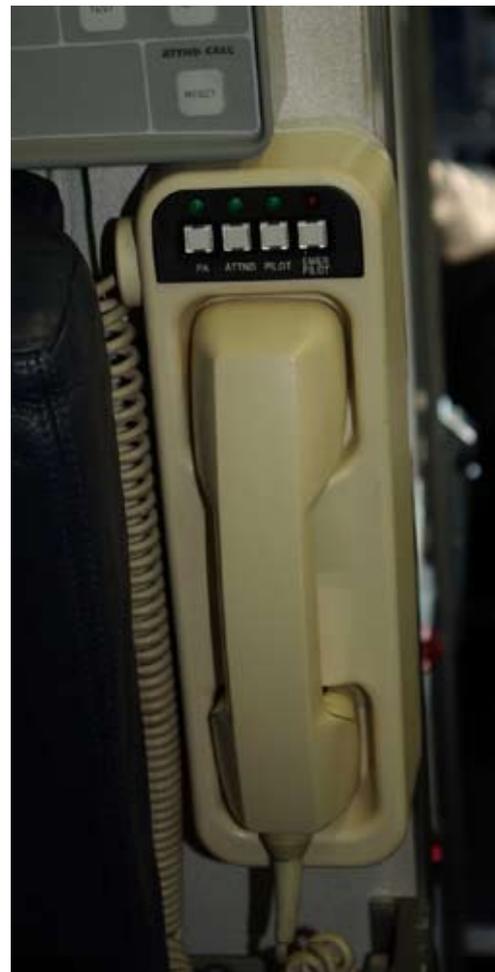
Figure 1

Cabin interphone handset at front galley

The interphone system includes handsets with illuminated pushbuttons at the forward and aft galleys (Figure 1) and illuminated push-buttons on audio panels in the flight deck (Figure 2). With normal power applied to the aircraft, removing the handset from its cradle and then pressing the PILOT call pushbutton above the handset causes a single chime to sound in the flight deck, and the CAB pushbuttons on the pilots' audio panels illuminate to show an incoming communication. Pressing the pushbutton on either pilot's panel enables voice communications. Pressing the EMER PILOT pushbutton on the handset causes a triple chime to sound in the flight deck, and the EMER pushbuttons on the pilots' audio panels illuminate to show an incoming communication. Pressing the pushbutton on either pilot's panel enables voice communications.

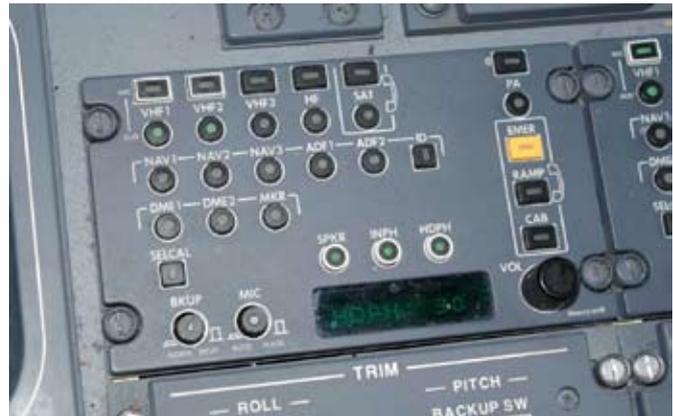
Figure 2

Pilot's audio panel in flight deck

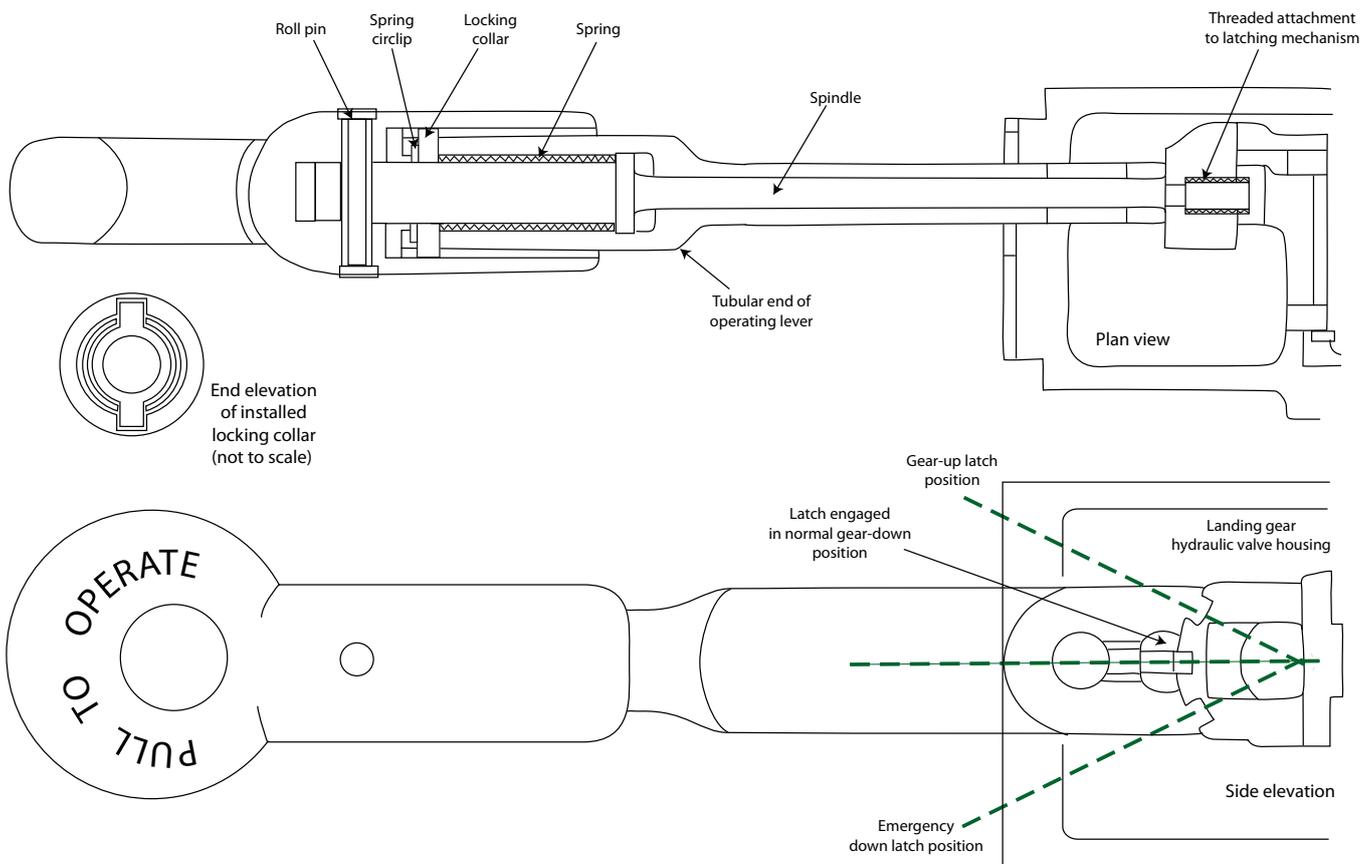
Figure 1
Landing gear selector assembly

The landing gear selector assembly was removed and examined by the component manufacturer in the presence of representatives from the aircraft manufacturer and the AAIB. On disassembly, it was found that the spring circlip had come out of its locating groove, permitting the locking collar to move longitudinally and disengage, freeing the handle and spindle to rotate. The circlip

and groove were undamaged and it was surmised that the circlip may have been incorrectly located during assembly of the mechanism. Records showed that the selector assembly had been overhauled by the component manufacturer approximately two years before the incident. There was no record of any difficulties having been experienced when assembling the unit. According to the aircraft maintenance records the unit had been recently fitted to G-ELTE.

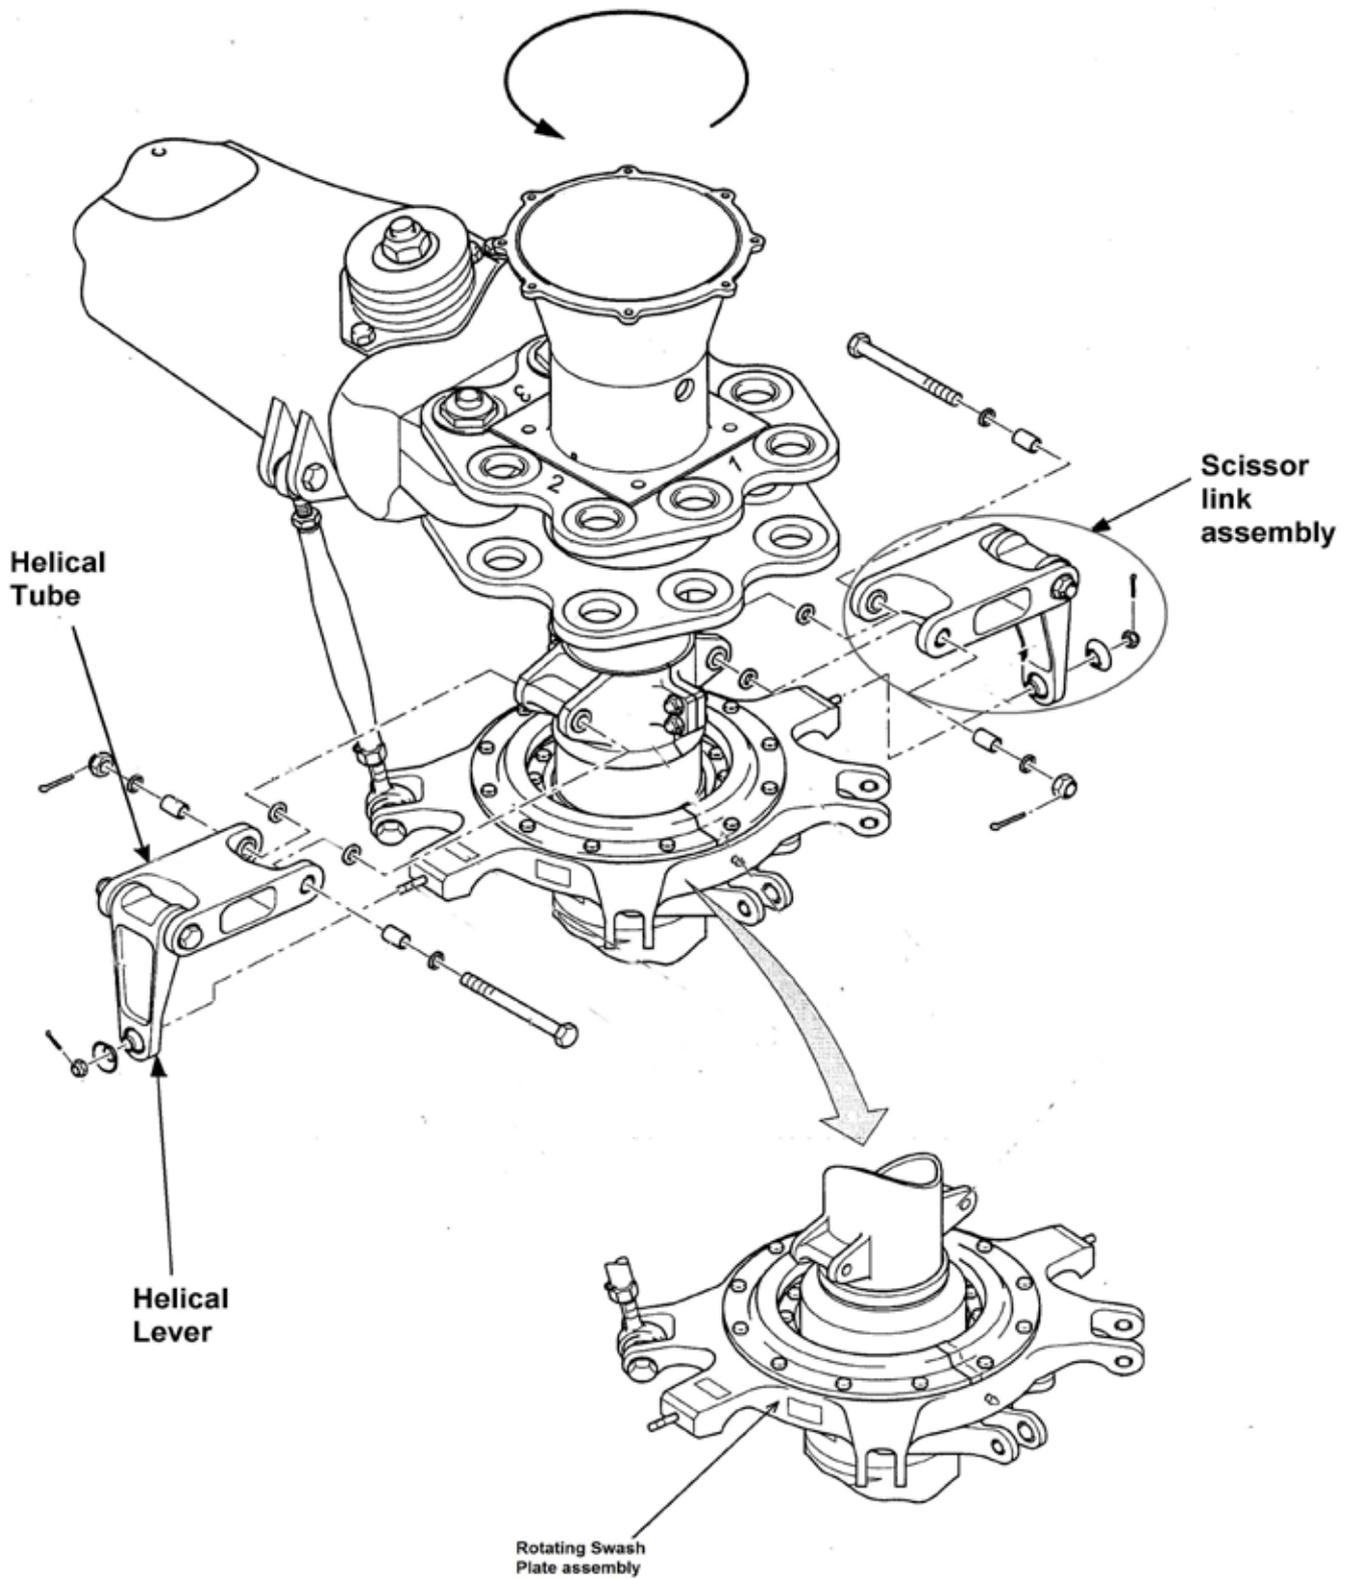
Figure 1
Rotor mast and scissor link assemblies

The EC135 is fitted with two identical scissor link assemblies, mounted on the main rotor mast (see Figure 1), which connect the rotating swash plate to the mast. Initial examination confirmed that one of the two scissor links (the one located between the yellow and green main rotor blades) had become detached from its mounting stud on the rotating swash plate. Damage was also found on the engine/gearbox cowlings, where the scissor link had struck them whilst rotating. No other damage was identified.

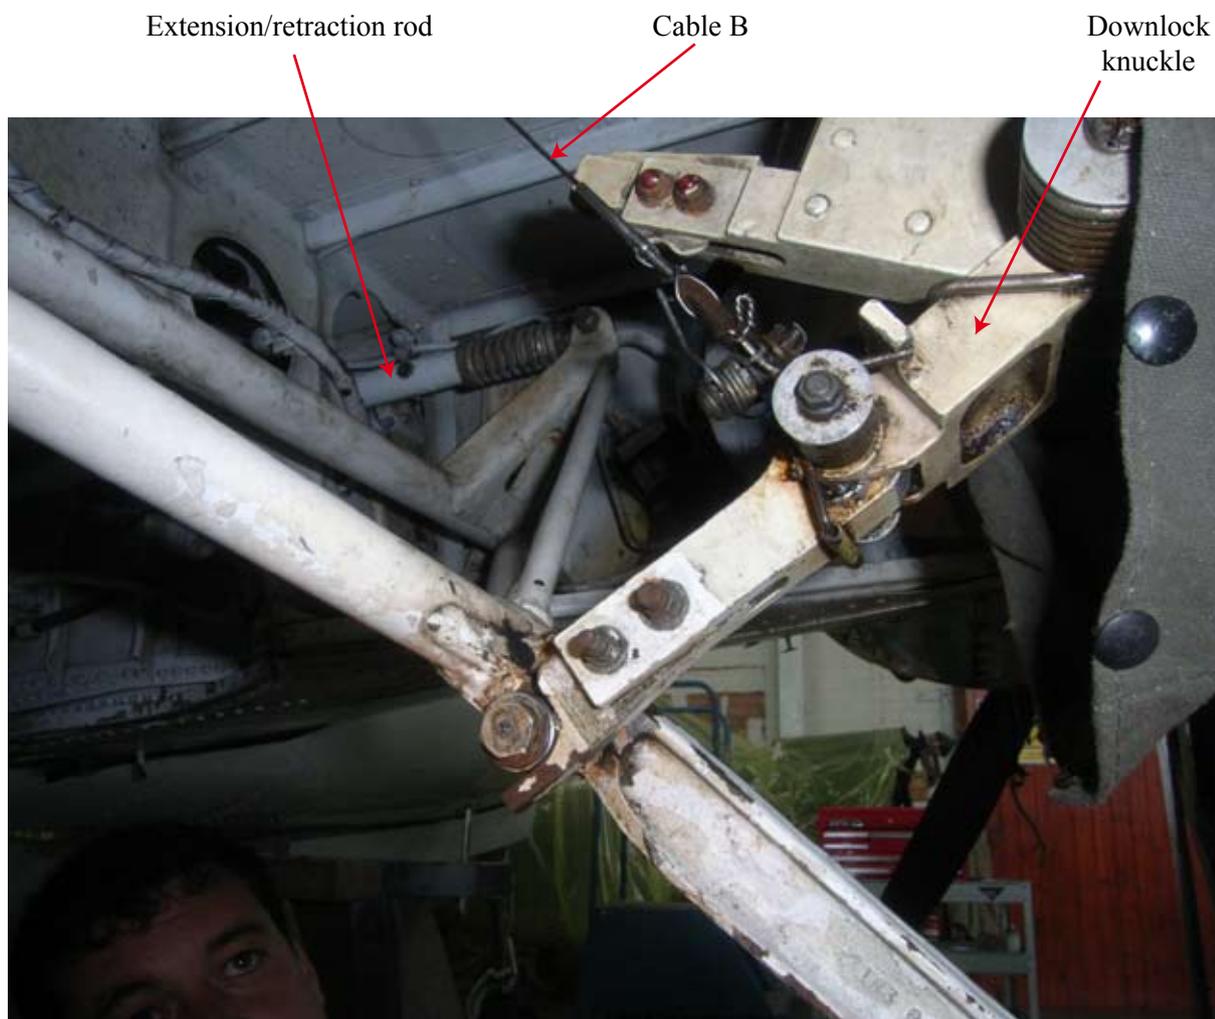
Figure 1
Gear down and locked

downlocked upon landing, the gear will start to fold and buckle the actuator rod, as it cannot backdrive the actuator. It will also damage the inboard door, which is only open during extension/retraction cycles.

Maintenance Manual (MM) requires this gap to be only 0.010 – 0.020 inches. In Figure 1 it can be seen that the secondary lock is hard up against the roller, whereas the MM specifies the same clearance. Both left and right gear rollers were found to have seized solid and could not be freed. A third roller of the same type in the nose landing gear mechanism was also seized.

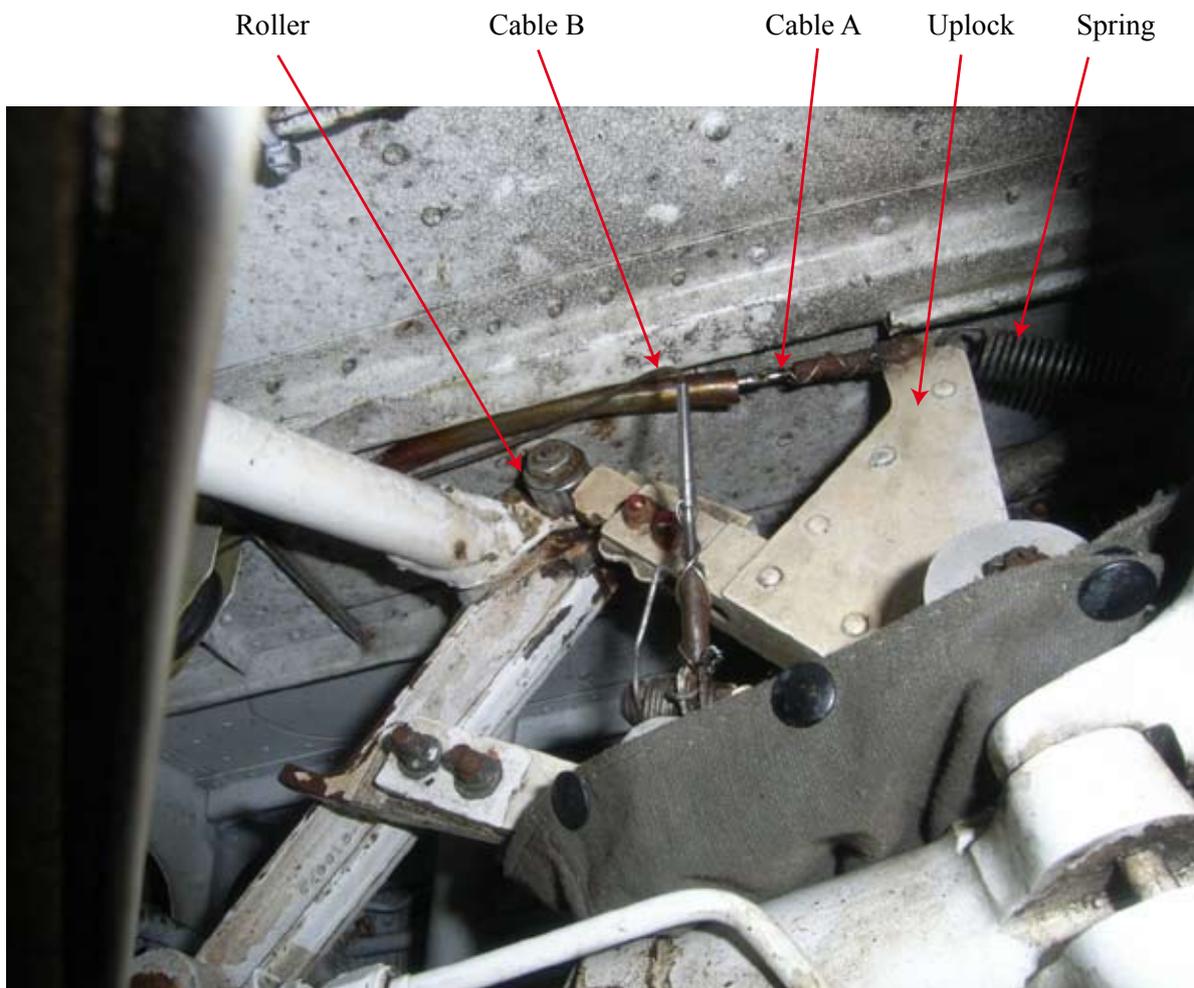
Figure 2
Gear up and locked

Figure 2 shows the right main landing gear of G-OSDI in the up-and-locked condition (doors removed for access): cable 'A' is tensioned and pulling the uplock against its spring under the roller. Although not apparent in the photograph, there was a clearance of about 0.25 inches between the uplock and the roller. The

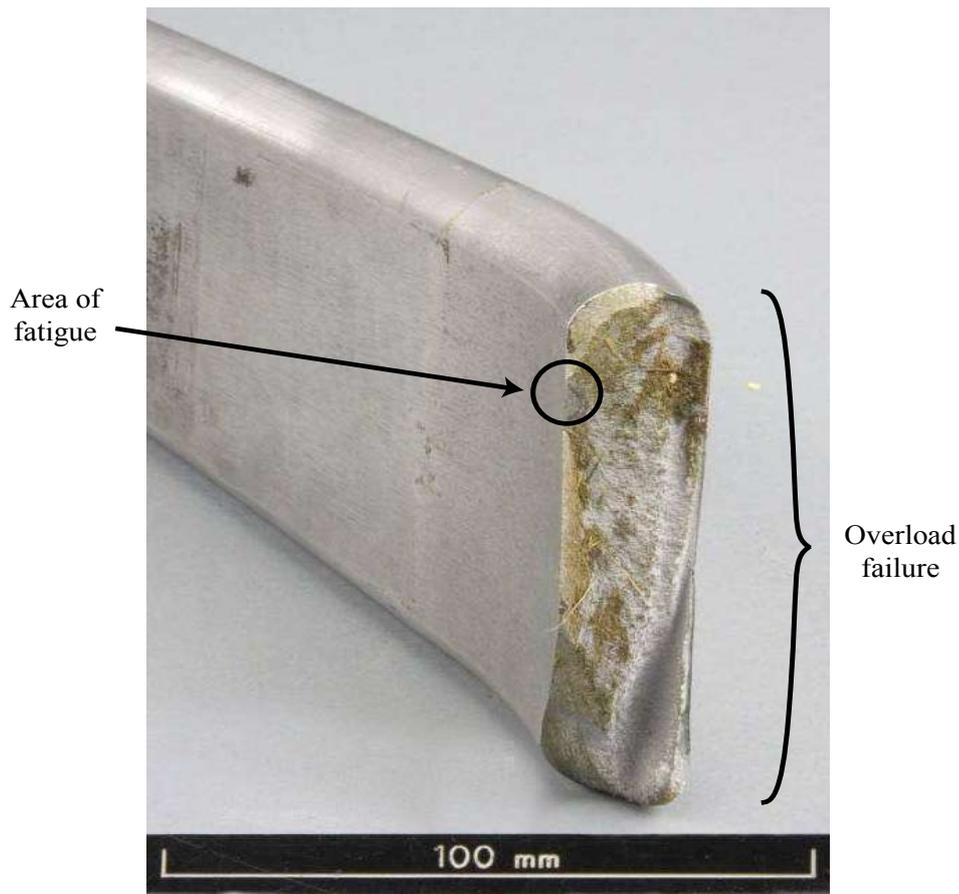
Figure 1

Initial examination of the failure surface of the aluminium landing gear indicated an area of fatigue (Figure 1).
