(ALL TIMES IN THIS BULLETIN ARE UTC)

**SERIOUS INCIDENT**

<b>Aircraft Type and Registration:</b>	Cessna 550 Citation II, G-JBIZ
<b>No &amp; Type of Engines:</b>	2 Pratt & Whitney Canada JT15D-4 turbofan engines
<b>Year of Manufacture:</b>	1979
<b>Date &amp; Time (UTC):</b>	14 March 2008 at 1433 hrs
<b>Location:</b>	On approach to Edinburgh Airport
<b>Type of Flight:</b>	Commercial Air Transport (Passenger)
<b>Persons on Board:</b>	Crew - 2                      Passengers - None
<b>Injuries:</b>	Crew - None                      Passengers - N/A
<b>Nature of Damage:</b>	None
<b>Commander's Licence:</b>	Airline Transport Pilot's Licence
<b>Commander's Age:</b>	32 years
<b>Commander's Flying Experience:</b>	5,450 hours (of which 750 were on type) Last 90 days - 200 hours Last 28 days - 52 hours
<b>Information Source:</b>	AAIB Field Investigation

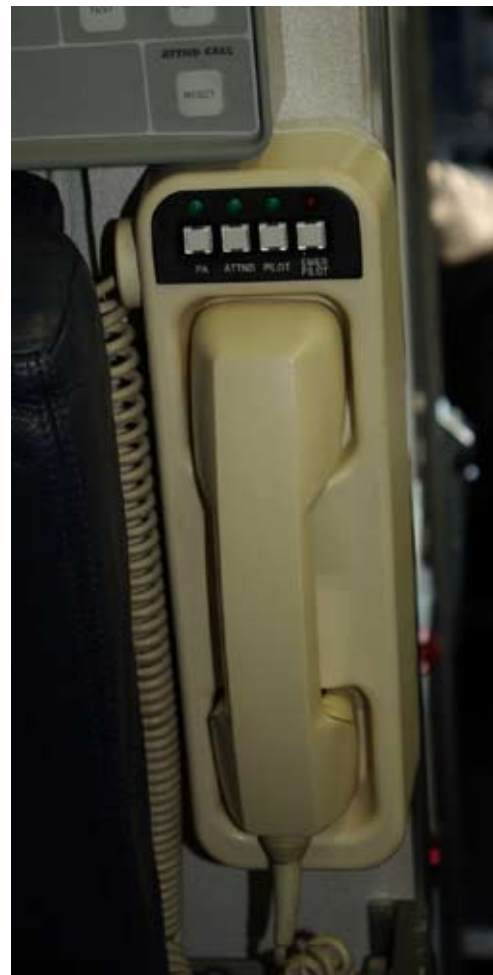
**Figure 1**

Cabin interphone handset at front galley

It is recommended that Embraer (Empresa Brasileira de Aeronautica SA) modify the functioning of the interphone systems of Embraer 190 family aircraft to provide crew with the facility to make both normal and emergency calls when the aircraft is supplied only with emergency electrical power.

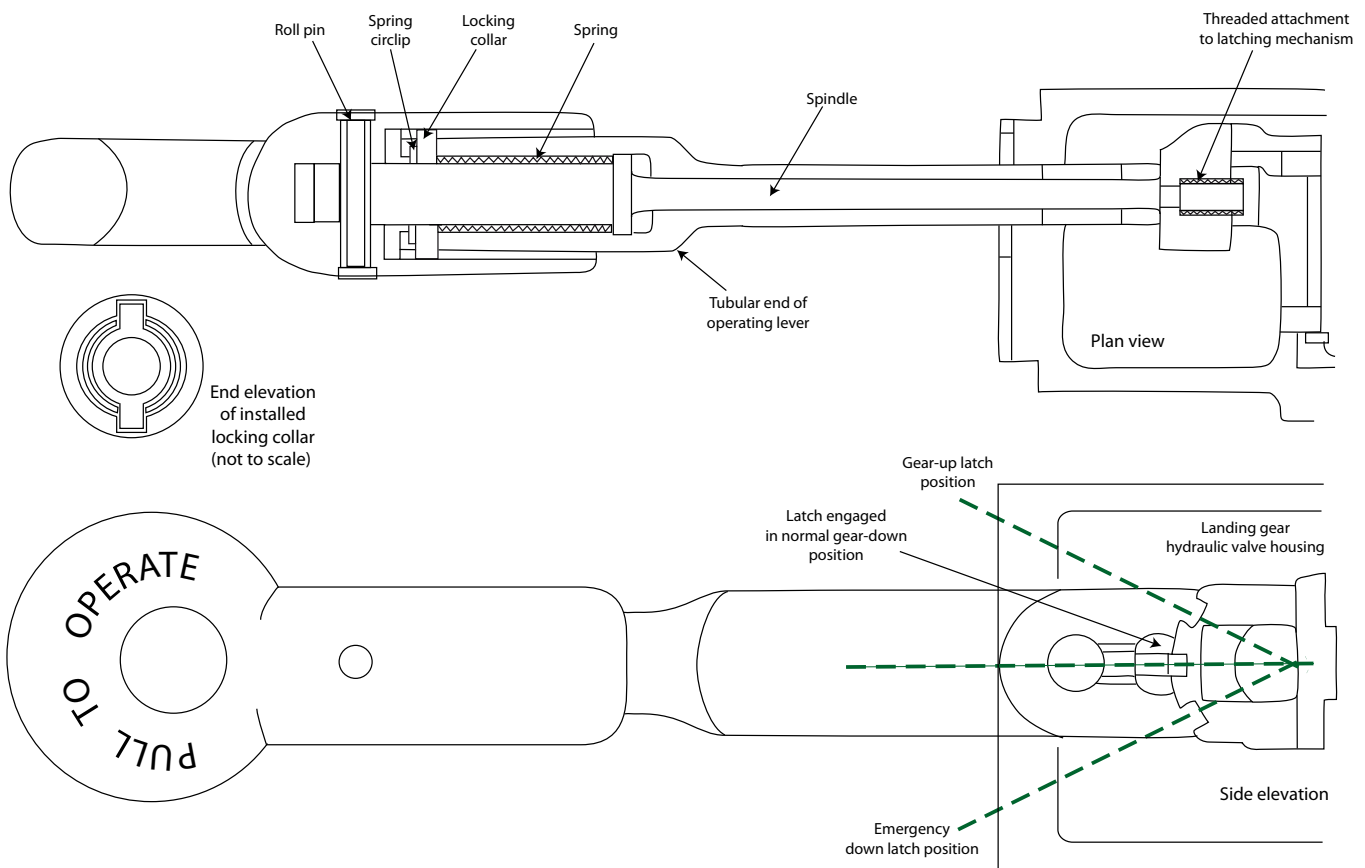
**Figure 1**  
Landing gear selector assembly

The landing gear selector assembly was removed and examined by the component manufacturer in the presence of representatives from the aircraft manufacturer and the AAIB. On disassembly, it was found that the spring circlip had come out of its locating groove, permitting the locking collar to move longitudinally and disengage, freeing the handle and spindle to rotate. The circlip

and groove were undamaged and it was surmised that the circlip may have been incorrectly located during assembly of the mechanism. Records showed that the selector assembly had been overhauled by the component manufacturer approximately two years before the incident. There was no record of any difficulties having been experienced when assembling the unit. According to the aircraft maintenance records the unit had been recently fitted to G ELTE.

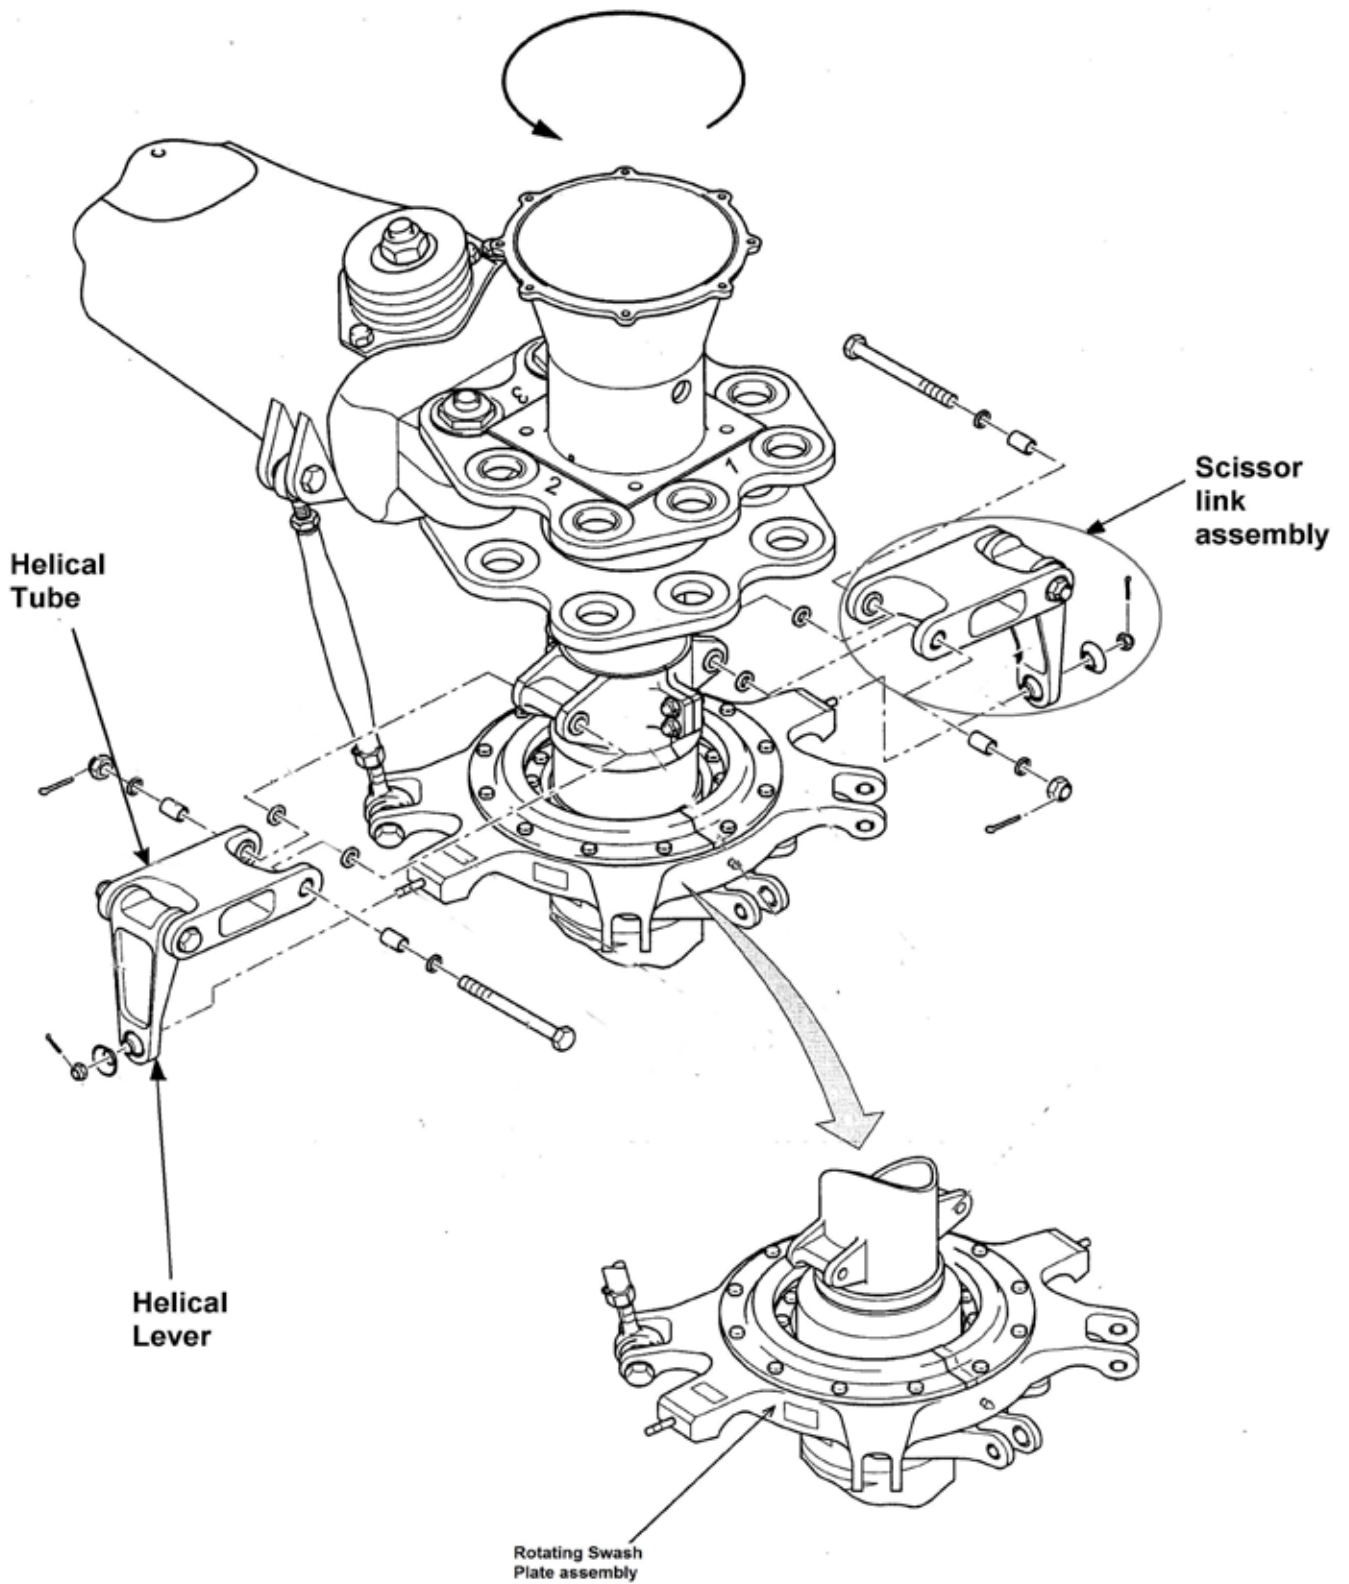
**Figure 1**

The EC135 is fitted with two identical scissor link assemblies, mounted on the main rotor mast (see Figure 1), which connect the rotating swash plate to the mast. Initial examination confirmed that one of the two scissor links (the one located between the yellow and green main rotor blades) had become detached from its mounting stud on the rotating swash plate. Damage was also found on the engine/gearbox cowlings, where the scissor link had struck them whilst rotating. No other damage was identified.

Rotor mast and scissor link assemblies

were installed in accordance with the manufacturer's Repair Design Approval Sheet (RDAS) 1756. After completion of this task an attempt to refit scissor link B to the rotor mast was made but it was found that the replacement bushes appeared to be too large to allow the helical tube to fit around its locating lug on the rotor mast. At this point scissor link A was completely removed for comparison purposes. This confirmed that the replacement bushings were oversized. Subsequent communication with the manufacturer revealed that the bushes required honing before installation, which was not detailed in the RDAS. It was not possible to remove the newly installed bushings without damaging them so a second, replacement set of bushings were ordered from the manufacturer and scissor link B remained uninstalled. Scissor link A was reattached to the rotor mast by Fitter 2, who fitted the castellated nut on the bolt and installed, but did not 'bend over' the split pin; this was subsequently done by LAE1. The helical lever of scissor link A was not attached to the rotating swash plate.

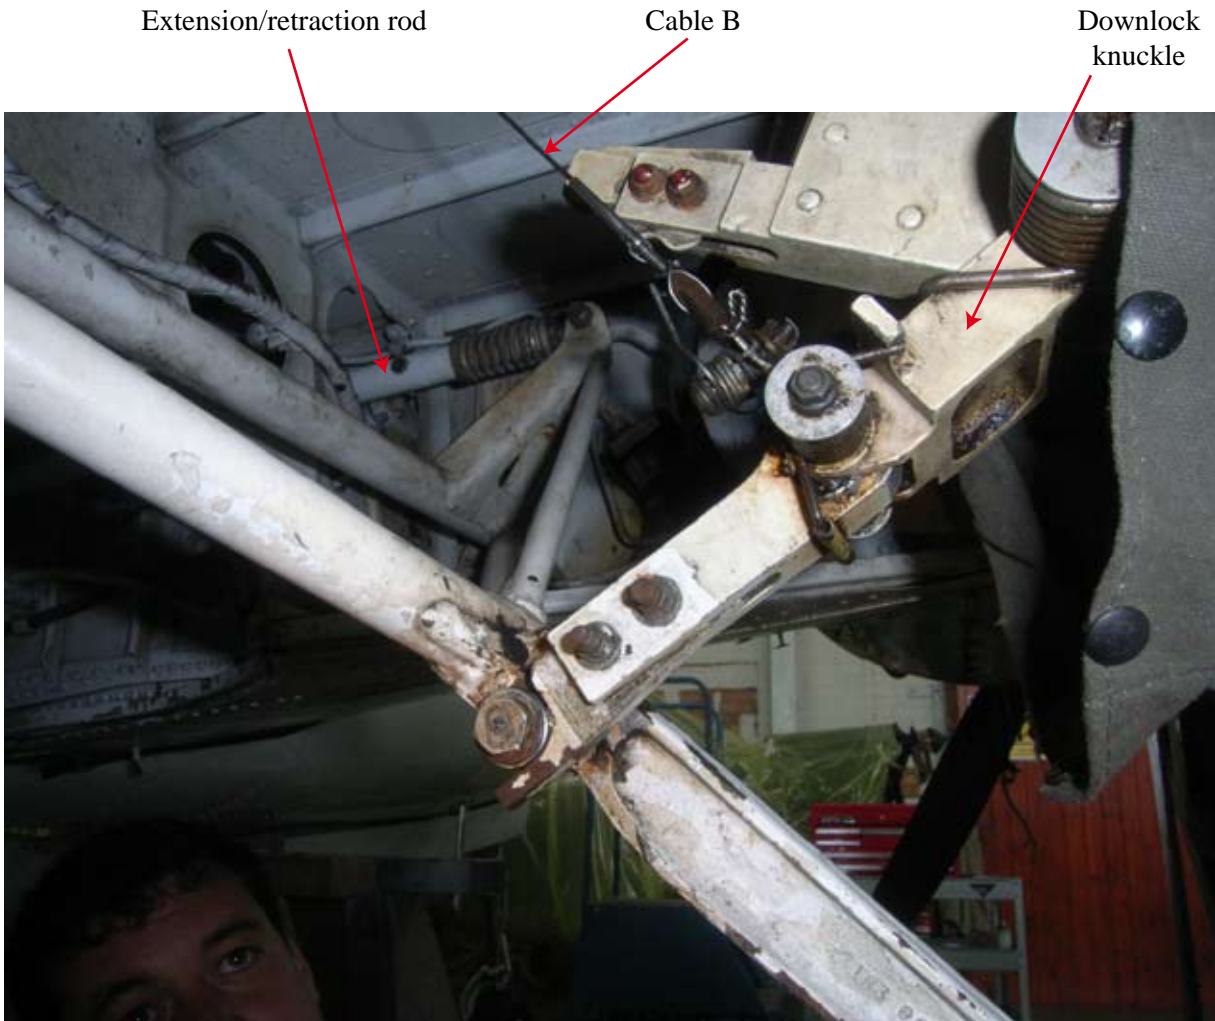
**Figure 1**  
Gear down and locked

downlocked upon landing, the gear will start to fold and buckle the actuator rod, as it cannot backdrive the actuator. It will also damage the inboard door, which is only open during extension/retraction cycles.

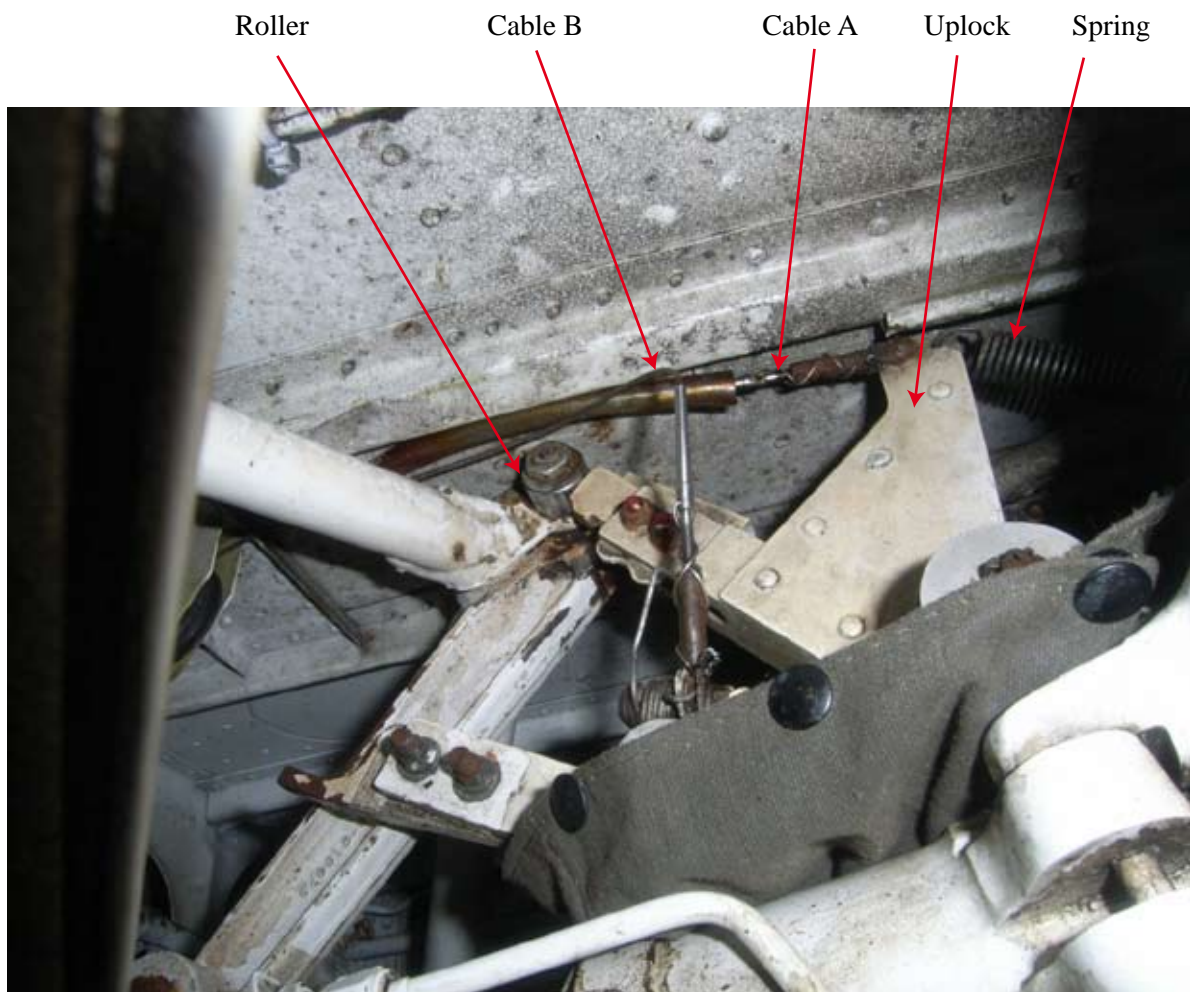
**Figure 2**

Figure 2 shows the right main landing gear of G-OSDI in the up-and-locked condition (doors removed for access): cable 'A' is tensioned and pulling the uplock against its spring under the roller. Although not apparent in the photograph, there was a clearance of about 0.25 inches between the uplock and the roller. The

Gear up and locked

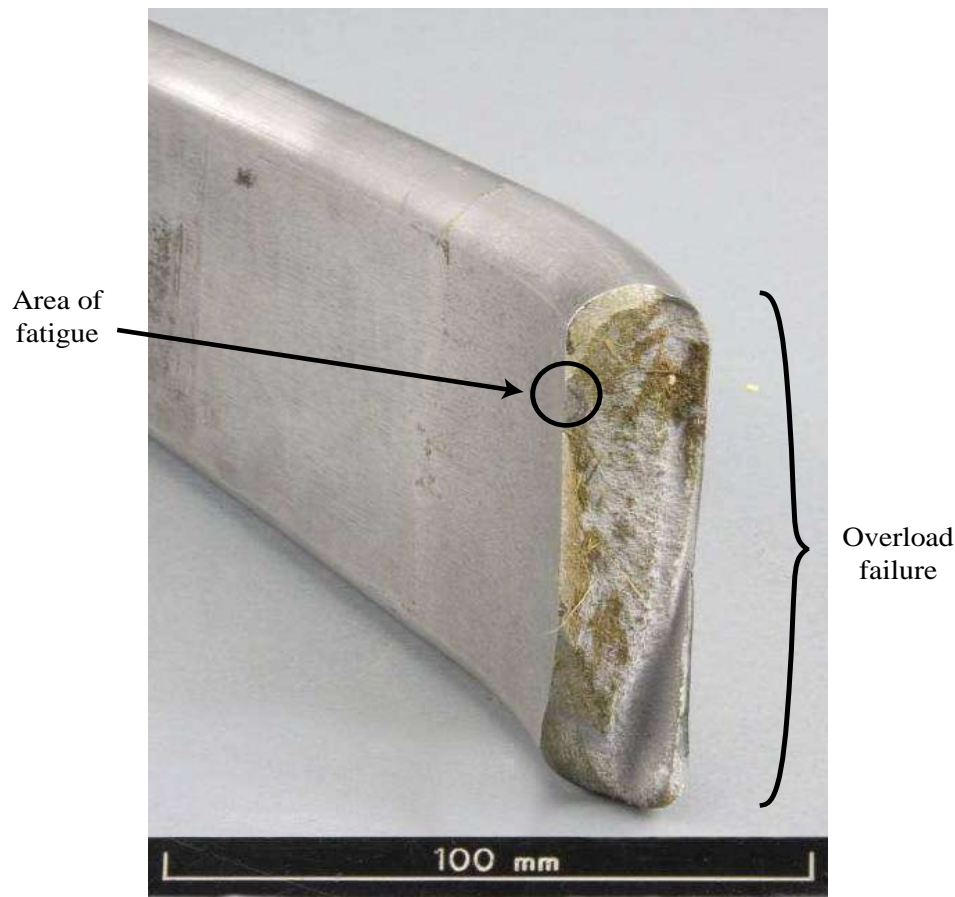
**Figure 1**

Initial examination of the failure surface of the aluminium landing gear indicated an area of fatigue (Figure 1).

Landing gear leg, G-CBUA
