CONTENTS

SPECIAL BULLETINS

COMMERCIAL AIR TRANSPORT

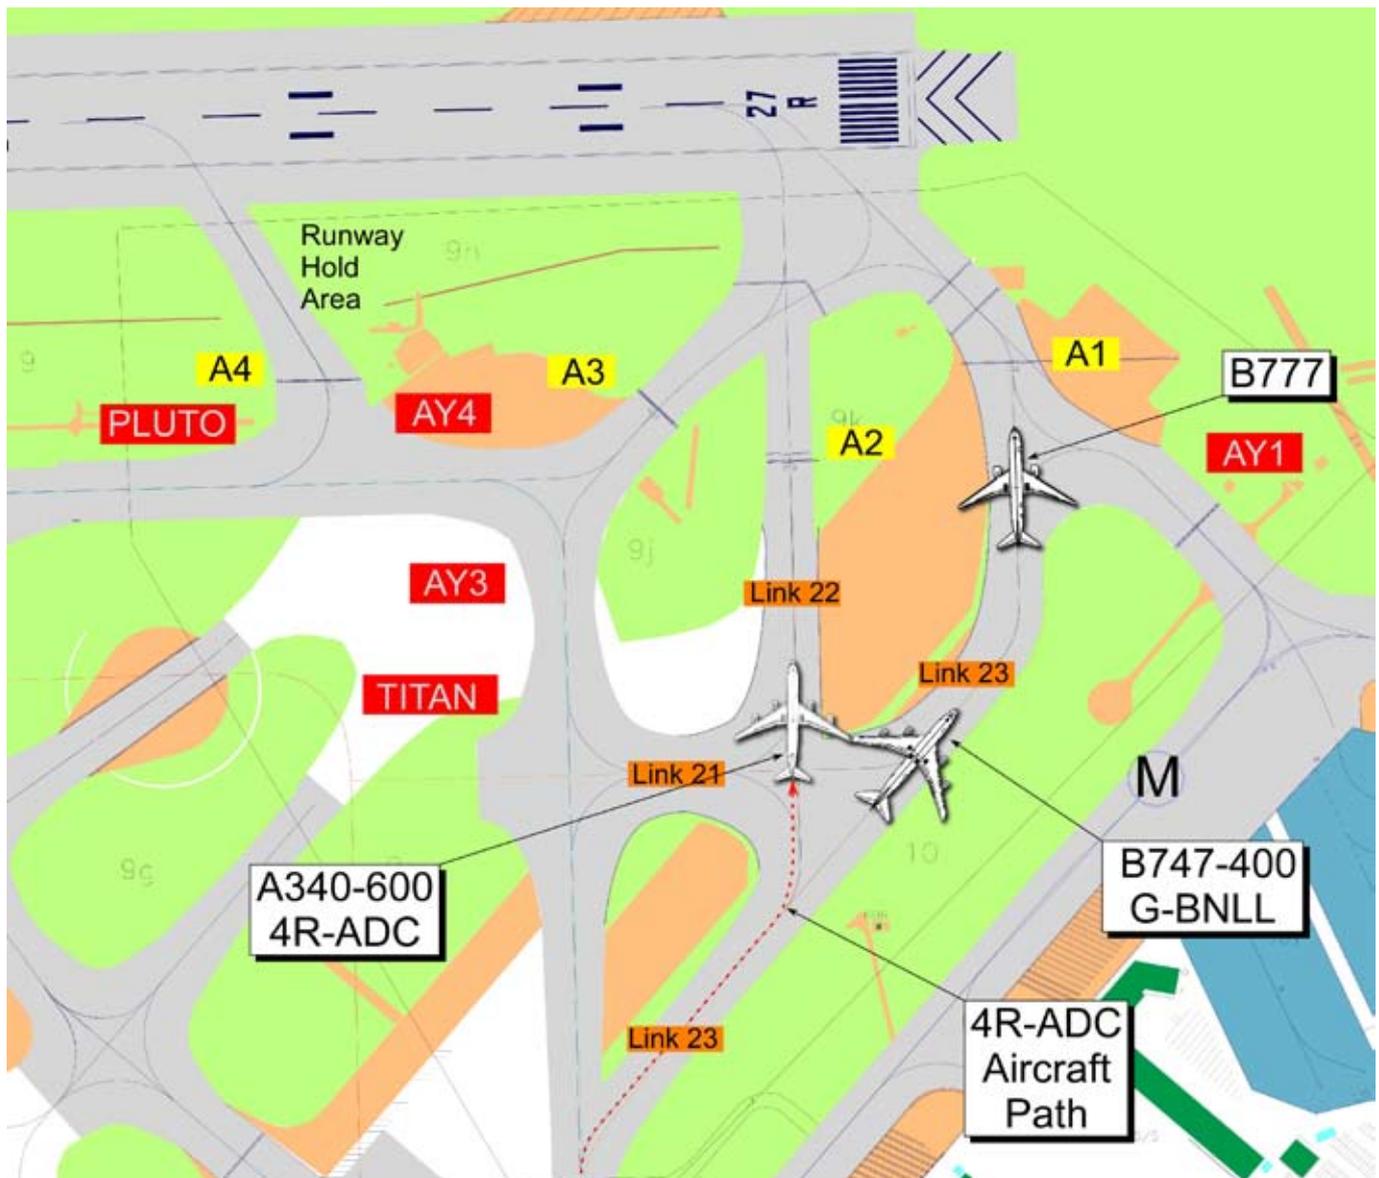
Figure 1

Point of collision at holding points for Runway 27R

The Boeing 747-400's left winglet had been severed approximately 1.7 metres from its tip. The winglet was subsequently replaced prior to the aircraft returning to service.

The Airbus A340-300 had a fractured right wing

navigation light assembly and some damage to the leading edge of the right winglet. The damaged winglet was removed, as permitted in the Minimum Equipment List (MEL), and the navigation light assembly was replaced before the aircraft returned to service the following evening.

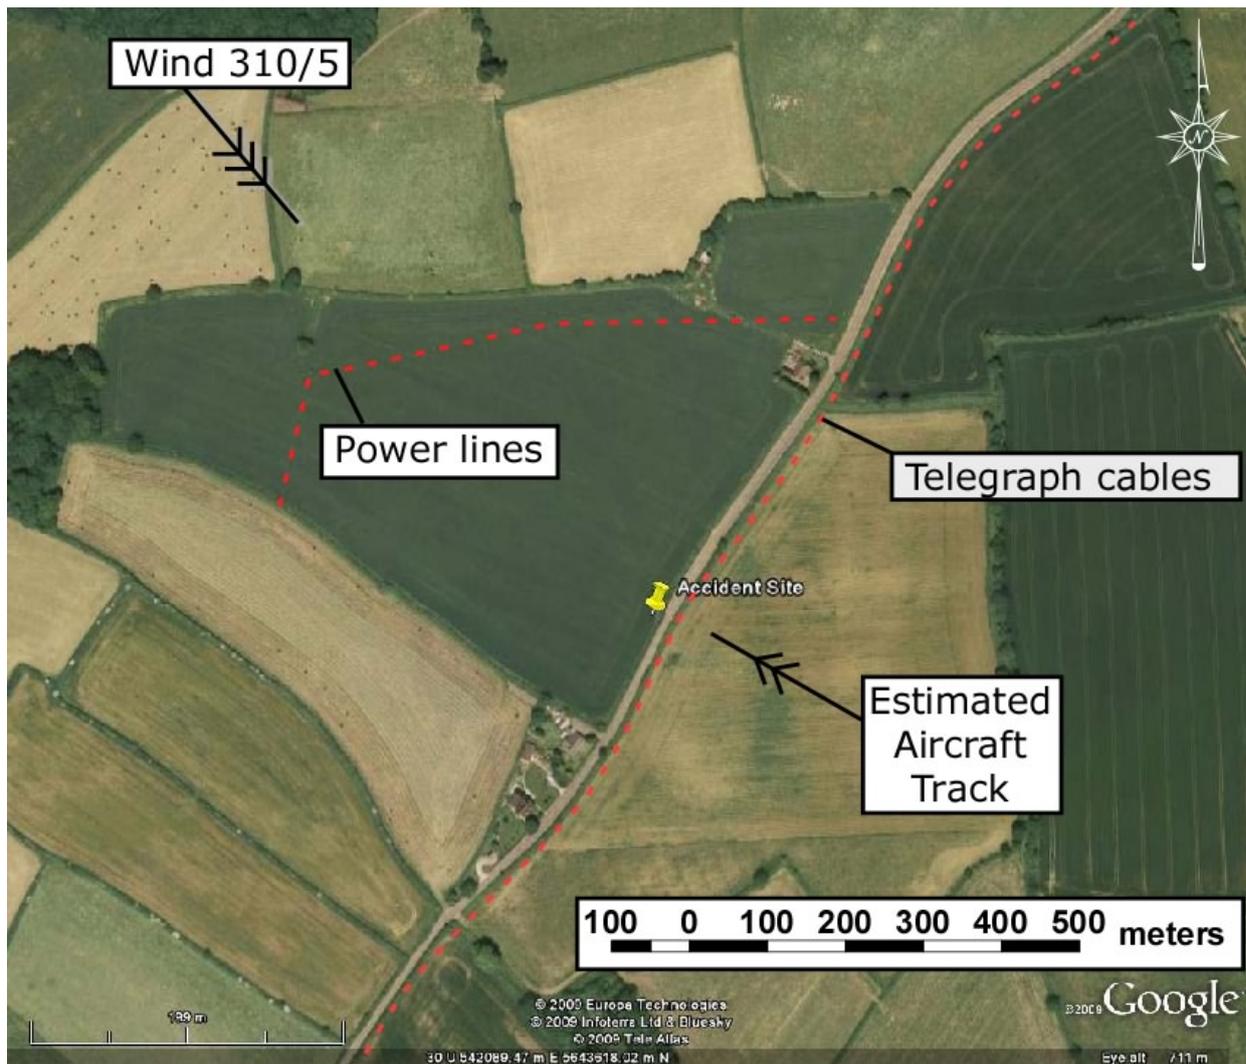
Figure 1

Accident location

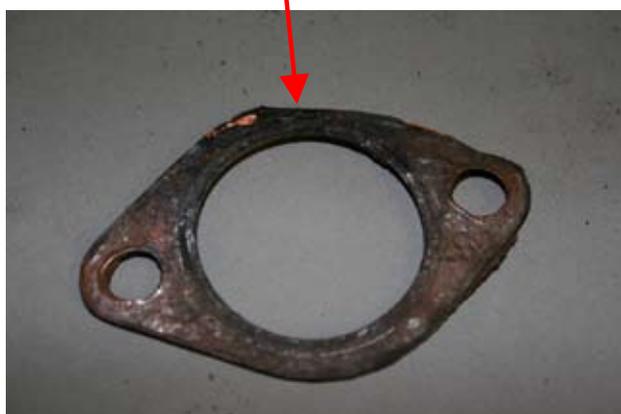
Figures 2 & 3

Notable area of carbon deposited which could indicate significant pre-accident exhaust gas leakage

Exhaust gaskets removed from the accident aircraft

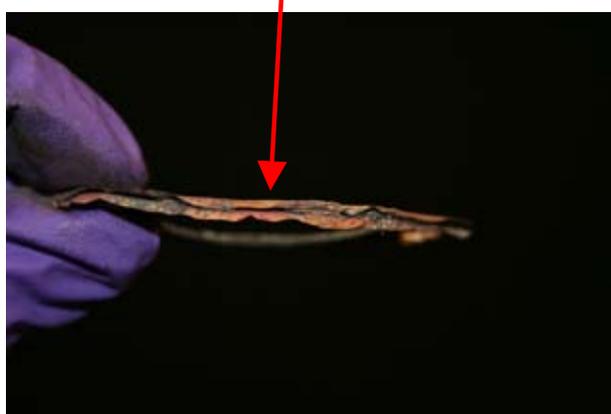
Significant gasket de-lamination

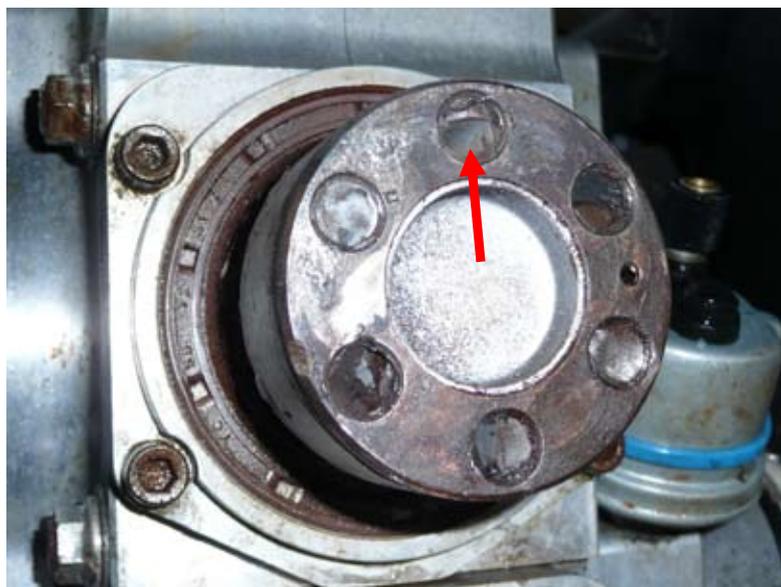
Figure 1

The student had just climbed the aircraft to the circuit height of 700 ft, turned downwind and was throttling the engine back to cruise power, when a rumbling noise was heard from the front of the engine. Approximately ten seconds later the propeller detached from the engine. The instructor took control and completed a successful forced landing in a field which he often used for practice engine failures after takeoff. There were no injuries and the aircraft suffered no further damage. Subsequent examination revealed evidence of extensive fatigue crack propagation in the propeller attachment bolts (Figure 1), which eventually failed in ductile overload, causing the propeller to detach.

View on propeller mounting flange showing failed bolts with evidence of fatigue propagation (arrowed)
