CONTENTS

INCIDENT

Aircraft Type and Registration:	Airbus A320-232, G-EUUR
No & Type of Engines:	2 International Aero Engine V2527-A5 turbofan engines
Year of Manufacture:	2003
Date & Time (UTC):	26 November 2008 at 0820 hrs
Location:	Approx 10 miles north-east of Glasgow Airport
Type of Flight:	Commercial Air Transport (Passenger)
Persons on Board:	Crew - 4 Passengers - Not known
Injuries:	Crew - None Passengers - None
Nature of Damage:	None
Commander's Licence:	Airline Transport Pilot's Licence
Commander's Age:	49 years
Commander's Flying Experience:	14,750 hours (of which 5,400 were on type) Last 90 days - 150 hours Last 28 days - 82 hours
Controller's Experience	The controller had qualified in 1973, had been an approach radar controller since 1980 and employed at Glasgow since 1994
Information Source:	AAIB Field Investigation

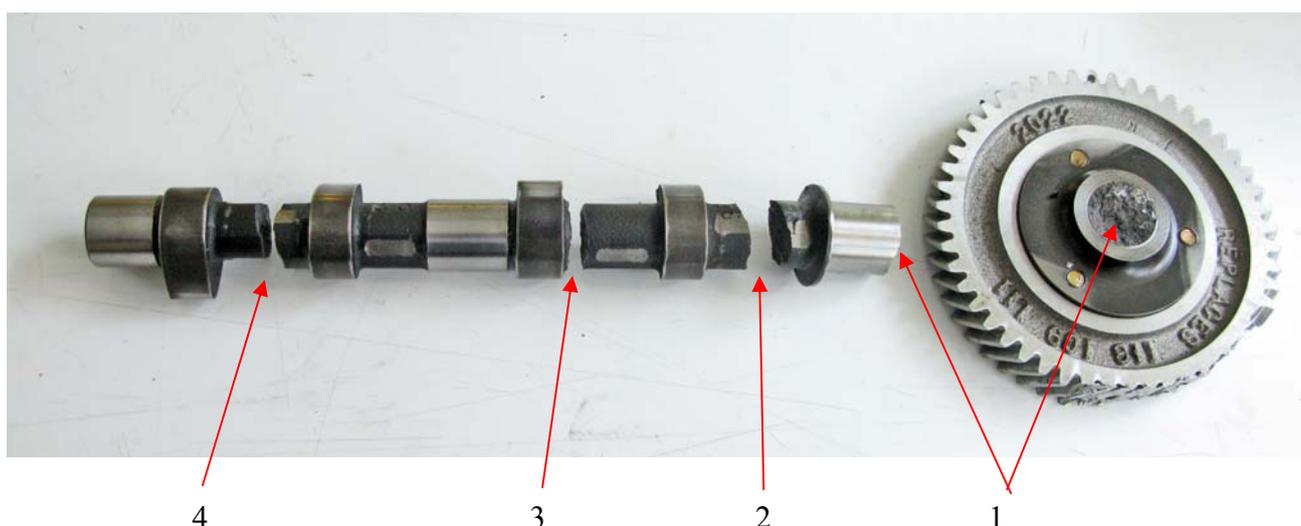
Preliminary examination of the engine by Rotorway's UK agent, established that it would not turn freely and that, within the little movement of the crankshaft available, no corresponding movement of the valve gear could be detected. Subsequently, a bulk disassembly of the engine under the AAIB supervision established that the aluminium camshaft drive gear teeth were stripped over a segment comprising almost a quarter of its circumference. The camshaft had fractured at three separate locations along its length internal to the crankcase, and also at a fourth location, externally, in the accessory case, immediately behind the drive gear attachment flange. Figure 1 shows the fractured camshaft and partially stripped gear, with the camshaft fractures identified and numbered one to four for reference.

Camshaft fractures and gear failure

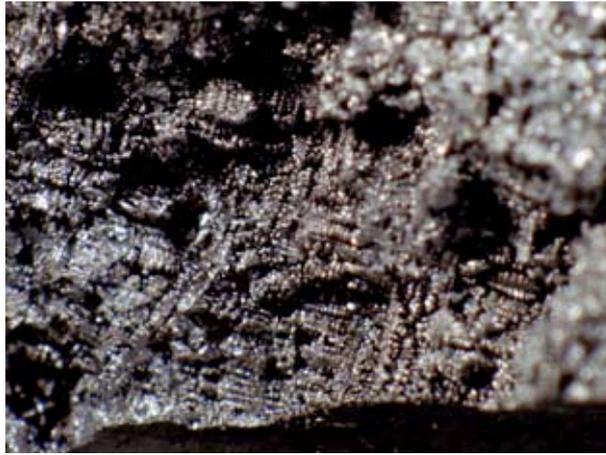
Figure 2

Tooth fracture face, displaying extensive voiding (evidenced as bead-like features) where metal has solidified upon encountering a void

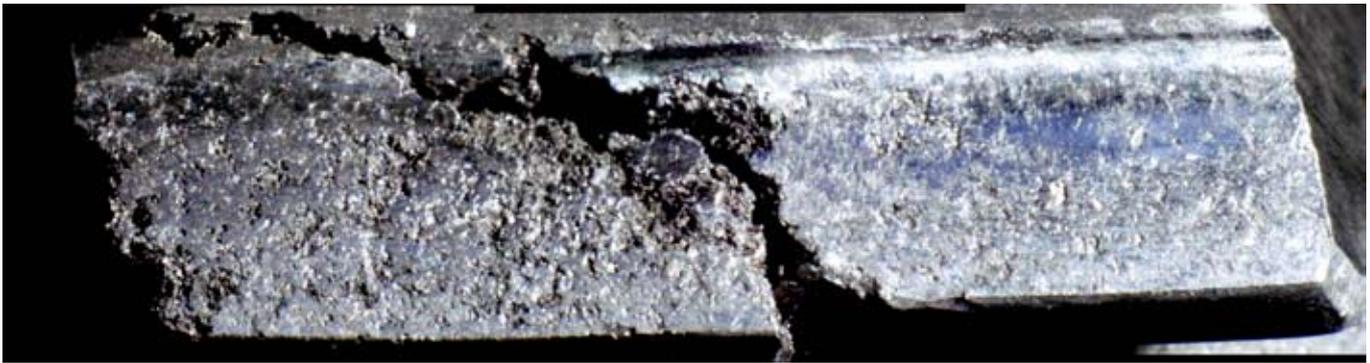
Figure 3

Flank of fractured tooth (separated piece re-positioned, showing porosity at the surface)

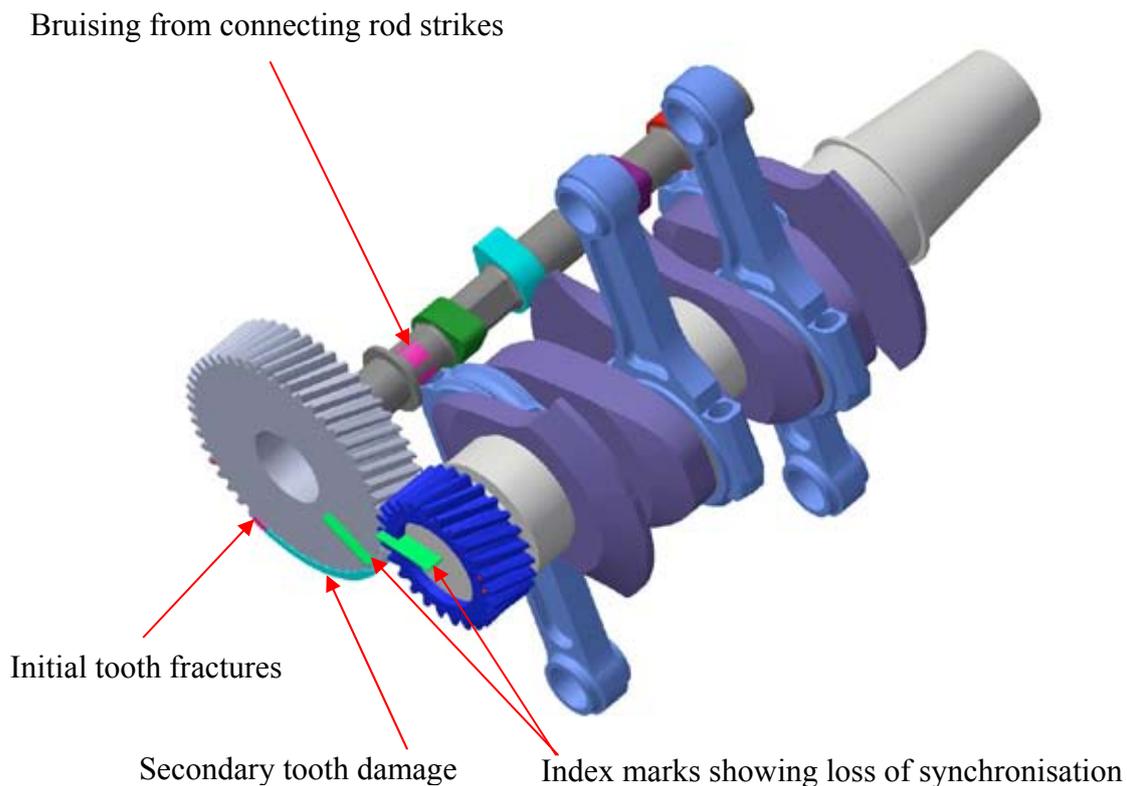
Figure 4

caused directly by a connecting rod strike. Since a connecting rod strike will not occur whilst the camshaft and crankshaft are correctly synchronised, it follows that fracture Nos 2, 3 and 4 were all produced after synchronisation was lost, and that the primary failure was either the fracture at position No 1, or drive gear tooth failure(s).

Analysis of the various connecting rod strikes on and around fracture No 2 showed that several strikes at this location, including strikes on opposing sides of the camshaft, corresponded with positions of the gear where teeth were intact, ie, at positions where the gears

Typical example of connecting rod strike on the camshaft and associated loss of synchronisation

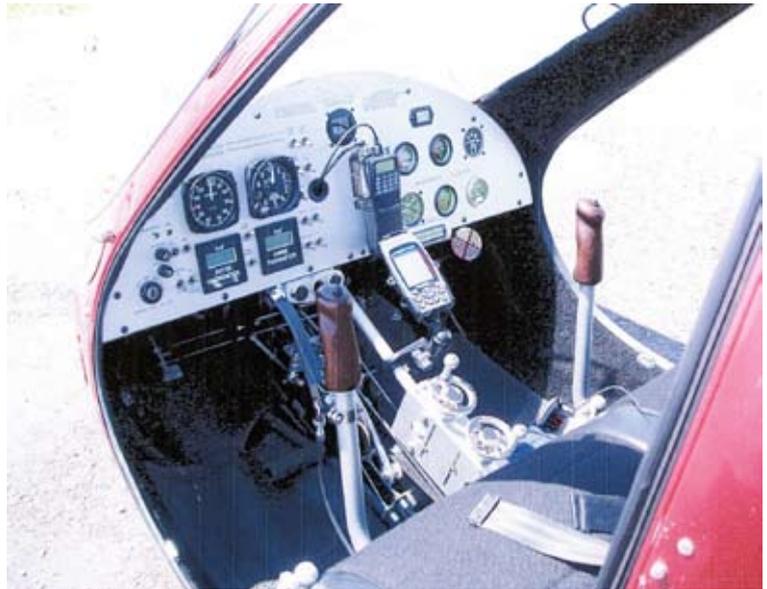
Figure 1

The RAF 2000 type is not approved for night flying and G-CBCJ had neither cockpit lighting nor illuminated flight instruments. See Figure 1.

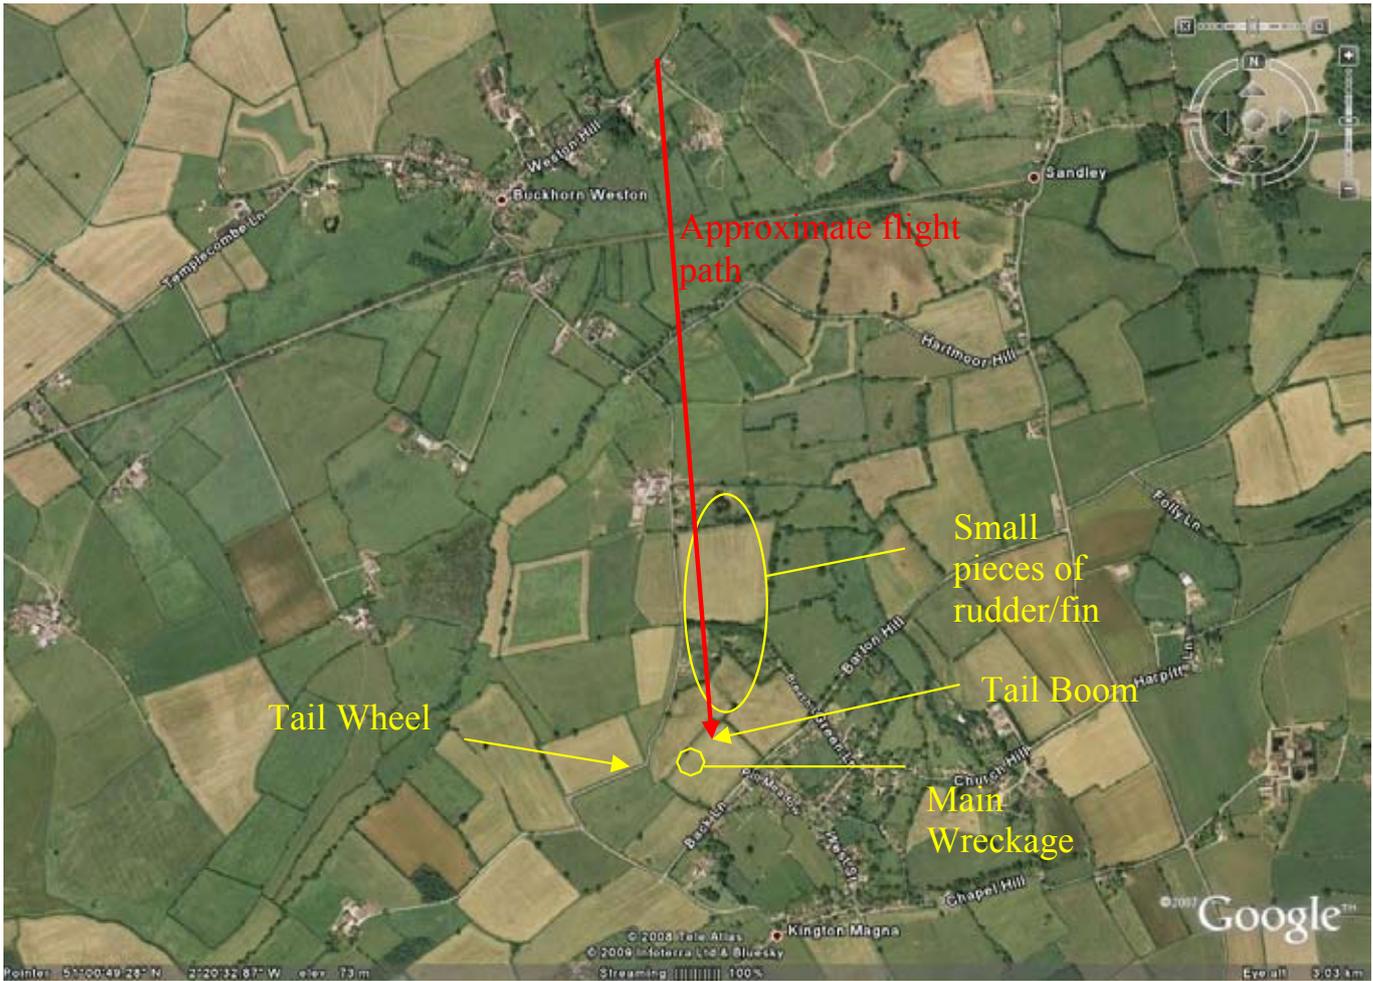
soft ground. The tail boom and a portion of the fibreglass fin were found in the same field, approximately 50 m to the north. Further pieces of wreckage, comprising the remainder of the fin and the rudder, were spread along a trail, in a northerly direction from the main wreckage site, up to a distance of 600 m. The tail wheel was found approximately 100 m to the west of the main wreckage. Figure 2 shows the wreckage distribution.

Wreckage distribution

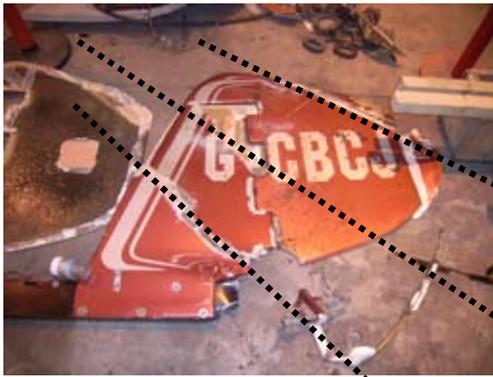
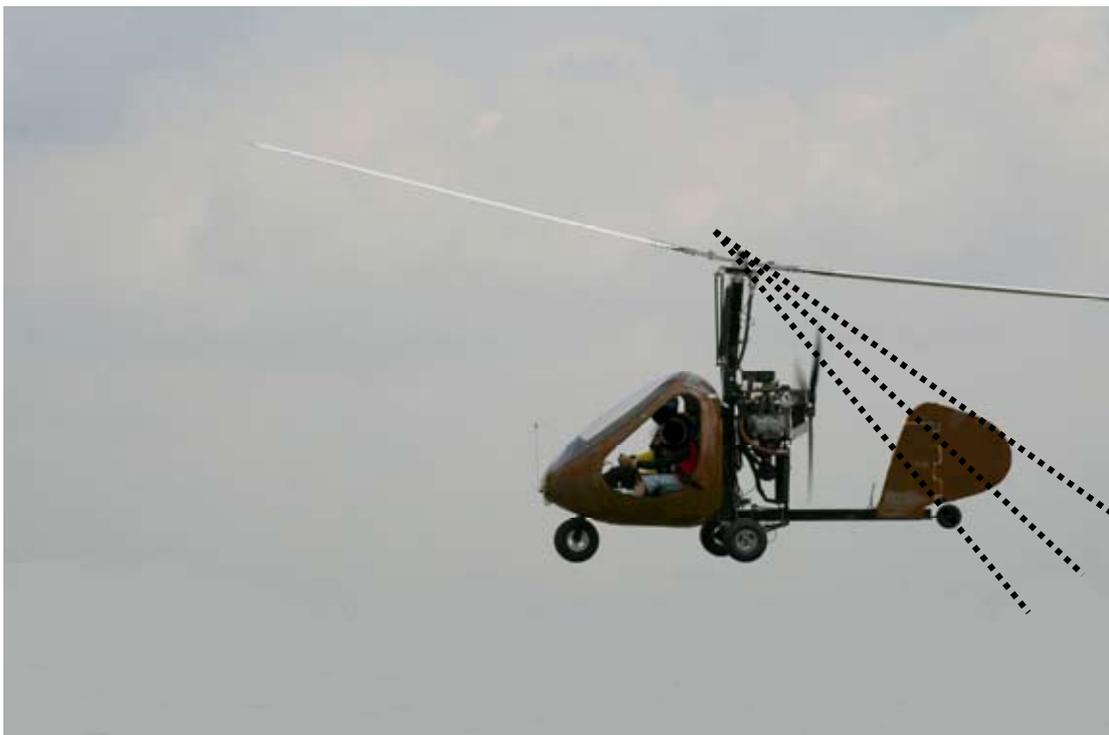
Figure 3

Evidence from ground marks indicated that the rotor blades had not been rotating at impact. However, there was evidence along the length of the blades of multiple impacts with the propeller blades, together with paint transfer arising from impact with the fin and rudder. Reconstruction of the fin and rudder pieces recovered from the wreckage trail indicated that there had been three strikes from the main rotor blade. The first strike had been at the top of the fin/rudder, the second mid-way down, and the third at the base of the rudder, resulting in the detachment of the tailwheel and most of the keel beam. See Figure 3.

Illustration of the three strikes on the fin and rudder by the main rotor
