CONTENTS

SERIOUS INCIDENT

Aircraft Type and Registration:	Boeing 737-8AS, EI-DAL
No & Type of Engines:	2 CFM 56-7B26 turbofan engines
Year of Manufacture:	2003
Date & Time (UTC):	19 November 2009 at 2124 hrs
Location:	Runway 27, Bristol Airport
Type of Flight:	Commercial Air Transport (Passenger)
Persons on Board:	Crew - 6 Passengers - 135
Injuries:	Crew - None Passengers - None
Nature of Damage:	Underside of right engine cowl
Commander's Licence:	Airline Transport Pilot's Licence
Commander's Age:	32 years
Commander's Flying Experience:	3,553 hours (of which 3,248 were on type) Last 90 days - 209 hours Last 28 days - 87 hours
Information Source:	Aircraft Accident Report Form submitted by the pilot and further enquiries by the AAIB

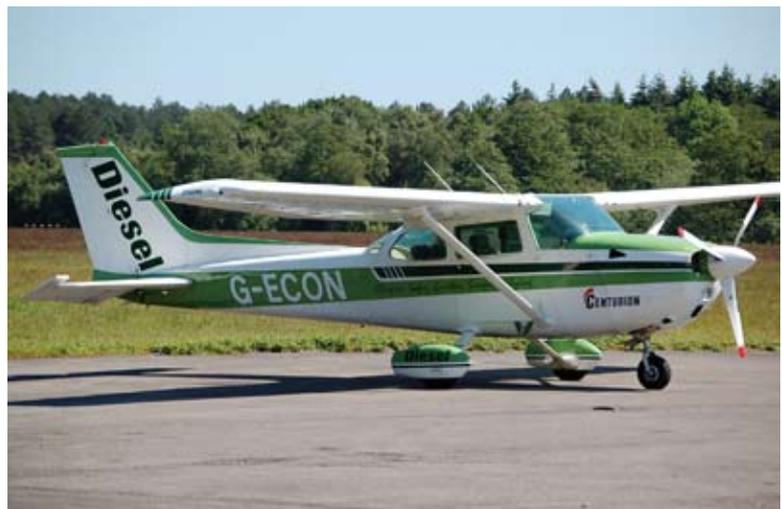
Figure 1
G-ECON

The inner section of the wheel hub and the wheel bearing assembly had remained correctly attached to the axle by its retaining nut, but the outer section of the wheel hub, the tyre and inflated inner tube had departed the axle. The wheel spat had also broken away, in one piece, from its mounts on the landing gear and was found lying near the aircraft. Apart from some rubbing marks on the outer sidewall, the tyre was in good condition. The bottom of the inner wheel hub and brake disc had been abraded and slightly distorted as a result of rubbing along the surface of the runway.

Four of the six bolts which clamp the two parts of the hub together were recovered. The threads on all four bolts were found to be intact and undamaged. On one of the bolts the last two threads were found to contain sections of thread which had been pulled out of the holes in the inner section of the hub. Of the six threaded holes in the inner section of the hub, four were relatively undamaged and the first two to three threads had been stripped in the remaining two holes.

The condition of the bolts and threads in the inner hub suggests that either the bolts were not fitted correctly, or the torque on all the bolts released and vibration caused them to unwind until there were only two to three threads on two of the bolts clamping the hub together. G-ECON has a very distinctive colour scheme and it is highly likely that the pieces of wheel spat found at Dunkeswell came from this aircraft. This evidence is consistent with the pilot's account of feeling a bump through the landing gear during the takeoff run, which was probably the point at which the left wheel hub started to come apart. The pilot commented that it was difficult to inspect the wheels with the spats fitted (Figure 1).

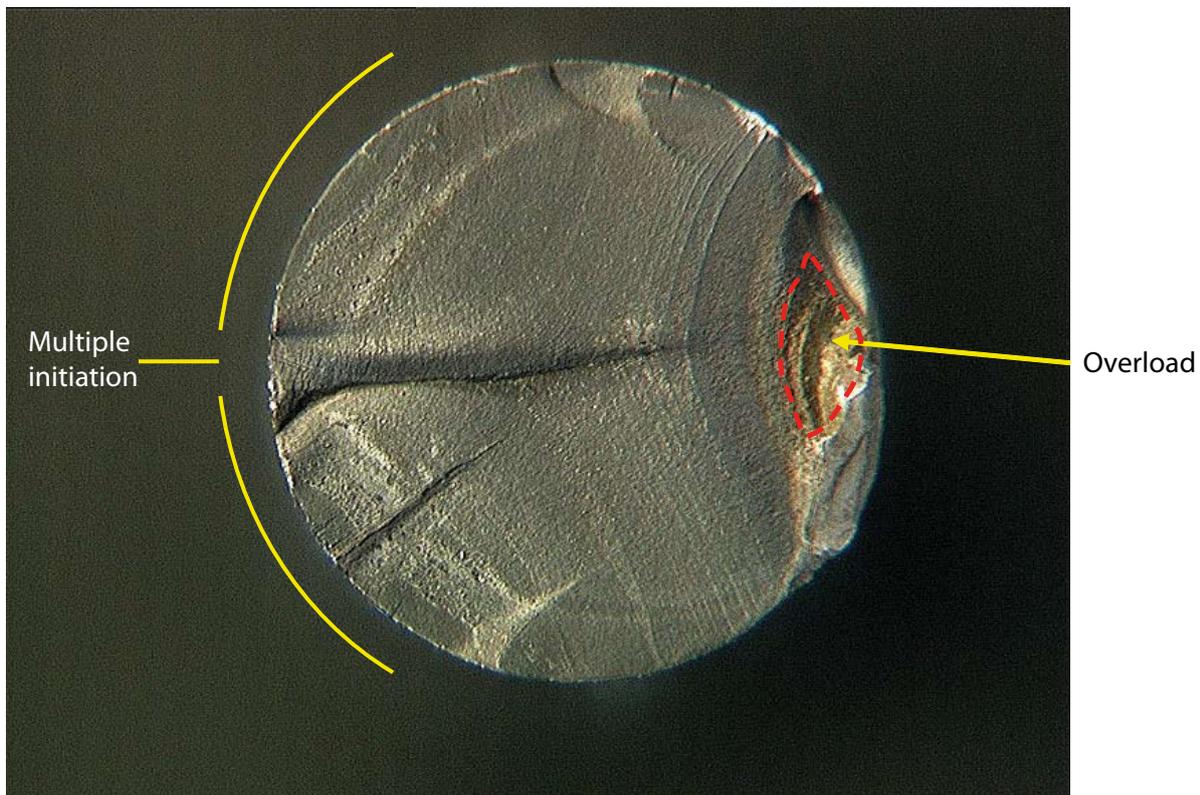
Figure 1

Examination of the No 3 exhaust valve showed that the fracture occurred in the stem of the valve adjacent to

the head radius. It was noted that the stem-side fracture was coated with a dark deposit unlike the head-side, which was relatively clean. Detailed examination of the stem-side deposit under high power optical microscopy revealed the presence of bright discrete globular metallic particles amongst the deposit. The particles were soft and could be smeared, which suggested that they could be particles of lead. After cleaning, the fracture surface of the stem side was examined and seen to exhibit beachmarks, which are characteristic of failure due to fatigue crack growth (Figure 1). Multiple fatigue crack initiation sites were present around the majority of the valve circumference, although crack growth appeared to have been predominantly from one side of the valve. A small area of overload was present at the end of the fatigue.

Fracture surface of No 3 exhaust valve from G-JAAB after cleaning

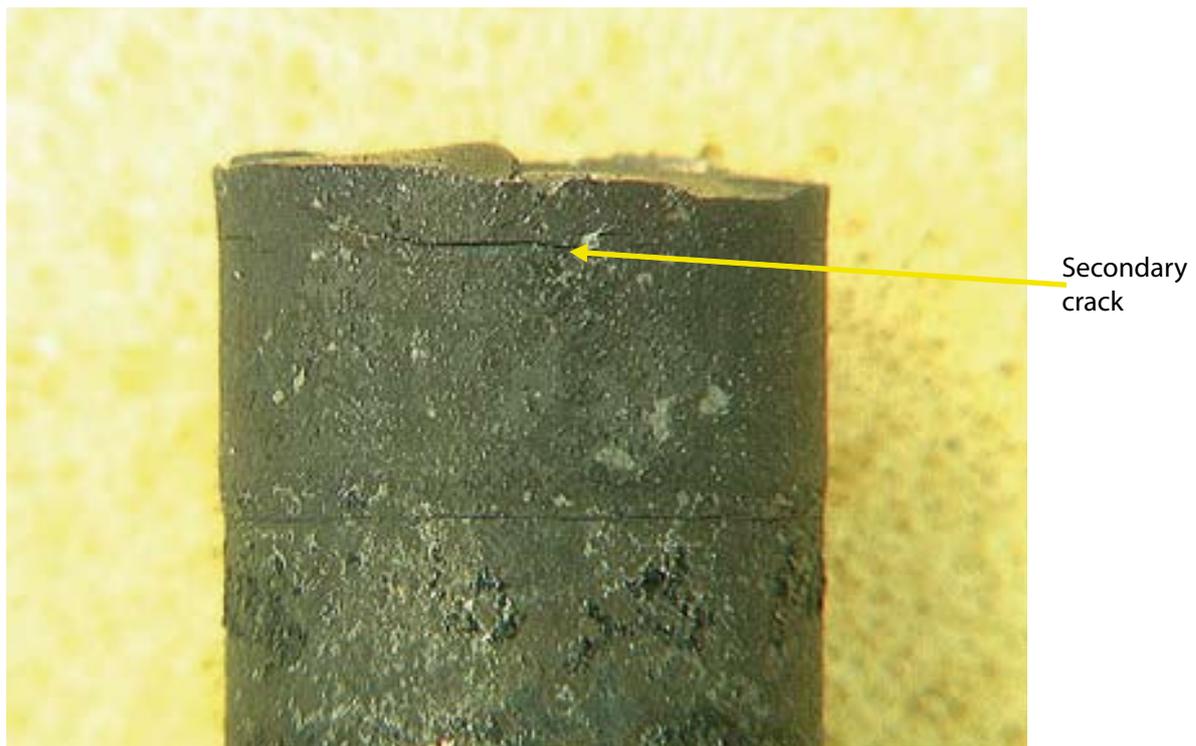
Figure 2

Visual examination of the remaining section of the exhaust valve stem revealed secondary cracking adjacent to the fracture surface (Figure 2).

Stem of No 3 exhaust valve from G-JAAB adjacent to fracture showing secondary cracking

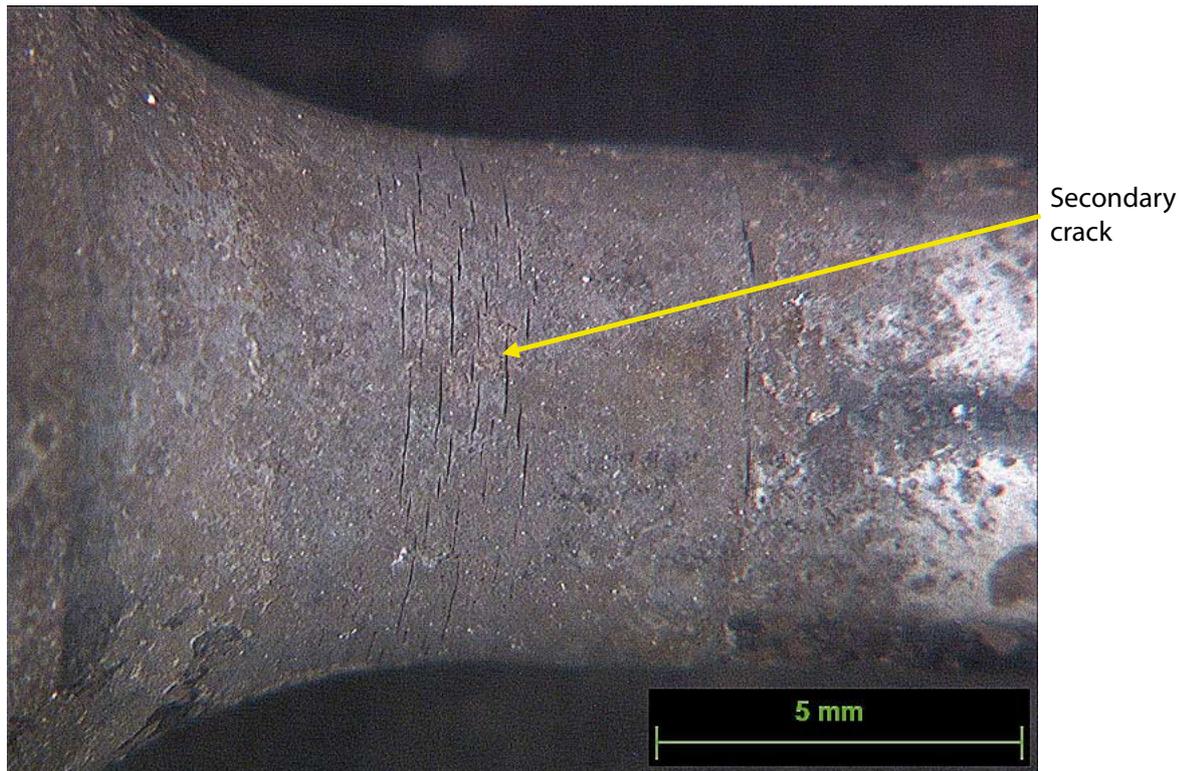
Figure 3

Exhaust valves 1, 2 and 4 exhibited small transverse cracks (Figure 3) at the edge of the head radius, in a position similar to the fracture point of the exhaust valve from cylinder No 3, indicating that all the cylinders had experienced similar high temperatures.

No 4 cylinder exhaust valve from G-JAAB showing secondary cracking

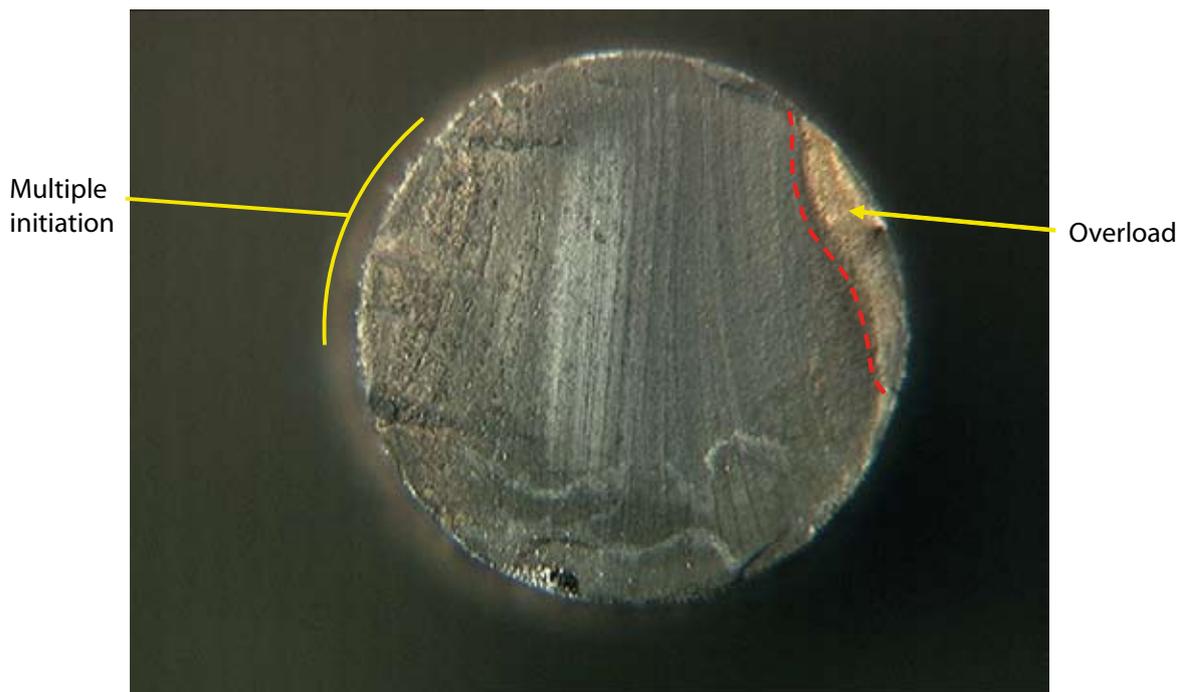
Fracture surface of No 1 exhaust valve from G-CBIP

within the exhaust port. Figure 4 shows beachmarks clearly visible on the fracture surface, characteristic of fatigue crack growth. The fatigue appeared to have initiated from multiple points on one side of the valve and propagated across the majority of the valve stem before final overload failure occurred.

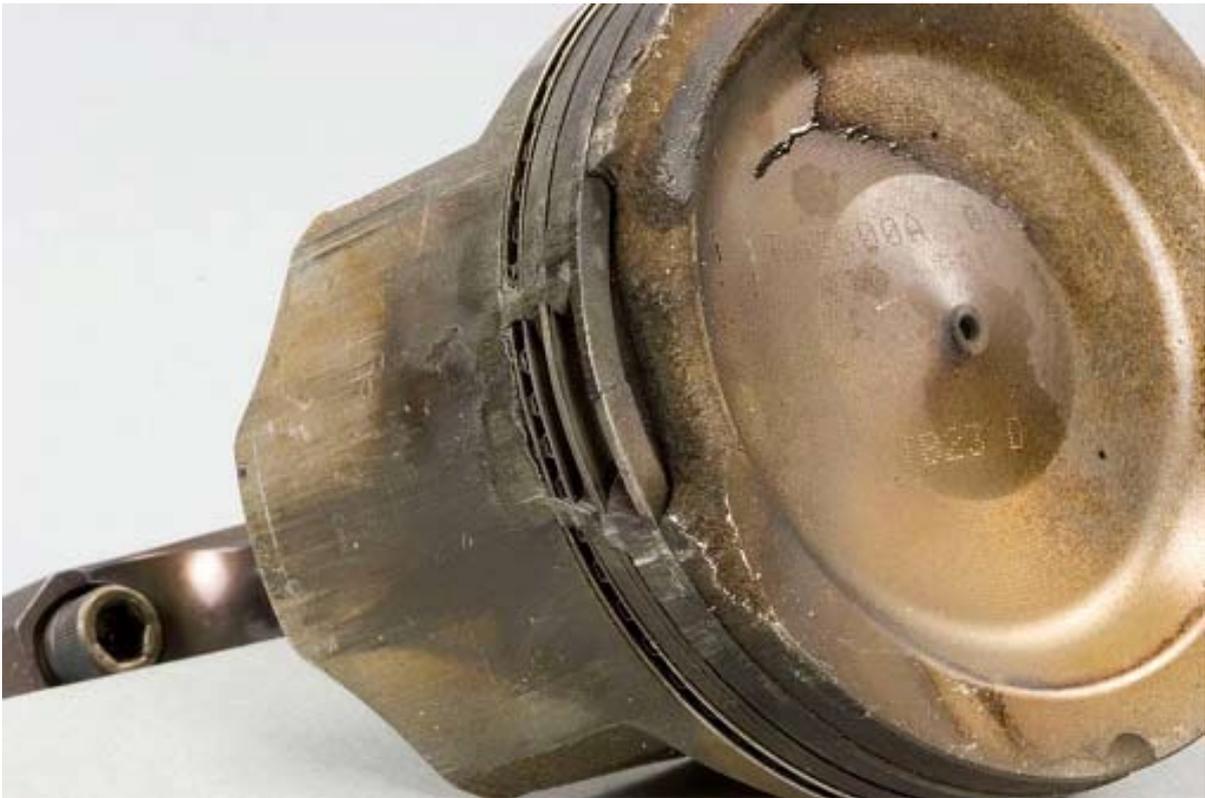
Figure 1

Carbon deposits were unlikely to be the cause in this case; no carbon build-up was observed in the cylinders and the engine was relatively new (43 hours since manufacture). The spark plugs in the cylinders received

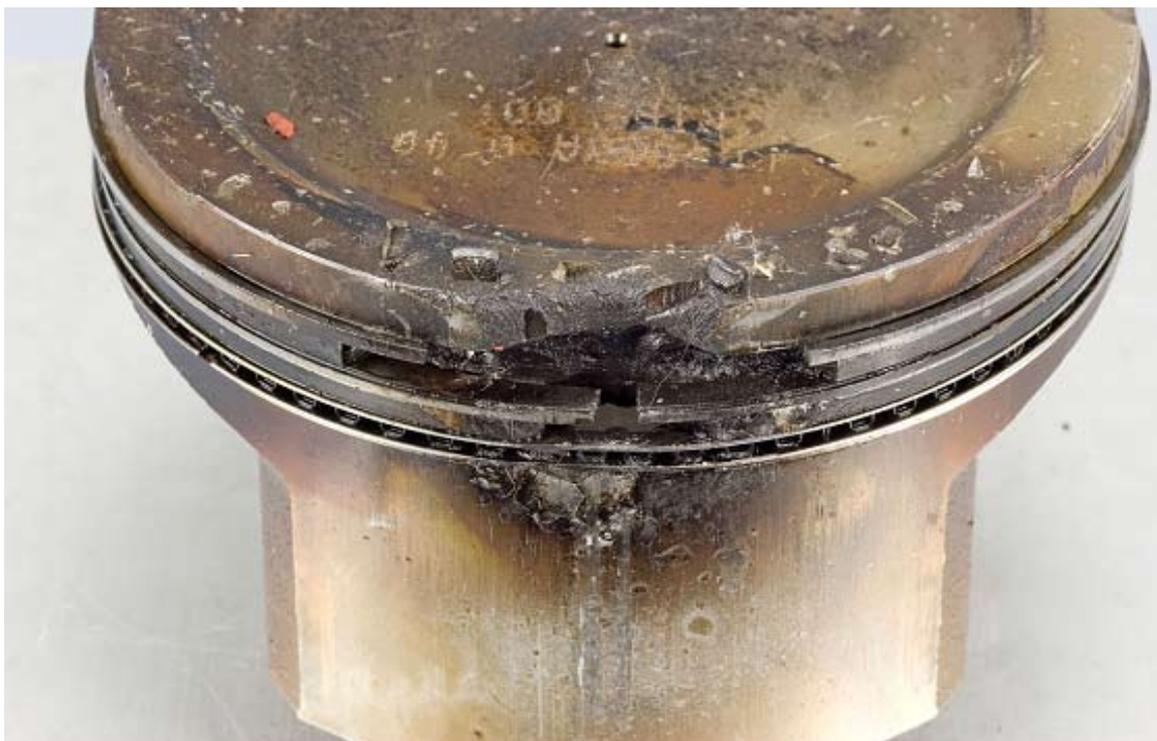
Figure 2

Three cylinders and their associated pistons were taken to the Materials Department at QinetiQ for detailed metallurgical examination. Examination of the three cylinders showed that No 3 piston and cylinder exhibited characteristics similar to the No 3 piston and cylinder from G-CEED. The piston/cylinder head interface exhibited sooting on one side of the cylinder, with the corresponding edge of the piston exhibiting burn-through (Figure 2). The internal surface of the cylinder showed evidence of minor wear and material pick-up from the piston at the point of the piston burn-through. Skirt wear was observed on the piston similar to that observed in the examination of the engine from G-CEED. Minor wear was observed below the burn-through with the opposite skirt exhibiting more severe wear. The other two pistons both exhibited skirt wear similar to the No 3 piston. One of the pistons showed evidence of damage to the edge of the piston crown with reciprocating wear and material pick-up on the internal surface of the cylinder. The damage appeared to be purely mechanical, with no evidence of burn-through as seen in the No 3 piston.

Examination of the piston rings and oil scraper rings showed that the lower piston ring was seized in the closed position on one of the pistons and on another the upper ring was seized at the area of the damage, so that it was flush with the piston edge. The other end of the piston ring was free to move. On the No 3 piston both the lower piston ring and oil scraper ring were seized in the closed position.
