CONTENTS

SERIOUS INCIDENT

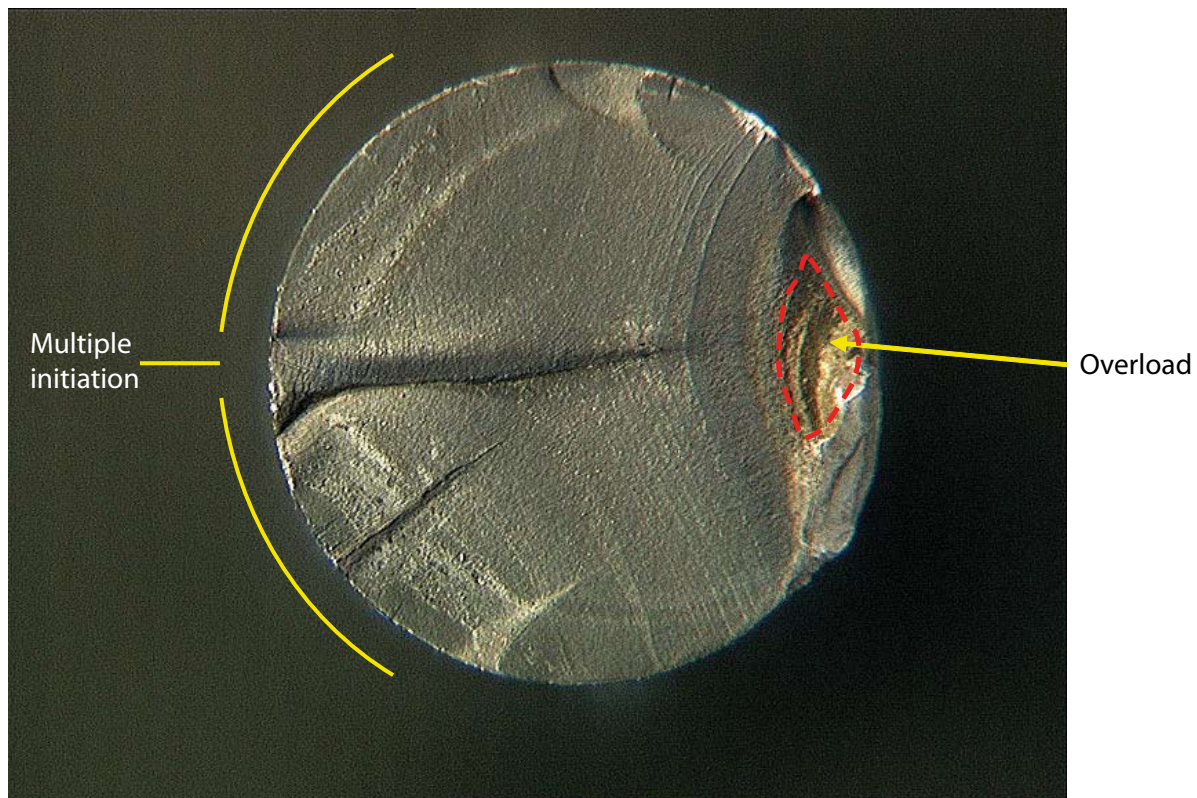
Figure 1

Examination of the No 3 exhaust valve showed that the fracture occurred in the stem of the valve adjacent to

the head radius. It was noted that the stem-side fracture was coated with a dark deposit unlike the head-side, which was relatively clean. Detailed examination of the stem-side deposit under high power optical microscopy revealed the presence of bright discrete globular metallic particles amongst the deposit. The particles were soft and could be smeared, which suggested that they could be particles of lead. After cleaning, the fracture surface of the stem side was examined and seen to exhibit beachmarks, which are characteristic of failure due to fatigue crack growth (Figure 1). Multiple fatigue crack initiation sites were present around the majority of the valve circumference, although crack growth appeared to have been predominantly from one side of the valve. A small area of overload was present at the end of the fatigue.

Fracture surface of No 3 exhaust valve from G-JAAB after cleaning

Energy dispersive X-ray (EDX) analysis was carried out in a scanning electron microscope (SEM) on the fracture surface of the No 3 exhaust valve prior to cleaning to determine the composition of the deposit. The EDX spectrum identified elements such as iron, manganese and chromium from the underlying valve steel. However, large amounts of lead, phosphorus and bromine were present, with carbon and oxygen. A metallurgical section of the valve stem was subjected to EDX analysis and the spectrum obtained was consistent with 21-4N valve steel. The SEM examination showed that the microstructure was typical of a 21-4N valve

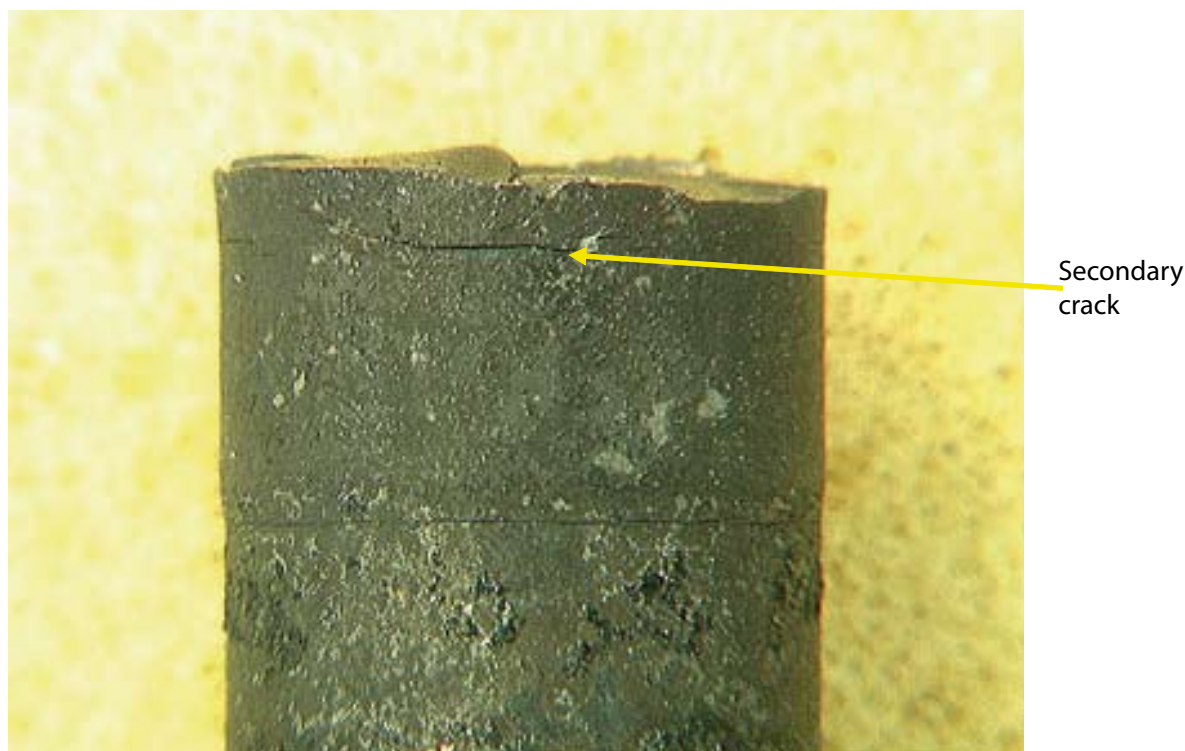
Figure 2

Visual examination of the remaining section of the exhaust valve stem revealed secondary cracking adjacent to the fracture surface (Figure 2).

Stem of No 3 exhaust valve from G-JAAB adjacent to fracture showing secondary cracking

steel, showing an austenitic¹ microstructure structure containing carbide stringers². Adjacent to the failure area, secondary cracking was observed. Corrosion was observed on the surface of the stem and the microstructure showed evidence of grain boundary precipitates³.

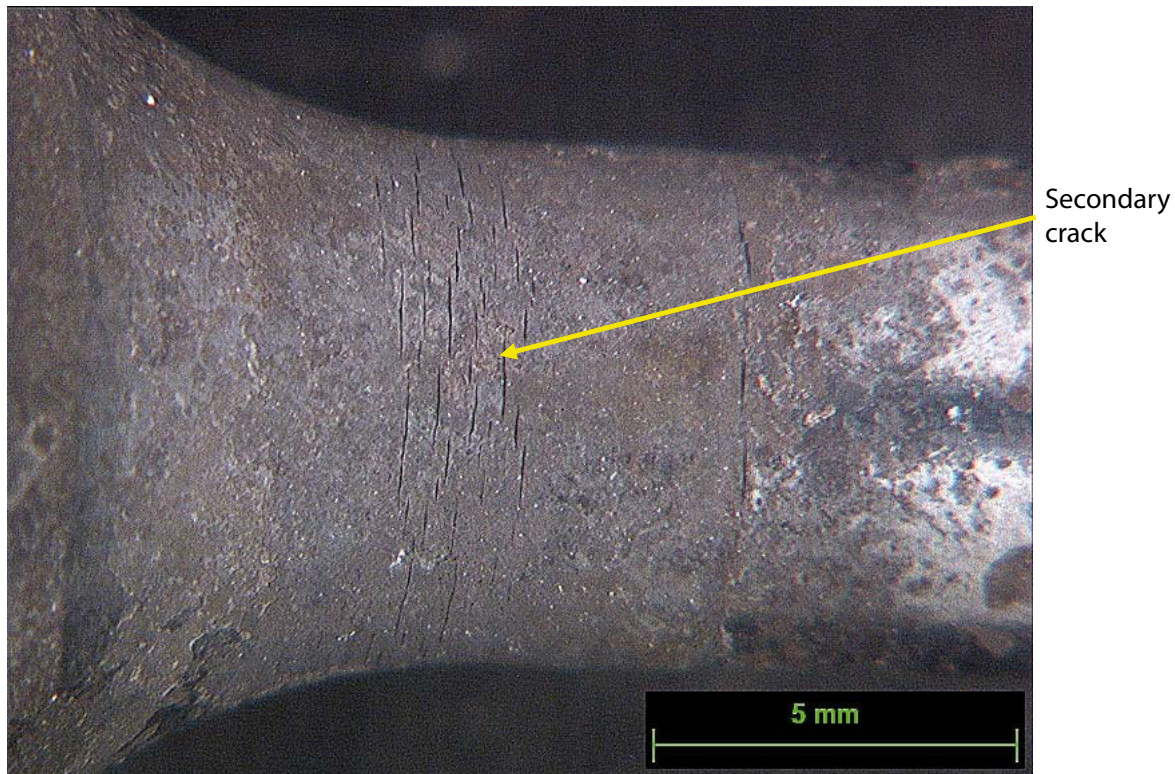
Figure 3

Exhaust valves 1, 2 and 4 exhibited small transverse cracks (Figure 3) at the edge of the head radius, in a position similar to the fracture point of the exhaust valve from cylinder No 3, indicating that all the cylinders had experienced similar high temperatures.

No 4 cylinder exhaust valve from G-JAAB showing secondary cracking

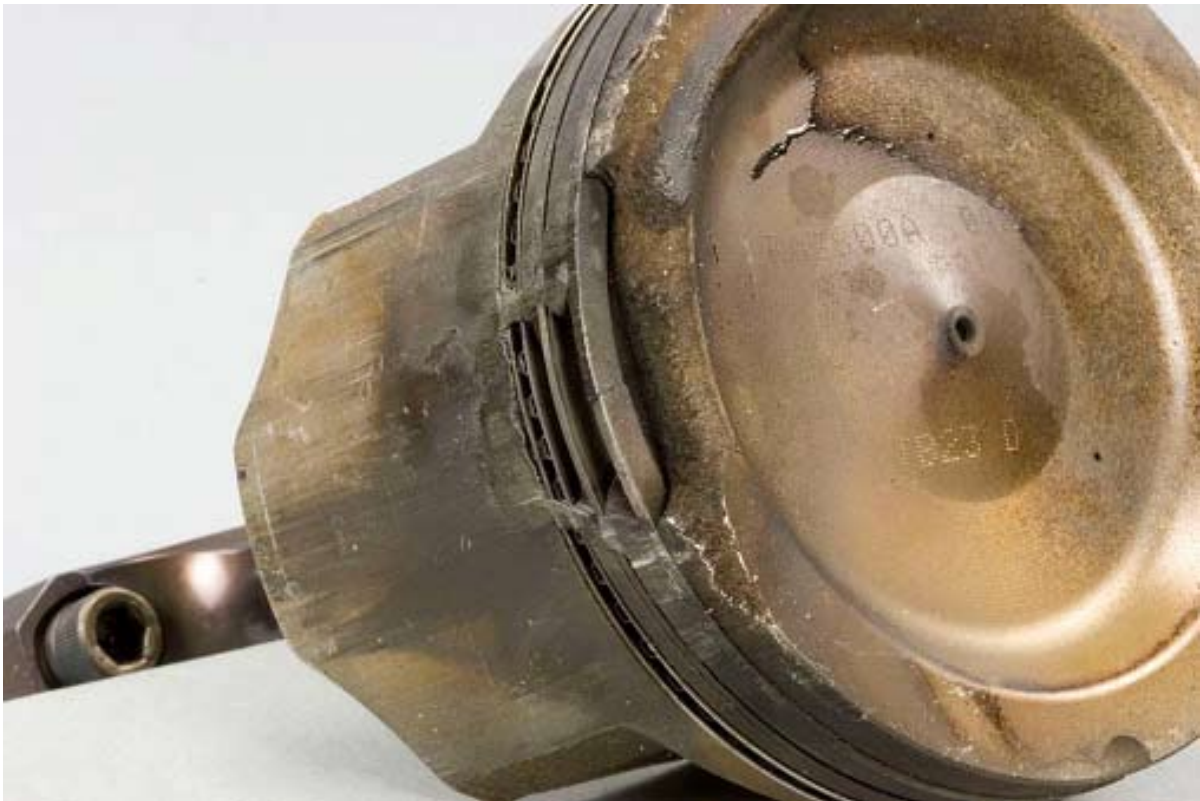
Figure 1

Carbon deposits were unlikely to be the cause in this case; no carbon build-up was observed in the cylinders and the engine was relatively new (43 hours since manufacture). The spark plugs in the cylinders received

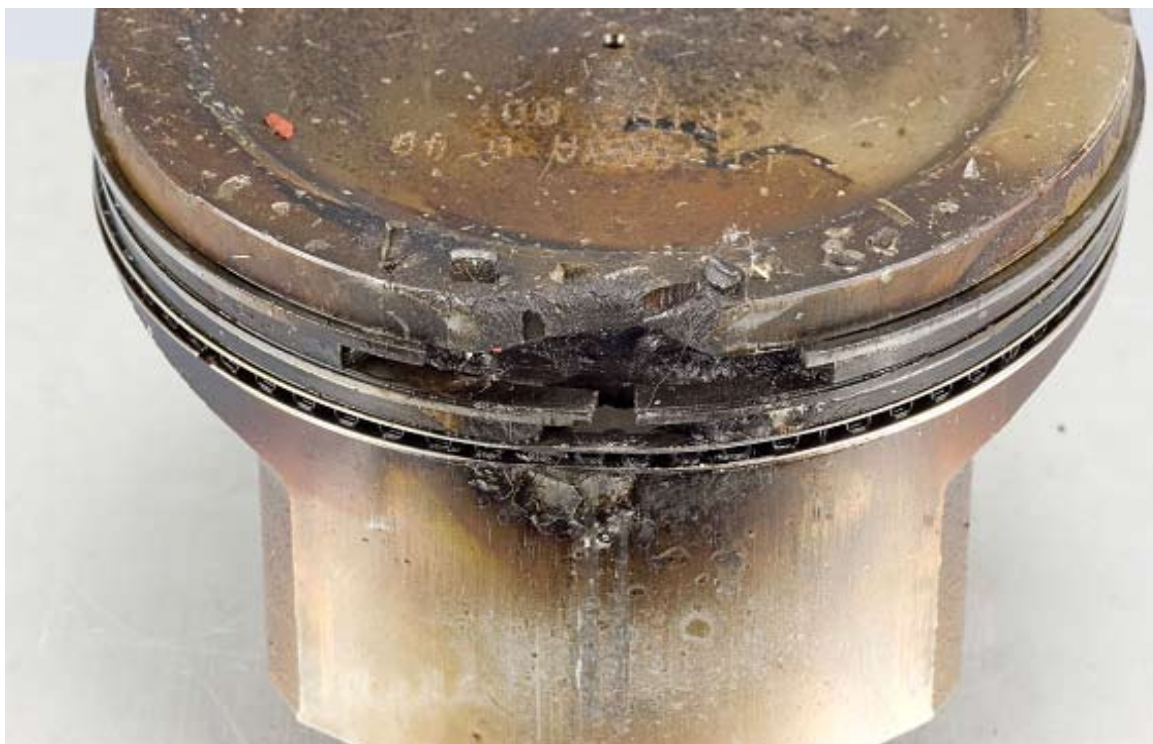
Figure 2

Three cylinders and their associated pistons were taken to the Materials Department at QinetiQ for detailed metallurgical examination. Examination of the three cylinders showed that No 3 piston and cylinder exhibited characteristics similar to the No 3 piston and cylinder from G-CEED. The piston/cylinder head interface exhibited sooting on one side of the cylinder, with the corresponding edge of the piston exhibiting burn-through (Figure 2). The internal surface of the cylinder showed evidence of minor wear and material pick-up from the piston at the point of the piston burn-through. Skirt wear was observed on the piston similar to that observed in the examination of the engine from G-CEED. Minor wear was observed below the burn-through with the opposite skirt exhibiting more severe wear. The other two pistons both exhibited skirt wear similar to the No 3 piston. One of the pistons showed evidence of damage to the edge of the piston crown with reciprocating wear and material pick-up on the internal surface of the cylinder. The damage appeared to be purely mechanical, with no evidence of burn-through as seen in the No 3 piston.

Examination of the piston rings and oil scraper rings showed that the lower piston ring was seized in the closed position on one of the pistons and on another the upper ring was seized at the area of the damage, so that it was flush with the piston edge. The other end of the piston ring was free to move. On the No 3 piston both the lower piston ring and oil scraper ring were seized in the closed position.
