CONTENTS

AAIB Field Investigation reports

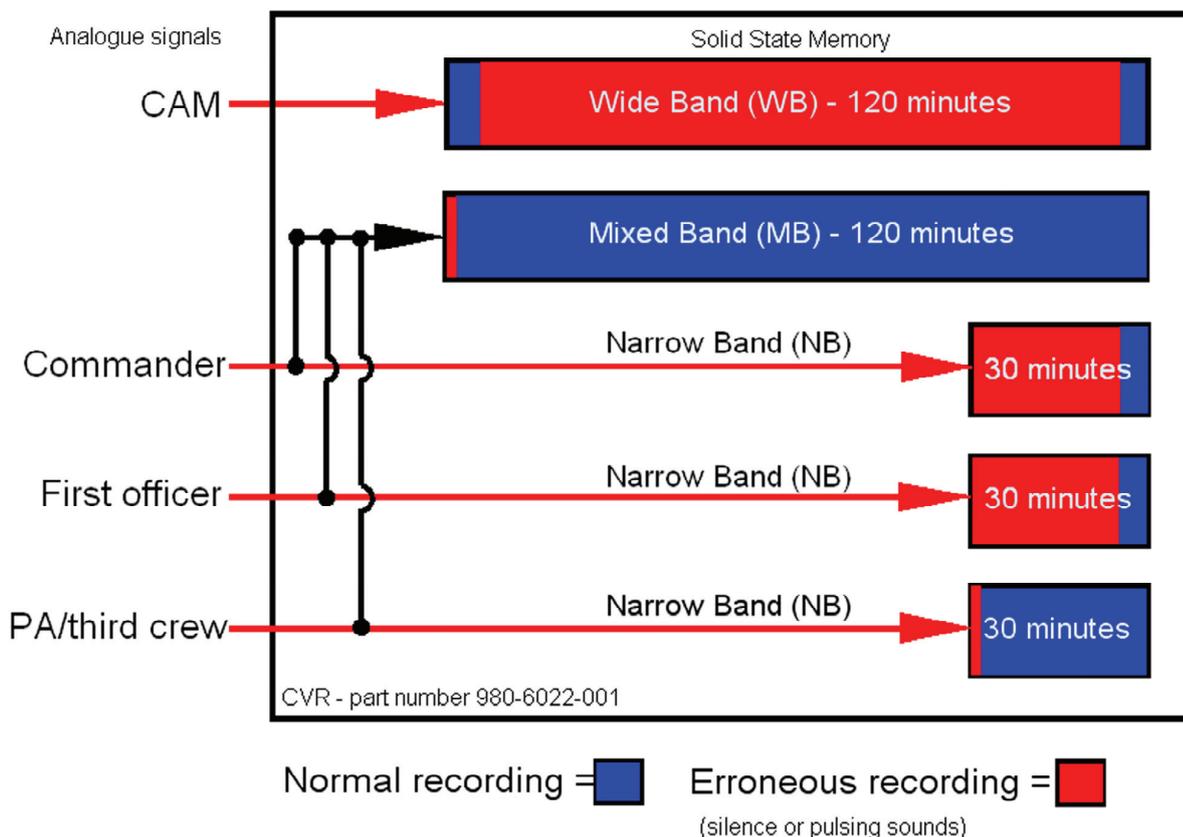
information stored in the solid state memory; this was successfully completed. The second process extracted the five audio channels and converted them to an industry-standard audio file. It was during this process that the manufacturer’s software tool, Playback 32³, indicated an error. Analysis of the audio files identified that although the WB channel was of the correct duration, it was found to contain only 12 minutes (seven towards the beginning and five at the end) of normal audio from the CAM. The remaining audio consisted of an erroneous ‘pulsing’ sound. Further, several minutes at the beginning of the MB also contained an erroneous pulsing sound and the three NB files were of only five minutes duration.

From information provided by the manufacturer, the AAIB developed its own software tool which generated 30-minute records for each of the NB channels. The PA/third crew member’s channel was found to contain 30 minutes of normal audio, other than at the beginning, where there was a very short duration erroneous pulsing sound. For the commander’s and co-pilot’s NB channels, only the most recent five minutes contained normal audio. The beginning of these channels also contained a very short duration erroneous pulsing sound, which was followed by 25 minutes of erroneously recorded silence. Figure 4 depicts the erroneous recordings on each channel.

Figure 4
Erroneous recording

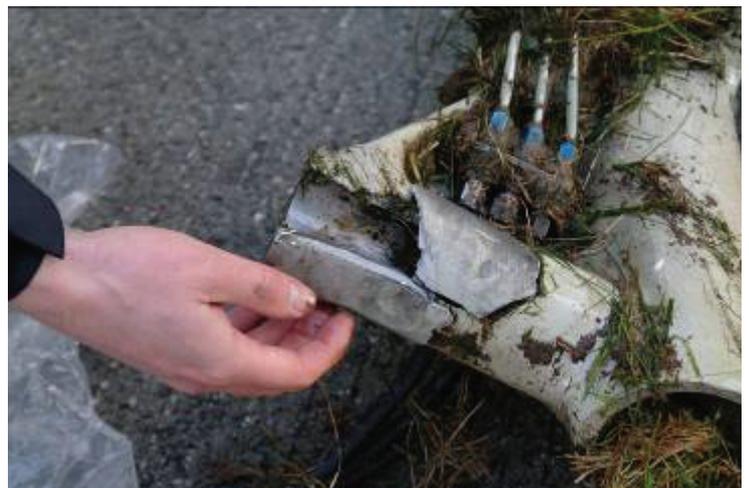
Figure 3

The blades on the right propeller had been badly damaged and the right engine appeared to be distorted in its engine mounts. The right propeller feathering mechanism had been damaged when the propeller blades contacted the runway. The right aileron balance horn, wingtip and a section of the pannier had abraded away. There was some distortion to the right wheel well and flaps where the landing gear had broken away but was no evidence of a leak from the wing fuel tanks. The main cabin door and over-wing emergency exit both opened freely. Apart

Damage to right forward yoke pintle

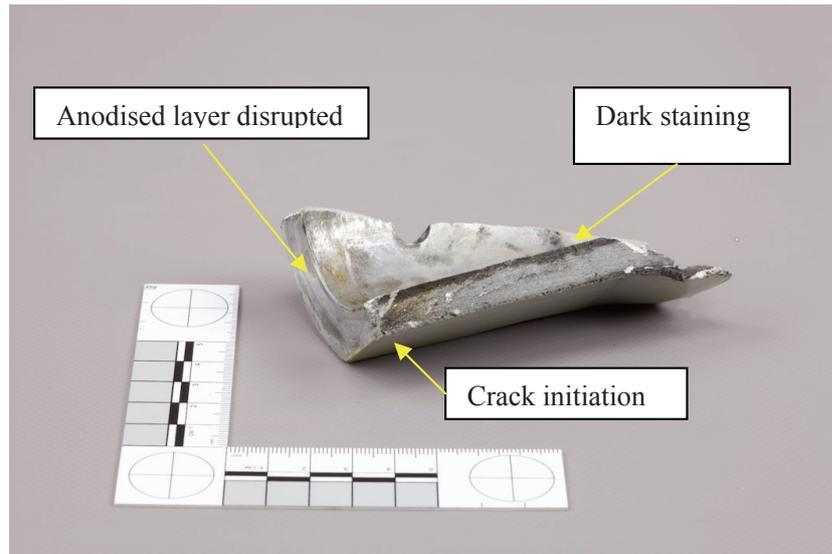
Figure 4

The anodised layer on the end of the pintle had been disrupted, possibly as a result of rubbing against the bearing cap that secures the leg to the aircraft, leaving the end grain of the metal exposed. A dark stain approximately 60 mm long and 2 mm deep ran along the inside face of the failed section of the pintle. A section taken along the stain, approximately 12 mm from the end of the pintle identified the presence of intergranular corrosion which extended 0.13 mm into the pintle. It

Failed section of forward yoke pintle

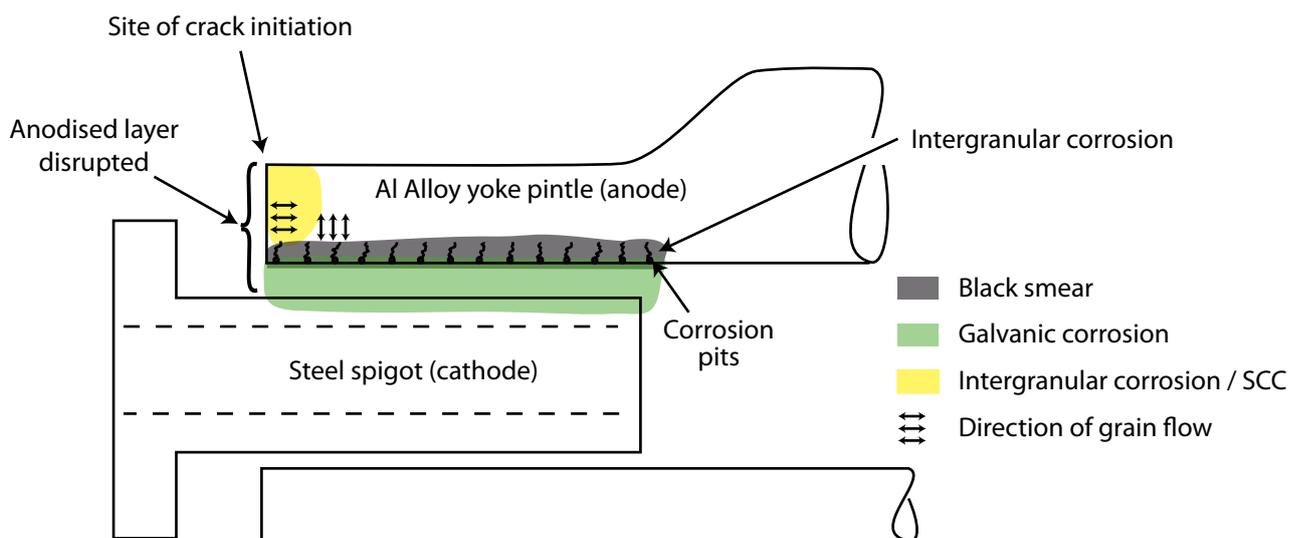
Figure 5

of the yoke pintle that was in contact with the corroded areas of the steel spigot. Dye penetrant and visual examination of the stained area, using high magnification devices, revealed the presence of numerous defects, the majority of which were less than 0.5 mm across. Microsections taken from this area determined that these defects were not stress-driven, but were consistent with intergranular corrosion. A smaller number of these

Defects found on forward yoke pintle

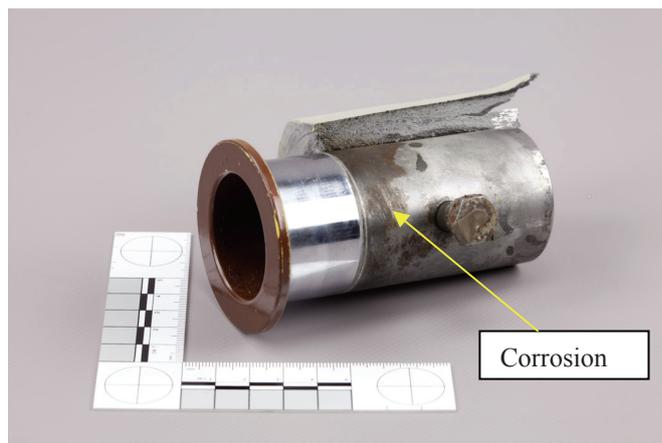
Figure 6

Corroded areas on steel spigot

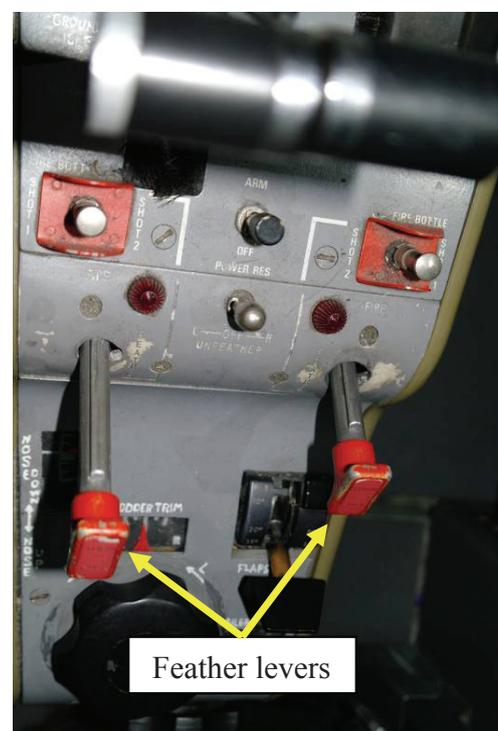
Figure 7

The dimensions of the holes in the console, through which the feather levers pass, are specified in the aircraft drawing as 0.500" +.01" (12.7 mm +0.25 mm), which gives an upper tolerance of 12.95 mm. On G-CCPW the left hole was found to be 13.35 mm and the right hole was found to be 14.61 mm. The detents on both feather levers were found to be 13.97 mm, as specified in the aircraft drawings.

Position of feather levers after accident

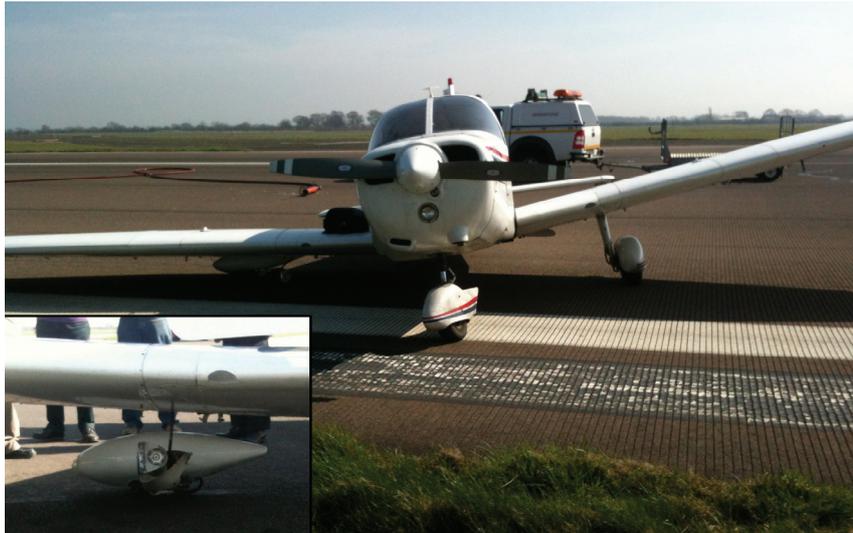
Figure 1

The right main landing gear leg was found to have separated from its wing spar attachment (Figure 1). After the aircraft was recovered it was examined by an engineering organisation. They determined that the landing gear leg had separated due to failure of the four upper screws and four lower bolts (items 1 and 6 in Figure 2) which secured the leg to the right wing main spar.

G-BCTF resting on its right wing (inset: close-up of separated gear leg with wing supported)

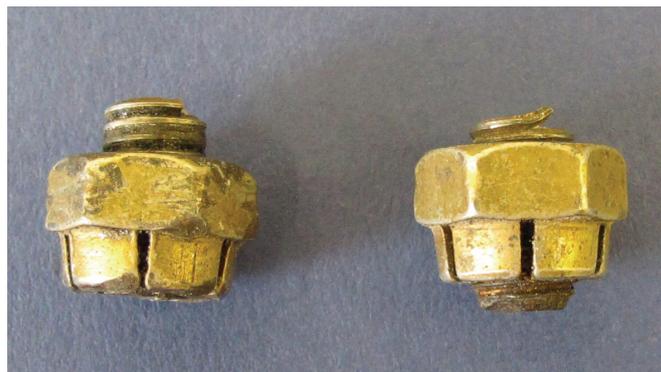
Figure 3

It was also evident that the nut on one of the bolt ends was not ‘in safety’ as there were no threads protruding beneath the nut (left nut in Figure 3).

Failed bolt ends that had evidence of fatigue on thread fracture surface

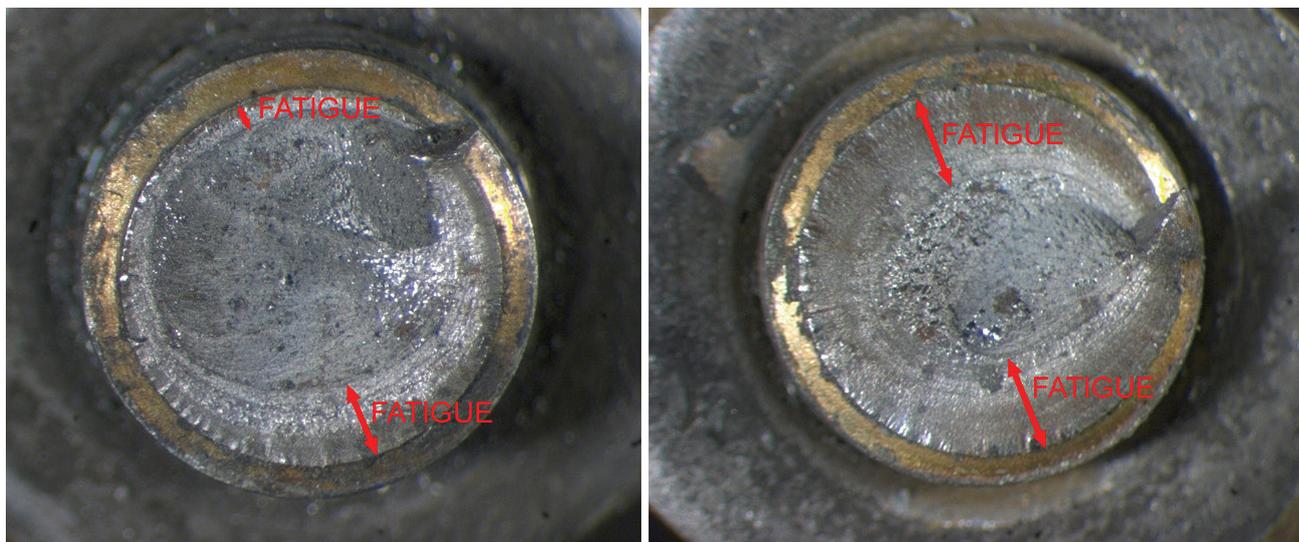
Figure 4

Fracture surfaces of the failed bolt ends showing fatigue features at the thread

As part of the repair work the engineer decided to replace the attachment bolts on the left main gear leg as a precautionary measure. He recalled that one or two of the nuts on the lower attachment bolts were slightly loose by about half a turn. Unfortunately these bolts were not retained so they could not be measured for indications of stretch.
