CONTENTS

SPECIAL BULLETINS

COMMERCIAL AIR TRANSPORT

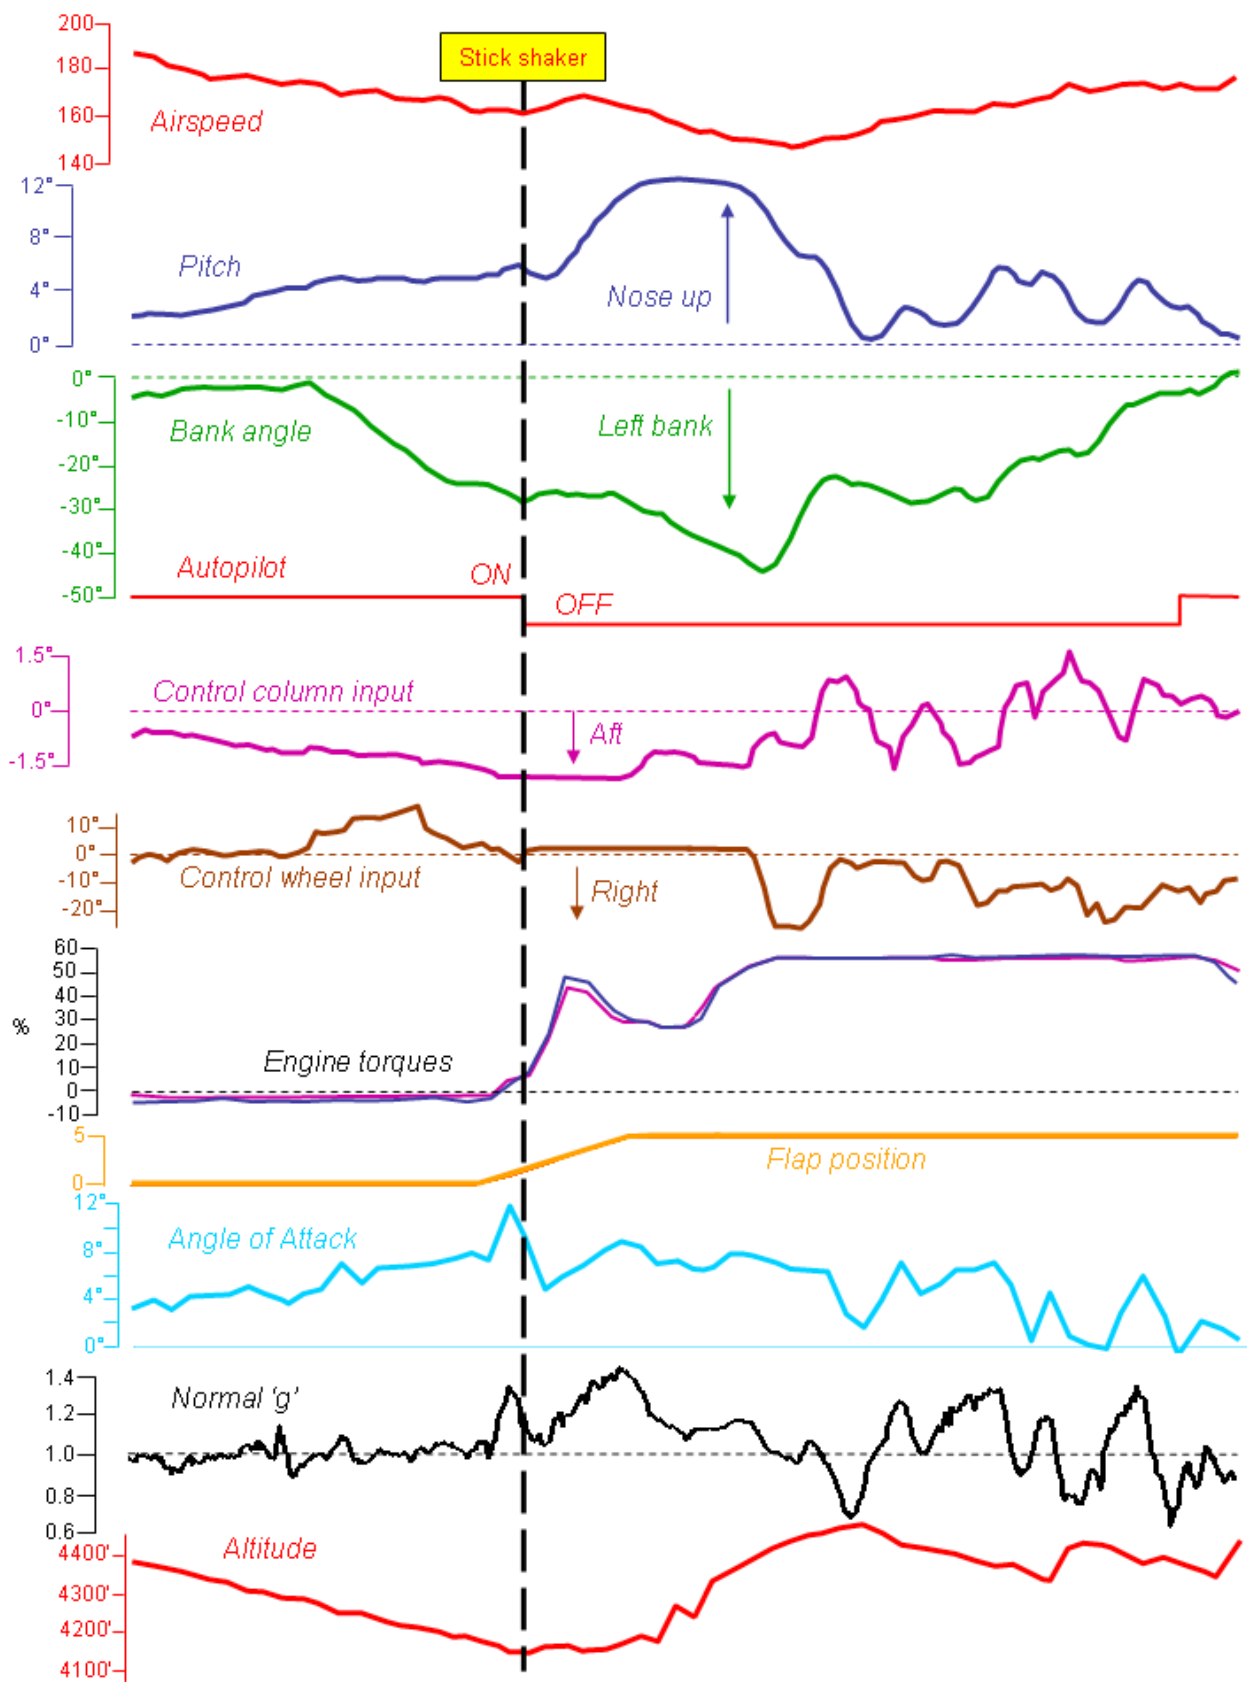
Figure 1

Relevant FDR parameters over a 65 second period surrounding the stick shaker event (simplified)

As the pitch approached its maximum value, about four seconds after autopilot disengagement, there was a small forward movement of the control column, which was soon removed, with no wheel displacement. Only when the bank angle increased beyond 40° was a large lateral control wheel input made, which corrected the overbanked condition. This was about 13 seconds after autopilot disengagement.

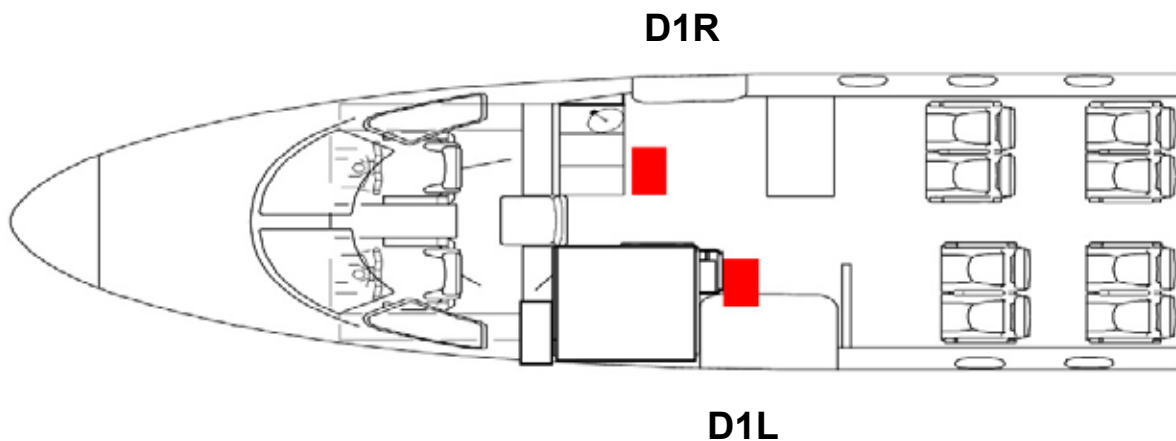
Figure 1

approximately midway up the cabin, over the wings. On hearing the order to evacuate, the cabin crew opened their allocated doors, the escape slides inflated automatically. The SCCM initially prevented passengers using Door 1 Left (D1L) as the slide had not fully inflated by the time the first passenger arrived there. Once it was fully inflated, the SCCM had to push himself past the flow of passengers to reach Door 1 Right (D1R) to open it. He commented that had he opened this door first, given the layout of the cabin, he would not have been able to push past passengers to get to D1L (Figure 1).

Forward cabin layout, showing forward exits (Doors 1 Left and Right)

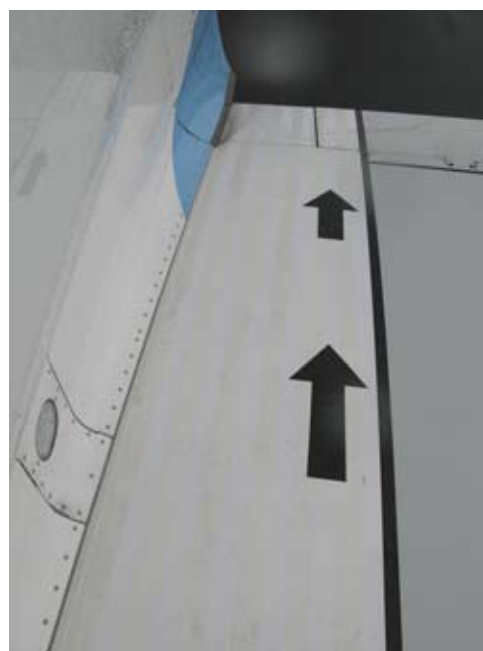
Figure 3

Two male passengers who evacuated via the overwing exit were able to jump down from the rear of the wing and assist other passengers to the ground. This included a mother carrying a baby. They believed that had they not been able to offer such assistance, it is likely that some of the passengers might have received serious injuries in attempting to climb off the wing. Passengers believed that the situation would have been worse had it either been raining or dark at the time of the evacuation.

Overwing exit evacuation route markings (left wing shown, view towards wing trailing edge)
