CONTENTS

SPECIAL BULLETINS

COMMERCIAL AIR TRANSPORT

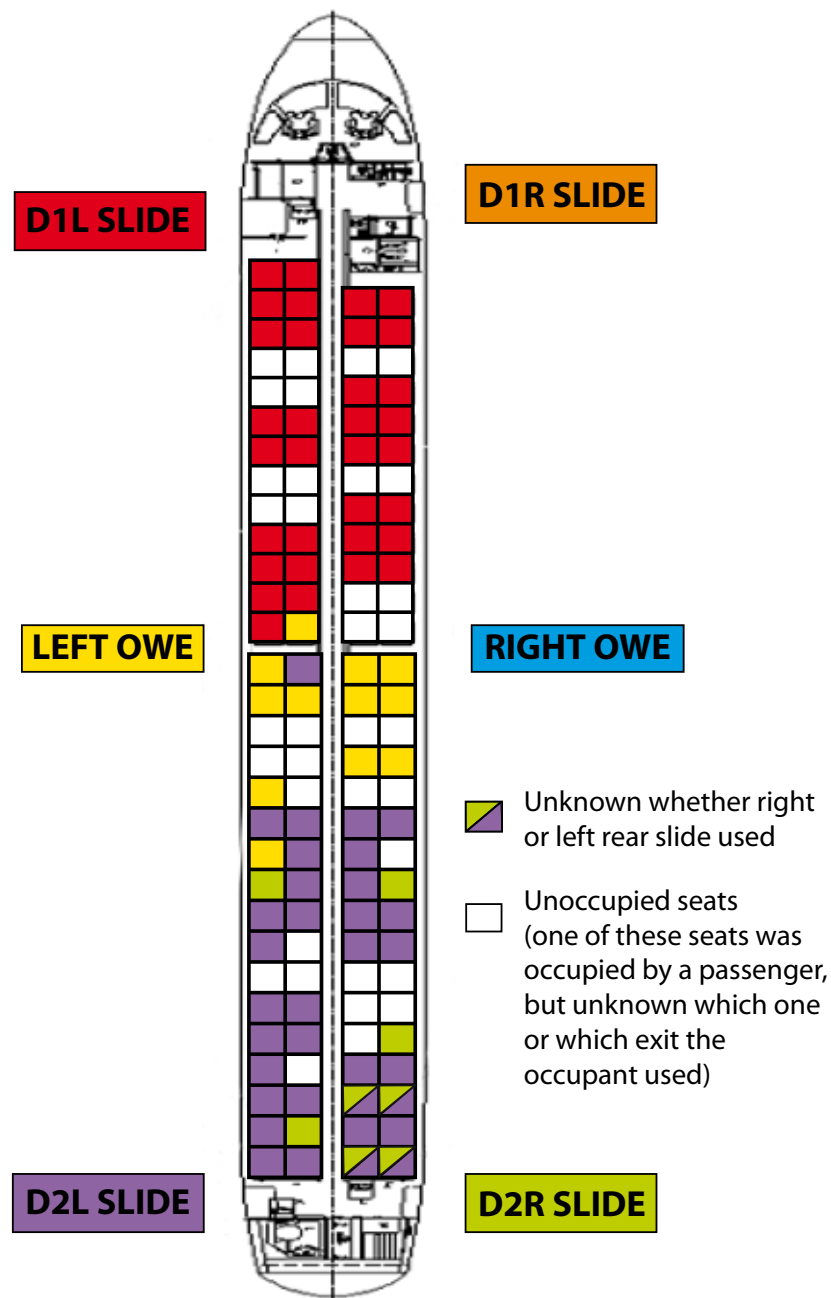
Figure 4 illustrates the exits used by the passengers, correlated by seat position. It shows that no passengers used D1R, despite this door being open with the slide
