CONTENTS

SPECIAL BULLETINS

(ALL TIMES IN THIS BULLETIN ARE UTC)

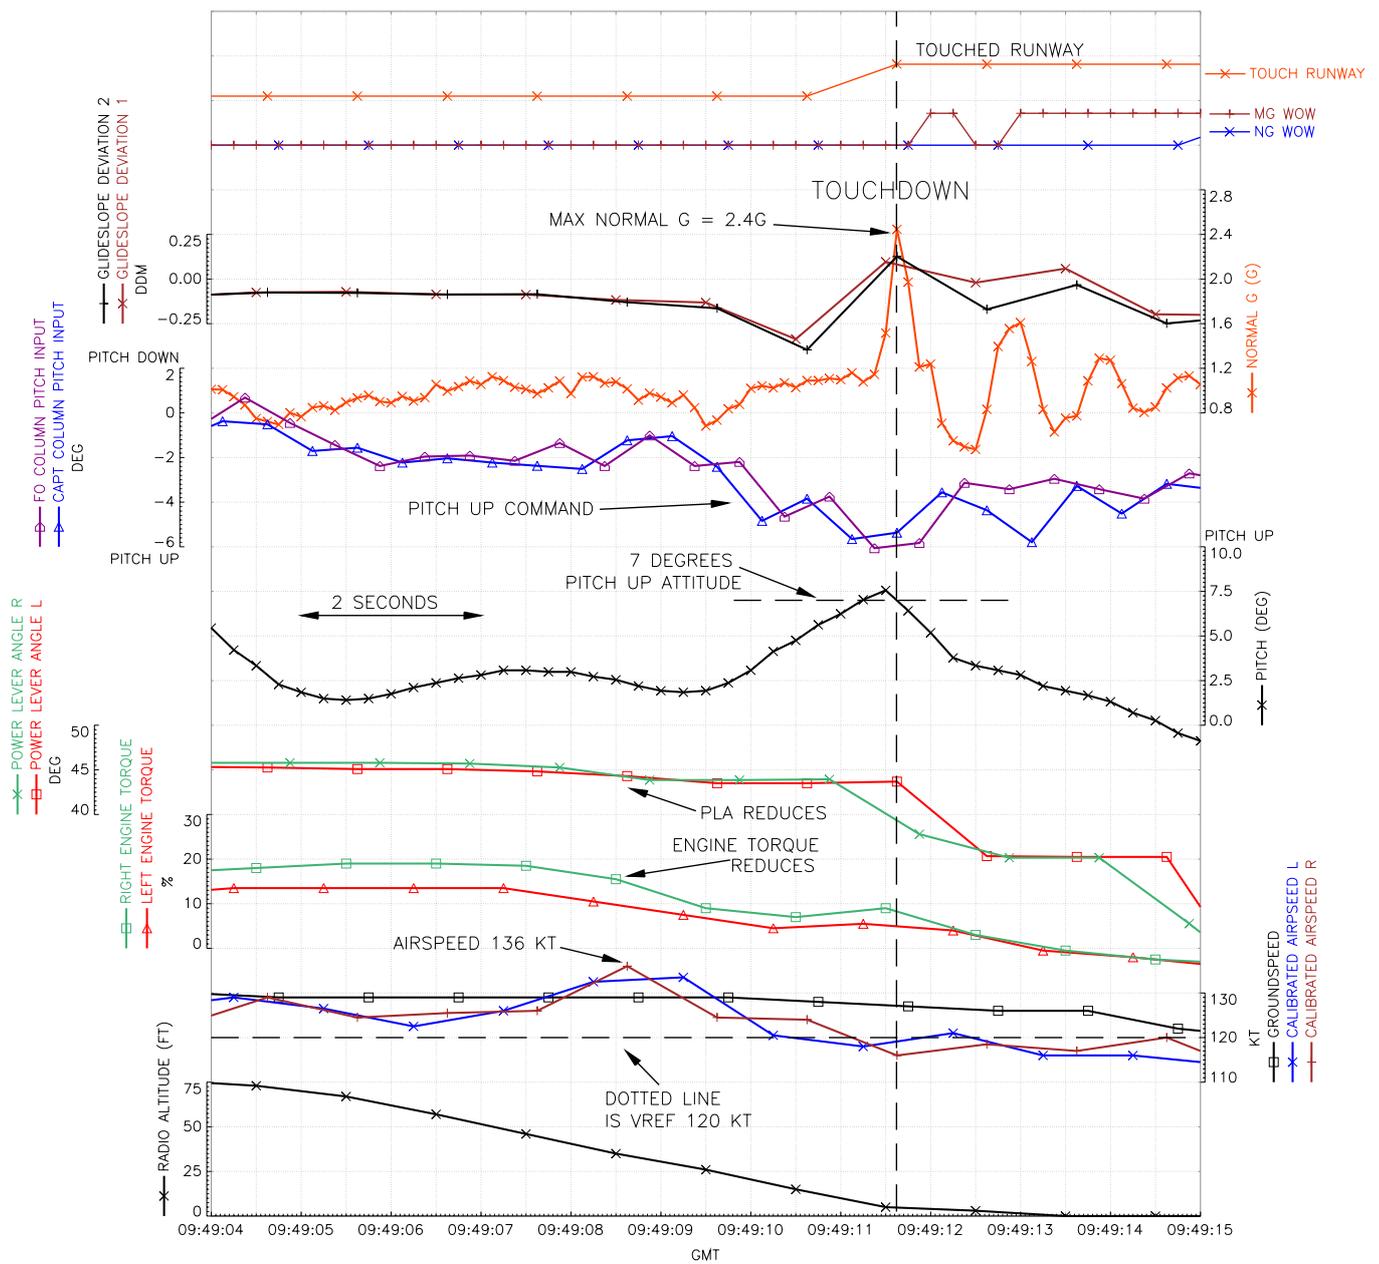
Figure 1

Structural damage

The fuselage lower skin was extensively damaged by abrasion over a region that straddled the centreline and extended some 2.25 metres longitudinally, and 0.75 metres laterally. Associated deformation of fuselage frames was also evident and the skin was fully penetrated by abrasion in the same area.

A scrape mark some two metres long was found on the runway near the threshold, approximately one metre to the right of the runway centreline. The scrape started at a point, and broadened to a maximum width of about 0.75 metres at its furthest point, consistent with the damage to the aircraft.
