CONTENTS

(ALL TIMES IN THIS BULLETIN ARE UTC)

SERIOUS INCIDENT

Aircraft Type and Registration:	Airbus A340-642, G-VYOU	
No & Type of Engines:	4 Rolls-Royce RB211 Trent 556A2-61 turbofan engines	
Year of Manufacture:	2006	
Date & Time (UTC):	12 December 2009 at 1657 hrs	
Location:	London Heathrow Airport	
Type of Flight:	Commercial Air Transport (Passenger)	
Persons on Board:	Crew - 16	Passengers - 282
Injuries:	Crew - None	Passengers - None
Nature of Damage:	None	
Commander's Licence:	Airline Transport Pilot's Licence	
Commander's Age:	50 years	
Commander's Flying Experience:	16,432 hours (of which 10,833 hours were on type) Last 90 days - 164 hours Last 28 days - 38 hours	
Information Source:	Aircraft Accident Report Form submitted by the pilot and further enquiries by the AAIB

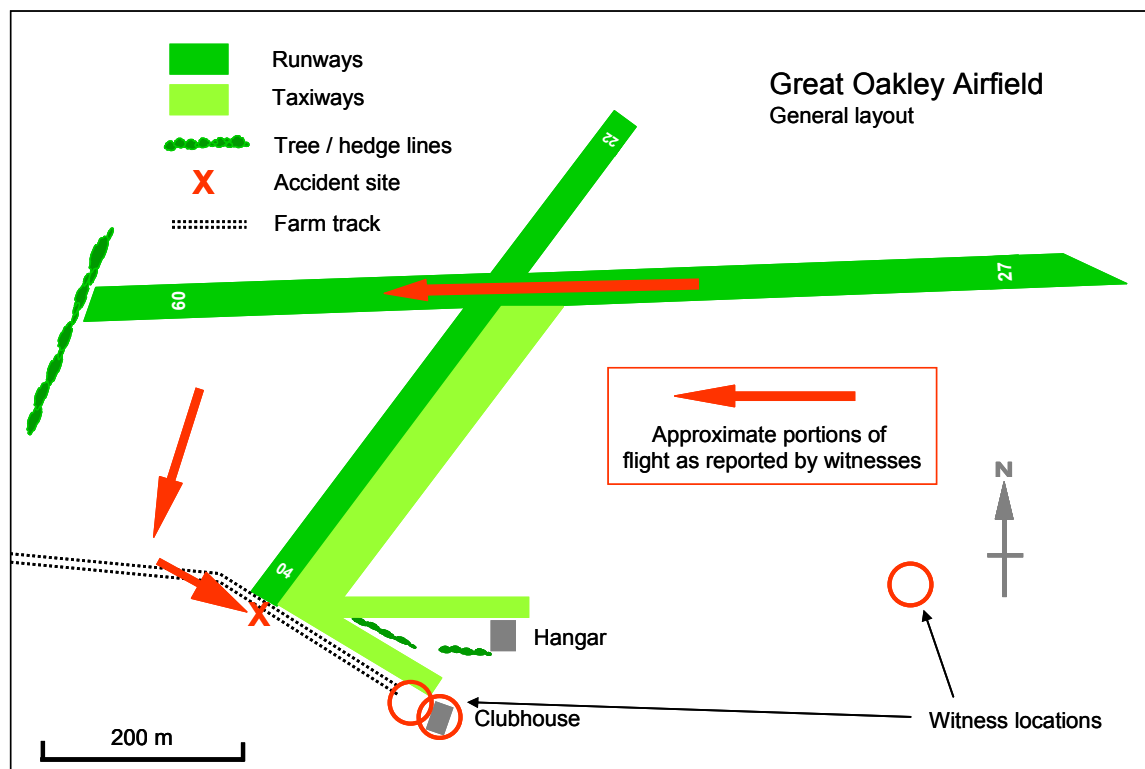
Figure 1

General layout of Great Oakley Airfield.
Portions of the flight seen by witnesses are shown

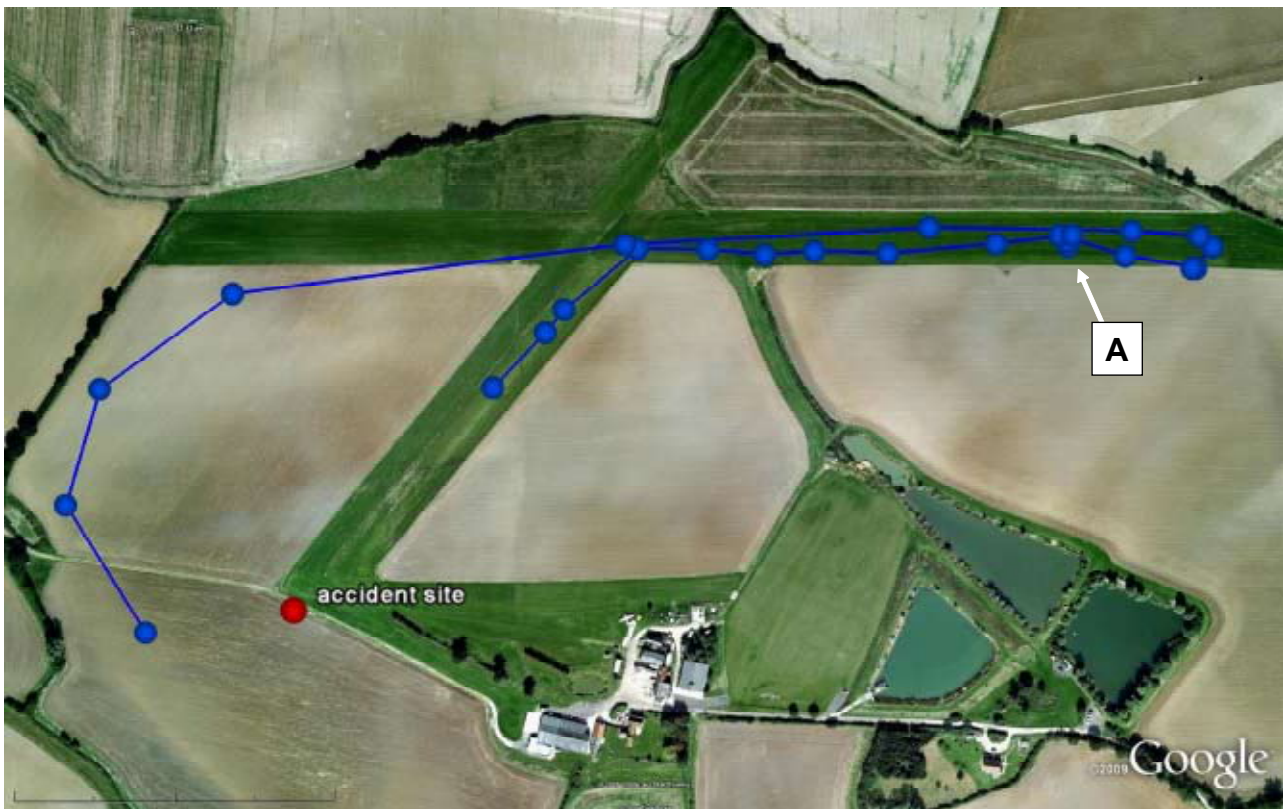
Figure 2

The track of the accident flight is shown at Figure 2. The recording starts at 10:37:20 hrs as the aircraft was taxiing prior to takeoff and ends at 10:42:43 hrs, near the accident site. The track shows that the aircraft entered Runway 09 and taxied part-way along it, before stopping for approximately one minute, presumably while the pilot carried out his before takeoff checks (position A of Figure 2). The aircraft then continued taxiing to the takeoff point. The average groundspeed between each GPS track point is presented in Figure 3.

GPS track of the accident flight.

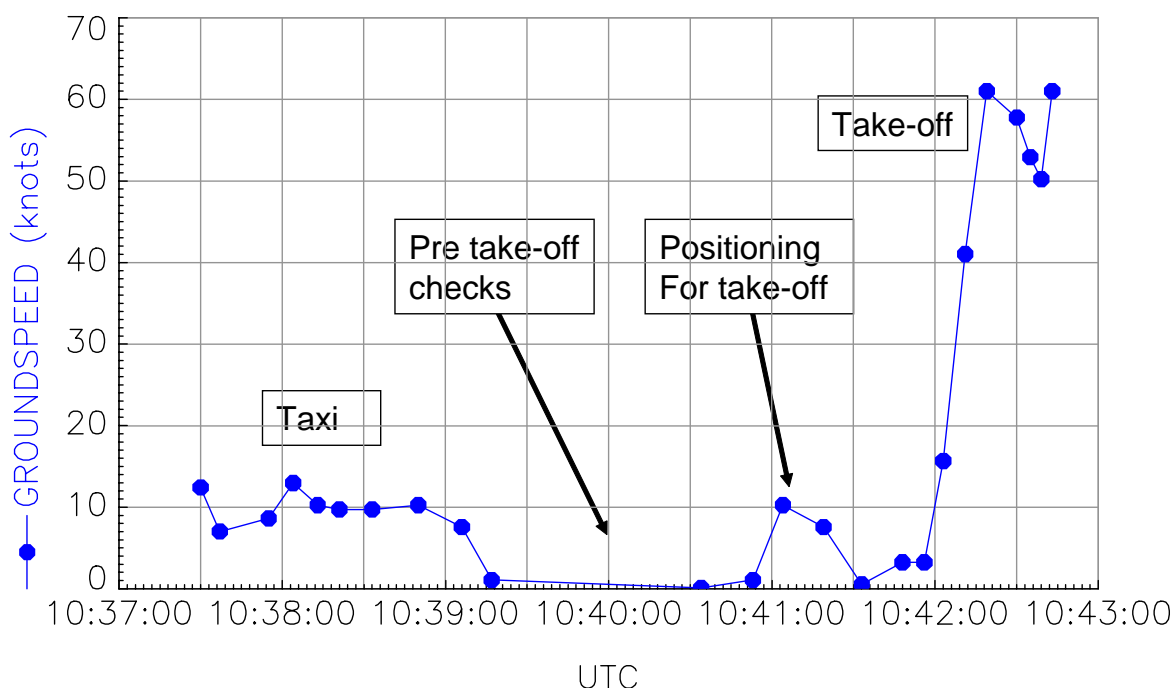
Figure 3

Accident flight calculated groundspeeds
